# An investigation of the Brumadinho Dam Break with HEC RAS simulation

Arun Raman<sup>1</sup>, Fei Liu<sup>2</sup>

<sup>1</sup> *New Jersey West Windsor - Plainsboro High School N*

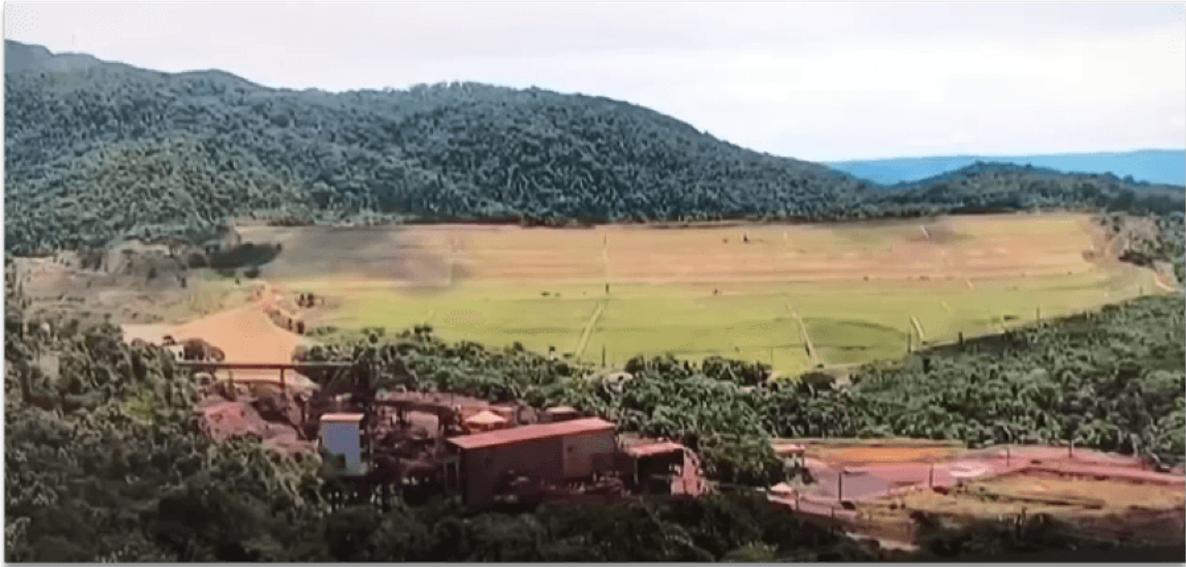
It is believed that sliding is the most likely cause of dam failure. From Figure 2, it is visible that the bottom portion of the dam is slowly creeping forward. This action diminishes the stability of the top portion, causing a total collapse and subsequent flood. The failure was caused by a design error present in upstream tailings dam. Evidence from the video footage suggests that the Brumadinho dam failure can be explained by the analysis presented in [21] and mismanagement of the mining company. Tailings dam requires continual monitoring for potential safety risks as the risk of failure increases with time, often inadequately examined in a laboratory environment. As noted in [21], an August 2018 (5 months before the failure) audit of the Brumadinho dam yielded the conclusion that the dam was stable.

Figure 2: Dam at the moment of the collapse

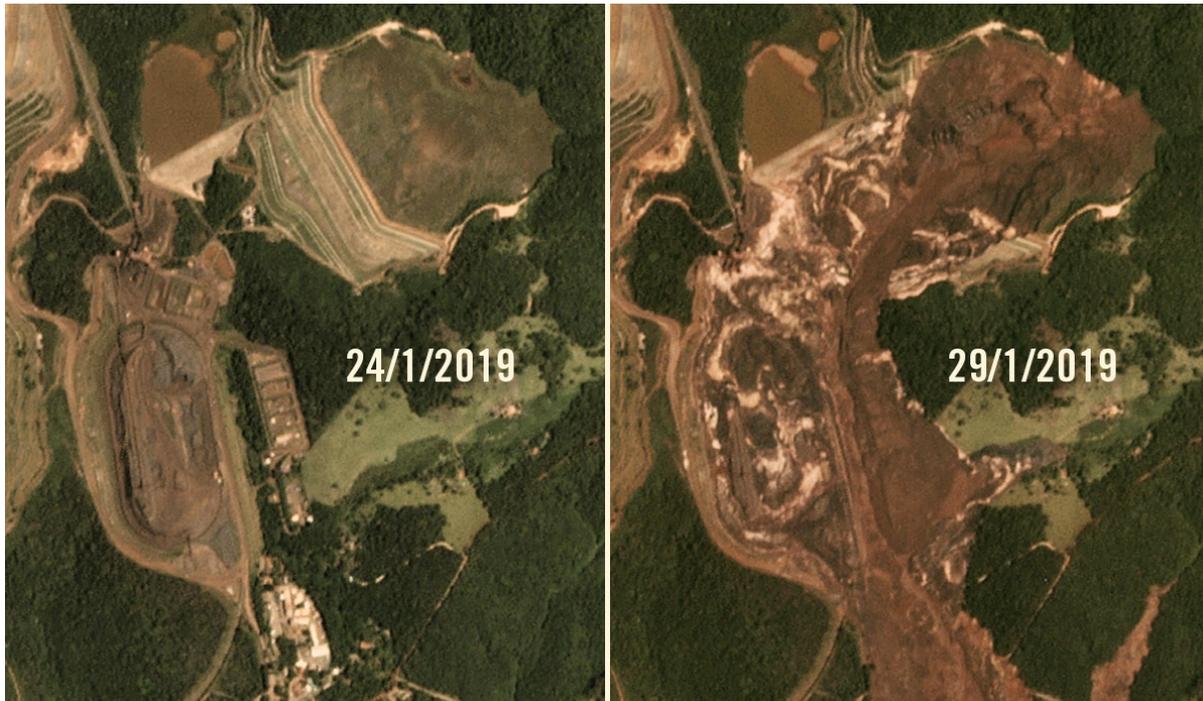
The Brumadinho dam broke during local lunchtime and subsequently the mud stored in the dam flew to the Paraopeba river after around 3 hours from the initial break. The event lasted a few more days as mud kept creeping both upstream and downstream along the river. The effect of the dam break near the dam can be seen in Figure 3 [22]. Due to the unfortunate timing of the break, most casualties took place in the dam worker's cafeteria as it was lunch hour when the dam broke.

Figure 3: Satellite image of the dam before and after the dam break

The Brumadinho dam break, due to mishandling of mining waste and inadequate dam maintenance, caused significant human life and property loss. Such a tragedy could have been avoided if simple precautions were taken. For instance, it was erroneous to place the work lounge and cafeteria on the low-ground directly beneath the dam. The majority of the human casualties due to this event would have been avoided if the lounge and cafeteria were placed on the high ground on the right side of the dam. It can be seen from Figure 3 that the right side of the dam was largely intact due to its elevation.

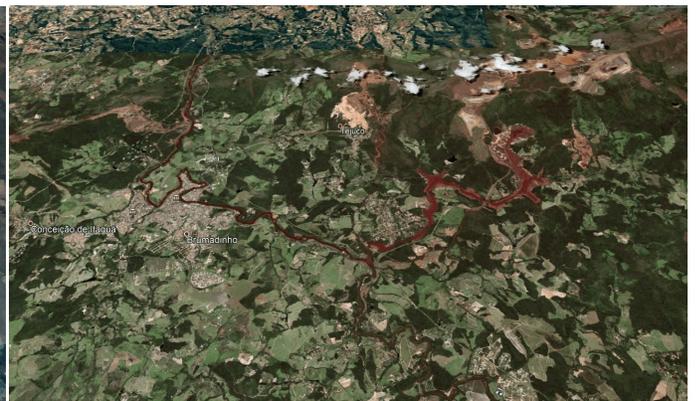
Figure 5: Extension of the mud-flow along the Paraopeba river

A video captured during the onset of the dam break by a local TV station [24] shows the bottom of the dam giving away due to structural failure leading to the entire dam's collapse on Jan 25, 2019. Over 12 million cubic meters of waste rushed downstream, contaminating the Paraopeba river with a large extension (Figure 6). The simulation of the dam break shows an astounding similarity between observed and modelled inundation patterns in overall and selected

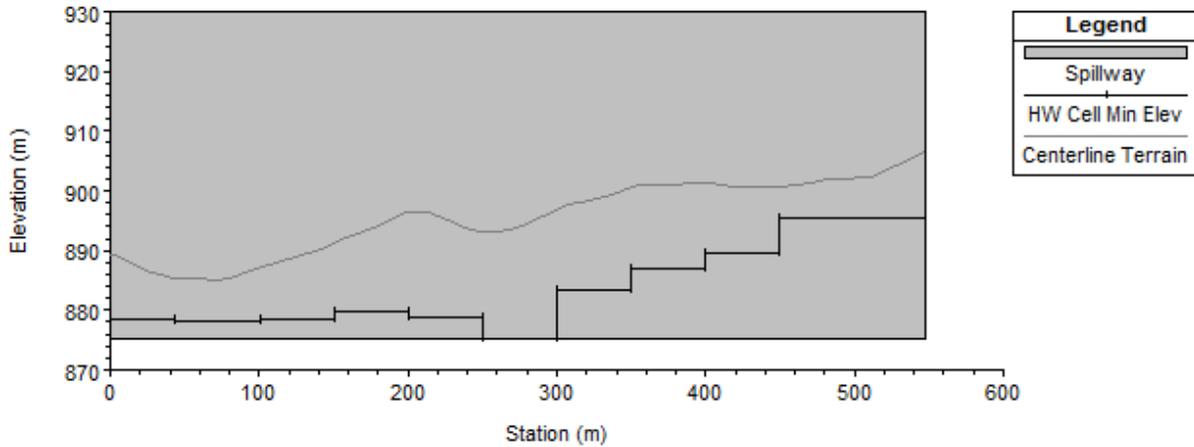
The set up of the dam and breach plan is shown in Figure 8, which demonstrates that the left side of the dam is significantly lower than the right. This led to more significant erosion occurring to the left side of the breach during the dam break as can be seen in Figure 3.

Figure 8: The dam modelled as 2D flow area and storage area connection

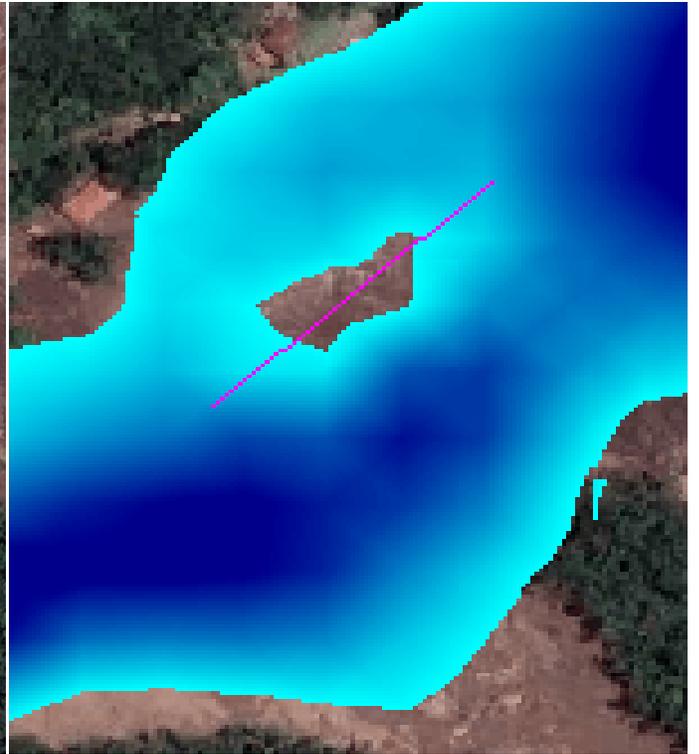
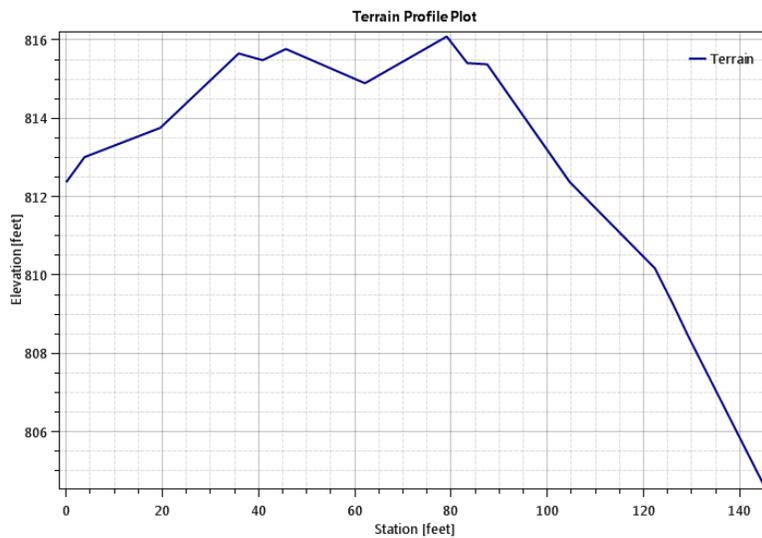
A location of interest is shown in Figure 15 and 16. It can be seen that in the image of the simulated result 16, there is a small area without flooding. Upon closer examination of the

satellite image and the bottom topography height along the line in 16, a local high ground is revealed 17 at this spot that pushes mud flow to circumvent around the local high ground.

Figure 16: Loc. 3: HEC-RAS

Figure 17: Terrain plot of Loc. 3 as shown above
