# Reconstruction of the collapse of the ‘Azure Window’ natural arch via photogrammetry.

## Abstract

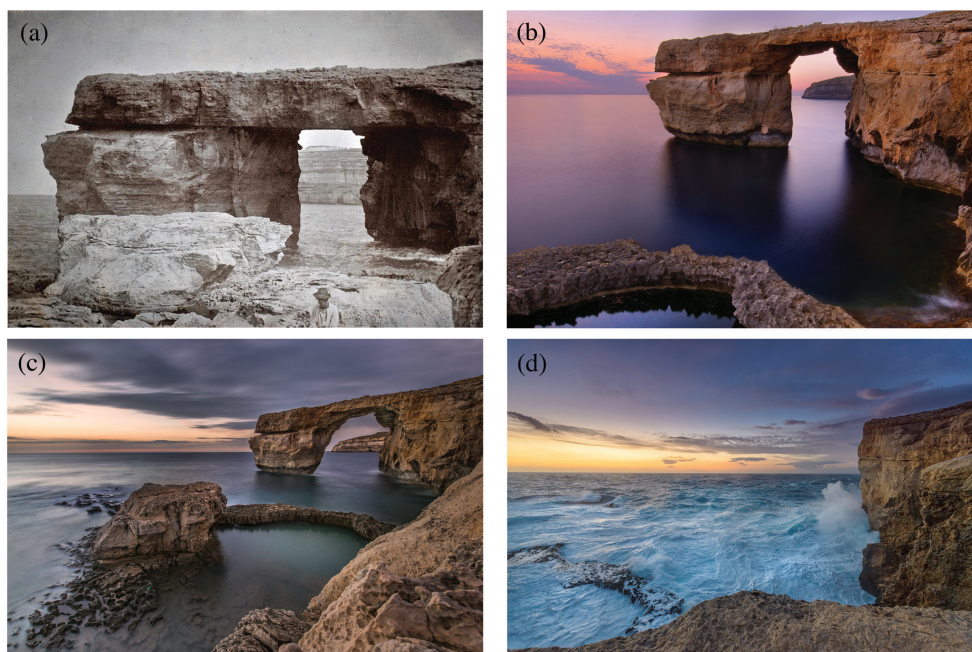
Figure 3: This sequence of images shows the deterioration of the arch leading up to its collapse. Panel (a) is a photograph by Richard Ellis from *c.* 1900, in which the arch exhibits a rectangular shape (practically identical to that visible in the 1981 film ‘Clash of the Titans’). Panel (b) is an April 2011 photograph that shows substantial thinning of the arch’s ceiling. Also visible is a long crack in the pillar that had developed by this time. Panel (c) is an October 2012 photograph in which one can observe a wider arch due to the collapse of a large segment of the pillar, which detached along the crack visible in panel (b). Panel (d) is a photograph of the site on the evening of the arch’s collapse on the 8th of March, 2017. Although the weather conditions were worse at the time of collapse, significant wave action can still be seen. Photo (a) is being used with the permission of Giovanni Bonello. Photos (b)-(d) are copyrighted by J. Caruana.

to its demise. From a very rectangular form (Fig. 3a) it progressed to an arched aspect due to bridge-thinning (Fig. 3b), losing a significant segment from the pillar in 2012 (Fig. 3c), and collapsing 5 years later (Fig. 3d).

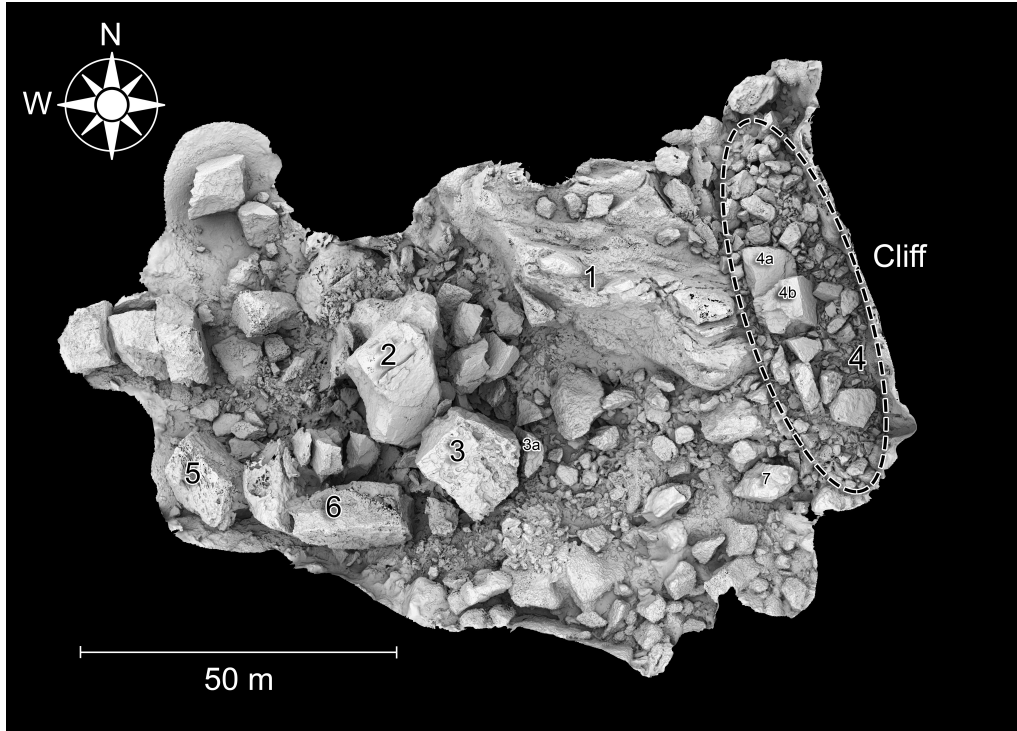
Figure 7: Ortho-image of the site of the former Azure Window generated with the software Metashape, xNormal, and Cloud Compare. Principal identified components are as follows: [1] Base of the pillar; [2] Attard member of pillar; [3] Component from Xlendi/Mara region atop pillar; [4] Remains of the Azure Window's bridge, with '4a' and '4b' being the bridge's two main components; [5] Component from Xlendi/Mara region atop pillar; [6] Component from Xlendi/Mara region atop pillar; [7] Attard member of pillar that collapsed in 2012. The vertical cliff to which the arch used to be connected is labelled on the right.

Referring to Figs. 7 and 11, Component 1 is the base that supported the Azure Window's pillar. Component 2 in Fig. 7 is part of the original pillar (Attard member, with Xlendi parts on the face that was previously in contact with the Xlendi component), whereas Components 3, 5, and 6 are sections from the top part (Xlendi/Mara) above the pillar. The boulder field (4) located right underneath the original location of the bridge consists of its fragmented remains.

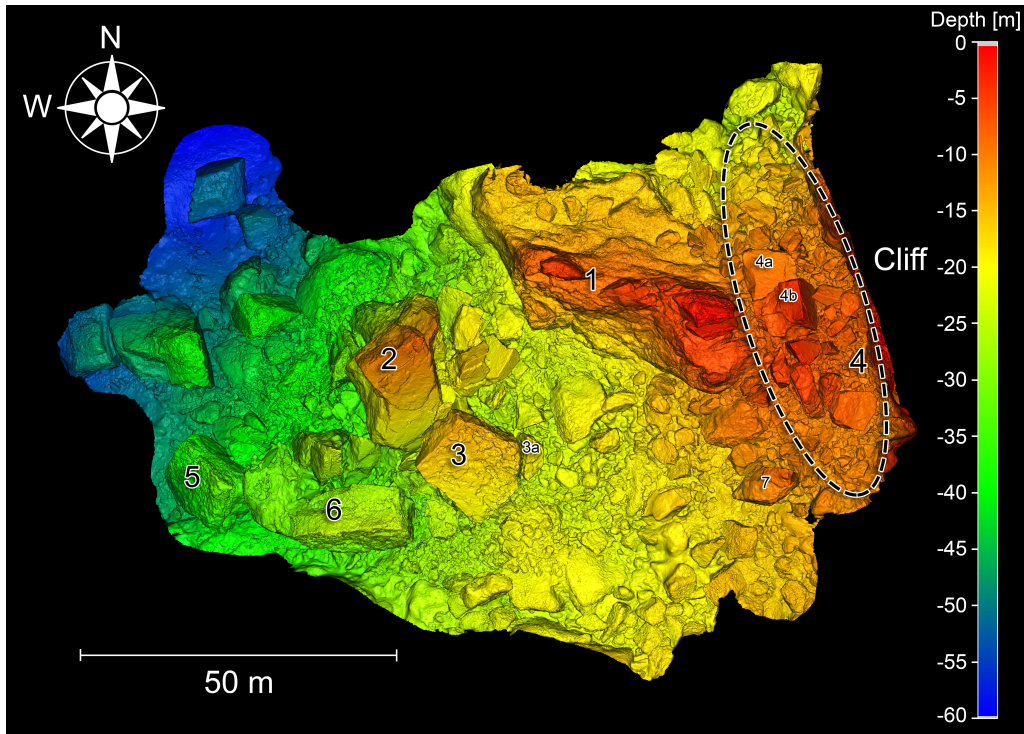
Figure 8: Depth-map of the site of the former Azure Window generated with the software Cloud Compare. Identified remains are scattered across a wide range of depths, from  $\approx 3$  m below the surface down to  $\approx 60$  m. The seabed slopes from shallow waters in the east to deeper waters in the west.

From Fig. 8 one may appreciate how the seabed exhibits a slope from shallow waters in the east (beneath the cliff) to deeper waters in the west.

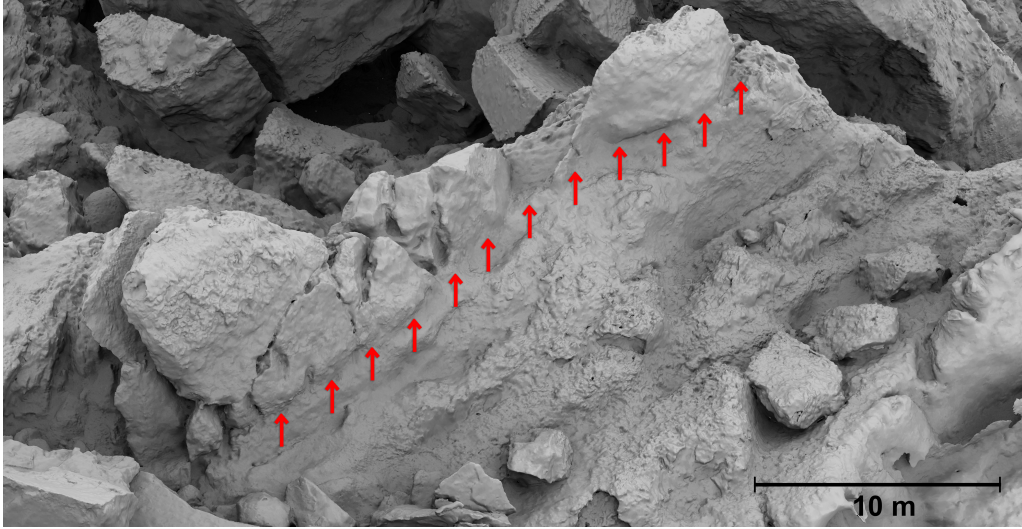
1. 40 m long  $\times$  14 m wide (at base)  $\times$  15 m high ridge that tapers upwards towards the surface. The top of the ridge has a jagged surface with pointy sections, cracks, and steps which seem to follow the joint pattern of the rock. The northern flank has a regular notch at a depth of  $\approx 8-9$  m (see Fig. 9). Sections of the ridge in the north and northwest exhibit a stepped morphology, with the deepest point sitting at  $\approx 28$  m. The ridge extends to very shallow waters in some areas, with the shallowest section ( $\approx 1.4$  m) being located to the east.

Figure 9: An ortho-image of Component 1, derived from the model using the software Metashape and Cloud Compare. The image shows the view when looking towards the southwest, exhibiting the northern face of the ridge (running diagonally from lower left to upper right of this image). The ridge, which tapers upwards towards the surface, exhibits a regular notch at a depth of  $\approx 8\text{-}9\text{m}$  (marked with arrows) and several cracks and steps.

The cause of the collapse of the pillar section is likely erosion at its base. The tapered ridge as well as a notch that was formed at the base of the pillar (Fig. 9) clearly point to progressive loss of support. (See Fig. 13 for side-views of the pre-collapse Azure Window and the post-collapse base of the pillar.) The end-result was that no stack remained above the waterline. The collapse was precipitated by the violent storm that battered the site at the time, with numerical models of meteo-marine fields yielding wave-heights of up to around 3 m and wind-speeds larger than  $16 \text{ ms}^{-1}$  (see Fig. 5 in Galea et al., 2018), in agreement with wind records that show wind gusts reached  $\approx 18\text{-}20 \text{ ms}^{-1}$  before the collapse.

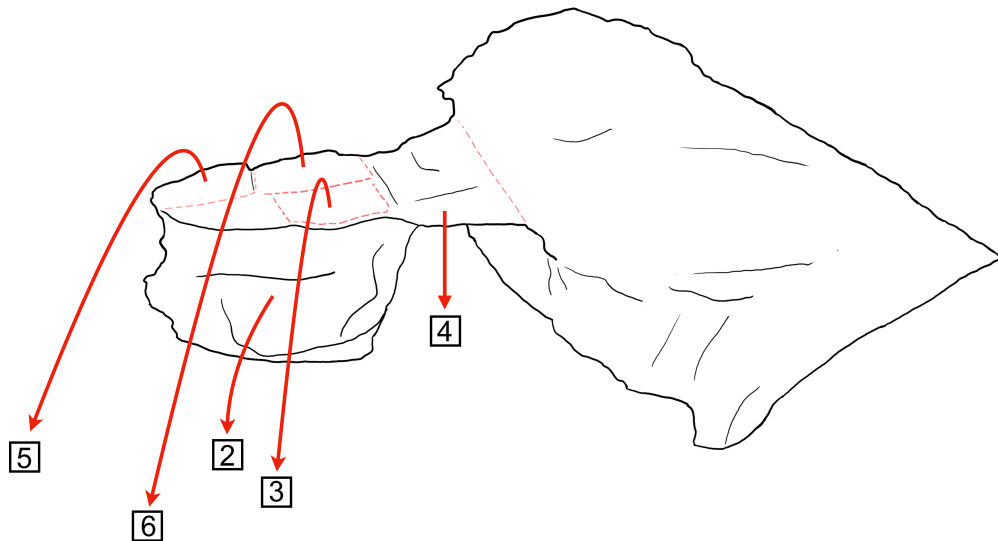
We therefore reconstruct the collapse of the Azure Window as follows. The entirety of the pillar section above the waterline collapsed in the southwest direction, breaking into two principal components, '2' and '3' in Fig. 7, their shortest distance from the base of the pillar being  $\approx 13$  m and  $\approx 17$  m respectively. Other blocks of modest size and smaller fragments strewn in the vicinity of these large blocks represent other pieces from the collapse. The clean separation of components according to their type - e.g. '2' being Attard, and '3' and '5' being Xlendi/Mara - clearly indicate separation along the lithological boundary. It is also evident that separation of pillar segments followed pre-existing jointing; from Fig. 12, which shows three of the components ('3', '5', and '6') overlain on a pre-collapse aerial photo of the Azure Window, it can be appreciated that these fit perfectly within the outline formed by these joints. Some nearby chunks of rock from the collapse may either be slabs that failed before the pillar collapsed, or fragments that were formed following impact of the pillar with the seafloor. The final resting position of the principal components, wherein the most northerly sections (Components 5 and 6) ended up in the southernmost region of the seabed and vice-versa (see Fig. 11), corresponds to a scenario whereby the pillar toppled as one whole piece (towards the southwest), breaking up upon impact with the seafloor.

The bridge (Component 4 in Fig. 7) collapsed vertically upon loss of support from the pillar, and broke into two main components ('4a' and '4b'), with the rest of it fragmenting into smaller pieces strewn across a  $\sim 1,000$  m<sup>2</sup> area (the boulder field marked '4' in Fig. 7). This breakup is consistent with the nature of the Xlendi and Mara members and their closely spaced jointing, as described in Sec. 2.1. The reconstructed series of events is

Figure 11: A simplified sketch that illustrates the final resting position of principal components of the Azure Window. Top sections (Xlendi/Mara) from the pillar [3, 5, 6] collapsed to the southwest, as did a large segment of the Attard member of the pillar [2]. The bridge [4] collapsed vertically upon loss of support from the pillar.

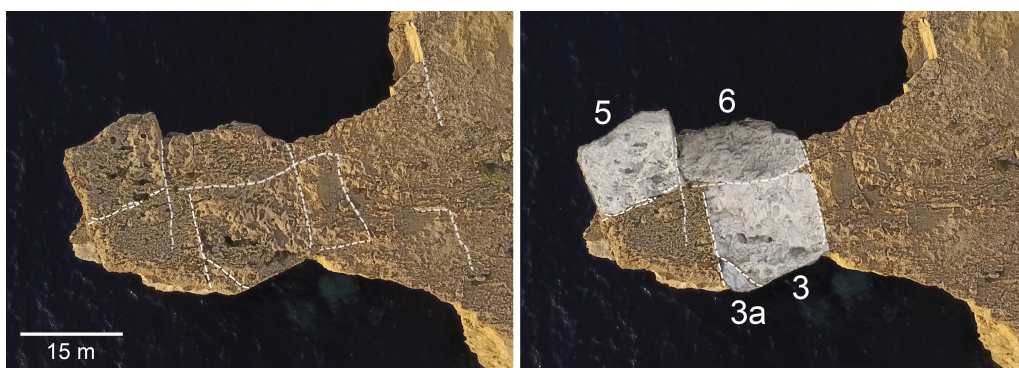
Figure 12: Surface lithology of the Azure Window. Dotted lines mark some prominently visible joints on the surface of the bridge. The right panel shows (in greyscale) three of the components extracted from the 3D-model of the underwater site overlain on the pre-collapse photo. It is clear that breakup of the Xlendi and Mara members atop the pillar followed the contour delineated by pre-existing jointing. (Image copyright: J. Caruana.)

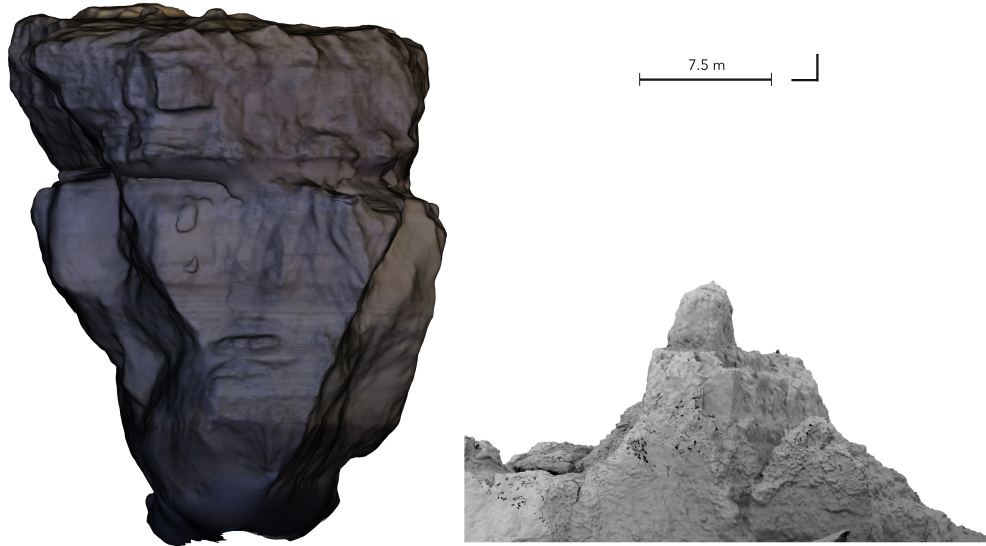
Figure 13: On the left, a side-view of the 3D-model of the (pre-collapse) Azure Window. On the right, a side-view (from the same angle) of the 3D-model of the (post-collapse) base that supported the pillar. (For both panels, the view is facing East.)

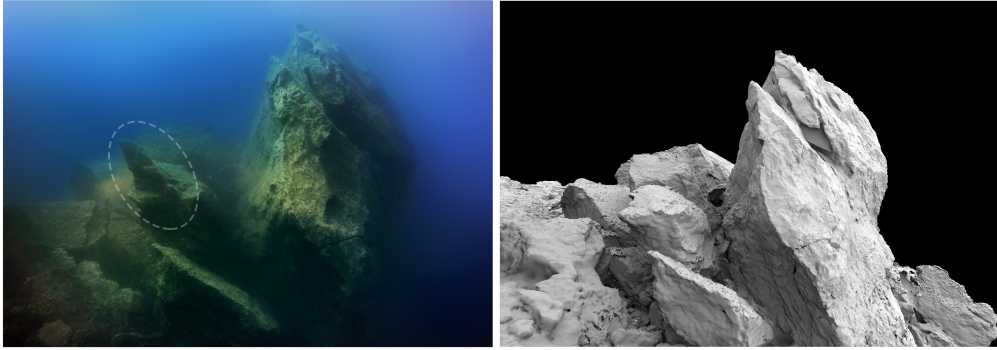
Figure 14: Comparison between a photograph acquired on the 22nd of August, 2018 and present-day photogrammetric representation of the same site, where the large component on the right is the Attard member of the pillar (i.e. Component [2] in Fig. 7). Note the collapse of the feature circled in the photograph. (Left image is copyrighted by J. Caruana.)

Noteworthy instances of collapse have also been recorded, specifically in unstable/fragile rock formations that were particularly susceptible to destabilisation, as can be seen in Fig. 14. In this case, we also note that the formation happened to be completely exposed to the northwest, which probably exacerbated its condition. These observations lead us to anticipate that the morphology of some of the components might see further changes in the short-term.
