# A strategy to identify breakdown location in MITICA test facility: results of high voltage test campaign

*Abstract – The Acceleration Grid Power Supply of the MITICA test facility in Padova (Italy) is currently under commissioning. The power conversion system, the DC generator, and the High Voltage equipment have been individually commissioned, whereas the integration tests are ongoing. It is a challenging process due to the unconventional application, to the variety of different electrical technologies involved and to the complexity of the interfaces.*

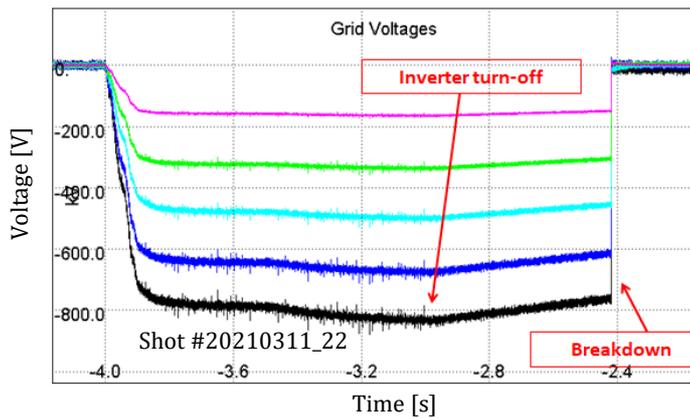
After some days of successful operation, where the capability of the system to sustain voltage as high as 700kV in stable operation for at least 1000s has been demonstrated, an event occurred during a pulse at 800kV, see Fig. 4. The event was experienced as a strong noise captured by the microphones placed in the High Voltage Hall (the building where the HVD1 and DL are installed). Looking at the grid voltages, which suddenly fell to zero, it was clear that a breakdown was triggered somewhere in the plant.

Fig. 4 – Voltage of the grids in pulse #20210311\_22. Same color code as Fig. 3. A breakdown occurred at about -2.4s.

The following inspection of the plant did not show sign of BD neither in SF<sub>6</sub> insulated components nor in air, but a broken diode bridge arm in one DCG stage was detected. The analysis based on circuit simulations taking into account stray parameters of the DCG gave a convincing explanation of why the diode bridge was damaged, highlighting that the voltage surge caused by a BD in the plant could damage the first stage of the DCG due to excessive overvoltage. However, the position of the BD was not found in the inspection. Being the AGPS out of service due to the fault in the diode bridge, it was decided to check again the voltage withstanding capability of the HV equipment by using the TPS, connected in place of the AGPS-DCG. The test consisted in increasing the voltage in steps up to the nominal value and check that the equipment was able to sustain the voltage, confirming the results of the acceptance tests. However, immediately after reaching -1MV dc, an arc in air was triggered at the top of the -1MV Insulating Transformer bushing, precisely between the guard rings and the AC line feeder terminals of the secondary side of the transformer, as indicated in Fig. 5. Thanks again to a analyses based on circuit simulations [8,9] which considered the contribution of transformer and bushing stray parameters, it turned out that a large transient overvoltage (more than 1MV), able to trigger an arc, can appear between the guard rings and the ac line terminals in case of BD on other parts of the system.

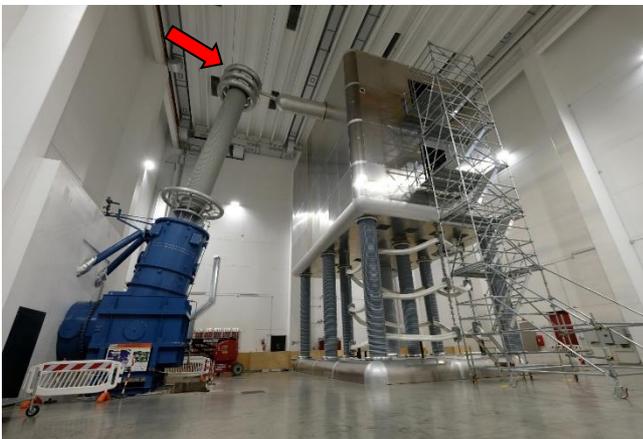
Fig. 5 – Picture of the HVH showing the position of the arc in air triggered during TPS test.

On the basis of these simulations, the most likely explanation appears to be that the arc was actually triggered by a first BD somewhere in the HV plant, which propagated an overvoltage at the top of the transformer bushing. Once triggered, the arc in air was sustained by the ac voltage until the opening of the protection breaker. Unfortunately, not all plant components could be inspected and none of the accessible components of the plant did show clear marks of BD, neither in air nor in SF<sub>6</sub>. Nevertheless, the integration tests were very useful to highlight that a BD in the plant is able to cause unexpected overvoltage on some components: this demonstrates the clear advantage of testing the HV equipment in MITICA in advance of the ITER installation. The location of the BD must be identified in order to get a full understanding of the phenomena and take the necessary mitigation actions. This is the reason why a strategy based on a new test campaign with increased diagnostic capabilities has been conceived as described in the next section. This strategy will be tested in MITICA but will give important information for the ITER NBI also.

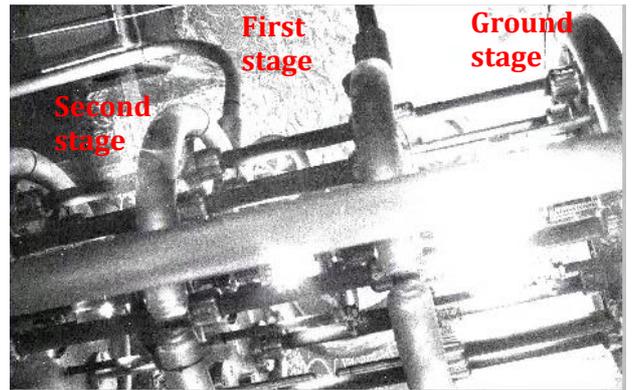
Fig. 11 – A frame of the slow camera C1 looking at the SCD, only some stages are shown. A BD between movable contacts is visible; the light is reflected by the internal wall of the vessel.

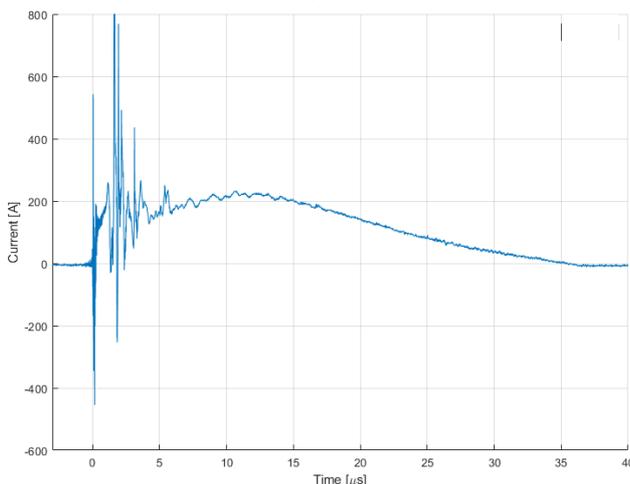
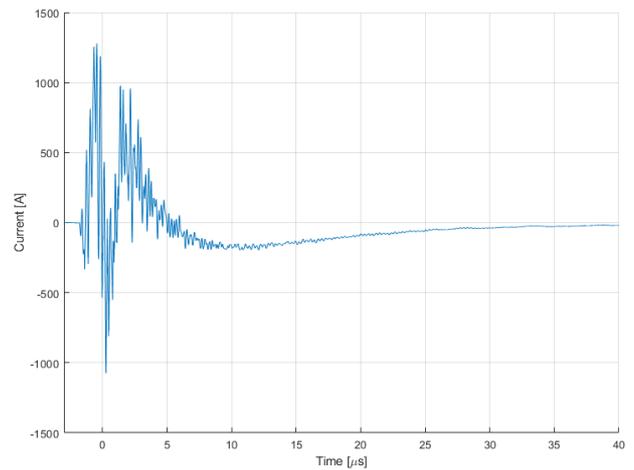
Fig. 12 – I0 (upper plot) and I2 (lower plot) signals recorded during the first event in Phase 2 tests. Both signals are compatible with a BD in vessel.

Inspection of the TPS showed signs of discharge in the output limiting resistor, likely due to the sudden overvoltage applied to this element at the onset of the BD.

The next round of tests started after the repair of the TPS, in July 2022. The diagnostic set was further enhanced with the addition of a fast camera (C0) looking at the vessel, with the introduction of an array of acoustic sensors all along the plant and the addition of more cameras in the HVH and inside the HVD1, pointing at the source of sound and other parts of the plant. After an analysis on the safe voltage limit, the length of the gaps has been increased to 70 mm to enhance the theoretical voltage withstanding capability of the equipment while preserving the protective function. The test was repeated as usual increasing the TPS voltage in steps and moving around the HVH partial discharge and corona sensors in search of a weak insulation area in air. Again, a BD was triggered at about 850kV, with the same pattern of events: light detected in the vessel, sound coming from the acoustic sensors, TPS protection tripping. No evidence of phenomena in air came from the HVH instrumentation also this time [6]. The fast camera was set to look at the fifth stage (1000kV-800kV) with a time resolution of about 1 μs, therefore we were able to capture the evolution of the BD in vessel, even though only a partial view was available. Fig. 13 shows a sequence of frames of the discharge, starting from the very first frame with light.

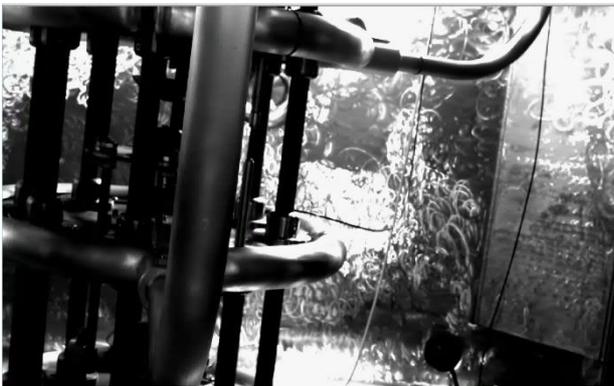
Fig. 14 – A frame of the slow camera C1 looking at the stage 400kV-200kV. The light seems to come from the region above the framing.

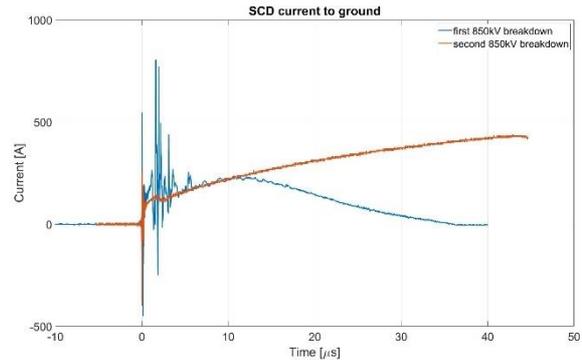
Fig. 15 –  $I_0$  signals recorded during the first event (blue curve) and second event (red curve).

The current seems to reach quite high values (up to 500A) and last for a relatively long time (probably more than 100  $\mu\text{s}$ ). The inspection following the event revealed marks compatible with a BD on fixed spark-gaps of the fifth (1000kV-800kV) and fourth (800kV-600kV) stages, but no other signs of BD elsewhere in  $\text{SF}_6$  or air equipment. This is not compatible with the information coming from C0 and C1 cameras and with the current showed in Fig. 15, as it seems that there is no path for the circulation of this current. In fact, cameras and marks confirm that the arc is not present on all SCD fixed gaps and apparently there is no way for the current to reclose through the cable connection between the last SCD stage and the vessel, where  $I_0$  sensor is placed. This inconsistency between signals and camera information is so far unexplained. The analysis is still going on also considering all other measurements in order to find a self-consistent explanation and inspection on other parts previously not considered.
