VISUAL, OPTICAL AND REPLICA INSPECTIONS: SURFACE PREPARATION OF 650 MHz NB CAVITY FOR PIP-II LINAC*

V. Chouhan[†], D. Bice, D. Burk, M. K. Ng, G. Wu, Fermi National Accelerator Laboratory, Batavia, USA

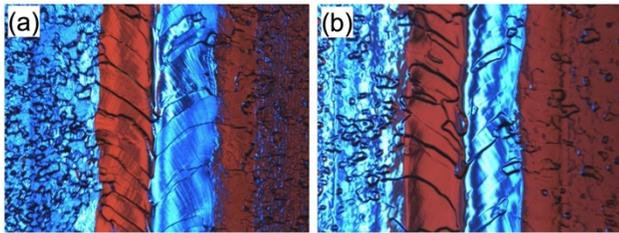
Figure 3: Optical image of the equator surface (a). LCSM images of replica surface representing the weld (b) and near-weld (c) equator positions.

To examine the surface, the entire equator surface in all 5-cells was scanned with the optical camera. A typical image of the equator surface is shown in Fig. 3. The optical inspection revealed a rough surface that differed from a standard electropolished surface. Although the optical images clearly showed that the surface was rough, it could not provide any information on roughness value. To obtain this information, a replica of the equator surface was created and examined using a laser confocal scanning microscope

(LCSM). The replica images for weld and near-weld zones on equator are presented in Fig. 3 (b) and (c). Average roughness R_a of near-weld surface was estimated to be ~8 μm and grain step height was measured to be ~32 μm . The roughness was significantly higher than the buffered chemical polishing (BCP) surface which is usually found very rough with grain step height of ~5 μm . The rough surface might be responsible for the low quench field.

The information obtained with optical and replica images played a crucial role in evaluating the EP performance. It became evident that modifications to the electropolishing conditions were necessary to achieve a smoother surface. A study was conducted to optimize the EP parameters, details of which can be found elsewhere [4, 5]. The cavity after reset EP under optimized conditions met the E_{acc} specification ($E_{acc} = 22.4 \text{ MV/m}$) set for the baseline test as reported elsewhere [5, 6].

Throughout the process of parameter optimization, optical inspections were performed at various stages to evaluate the surface yielded with different EP conditions. Figure 4 shows two images of the equator region, one after 70 μm removal under unoptimized conditions, and after 120 μm removal that included last 27 μm removal using the improved EP conditions. These images clearly demonstrate that the optimized EP process led to a smoother surface.

Figure 4: Optical image after unoptimized EP performed for 70 μm removal (b) Image after additional 23 μm removal with unoptimized EP and 27 μm removal with improved EP. Image size: 12 \times 9 mm.

Based on this feedback, two new cavities (B61C-EZ-101 and -104) were processed using the optimized EP conditions, taking into account the surface smoothening observed in the images.

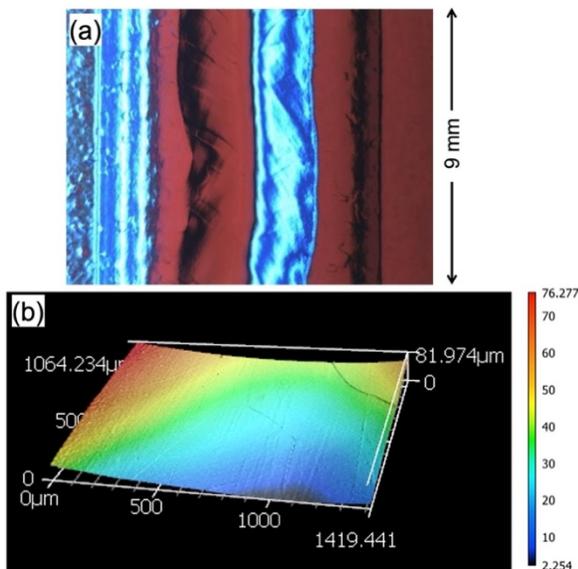
B61C-EZ-101 and -104: These cavities experienced optimum EP conditions in bulk and light EP [4, 5]. The cavity surface was examined with optical camera and by making replica. The replica that provided high-resolution features at the sub-micron level was inspected with LCSM. The optical and replica surface images after 120 μm removal are shown in Fig. 5. Average roughness R_a measured using LCSM was $\sim 0.6 \mu\text{m}$. The effectiveness of the optimized EP conditions was confirmed through these optical and replica inspections.

Figure 5: Optical image of typical equator surface of B61C-EZ-104 (a) and LCSM image of the replica representing the equator surface of B61C-EZ-101.

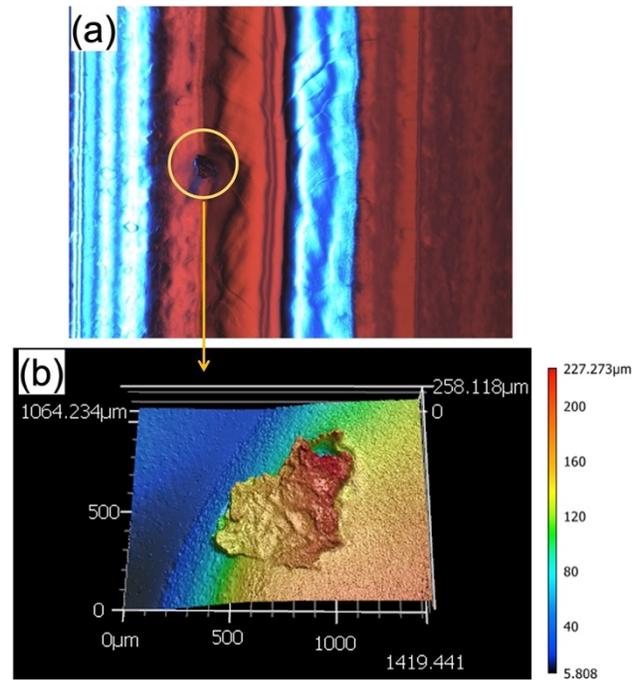
The entire equator surface in all five cells was inspected with the optical camera. A unique feature on the equator surface in cell-1 was found as shown in Fig. 6 (a). The feature found in the optical inspection was unclear to decide the next surface processing.

Figure 6: (a) Optical image showing a unique feature (image size is 12 \times 9 mm). (b) LCSM image of replica representing the surface in (a).

To get a detailed information of the feature, replica of the surface was made. An LCSM image of the feature captured by replica is shown in Fig. 6 (b). The image represented that the feature on the cavity surface was a random-shaped crater with a depth of $\sim 170 \mu\text{m}$. The deep crater with sharp edges was identified as the likely cause of the early quenching.

Given the size and depth of the feature, employing additional electropolishing (EP) was deemed unsuitable for removing the surface defect. Therefore, the decision was made to do local mechanical grinding to remove the defect. The subsequent sections will provide further details on the specific approach taken for grinding.

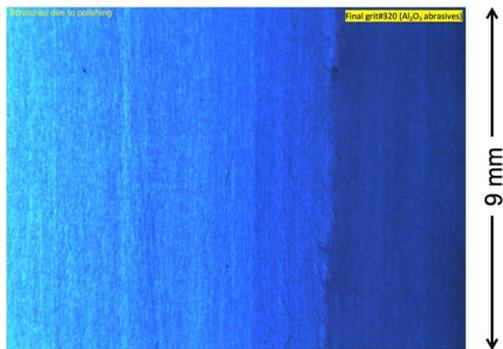
Local grinding and post-grinding process (B61C-EZ-101): The defect spot in the end cell of cavity B61C-EZ-101 was manually polished with aluminum oxide (Al_2O_3) abrasive media while the cavity was sitting on the optical stand for surface inspection during the different polishing steps performed with different grit size papers. The polishing paper was fixed on a handy tool having a rubber pad. This rubber pad holding the polishing paper might minimize embedding of particles into the Nb surface. The final polishing step utilized a grit size of 320. An optical image of the polished surface to compare with the original image (Fig. 6) is shown in Fig. 7. The image revealed that the defect was successfully polished, resulting in a smooth surface with

Figure 7: Optical image of the defect position shown in Fig. 6 after local grinding with Al_2O_3 abrasive media.

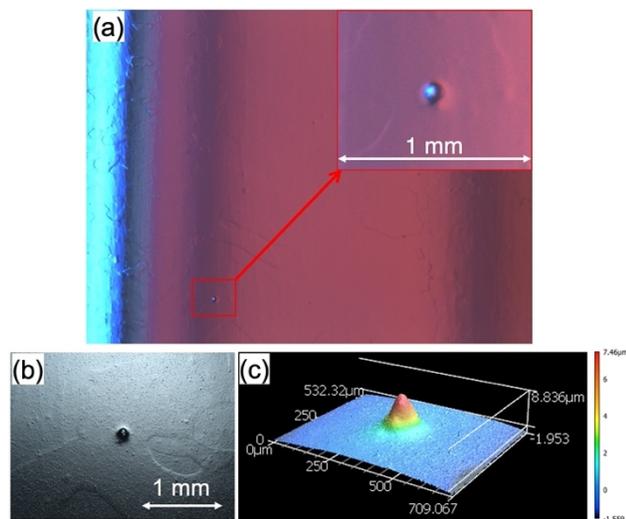
Figure 8: (a) Optical image of equator surface mechanically polished followed by EP for $60\ \mu\text{m}$ removal. (b) Optical image of replica representing surface in (a). (c) 3D image of the negative replica showing the pit.

The next processing step was chosen to be electropolishing for a removal thickness of $90\ \mu\text{m}$. This removal depth was considered sufficient to remove embedded particles out from the Nb surface. Following the EP process, an optical inspection was conducted to assess the presence of any remaining defects on the surface. The inspection revealed the presence of certain polishing features, including pit- or bead-like structures in the polishing region, as shown in Fig. 8 (a).

Given that optical inspection alone could not definitively determine whether these features were pits or embedded particles, a surface replica was made to confirm the same. The replica image apparently showed that the cavity surface had a pit having a diameter of $\sim 200\ \mu\text{m}$ and a depth of $\sim 7\ \mu\text{m}$. It is likely that this pit formed when a large-sized embedded particle detached from the surface during the EP process. The results suggested that the polishing media and the grit size should be properly selected to avoid such pit

formation on the surface. Based on the depth of the observed pits, $20\ \mu\text{m}$ removal in EP was decided, where each $10\ \mu\text{m}$ was removed before and after subjecting the cavity to a heat treatment at $900\ ^\circ\text{C}$ for 3 hours.

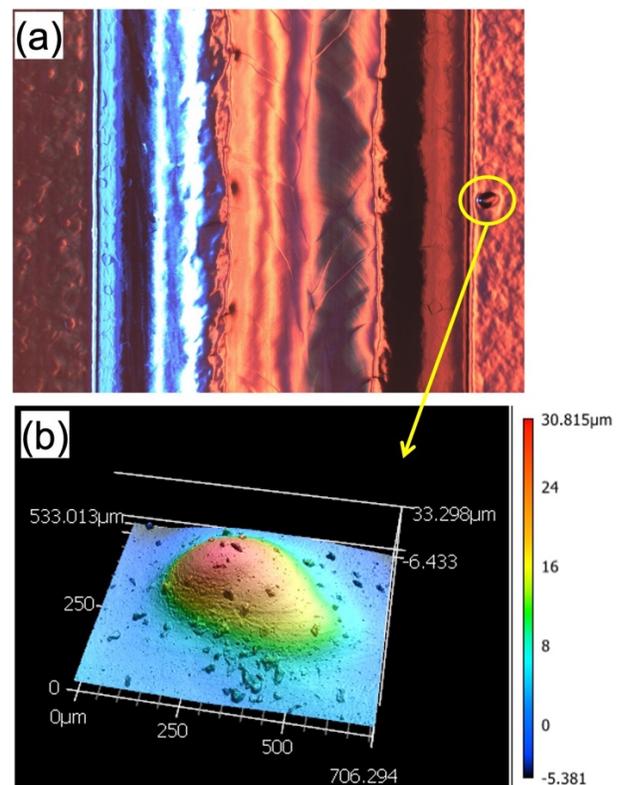
B92F-RI-203: Optical inspection of the cavity surface was performed after $160\ \mu\text{m}$ removal in EP conducted with the conditions specified in reference [7]. A defect appeared as a cat-eye feature on equator surface in cell-1 of the cavity. The cat-eye feature is usually treated by local mechanical grinding or centrifugal barrel polishing. To obtain detail of the cat-eye feature, replica of the surface was prepared. The optical image of the surface and the corresponding replica image are shown in Fig. 9 (a) and (b). The feature was a wide pit with depth of $\sim 25\ \mu\text{m}$, respectively. This pit indicated the presence of an underlying defect in the Nb bulk, which became apparent as a pit following the $160\ \mu\text{m}$ removal during the EP process.

Figure 9: (a) Optical image showing a cat-eye feature on equator surface in cell-1 of B92F-RI-203. (b) 3D image of the cat-eye feature captured with surface replica.

Since the cat-eye feature had no sharp edges, the surface was not mechanically polished. The cavity was processed with $900\ ^\circ\text{C}$ followed by EP for $10\ \mu\text{m}$ removal.

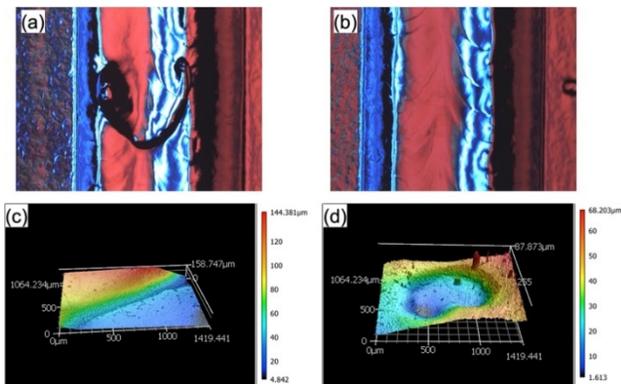
Figure 10: Optical images (12×9 mm) (a) showing defect on weld-zone and (b) a defect near weld-zone of equator. (c) Replica image of the defect in (a). (d) Replica image of the defect in (b).

B92F-RI-202: The equator surface, as observed with optical camera, of the as-received cavity showed some weld features on the equator in all the five cells. An optical inspection performed after 167 μm removal in the EP process showed that the features remained on the surface as shown in Fig. 10 (a). An additional defect on the equator surface in cell-5 was found (Fig. 10 (b)). The replica of both features was produced. The LCSM images of the replica surface is shown in Fig. 10 (c) and (d).

The replica image revealed that the edges of the feature were not sharp. Considering the feature details in the replica, the cavity surface was processed to prepare for a baseline test. The vertical test result will be reported later.

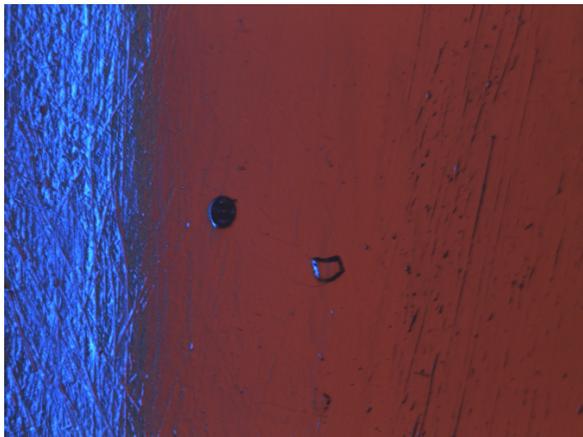
B92D-RRCAT-502: The cavity was processed with EP for 150 μm removal, N-doping, and post-doping EP for 5 μm removal. The cavity tested after the processing was prematurely quenched at 11.2 MV/m. In optical inspection, the cavity surface in cell-5 showed a pit that was polished by local grinding followed by 60 μm EP, heat treatment at 800 °C for 3 h and light EP for 10 μm. The pit was still present on the surface as found in an optical inspection (Fig. 11).

Figure 11: Defect on the equator surface in cell-5 of B92D-RRCAT-502. Image size: 12×9 mm.

Replica was made to get the pit feature. The diameter and depth of the pit were ~450 μm and 160 μm, respectively. Similar to the grinding process applied to B61C-EZ-101, local grinding on the defect position was performed with Al₂O₃ abrasive media having grit size of 80–400 until the defect disappeared from the surface. Following the grinding, EP for 60 μm was applied to the cavity. The cavity reached at 29.8 MV/m and met the baseline specification.
