Hamamatsu R1584 PMT Modifications

Abstract

Four Hamamatsu H6528 Photomultiplier Tube (PMT) assemblies were purchased by the University of Regina, to be used on the SHMS Heavy Gas Čerenkov detector. Despite the excellent gain, the H6528 signal output has two disturbing characteristics: discharges and ringing tails. In this report, we offer solutions to overcome these issues.

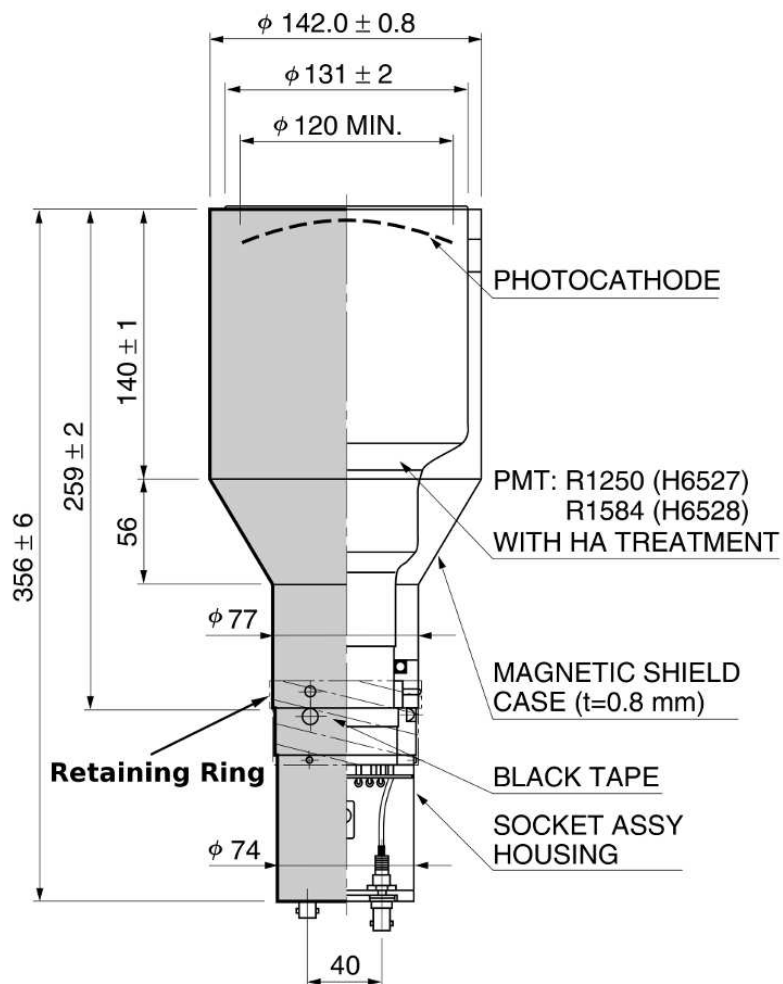
The H6528 PMT assembly consists of three parts: a R1584 PMT, a magnetic shield (μ -metal shield) and an electronic base, shown in Fig 1. Note that the μ -metal shield is coated with electrical insulation paint; the housing of the electronic base is made of aluminum. The maximum operating and recommended voltages are 3000 V and 2000 V according to the specification. The detector

Figure 1: Hamamatsu H6528 PMT assembly schematic diagram [1].

The basic design of the H6528 assembly consists of the PMT, the μ -metal shield and the electronic base. The PMT tube slides into the metal shield from the larger opening of the shield; the aluminum shielded base is installed from the smaller opening of the shield. The pins at the end of the PMT need to be inserted into the socket on the base, which hold together the entire assembly. Note that a plastic retaining ring near the end of the smaller opening of the shield prevents light leak as well as centers the PMT inside the shield, as shown in Fig.1.

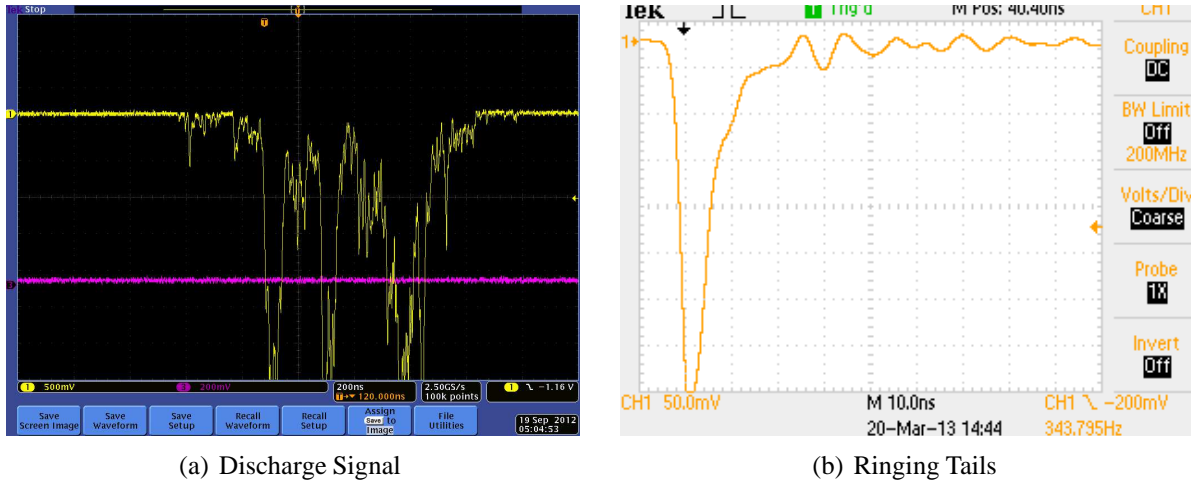
Despite the high quality gains, the Hamamatsu PMT assemblies as received from the factory have some disturbing characteristics: all four detectors show frequent discharge pulses, see Fig 2(a); sizeable ringing tails are attached to primary pulse, see Fig 2(b). Regarding each of these characteristics, we developed customized methodology to overcome these issues. Hopefully, the solutions presented in this report will be useful to the manufacturer as well as other physicists who may be experiencing similar difficulties.

Figure 2: Oscilloscope screen shot of the H6528 PMT signal at 2000 V as received from the factory. (a) is an example of a discharge pulse, note that the vertical scale is 500 mV and time scale is 200 ns per division; (b) is an example of a normal pulse with ringing tails, note that the vertical scale is 50 mV and time scale is 10 ns per division.

After the H6528 was operated for 5-10 mins at a voltage higher than 1500 V, discharge pulses began to appear at a rate of few Hertz (Hz) as observed on an oscilloscope. The discharge rate seems to be proportional to the operating voltage; the initial discharge rate at 2000 V is around 10 Hz, and gradually increases over time. Fig. 2(a) shows an example of a discharge pulse. The height of the discharge pulse could vary from 200 mV to 10 V, and be a few μ s wide.

Fig. 2(b) shows an example of the H6528 signal output as delivered from the factory. At 2000 V, the ratio between the primary and the first ringing tail is 10:1, this ratio increases as the operating voltage rises. When there is a large pulse ($>1\text{V}$), it is possible for the ringing tailing to trigger the electronic discrimination threshold, particularly at high event rates. It would be optimal to suppress the primary-to-ringing ratio without changing the other PMT signal output characteristics. After some study, we decided upon an electronic modification which satisfies the our requirement.

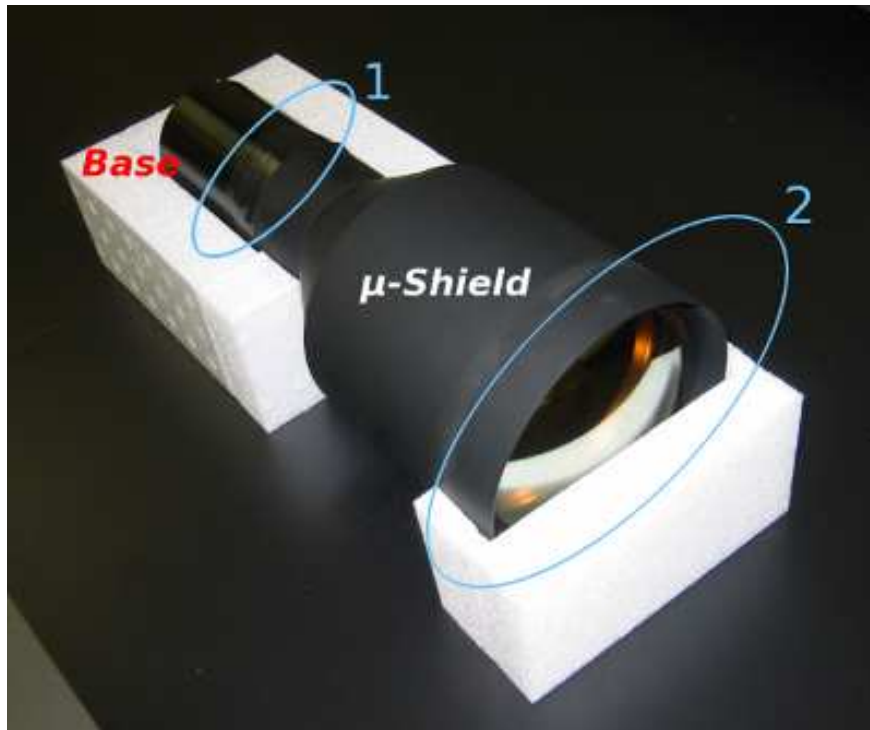
Fig. 3 shows a H6528 as received from the manufacturer. Two locations were identified which have contributed the discharge pulses:

1. 1st location is shown as the #1 circle in Fig. 3. Shield discharges to the base.
2. 2nd location is shown as the #2 circle in Fig. 3. Photo-cathode discharges to the shield.

From the our study, location #1 contributes around 75% of the discharge pulses.

Figure 3: H6528 PMT assembly as received from the manufacturer. Circles represent the identified discharge locations.

The location of this discharge source is shown as the #2 circle in Fig. 3. The discovery of this discharge issue was a surprise, since the μ -metal shields are coated with insulating paint. Additional insulation on the inner surface of the shield is required to completely eliminate the discharge. However, the insulation material must be thin to allow PMT to slide through. The best option we

found was to use 1-2 layers of 3/4" kapton tape to cover 6 cm of the inner surface from the opening. Since the kapton tape has thickness of $25.4 \mu\text{m}$ and a smooth surface, the PMT is able to slide freely into the shield.

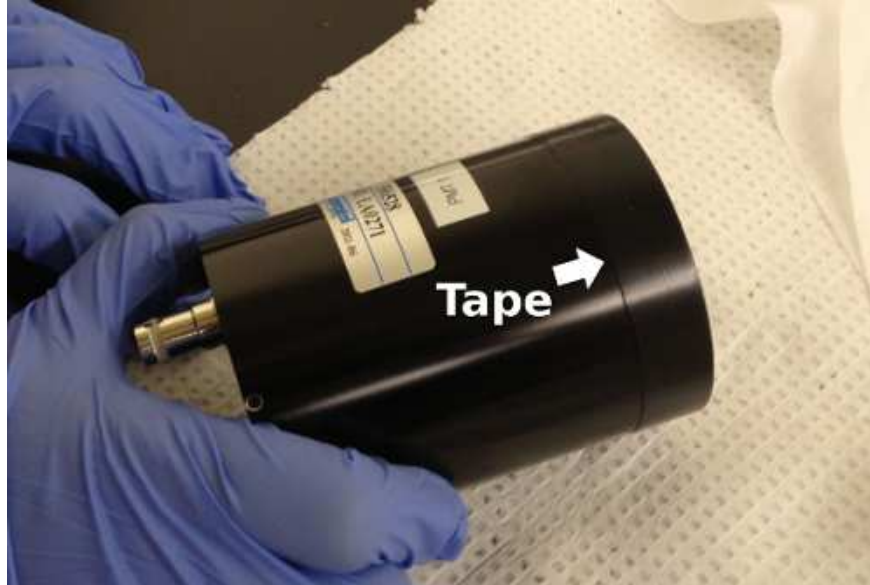
In order to ensure the PMT pins are installed straightly into the socket, the base is designed to be inserted into the μ -shield and pressed against the retaining ring, thus creating by 1 cm overlap between the base aluminum housing and μ -metal shield. From the factory design, only one layer of electrical tape at the end of the base provides the electrical insulation between the base and μ -metal shield, see Fig. 1 and 4. Our study shows that this level of insulation is not sufficient

Figure 4: H6528 base as received from the manufacturer. Note that one layer of electrical tape is at the end of the aluminum housing as white arrow indicates.

to prevent electric discharge from the shield to the aluminum housing of the base. To completely insulate the shield from the base, the socket end of the aluminum housing of the base was trimmed off and replaced by a 1" wide plastic ring, as shown in Fig. 5 (right).

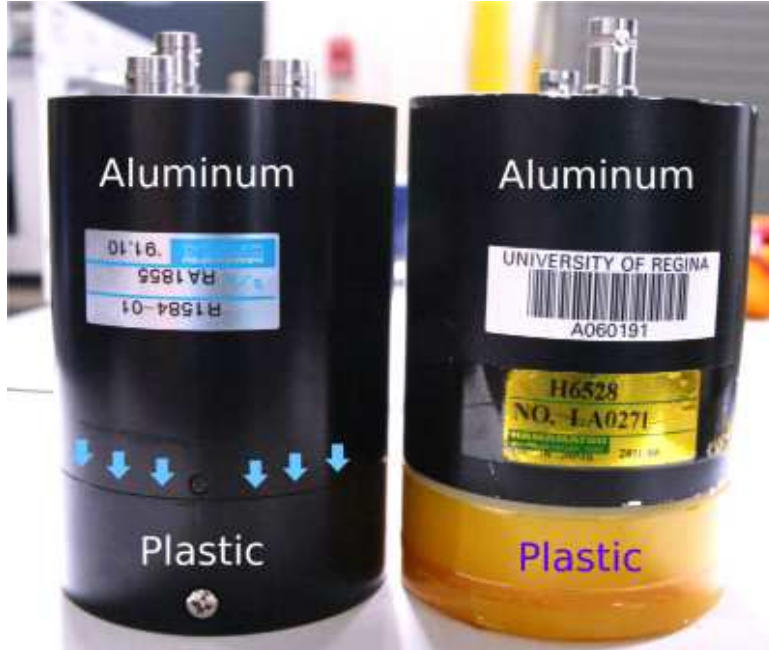
Fig. 5 shows a modified H6528 base (right) and a R1584 base (left), which was purchased in 1991 by the University of Virginia. The photo was taken after all H6528 bases were modified. To our surprise, both bases both have a 1" wide plastic ring to insulate the base from the shield. Obviously, Hamamatsu changed the 1991 base to the current design, thus causing discharges due to poor insulation.

Figure 5: Left: original R1584 PMT base was purchased by University of Virginia in 1991. Right: H6528 (current R1584) PMT base after modification; 1" wide insulation ring is covered with 2 layers of kapton tape.

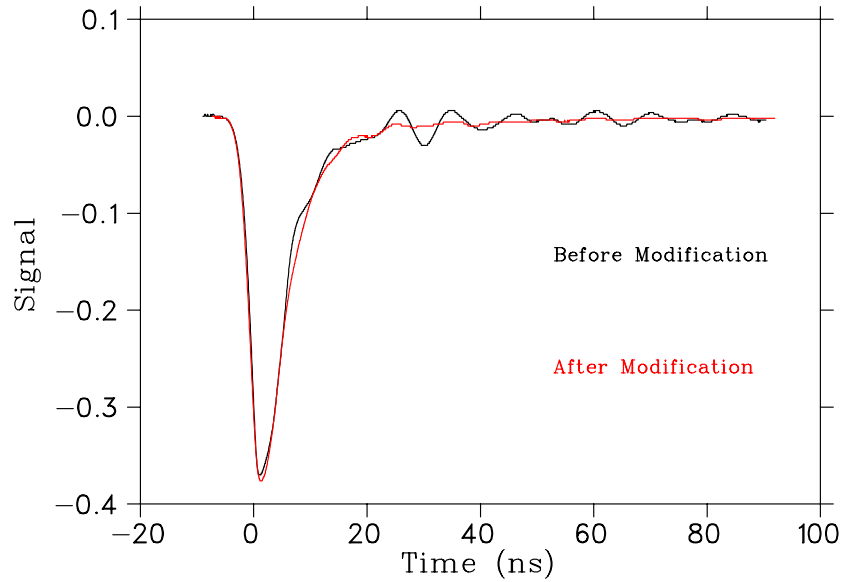
Figure 6: PMT signal output before (black) and after (red) the modification at 2000 V. The oscilloscope trigger was set at 200 mV; both signals were averaged over 16 pulses.

Fig. 6 shows the original and modified PMT signal output at 2000 V. The ringing tails after the modification seem to be effectively suppressed to a satisfactory level.

The modified H6528 base circuit diagram is attached in App. A. Two $0.01 \mu\text{F}$ high voltage

capacitors are added between dynode chains #10 and #11 and the ground [3]. A 51Ω metal film resistor is also introduced in series to the signal output; its power rating is 0.6 Watt.

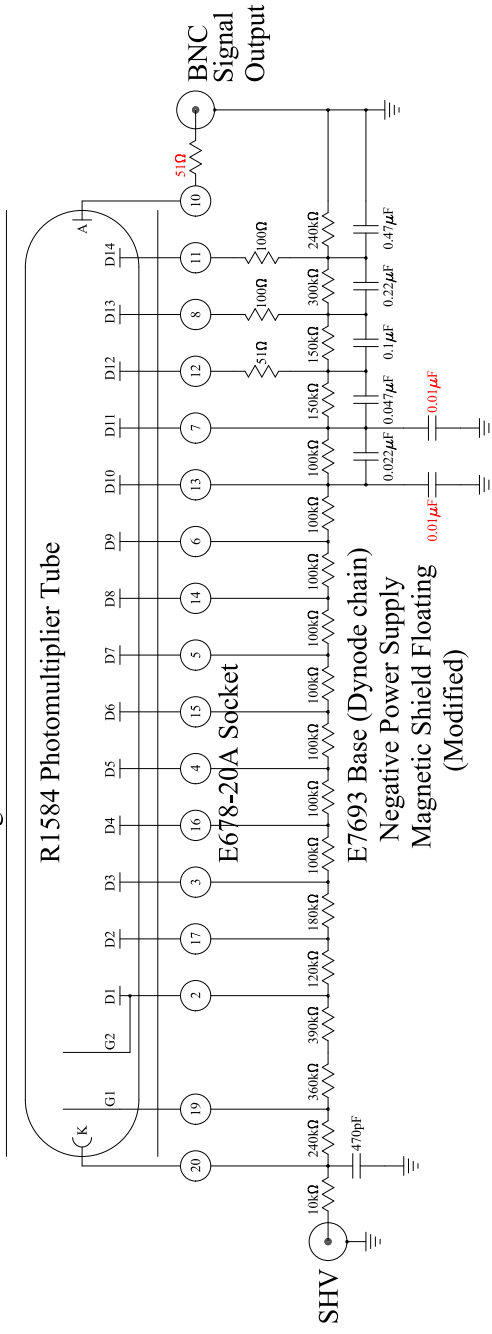
TITLE: Modified Hamamatsu H6528 Assembly

The following is the modified circuit diagram of H6528 base.

0.01 μ F Capacitors added on recommendation of Dr. A. Semenov, Dept. of Physics, U of R. 51 Ω resistor is a common impedance matching technique.
