Performance-defining properties of Nb₃Sn coating in SRF cavities

Abstract. Nb₃Sn has great potential to become the material of choice for fabrication of SRF cavities. The higher critical temperature of Nb₃Sn potentially allows for an increased operational temperature in SRF cavities, which could

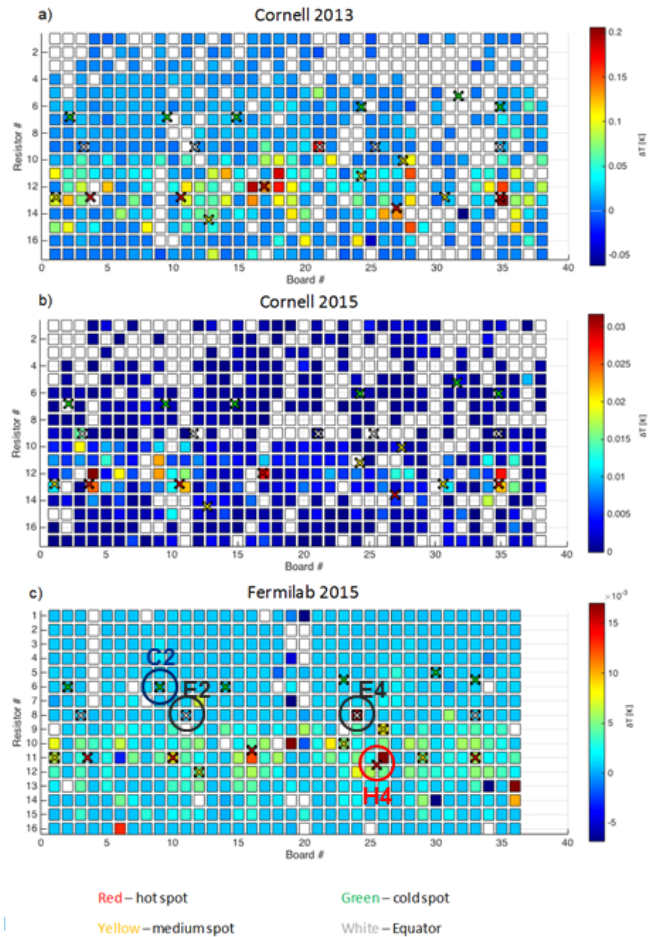
Figure 1. Temperature maps showing excessive heating in one half cell (regions below resistor 9 on the Cornell T-map and below resistor 8 on the Fermilab T-map). First measurements were taken at Cornell in 2013 (a) then new studies were performed in 2015 at Cornell (b) and FNAL (c).

1.3 GHz single cell Nb cavity coated with Nb₃Sn (ERL1-5) at Cornell University [8] had been RF characterized at Cornell in 2013 and at Fermilab in 2015 (Fig.1). The first cavity coated under Cornell's program [9], ERL1-5 demonstrated significantly degraded performance compared to the cavities which had been Nb₃Sn-coated afterwards. Temperature map shows

Temperature maps indicate that the half-cell with the unusually shiny appearance has large regions with far a higher surface resistance than is observed in the other half cell. The intention of repeated RF characterization at Fermilab was to map out well the surface resistance of the cavity, so that the “hot” and “cold” regions could be identified with a high degree of confidence. T-map was measured at 9 MV/m at 4.2 K at Fermilab. Coupons located at these hot and cold spots were subsequently cut out from the cavity. Cutouts were in a 1cm diameter, circular shape. Two cutouts were depicted for the analysis. Spot marked as “H4” on the temperature map, was taken from the shiny half-cell as representative of strongly dissipating region (referred as hot spot). “C2” on the temperature map indicates the location of non-dissipating cold spot taken from the matte half-cell (Fig.1c). Fig.2a and b shows optical images of cold cutout (C4) and hot cutout (H1), respectively.

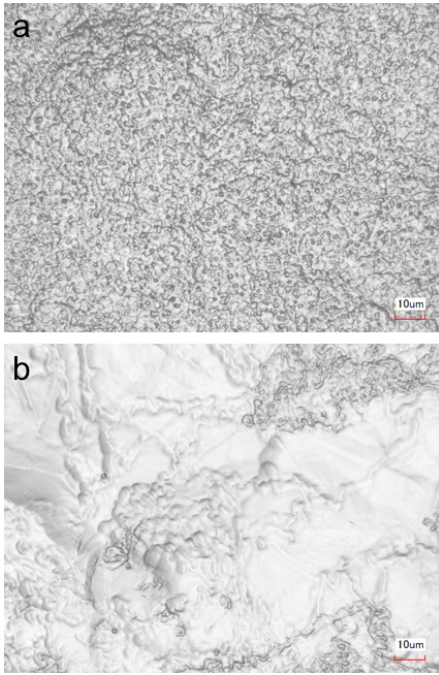
Figure 2. Images of (a) cold and (b) hot cutouts from optical microscope.

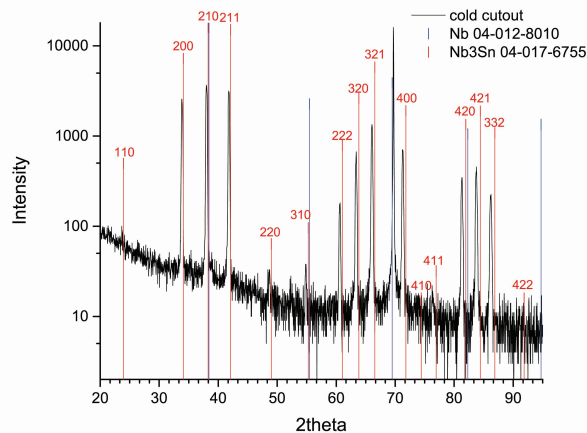
Figure 3. XRD of cold cutout taken with Pananalytical/Philips X'pert². Red and blue markers indicated positions of the reference peaks for Nb_3Sn and Nb, respectively.

Structural characterization of ERL1-5 cavity cutouts was initiated in order to confirm A15 Nb_3Sn structure of the coating and the absence of non-stoichiometric phases, such as Nb_6Sn_5 . XRD taken with medium resolution X’pert² diffractometer showed A15 Nb_3Sn structure (PDF 04-017-6755) in both, cold and hot cutouts. Fig.3 demonstrates data for cold cutout as an

example. Due to the relatively large probing depth of XRD, Nb substrate signal is also present (PDF 04-012-8010). XRD confirmed the absence of non-A15 phases in the coating. Lattice constant of Nb_3Sn in cold cutout was estimated to be 5.2889 Å. Lattice constant of Nb_3Sn in hot cutout is 5.2901 Å. According to the previous measurements [10], lattice constants for both cutouts translate into Sn content in the desired range of 24-25 at.%. Wavelength-dispersive spectroscopy (WDS) (not shown here) on cold cutout supports this assumption, demonstrating Sn content of 25 at.%.

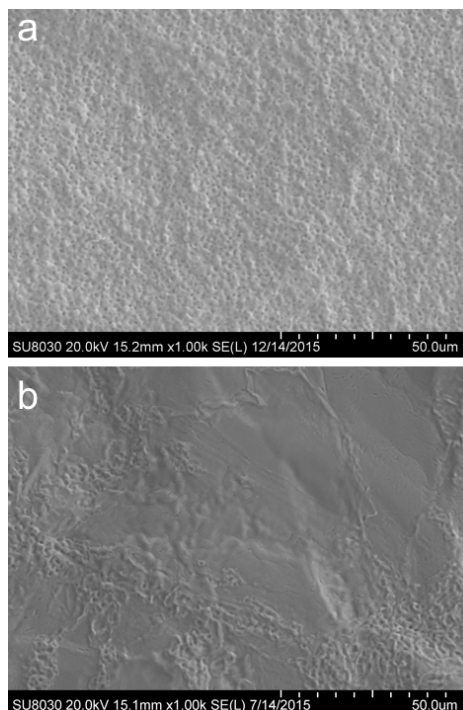
Figure 4. SEM images of (a) cold and (b) hot cutouts.

SEM images in Fig.4a and b demonstrate the surface of the coating in cold and hot cutouts, respectively. Cold cutout is uniformly covered with micron-sized Nb_3Sn grains. Hot cutout, on the other hand, shows “patchy” regions surrounded by the areas of uniform coating with an appearance similar to the cold cutout surface. EDS maps of cold cutout taken at the incident accelerating electron voltage of 20 kV are highly uniform and completely featureless (not shown here), demonstrating lateral and in-depth uniformity for Sn and Nb. Sn content from EDS maps was estimated to 24-25 at.%. Since Sn content estimation from EDS agrees well with WDS measurements at the same accelerating voltage, as well as with XRD, we can conclude at an accelerating voltage of 20kV most of EDS signal is coming from within the coating.

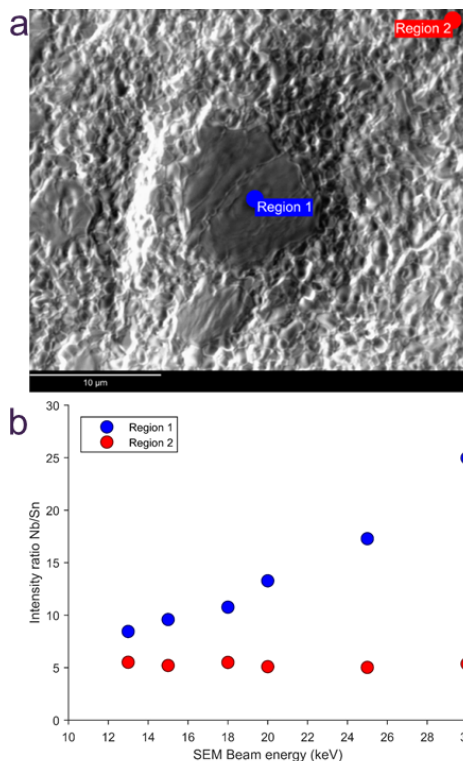
Figure 5. (a) SEM image of Nb_3Sn coating taken at Cornell University; (b) Niobium to tin intensity in two regions of the surface vs. SEM incident beam energy.

Fig.5a shows SEM picture of the typical patchy region taken at Cornell University. Fig.5b summarizes the incident voltage varying experiment. Niobium to tin ratio in the patchy region (Region 1) increases with an incident beam energy, since contribution of niobium from the substrate increases. Niobium to tin ratio outside the patchy region (Region 2) remains constant with an increase in beam energy, since EDS interaction volume is concentrated within the thickness

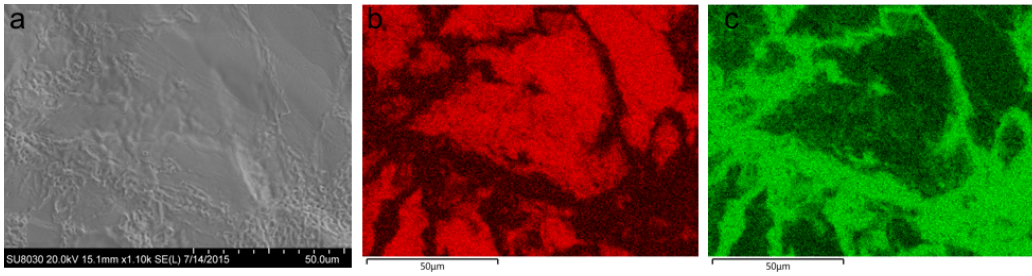
Figure 6. (a) SEM image of hot cutout with corresponding (b) Nb and (c) Sn maps at 20 kV.

The appearance of the Nb_3Sn coating surface in the hot cutout is very different, compared to the cold one. Fig.6 shows SEM image and corresponding Sn and Nb EDS maps of hot cutout taken at accelerating voltage of 20kV. Patchy regions show significantly

reduced Sn content (darker contrast in Sn map) and elevated Nb concentration (brighter contrast in Nb map). Reduced Sn signal in EDS map can indicate either significantly reduced Sn concentration in the coating which no longer supports A15 structure or variation in thickness of the coating itself.

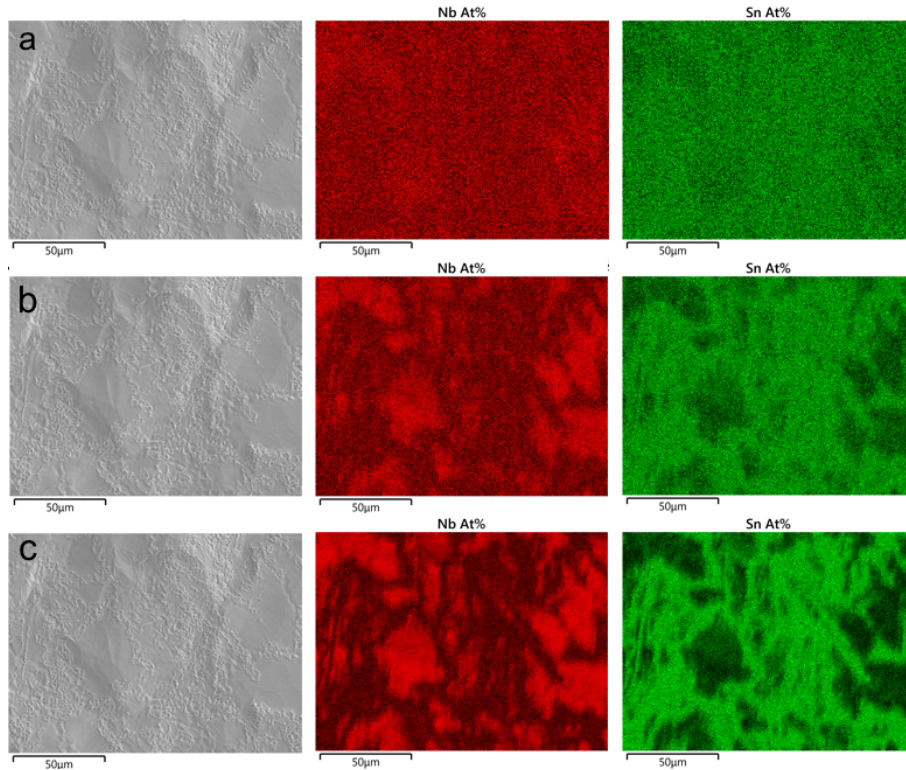
Figure 7. SEM images and EDS maps of Sn and Nb taken from the same spot on hot cutout at (a) 10kV, (b) 15 kV, and (c) 20 kV.

By varying the incident electrons accelerating voltage in SEM, one can change probing depth for EDS signal. Fig.7 demonstrates the result of changing the accelerating voltage. As we increase incident electron voltage, EDS probes a thicker surface layer. Most of the EDS signal comes from within hot cutout's coating at the lowest voltage of 10 kV, as can be seen from Fig.7a. Sn concentration taken from the map which was acquired at 10 kV, is close to 24 at.%. Much lower Sn and higher Nb content in maps taken at 15

kV and 20 kV (Fig.7b and c, respectively) indicates that the EDS signal comes not only from the coating but also from Nb underneath. Comparing Fig.7a with Fig.7b and c, we can conclude that Nb_3Sn coating in the patchy regions in hot cutout is much thinner than in cold one. The hot cutout shows significant variation in Nb_3Sn coating thickness across the whole area.

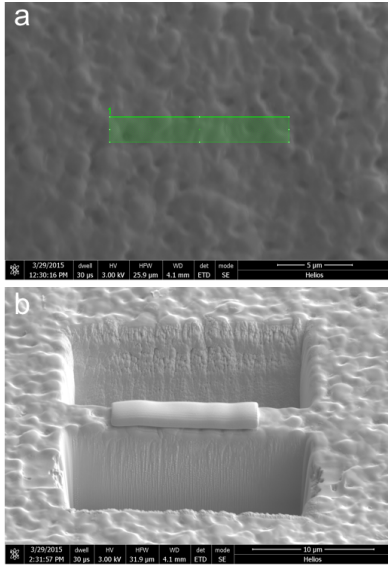
Figure 8. SEM image of Nb_3Sn coating in cold cutout (a) prior to FIB sample preparation, (b) with trenches around the cross-sectional cut.

Cross-sectional TEM samples had been prepared from cold and hot cutouts to evaluate Nb_3Sn coating thickness directly (Fig.8). Fig.9a and b demonstrates TEM bright field (BF) images of cold and hot cutouts, respectively. Hot cutout FIB sample was taken from the patchy region of the surface which has thinner coating according to SEM studies. Difference in Nb_3Sn coating thickness in cold and hot cutout is obvious when looking at TEM cross-sectional images. Nb_3Sn coating is about $2\mu m$ thick in cold cutout and in the order of only $0.1\mu m$ in the thinnest regions of hot cutout. More than 10 times difference in Nb_3Sn thickness can be noticed comparing cold and hot cutouts.

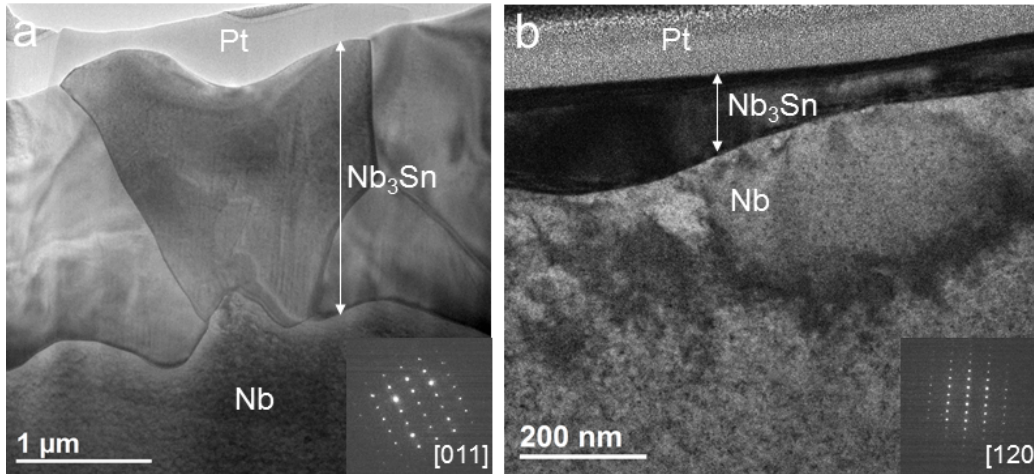
Figure 9. Bright Field image of FIB sample prepared from (a) cold and (b) hot cutouts with corresponding NED patterns.

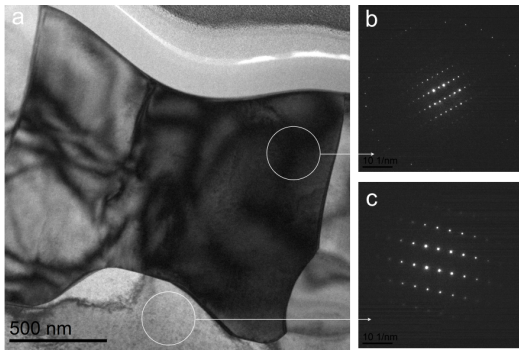
Figure 10. (a) BF image of Nb_3Sn coated sample's near-surface; (b) NED taken from within Nb_3Sn grain, $[120]$ Nb_3Sn zone axis; (c) NED taken below the coating, Nb $[113]$ zone axis.

It is worth mentioning that microstructure of Nb_3Sn coating in cold cutout is similar to the coating produced in the flat sample (Fig.10) which was coated in the same experimental setup at Cornell University.

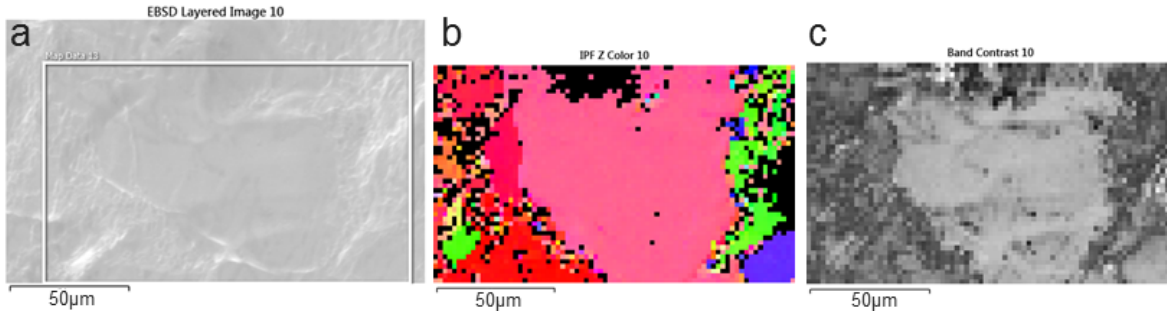
Figure 11. (a) SEM image of the patchy region on hot cutout surface; (b) Inversed Pole Figures (IPF) colors; (c) Band contrast.

from EBSD taken from one of the patchy regions in the surface of hot cutout (Fig.11), the entire thin (patchy) region is a single Nb_3Sn grain of about $100\mu m$ in diameter. Our conclusions are supported by the analysis of 5 additional TEM samples prepared from cold cutout and 2 additional TEM samples from hot cutout. Fig.9a shows contrast variation in the center of the largest grain which looks like a presence of some domain. Appearance of intragrain domains in cold cutout will be explored in the sections below.

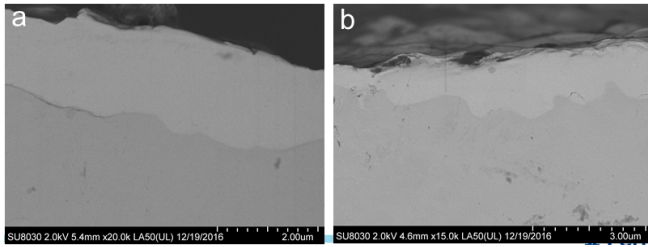
Figure 12. Backscattered images of cross-sectional SEM samples prepared from (a) cold cutout, (b) hot cutout.

In order to directly compare thickness of the coating over the area much larger than TEM sample dimensions, cross-sectional samples were prepared from cold and hot cutouts Fig.12. Hot sample demonstrates rapidly changing, wavy Nb_3Sn /Nb interface which was definitely not induced by Nb substrate. Cause of such peculiar interface line will be investigated in future studies.

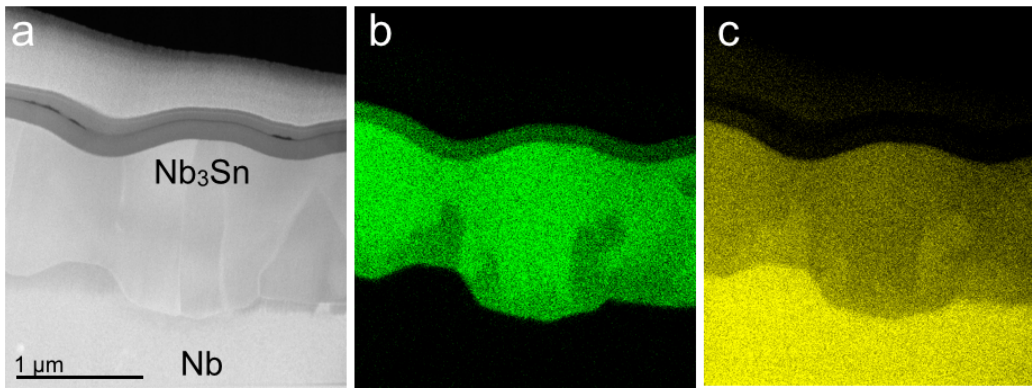
Figure 14. (a) Z-contrast image of the near-surface of the Nb₃Sn coated Nb sample; (b) EDS map for Sn; (c) EDS map for Nb.

Local composition of Nb_3Sn coating in both cutouts and flat sample was explored with STEM/EDS mapping. Fig.14a shows a Z-contrast image of the flat sample's near-surface. EDS maps of Sn and Nb distribution in the near-surface are represented in Fig.14b and c, correspondingly. Sn map of the near-surface shows several areas with decreased signal intensity in the Nb_3Sn coating. Decreased Sn intensity areas are few hundred nm in size and are located close to the interface between Nb_3Sn and Nb. Decrease in Sn signal intensity in the EDS map can be observed due to either a thinner region of the sample or deficiency of Sn in this particular area. If the thickness variation would be the case, the Nb map would show the same areas of decreased Nb signal intensity. However the Nb map shows brighter regions in Nb_3Sn coating which

indicates higher Nb content. Also no obvious thickness variation can be observed in corresponding STEM image of the area. Estimations of the Sn concentration difference between normal and Sn-deficient areas show the difference of 7 to 8 at. %, regardless of the model used for EDS quantitative evaluation. Sn-deficiency do not mimic individual Nb_3Sn grains.

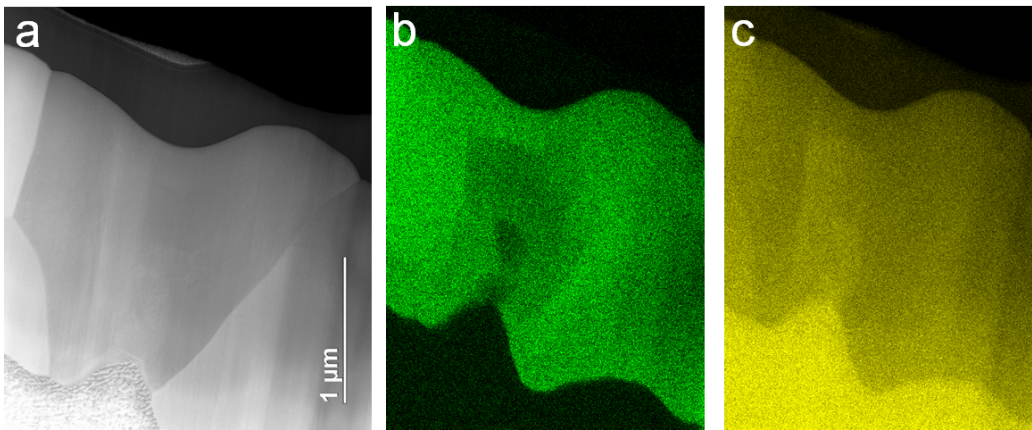
Figure 15. (a) Z-contrast image of the near-surface of cold cutout; (b) EDS map for Sn; (c) EDS map for Nb.

Sub-micrometer-sized regions of Sn-deficiency, similar to the ones observed in the flat sample's coating, were found in Nb_3Sn coating in cold cutout (Fig.15). Three samples prepared from the cold cutout and one sample prepared from the flat sample were STEM/EDS measured. Sn-deficiency regions were found in all of them. Sn-deficiency regions with likely reduced T_c were found in Nb_3Sn -coated cavity for the first time. The presence of Sn-deficiency regions in the flat sample implies that their formation is inherent to the deposition process rather than the substrate geometry. Appearance of Sn-deficiency region approximately in the center of the largest grain in cold cutout (Fig.15) might be explained by deficiency of Sn during grain growth. Sn from the surface is expected to diffuse along the grain boundaries during the deposition process [11, 17]. The region in the center of the largest grain is the furthest from the grain boundaries which provide Sn source during the film growth.

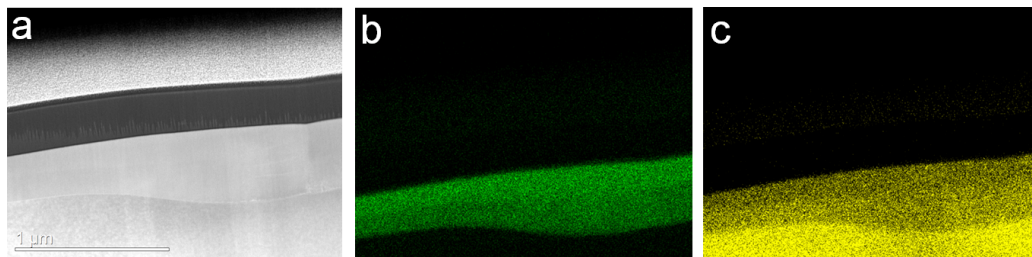
Figure 16. (a) Z-contrast image of the near-surface of hot cutout; (b) EDS map for Sn; (c) EDS map for Nb.

STEM/EDS characterization of hot cutout is demonstrated in Fig.16. Two TEM samples prepared from a hot cutout were studied with the STEM/EDS. It was observed in both TEM samples that the Nb₃Sn coating in hot cutout shows reduced Sn signal and brighter Nb signal at the bottom part of the coating. Observation of lower Sn concentration at the bottom of the coating can be explained by insufficient Sn supply from the grain boundaries during the growth. Being thin, 100 μ m-sized single grain, the patchy region most likely demonstrates Sn-deficiency due to lack of close grain boundaries which transport Sn below the surface.

However signal intensity variations in Sn and Nb maps in hot cutout samples are rather weak.

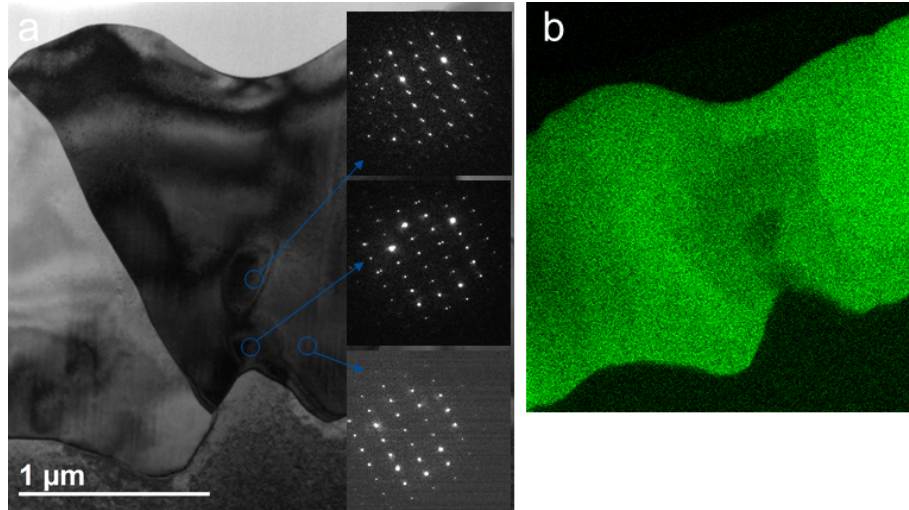
Figure 17. (a)BF TEM image of intragrain domain in cold cutout sample with NED patterns, (b)EDS Sn-map of the same area.

Sn-deficiency regions produce contrast variation in the TEM images in some samples (Fig.17). Sn-deficiency regions look like domains in the largest Nb₃Sn grains in TEM and TEM BF images. NED with parallel beam of approximately 100 nm in diameter was used to explore the structure of Sn-deficient domains. Fig.17a, b shows BF TEM image of intragrain domain in

cold cutout sample and EDS Sn-map of the same area, respectively. Corresponding NED show Nb_3Sn patterns from intragrain Sn-deficient domain and surrounding area from the same grain. No change in crystal structure within the grain containing deficiency region was noticed. However weak additional reflections accompany major diffraction spots inside of Sn-deficiency domain. Similar additional reflections observed in intragrain domains in all cold cutout TEM samples.

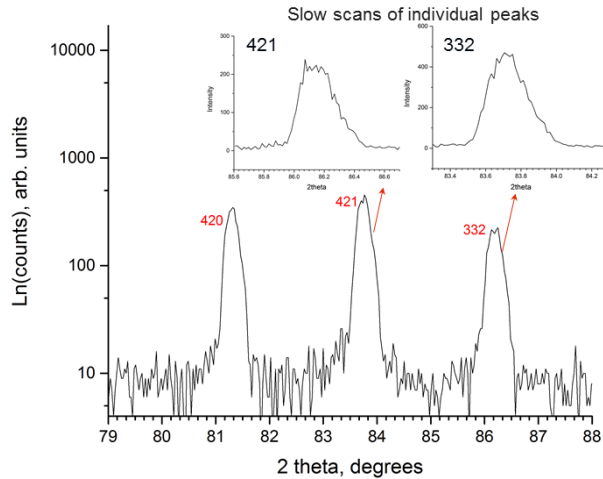
Figure 18. High resolution slow XRD scan of cold cutout.

Effect of compositional variation in Sn-deficiency regions on global properties of the film was explored with high resolution XRD performed with X'pert¹ diffractometer. One would expect reduction of the lattice constant with lower Sn concentration. Since A15 Nb_3Sn structure was already confirmed in cold cutout, shape of diffraction peaks was investigated with higher resolution. Fig.18 shows several diffraction peaks which were slowly scanned with the best possible resolution and count rate. Every Nb_3Sn diffraction peak in cold cutout shows some asymmetry in the peak shape. Asymmetry extends toward higher

diffraction angles. According to Bragg's law diffraction peaks at higher angles indicate smaller d-spacings in diffracting material which, for cubic structures, translates into the smaller lattice constant. Previous experiments [10] show decrease in T_c of Nb_3Sn with reduced lattice constant which was induced by lower Sn concentration. Consistent asymmetry of diffraction peaks shape indicates a spread in d-spacings in diffracting material which can be interpreted as presence of A15 Nb_3Sn with a few slightly different lattice constants. Smaller lattice constants are most certainly originating from Sn-deficiency regions observed by STEM/EDS. Presence of a spread in lattice constants was previously reported in Nb_3Sn coating prepared by the same method [21].
