In situ transformation and cleaning of tin-drop contamination on mirrors for extreme ultraviolet light

Abstract

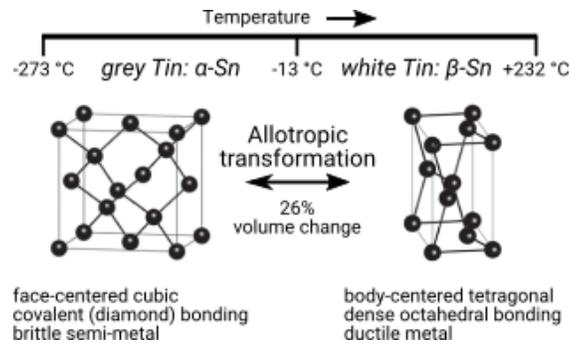
Fig. 1. Illustration of temperature-dependent allotropic transformation between α -phase gray tin and β -phase white tin. The corresponding crystal structures are shown, as well as the geometric classification, the bonding and the metallic nature for both phases.

cleaning tin-drop contaminated optics in this way, and the related material science aspects of this method were presented very recently in a communication by one of us.¹⁷ When tin in its normal metallic phase, β -Sn, is cooled to temperatures in a range of about $-20\text{ }^{\circ}\text{C}$ to $-50\text{ }^{\circ}\text{C}$, it can undergo a phase transformation to gray tin, a rather brittle semimetal.¹⁸ This phase, α -Sn, is the stable phase of tin with slightly lower entropy in comparison to β -Sn at temperatures below $13\text{ }^{\circ}\text{C}$.¹⁹ The transition, also called tin pest, occurs by a process of nucleation and growth^{18,20}; generally, it needs to be induced by a seeding initiation mechanism on the surface²¹. As illustrated in Fig. 1, the allotropic transformation is accompanied by a structural change of the material from a body-centered tetragonal to a face-centered cubic (diamond-like) lattice leading to a strong volume expansion of about 26%. The extreme brittleness of converted tin deposits and its breakup by cracking after transformation to the α -Sn phase is the attractive feature for the purpose of optics cleaning.

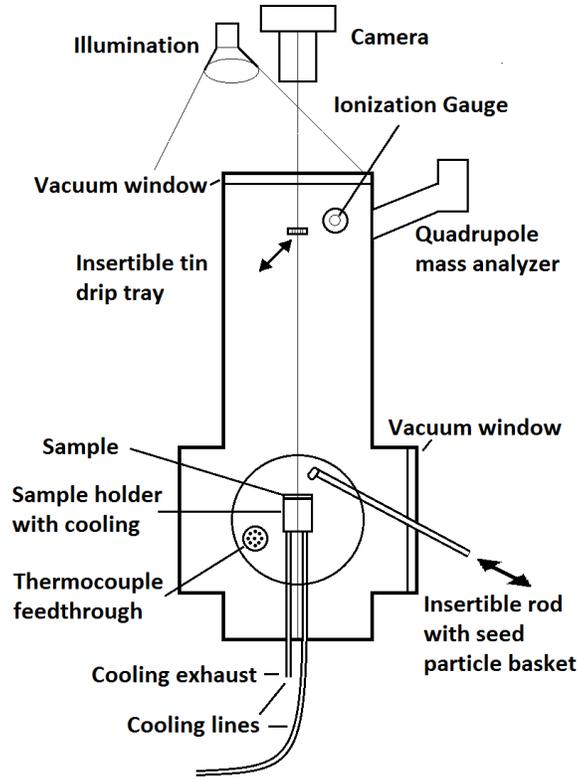
Fig. 2. Schematic view of the experimental setup. The vacuum chamber contained the equipment for tin dripping, sample inoculation, substrate cooling and temperature measurements. Illumination and photographic recording was provided via vacuum windows.

An UHV chamber with flanges of up to 8-inch size that had previously been used for tests of ML-coating depositions by electron-beam evaporation was adapted for use in tin transformation experiments. The main parts of the experimental setup are shown schematically in Fig. 2. The vacuum chamber consisted of a vertically mounted, 8-inch diameter cylinder with preparation and diagnostic capability in its upper section and sample holding and cooling part in its lower section. In the upper portion, a heatable tin drip tray could be inserted via a 2-inch vacuum translation stage. An ionization gauge and a quadrupole mass analyzer were attached to the chamber for vacuum diagnostics. Sample illumination was provided through the top and in addition (optionally) also through vacuum windows on the side of the chamber. Optical detection was the main analysis method. It enables the monitoring of the behavior of tin contamination during phase transition in situ by illumination, imaging and recording through a vacuum

The ML-coated EUV mirror samples were mounted in horizontal orientation on a fixed holder made from stainless steel and copper blocks with attached cooling lines inserted at one of the four lower 6-inch vacuum flanges. The copper table on which samples could be mounted had an area of 50 mm x 50 mm. A multiple-connection vacuum feedthrough enabled temperature monitoring by several sets of thermocouple wires (chromel-alumel type K) that could be attached at various positions on the sample or sample holder. A magnetically-coupled linear translation rod with rotation possibility was mounted via adjustable bellows for manipulation for insertion at a distance of a few centimeters above

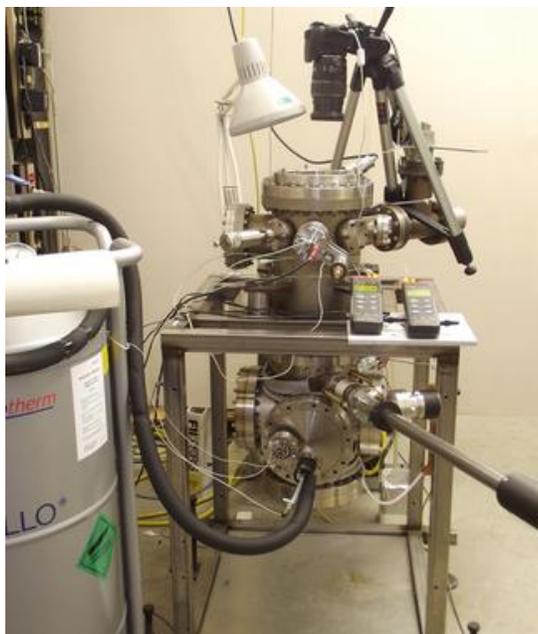
Fig. 3. (Color online) Photograph of vacuum chamber used during tin transformation experiments. A liquid-nitrogen container was connected via insulated cooling line for

sample cooling. Photographic imaging and temperature recording equipment is also visible.

A liquid-nitrogen container with pressure regulation and relief valves was attached to the inlet of the cooling line. It enabled a simple means of sample cooling by a regulated flow of cold nitrogen vapor from evaporated liquid nitrogen leading to pressure-built up inside of the reservoir. Temperatures measured by thermocouple probes at the sample holder could be kept stable to within ± 5 °C by this technique. Figure 3 shows a corresponding photo of the UHV chamber with its attached equipment. The chamber was pumped by a 330 l/s plasma turbo-molecular pump (Balzers TPH 330S, not visible in the photo) operated with fomblin lubricant and a rotary two-stage fore-pump equipped with a trap for oil-vapor suppression. For protection of the blades of the turbo-pump from metal particles a large baffle trap was positioned at the backside pumping port between the vacuum chamber and pump section. The base pressure of the UHV chamber was about 10^{-5} Pa when its walls were not baked. A mix of copper and viton gaskets was used for the sealing of the conflat vacuum flanges.

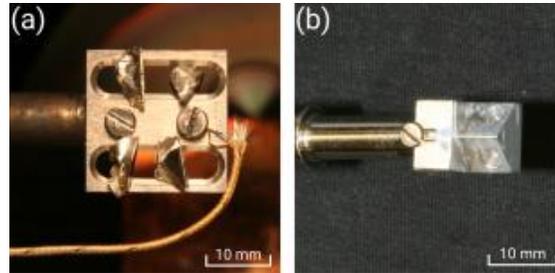
Fig. 4. (Color online) (a) Heatable, slotted drip tray with tin pieces for melting and dripping. A thermocouple sensor was attached to the tray to monitor the temperature. (b) Tip of manipulator rod with two small baskets for sample infection.

A photo of the tin drip tray is shown in Fig. 4a. Before vacuum pump-down, several pieces of high-purity tin (previously untransformed β -Sn of 99.999% purity, mass of each piece: ~ 0.3 g) were placed on its two slots. Aluminum was used as tray material, since molten tin does not adhere to it and no alloys are formed at the melting temperature of tin. For the melting and dripping of tin, the tray was slowly heated up from room temperature to temperatures in the range of about 255 – 265 °C by resistive electrical heating while the tray temperature was monitored by a thermocouple probe. After melting, the tin pieces fell down as liquid drops if the adhesion to the tray was not too strong. If required, small vibrations to induce the dripping of tin could be created by touching the tray support with a bar mounted on a rotation feedthrough. After completion of tin dripping the tray was retracted in order to remove it from the view of the camera. The distance from the trip tray to the samples below was 41 cm, leading to a tin droplet speed of 2.84 m/s at impact. After full melting, flat tin drops were typically produced on the mirror samples with diameters in the range of 6 mm to 8 mm, often exhibiting a “finger” pattern at the edge. For single drops of fully melted tin the thickness at the center of the drop was measured to be typically about 0.30 – 0.35 mm. The relative surface area coverage by tin contaminations of the samples after tin dripping and after cleaning was determined from photos by means of software for image-analysis (ImageJ).

The tip of the manipulator rod for in-situ inoculation is shown in the photo of Fig. 4b. It consisted of an aluminum piece with two bores of 3 mm diameter creating small baskets that could be loaded with α -Sn powder for sample infection. By adjusting the bellows of the manipulator and rotating the baskets either clock- or counterclockwise for emptying, the tin contamination on the EUV mirror samples could be inoculated in situ from above with α -Sn seed particles in at least two general locations. Gray tin seed powder was prepared by temperature cycling of tin pieces with repeated transformation between the α -Sn and β -Sn phase, as was described previously.¹⁷ In most cases, but not always, inoculation of tin drops with α -Sn seeds was done within a few hours after tin dripping.

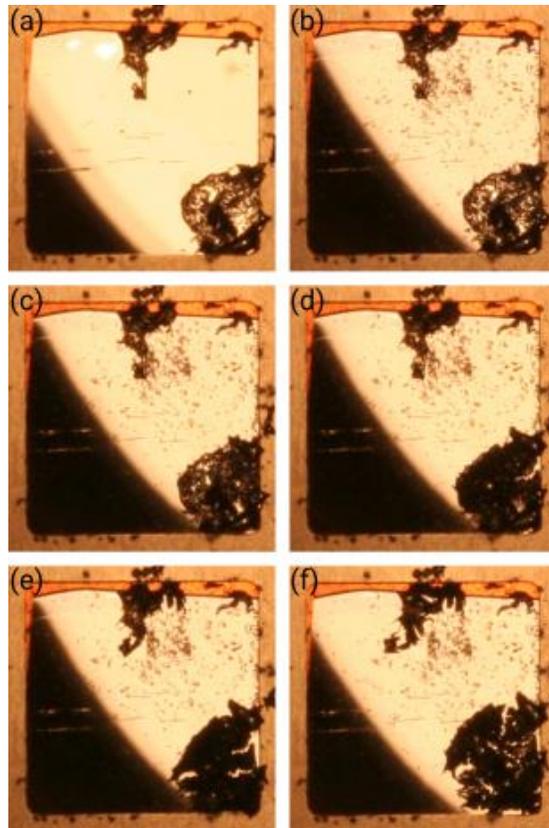
Fig. 5. (Color online) Images of ML-coated sample with small tin drop contaminations photographed at different stages during ongoing phase transformation: (a) after tin dripping, (b) after inoculation with seeds, after cooling for (c) 3 hours, (d) 4.5 hours, (e) 5.7 hours, and (f) 8 hours. The lower left part of the mirror was covered by a shadow.

contaminated with one tin drop only. However, as described in the experimental section, a few pieces of β -Sn could be melted simultaneously on the tray by heating in parallel leading to sequential in-situ dripping of several tin drops. Fig. 5a shows a photo of a sample after tin dripping where several tin contamination spots were produced on its surface. One tin drop impacted the mirror at the lower right corner. A second drop hit the Al holder and produced several Sn fragments, with two large ones attaching to the upper part of the sample. A third tin drop ended up mainly on the holder outside of the view, but produced a series of small elongated tin strings across the middle section of the mirror sample. With these deposits this sample represented a case of fairly severe thick Sn contamination. According to image analysis, about 16.3 % of the mirror surface was covered by tin, leading to a presumed corresponding relative loss in EUV reflectivity of similar magnitude. To reach good contrast for imaging, the illumination with visible light was adjusted in such a way that the uncontaminated mirror surface produced a bright reflection. Only, the lower left corner of the substrate could not be illuminated in this way, creating a dark shadow on the mirror in this region.

The sample was infected with gray tin powder under uninterrupted vacuum conditions and at room temperature by positioning the basket by use of the manipulator rod above the EUV mirror and emptying it by rotation, thus dripping α -Sn seeds onto the surface near and on the largest contamination spots. Fig. 5b shows the sample after in-situ inoculation, with the additional gray tin powder being clearly visible in the image. After infection the sample holder was cooled down with cold nitrogen vapor to low temperatures such that a thermocouple wire clamped between the copper body of the sample table and the Al holder reached temperatures in the range of about $-35\text{ }^{\circ}\text{C}$ to $-40\text{ }^{\circ}\text{C}$. Corresponding recordings at the exhaust of the cooling line showed temperatures down to between $\sim -50\text{ }^{\circ}\text{C}$ and $\sim -60\text{ }^{\circ}\text{C}$. The reading at the holder was considered to be representative for the temperature of the sample. After about three hours of cooling the ongoing phase transformations of the tin pieces were clearly visible in the photographic images by subtle changes in light reflection and progressive darkening of the tin drops, see Fig. 5c. Deformation and volume expansion of the converted tin and corresponding small movements of Sn bulk material could then be noticed as well, leading to the development of a crack in the large tin drop after ~ 4 hours (Fig. 5d). More cracks developed and the transformed tin showed movements on the mirror surface caused by volume expansion, see Fig. 5e. As shown in Fig. 5f, after cooling for 8 hours, the larger tin drop contaminations on the mirror were essentially fully transformed to gray tin and exhibited numerous cracks where the mirror surface below became discernable. Sample cooling was then stopped.

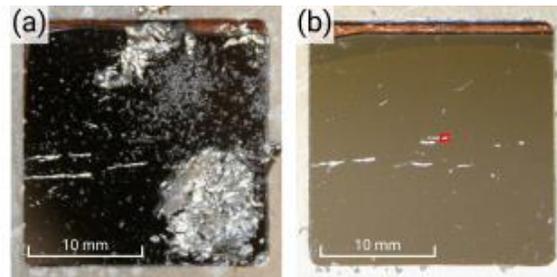
Fig. 6. (Color online) (a) Photo of mirror after in-situ transformation and removal from vacuum chamber. (b) Appearance of mirror after cleaning of tin pieces with dry air. The red rectangle near the center of the sample indicates the region examined in more detail in Fig. 7.

On the next day the sample was removed from the chamber after slow venting with nitrogen gas. Fig 6a shows a photo of the contaminated mirror in the Al holder after removal of the sample holder unit from the chamber. Since the substrate had been at room temperature for more than 12 hours, the appearance of the tin drops had reverted

back to a more whitish color, but the large drops were still very brittle. They were removed from the surface with ease by several gentle puffs of dry air. The sample appearance after tin cleaning is shown in the photo of Fig. 6b. The large tin drops could essentially be fully removed, since due to long enough cooling time the α -Sn phase had propagated through the entire bulk of contiguous Sn material. In Fig. 6b a small stripe of uncoated Si substrate is visible at the top of the sample. No differences were observed for coated and uncoated parts of the mirrors with respect to the behavior during tin contamination and transformation. Small pieces of tin debris adhering to the surface were more difficult to inoculate. A majority of the small tin strings on this sample had apparently not been infected by tin pest and still remained attached to the mirror. An image evaluation of the area coverage on the photo by Sn particles yielded a remaining coverage of 0.94 %. In contrast, all other test samples examined in our tests had smaller remaining tin coverages after cleaning, with corresponding fractions often below 0.1 %.

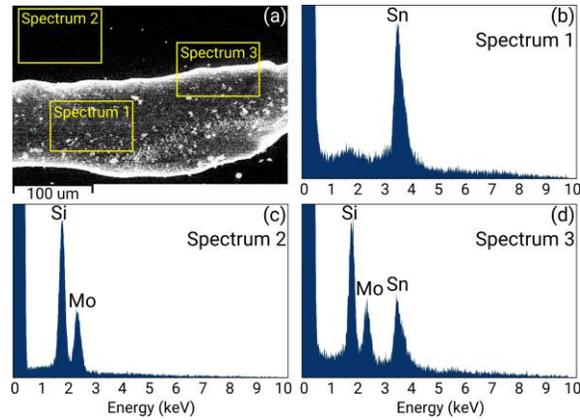
Fig. 7. (Color online) (a) SEM micrograph of red-labeled region of Fig. 6b. The regions where the corresponding EDX spectra 1 – 3 were recorded are indicated in the figure by yellow rectangles: (b) EDX spectrum 1, (c) EDX spectrum 2, (d) EDX spectrum 3.

For further analysis, the sample discussed above was inserted into a scanning electron microscope (SEM, Zeiss DSM 982 Gemini). Figure 7a shows one of the SEM images with low magnification (50x) for a tin string located in a region near the center of the sample, indicated by the red rectangle in Fig. 6b. The corresponding energy dispersive x-

ray (EDX) spectrum displayed a strong and dominant Sn signal (Fig. 7b). A neighboring region visibly free from contamination in the SEM image gave an EDX intensity signal with only Si and Mo, originating from the Mo/Si-coating (see Fig. 7c), whereas the spectrum in Fig. 7d for a region half-covered by the tin string showed signals of Si, Mo and also Sn, as was to be expected. Some of the very small micrometer-size particles on the surface were analyzed by SEM-EDX with much higher magnification, as well. Apart from the predominant particles containing Sn, a few particles producing Al or Si signals could also be found. Small aluminum particles could have originated from the holder; Si dust might have come from the edges of the Si wafer substrate.

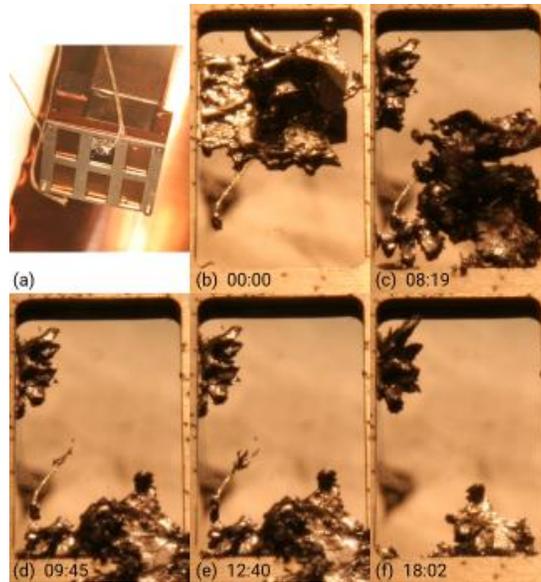
Fig. 8. (Color online) (a) Sample holder with ML-coated mirror contaminated by massive tin drop after tilting by an angle of 54° . (b – f) Images of sample with massive tin drop contamination photographed at different stages during cooling for phase transformation: (b) at start, (c) after ~8 hours, (d) after ~10 hours, (e) after ~13 hours, (f) after ~18 hours, corresponding to end of test. The total cooling time, counted from its start, is indicated.

Transformation experiments were also carried out with rectangular EUV mirror samples. Figure 8a shows such a sample where about 44% of the ML-coated mirror was covered by tin contaminations. Tin was dripped under vacuum onto this sample with two successive tin drops reaching the same spot. The first tin piece had only partially melted; the second drop covered the first one on the sample surface creating a massive Sn contamination, in part with a total height of almost 3 mm. In this case, the chamber was vented after tin dripping. The flange with the sample holder was then rotated by an angle

of 54 degrees with respect to horizontal (see Fig. 8a), in order to create an inclination of the mirror. A large copper plate was placed as a tray at the bottom of the chamber below the sample holder to collect falling pieces of gray tin. The sample was inoculated by placing α -Sn powder on the top surface of its Sn contamination. Next, the chamber was pumped down again. After the vacuum pressure had reached levels of below 10^{-4} Pa, the sample holder was cooled with cold nitrogen vapor to temperatures of around -40 °C, as measured by a thermocouple probe attached under the sample holder next to the mirror. Photos of the sample were automatically recorded at regular intervals of ~ 5 minutes or longer. Fig. 8b shows the mirror at the start of in-situ cooling; Fig. 8c shows its appearance after more than 8 hours of cooling. Within a few hours most of the contamination was transformed, starting first in the infected area with accompanied strong volume expansion of the Sn material. Loose pieces of transformed gray tin fell successively off from the sample and down under their own weight onto the copper tray below, or they became trapped at the bottom side of the sample holder. After about close to 10 hours of cooling, the majority of the massive Sn contamination had already been transformed and detached from the top section of the mirror sample by falling down (see Fig. 8d). An exception was a transformed piece on the left side that was held in place by the sample holder. Magnification of the image revealed that the original Sn contamination was removed completely from the mirror surface (to within detection limit). Only the bare surface remained, showing some weak reflections of the surroundings. A string of tin in the lower section of the sample was also partially transformed to gray tin, with the transition starting from both of its ends and progressing further (see, for example, Fig. 8e).

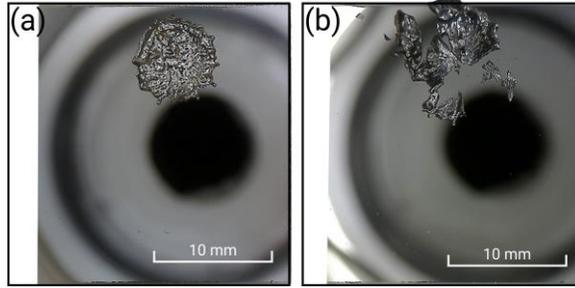
Fig. 9. Photo of ML mirror (a) after tin drop contamination and (b) after transformation at 7 hours of cooling. (The camera objective is reflected by the mirror.)

Potential EUV reflectance degradation of the optics was examined by using a pre-characterized mirror sample (25 mm x 25 mm square) that had been ML-coated with 50 Mo/Si- bilayers and a thin SiO₂ cap layer by magnetron sputter-deposition. The peak reflectance of the sample at near normal incidence that had been measured more than two years earlier at three positions on the mirror at the reflectometer of the PTB in Berlin²³, was $R_{\text{max}} = 68.0 \%$ at a wavelength of 13.6 nm. A tin drop with a diameter of $\sim 7.5 \text{ mm}$ was dripped ex-situ onto this mirror. Even though oxidation of tin occurred during dripping, no use of HCl was made for removal of surface oxides. Less than 30 minutes later, after infection with α -Sn seed particles placed on the surface of the drop, the sample was moved to a freezer for transformation at $-24 \text{ }^\circ\text{C}$, as described previously¹⁷. Photos of the sample with the tin drop before cooling and after 7 hours of cooling are shown in Fig. 9. Essentially full phase transformation throughout the entire drop was reached within only about 7 hours of cooling. After cleaning of brittle gray tin fragments by puffs of dry air, the mirror surface was found to be free from any apparent Sn residues in visual inspection.

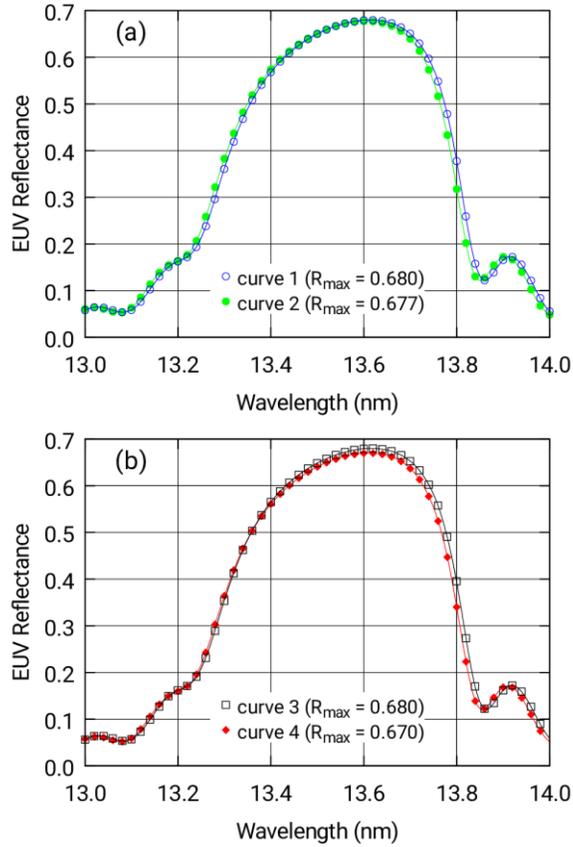
Fig. 10. (Color online) Wavelength dependence of EUV reflectance: Reflectivity curves before and after tin-cleaning of Mo/Si-coated mirror obtained (a) in the center of the sample (curves 1 and 2) and (b) in the region of tin drop (curves 3 and 4). Corresponding values of maximum reflectance for each curve are listed.

The reflectance of the cleaned sample was measured once more at PTB. As was briefly reported already¹⁷, the peak reflectance in the region of the tin drop location was then found to be $R_{\max} = 67.0\%$ at 13.6 nm. For a more detailed discussion, the corresponding EUV reflectivity data obtained at 5° incidence angle are compared in curves (1) and (2) of Figure 10a for the center of the mirror before and after the cleaning experiment, respectively. Additional reflectivity curves (3) and (4) shown in Fig. 10b (before sample use and after tin cleaning, respectively) were taken in regions of the sample that had been covered by the tin drop before its removal. An upper limit of 1% can be deduced for the EUV reflectance reduction of the mirror after tin dripping and cleaning. The decrease was more likely in the range of 0.5 % or less, since EUV reflectivity measurements in two regions outside of the tin contamination spot now resulted in peak reflectance values R_{\max} of 67.2 % and 67.7 %, respectively, also lower compared to the initial peak reflectance of 68.0 %. This may be attributed to small changes caused by aging of the coating and by degradation during sample handling. A very minor wavelength shift of the reflectivity curves by ~ 10 pm can be observed, also in the region that was not covered by the tin drop, when comparing the curves before and after sample cleaning (see Fig. 10). The full width at half maximum did not change significantly in comparison to the measurements before tin dripping.

of about 64.9% is of the same magnitude as the value obtained before cleaning at this wavelength (see Fig. 10 b). This coincidence can be explained by the observed very small wavelength shift of the curves after tin cleaning to slightly shorter wavelengths which effectively cancels the concurrent small decrease of reflectance. At the wavelength of 13.5 nm this led to almost the same EUV reflectance values before and after cleaning even though the peak reflectance of the reflectivity curves near 13.6 nm decreased slightly. It may be concluded that it is likely that a reduction in reflectance due to small remaining Sn particles on the mirror is considerably lower than the upper limit of 1%. It also has to be kept in mind that no clean-room environment was available for sample handling; therefore, very small amounts of dust accumulation, which could also cause a decrease in EUV reflectance, cannot be fully excluded.

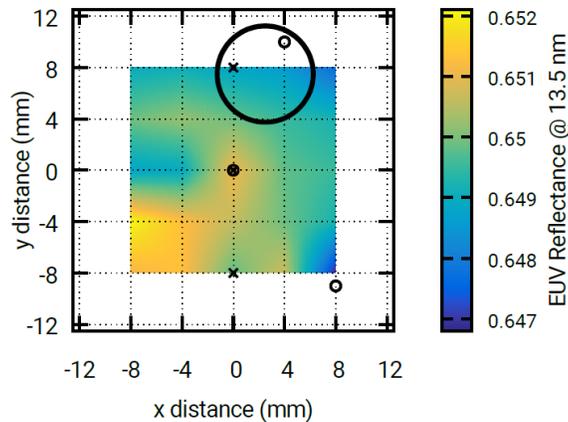
Fig. 11 (Color online) EUV reflectivity map after tin-cleaning recorded across the central part of the mirror surface at a fixed wavelength of 13.50 nm. The area that had been covered by the tin drop is indicated by a circle in the map. The locations on the mirror where reflectivity curves were measured before and after cleaning are also marked in the figure by crosses and open circles, respectively.

The result of EUV reflectivity mapping for a central portion of the sample at 5° incidence angle, taken by PTB at a fixed wavelength of 13.5 nm, i.e., 0.1 nm smaller than the wavelength of peak reflectance, is displayed in Fig. 11. The data show that the sample did not exhibit a fully homogeneous reflectance pattern. The gradient in reflectance for this scan at 13.5 nm was about 0.5 % across the inner portion of the cleaned sample, consistent with the observed variation of the peak reflectance values in the spots where reflectivity curves were recorded. The area that had been covered by the tin drop is indicated in the map, as well as the locations where reflectivity curves were measured. In the region covered by the tin drop the level of reflectance at 13.50 nm after tin cleaning
