Analysis of RF losses and material characterization of samples removed from a Nb₃Sn-coated superconducting RF cavity

Abstract

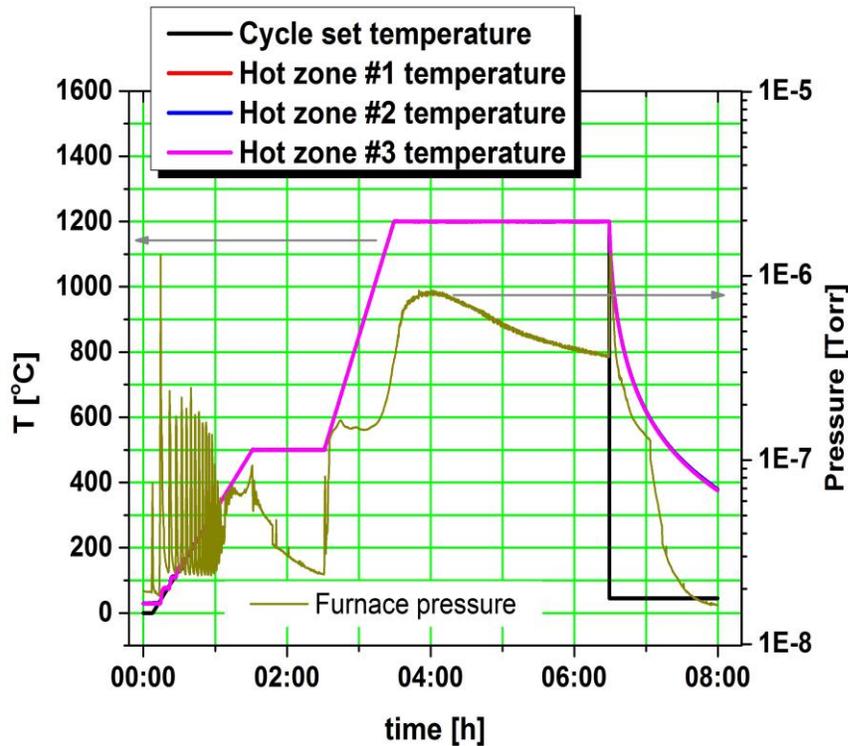
Fig. 1. The temperature and pressure profile from the first Nb_3Sn cavity coating run. Note the three separate regions: first, the temperature is increased at $6\text{ }^\circ\text{C}$ per minute, then, it is parked at $500\text{ }^\circ\text{C}$ to allow for $SnCl_2$ evaporation, then, the temperature is increased at $12\text{ }^\circ\text{C}$ per minute to $1200\text{ }^\circ\text{C}$, where the furnace temperature remains for 3 hours, finally, the heat is turned off and the furnace cools down.

evacuated for a couple of hours, and the heating profile was initiated. In Fig. 1 the temperature profile from the three heat zones of the furnace and the furnace pressure are shown. After the heating run and furnace cooldown, the insert and the furnace were purged with N_2 to atmospheric pressure, and the cavity was removed from the insert. A description of the coating system is available in [14]. In Fig. 2 (a) the cavity is shown sitting on the table after removal from the insert. When the Nb cover foils were removed, several features were observed: discoloration was seen on NbTi flanges (b), residues were observed on the bottom Nb cover and the Nb foils that contained Sn and $SnCl_2$ (c), and Sn condensation on the top Nb foil (d).

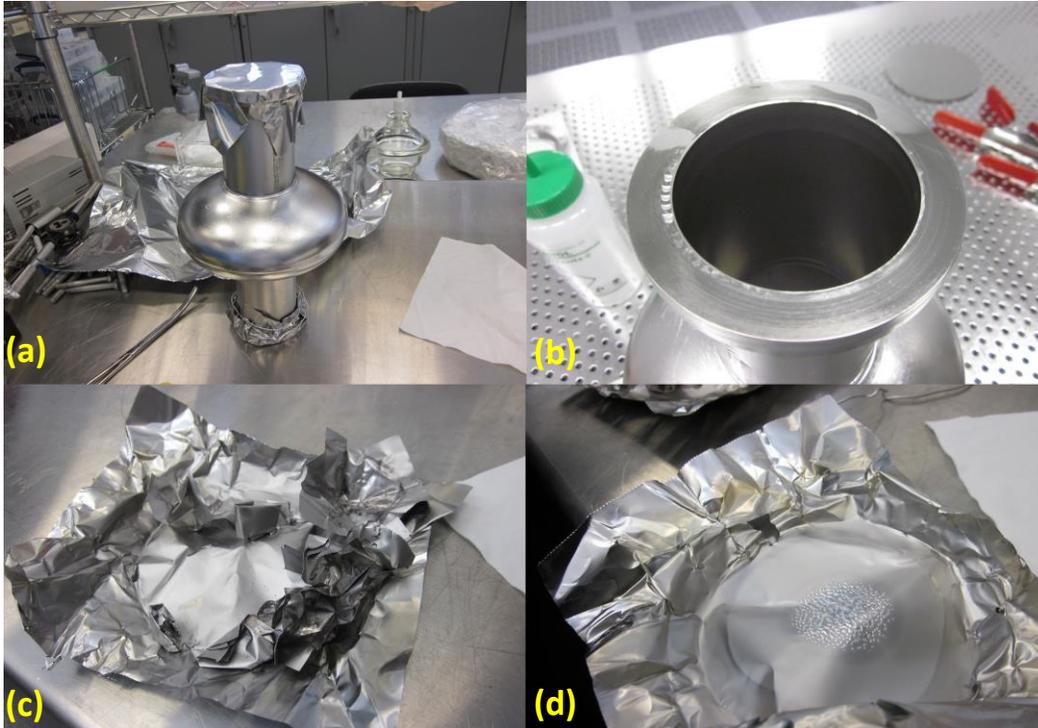
Fig. 2. Cavity C3C4 after the coating run. Note discoloration on the NbTi cavity flange (b) and 'tin' droplets on the niobium foil from the cavity top flange (d).

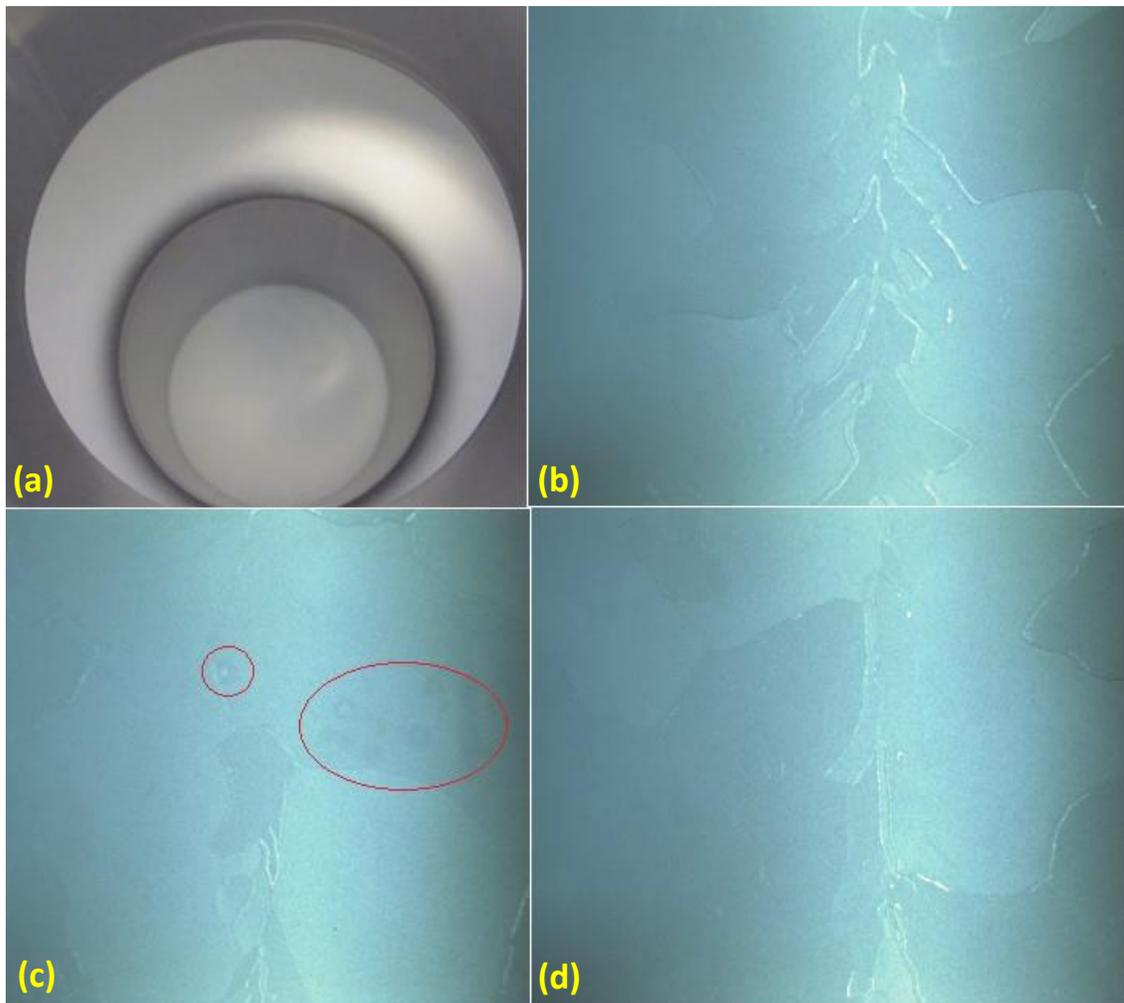
Fig. 3. Optical inspection pictures of C3C4. (a) shows the coated surface of the cavity viewed via one of the beam tubes. (b) and (d) show characteristic equatorial weld regions of the coated cavity. (c) shows an equatorial region with several observed features marked with red ellipses.

After the coating, the cavity interior was optically inspected with a KEK-style optical inspection bench [15]. The optical inspections of C3C4 revealed complete coverage of the surface. In one place at the equator area of C3C4, we found several $\approx 100 \mu\text{m}$ -size features, Fig. 3(marked with red ellipses).

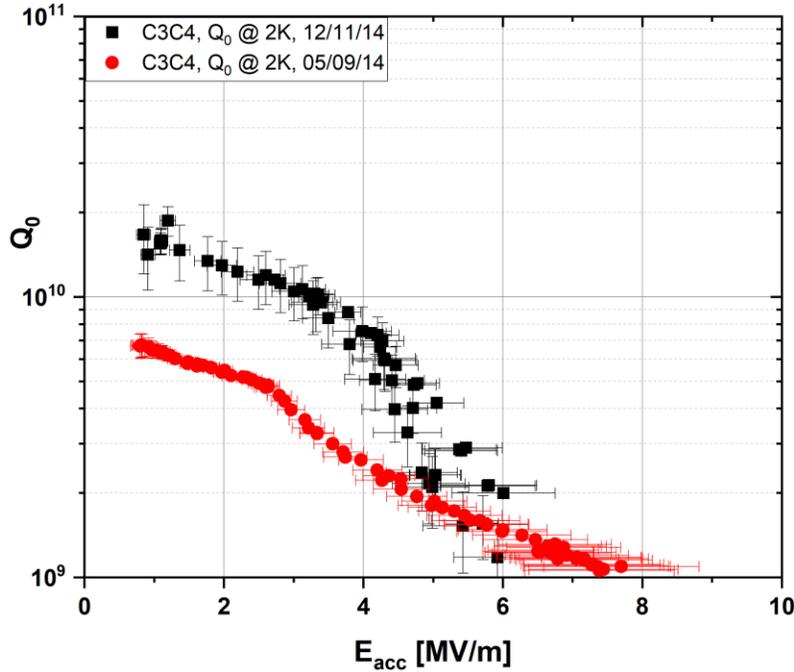
Fig. 4. Q_0 vs E_{acc} for cavity C3C4.

during cooldowns. The superconducting transition temperature of C3C4 was found to be 17.9 ± 0.25 K. We did not observe any transition at 9 K, which indicates complete Nb_3Sn coverage on the Nb. After Nb_3Sn coating, the cavity was limited by a strong slope in Q_0 at low fields at both 2.0 and 4.3 K helium bath temperature, Fig. 4. The cavity was then re-tested with a temperature mapping array installed around the cavity [17]. The Q_0 vs E_{acc} curve was similar, and the cavity was limited again at low gradients due to a strong slope. The low-field Q_0 was better in the re-test, which is attributed to a different cooldown condition. Due to the higher low-field quality factor, a “knee” at about $E_{acc} = 4$ MV/m is more evident than in the first test.

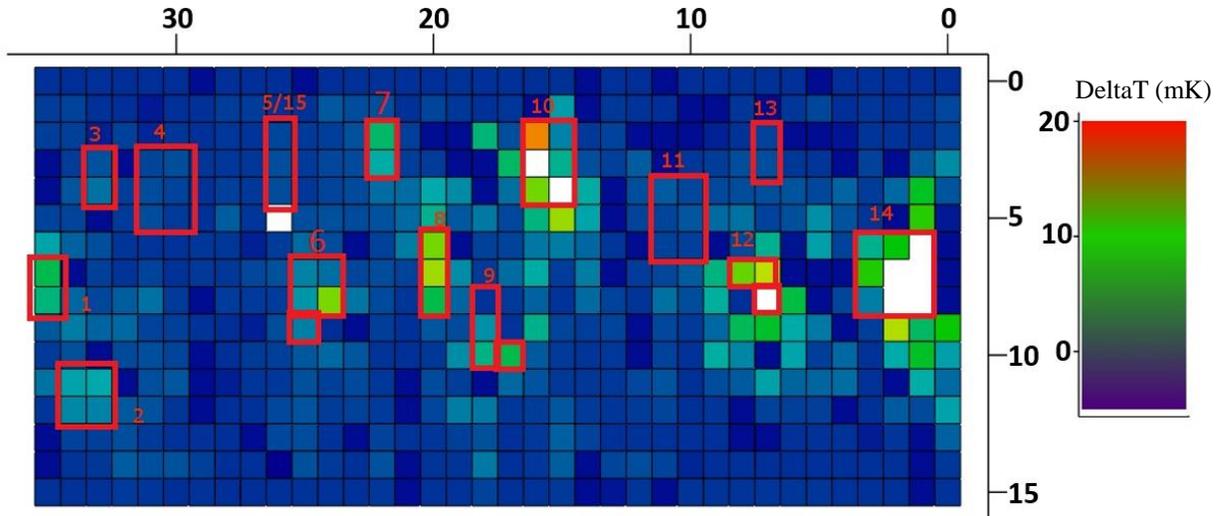
Fig. 5. Temperature map of C3C4 at $E_{acc} = 6$ MV/m shows the temperature delta due to RF fields on the outer cavity surface. See text for details.

During the latest test, temperature maps of the cavity surface were acquired at different field levels with the JLab temperature mapping system [17]. The system is comprised of 36 boards surrounding the cavity at the equally spaced interval. Each board has 16 temperature sensors mounted on spring-loaded pins that push against the outer surface of the cavity. The temperature difference between the outer cavity surface and the Helium bath at the highest gradient showed three regions with the strongest heating on the cavity surface at (15, 3), (7, 8), and (2, 7). The X-axis and Y-axis here represent board number and sensor number respectively. For example, (15, 3) represents the location at board 15 and sensor 3. Sensor 1 is at the top iris, sensor 16 at the bottom iris and sensor 8 is at the equator. To assess the heating in other areas, the maximum of the color scale is reduced to 20 mK in Fig. 5. The three hottest areas mentioned above are now off scale and became white squares. The white square at (26, 5) is an artifact of a malfunctioning temperature sensor. The areas which were cut out are marked with red line. The number next to the marked areas indicated the number assigned to the extracted sample. This temperature map shows that the heating on the surface is not uniform, with some distributed areas, e.g., at (35, 7), showing more heating than others, e.g., (29, 7). This temperature map was sectioned into areas with different heating behavior to guide extraction of characteristic samples from different surface areas.

After the RF test with temperature mapping, the outside surface of the cavity was marked with an engraver according to the temperature map in Fig. 5. Each area marked for extraction was encircled with engraver roughly following the contour of the thermometers. Several samples were then milled out with a 3/32 two-flute OSG Exomini TiN-coated end mill running at 3200 rpm as illustrated in Fig. 6. The cut was cooled with helium gas flowing through 1/4" tygon tubing. The helium gas nozzle was set approximately 5 cm from the end mill. The temperature of the niobium surface at the cut was checked with an infrared thermometer and never exceeded 40 °C during milling. During the milling, attempts were made not to cut through, but to leave a thin layer of material, to reduce contamination and damage to the internal surface from the milling process. This was not always possible due to cavity curvature, but some material was left when the milling was finished. The samples were then removed with pliers and de-burred.

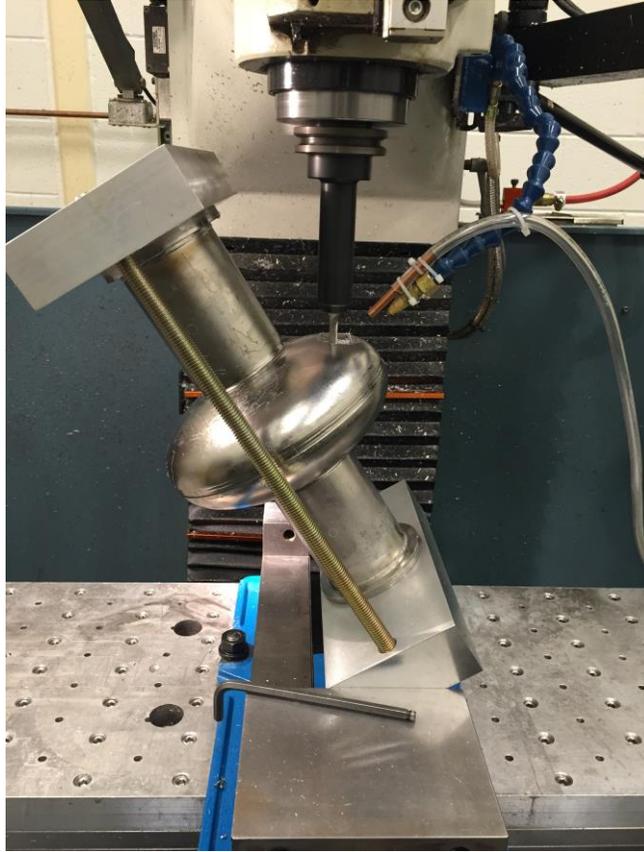
Fig. 6. Setup used to millout marked areas from the cavity C3C4 noted in Fig. 5.

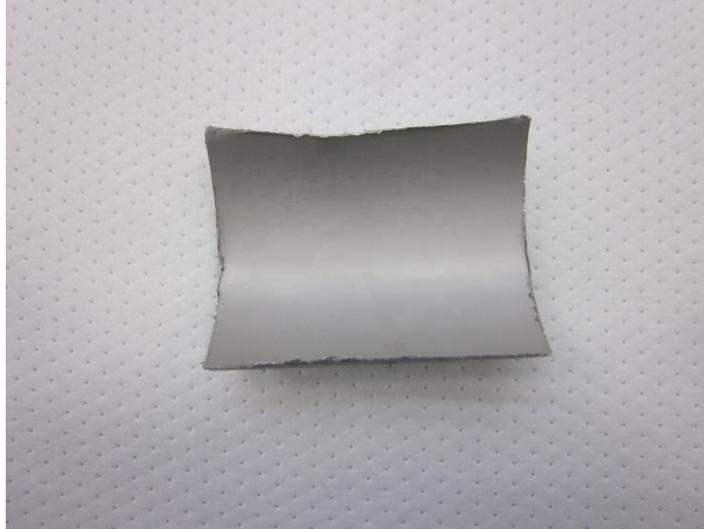
Fig. 7. Sample #14 (CVT14) following each cleaning step before the analysis.

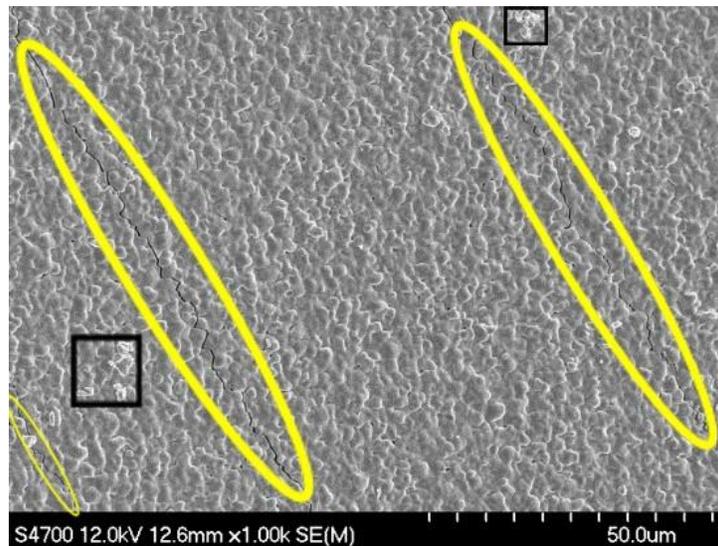
Fig. 8. Cutting artifacts in CVT8. Note that the cracks are aligned in the same direction. Some traces of contamination can be seen, which was found to be niobium.

Since intermetallic A15 compounds are extremely brittle, Nb₃Sn is vulnerable to fracture. It is known that brittle fractures can propagate faster along the direction perpendicular to the applied stress. Cracks observed in cutouts typically started from the edge and propagated in the same direction away from the edge, indicating that they were formed due to the applied mechanical stress during dissection.

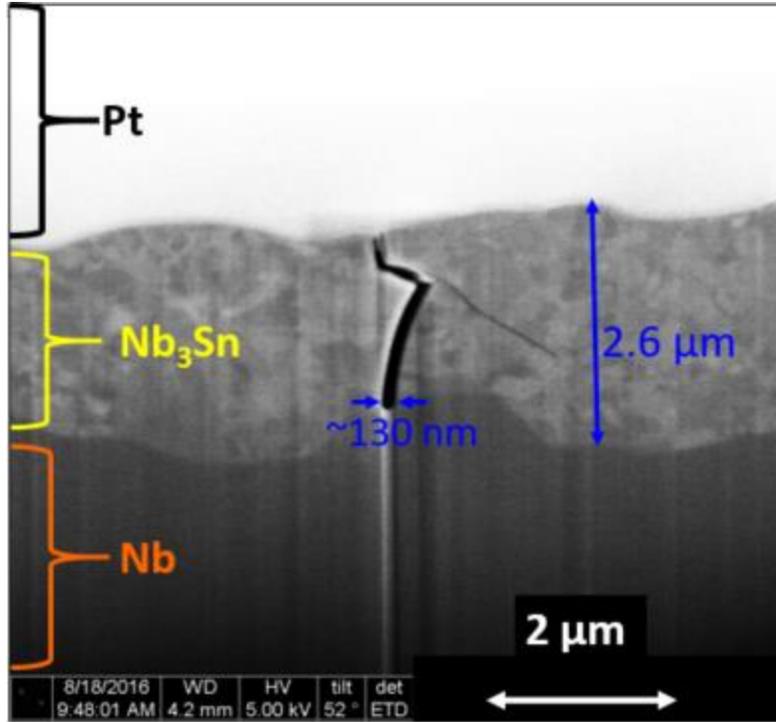
Fig. 9. A cross-sectional view of a crack observed in CVT14. Note that the crack extends down to the Nb-Nb₃Sn interface.

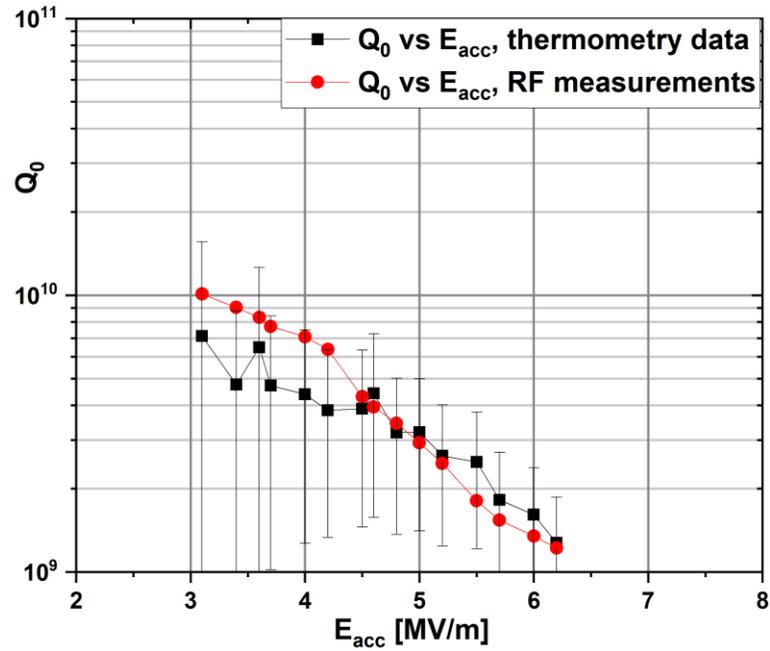
Fig. 10. The intrinsic quality factor derived from both RF and temperature mapping data.

With the caveat mentioned above, the average RF surface resistance of the cavity can be calculated from the temperature map of the whole cavity surface. Averaging the temperature rise adjusted for the local field amplitude over the entire surface of the cavity, the average surface resistance of the cavity can be calculated from the last equation. The average surface resistance can be calculated this way for each temperature map for each field level. The resulting field dependence of the surface resistance can be converted to the quality factor via $Q_0 = \frac{G}{\langle R_s \rangle}$, where $G = 273$ is the geometry factor for this cavity shape. In Fig. 10, the intrinsic quality factor derived this way is shown along with the quality factor measured during RF test using the standard phase-lock loop (PLL) technique. The error bars for the quality factor calculated

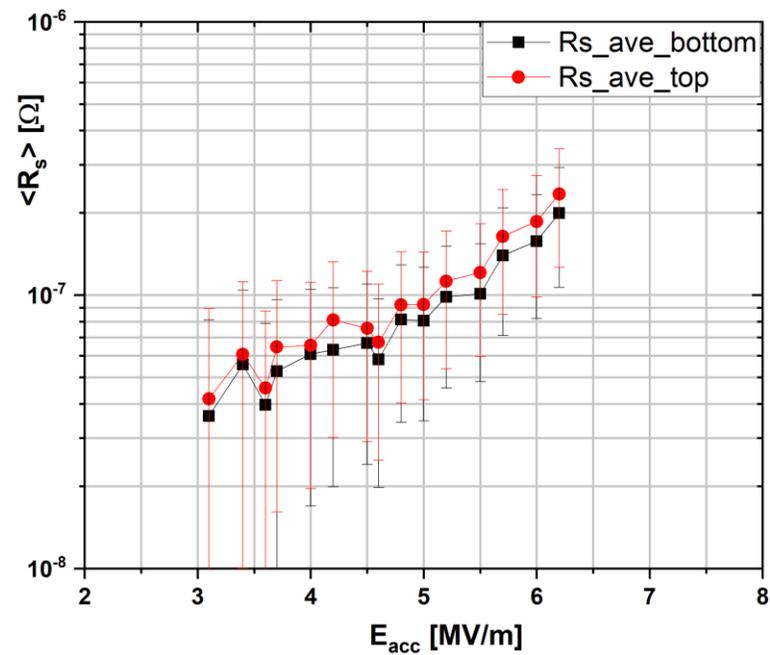
Fig. 11. The average surface resistance of the top and bottom half cells derived from temperature mapping data.

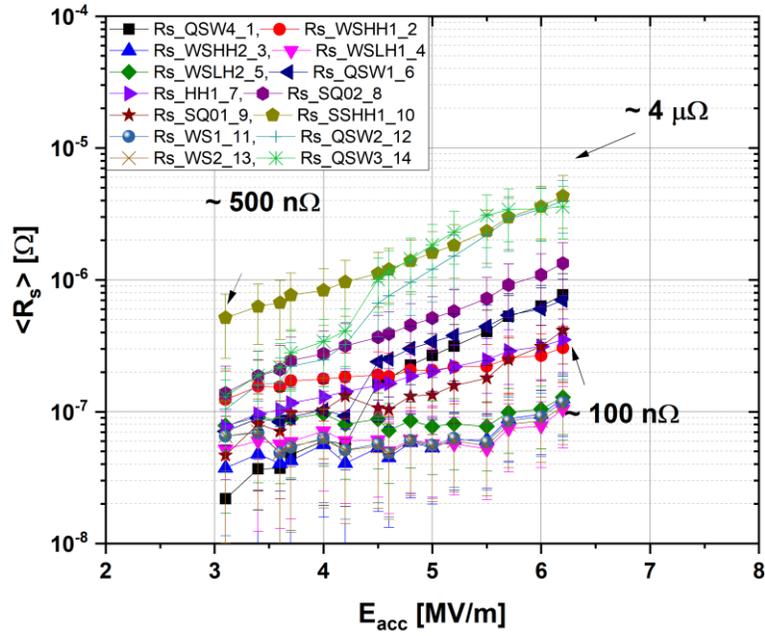
Fig. 12. The calculated surface resistance dependence with field for all cutouts.

from the thermometry data are derived from the temperature sensor efficiency spread of 37 % and the sensor noise floor, which was assumed to be 50 μK . The typical Q_0 error bars for PLL RF measurements are about 10 % (not shown in the plot). Considering different areas of the cavity, a difference in the average surface resistance between the top and the bottom half cells can be evaluated. For example, since the Sn source is located at the bottom flange, tin vapor pressure gradient along the cavity axis of symmetry may exist, which may result in a coating gradient. In Fig. 11, the average surface resistance of the top half cell vs. the bottom one calculated using thermometry data as a function of field is shown. The analysis shows the top half cell has a higher surface resistance, but the difference is within the errors of the analysis. The same analysis applied to the cutouts indicated in Fig. 5 is shown in Fig. 12. The temperature rise adjusted for the local field is averaged over the temperature sensors covering the specific cutout area. Figure 12 summarizes the data for all the cutouts.

All cutouts were broken down into three groups by the field dependence of their average surface resistance. The first group consists of the samples that have weak field dependence, that is, the surface resistance stays constant with the applied field up to the highest field. The second group consists of the cutouts, which have a weak field dependence until $E_{acc} = 4.5 \text{ MV/m}$, but have a surface resistance switch and a stronger field dependence above this field. The last group of cutouts comprises the surfaces that have a strongly field-dependent surface resistance from the lowest field. In Fig. 13, the average surface resistance for the cutouts that have field independent loss is shown. The surface resistance for these samples stays constant with the field. There is an increase in the surface resistance at the accelerating gradients above about 5 MV/m. The increase is within errors, but is evident for all the thermometers in this group, suggesting a systematic effect. In Fig. 14, the average surface resistance for the cutouts that have a resistance switch at $E_{acc} = 4.5 \text{ MV/m}$. There is a jump in the surface resistance at $E_{acc} = 4.5 \text{ MV/m}$. This effect is suspected to be caused by a weakly superconducting defect or defects becoming normal conducting at this field level. In Fig. 15, the average surface resistance for the cutouts that have a strong field-dependent loss. The surface resistance for these samples increases exponentially with field at all field levels, and the temperature at the highest field is an order of magnitude higher than the temperature rise measured at the lowest field.

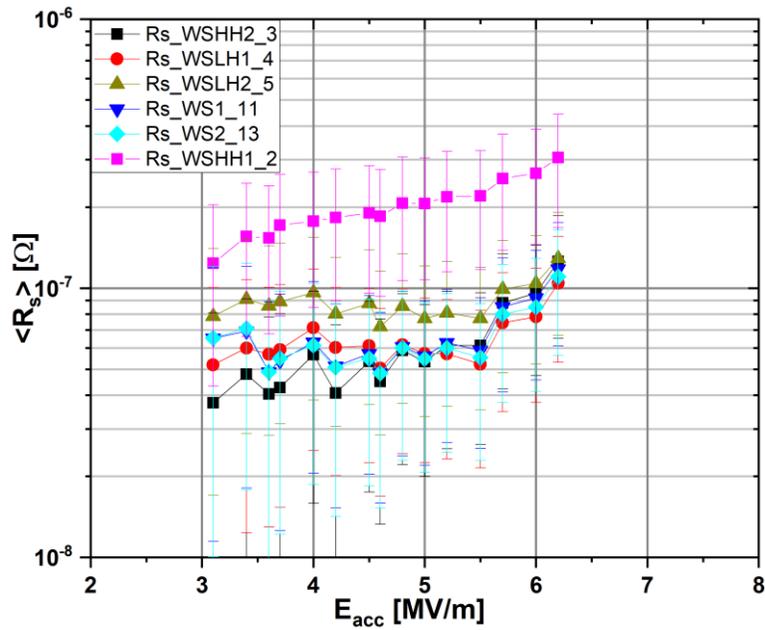
Fig. 13. The average surface resistance for cutouts that show a nearly field-independent loss.

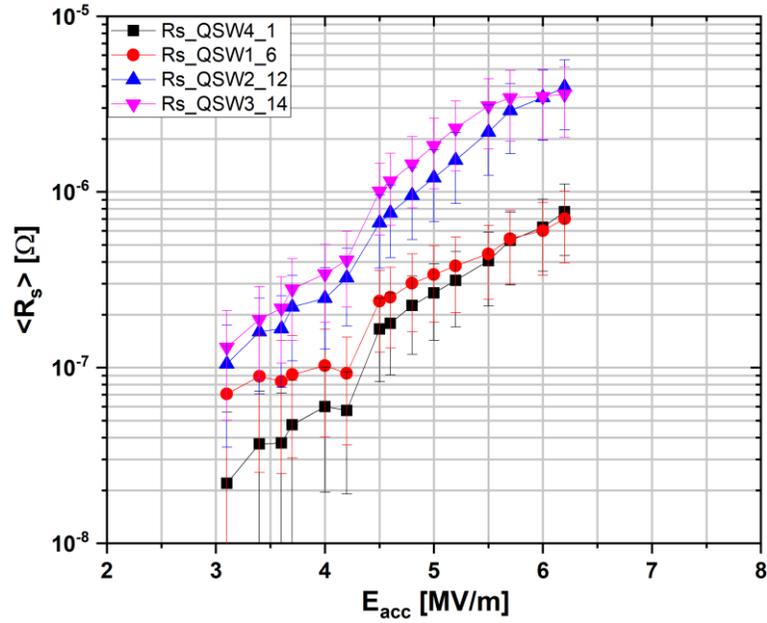
Fig. 14. The average surface resistance for cutouts that have a resistance switch near $E_{acc} = 4.5$ MV/m.

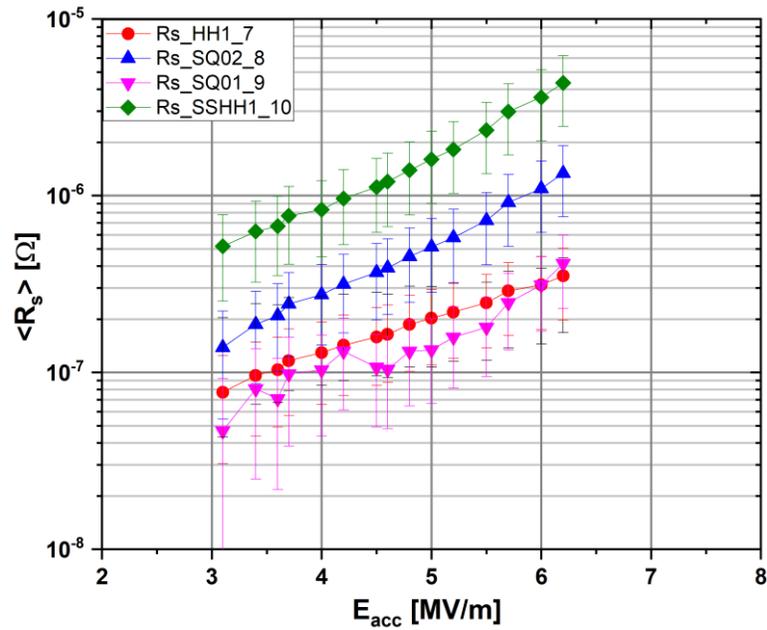
Fig. 15. The average surface resistance for the cutouts that have a strongly consistent field-dependent loss.

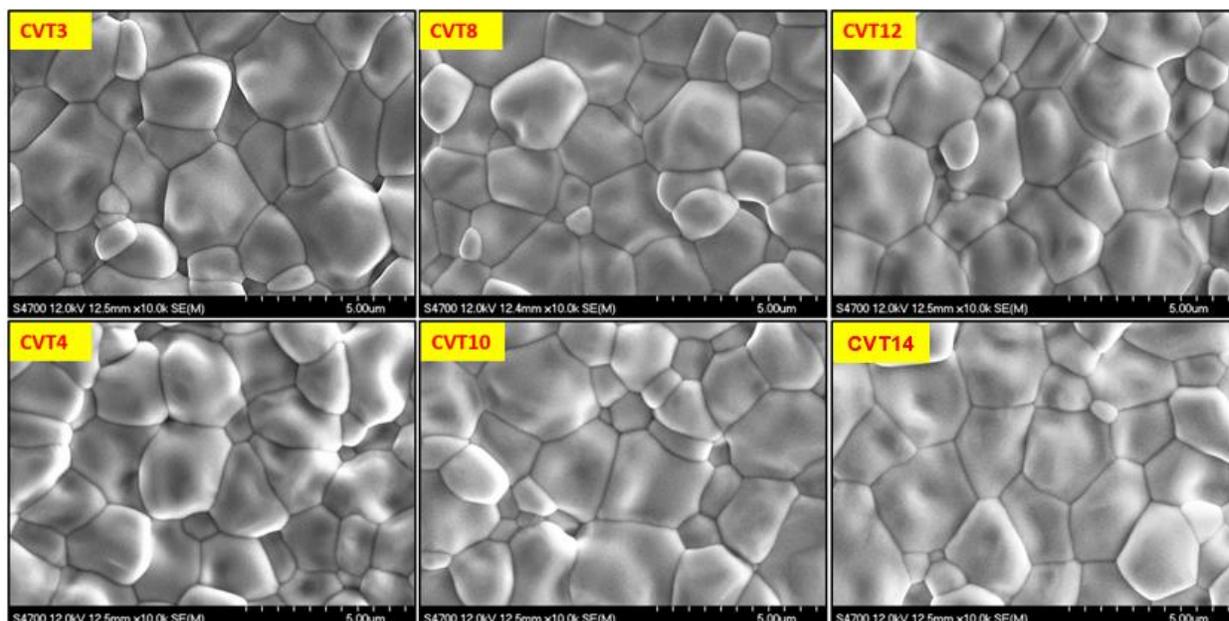
Fig. 16. SEM images from different cutouts representing different field dependence of average surface resistance.

SEM images captured from multiple locations of each sample showed a mostly uniform coating coverage. Observed microstructures were very similar, as shown in Fig. 16. Images at the first, second and third columns belong to different sets of samples that showed field-independent loss (Fig. 13), strong field-dependent loss (Fig. 15), and resistance switch near $E_{acc} = 4.5$ MV/m (Fig. 14), respectively. The composition was measured at several locations of each sample with EDS at 12 or 15 kV. Average compositions of each sample were found very similar as shown in Table I. Average tin content sensed in each cutout was slightly lower than the nominal Nb_3Sn .

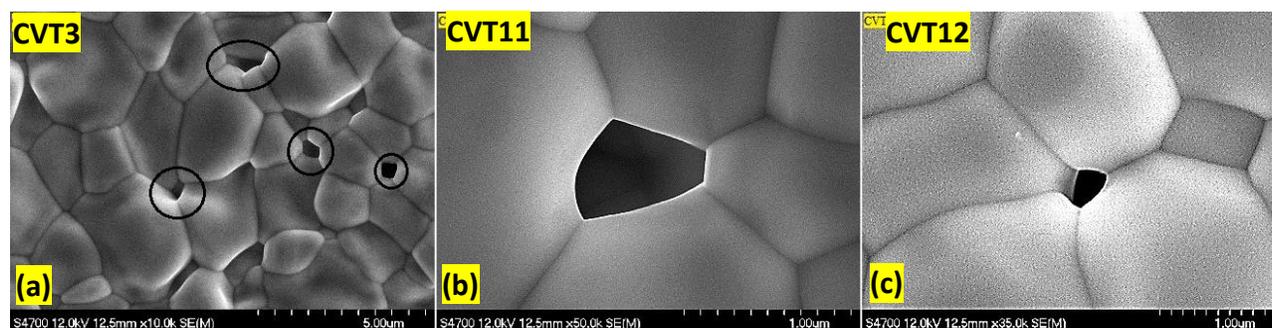
Fig. 17. Several voids (enclosed by ovals) from sample CVT3 are shown in the SEM image to the left. The other two images show pits found in CVT11 (center) and CVT12 (right). Bright outlines indicate sharp edges. Note that the diameter of the pit in CVT11 is about 600 nm.

On the other hand, cavity samples revealed several voids, including microscopic pits in the coating as shown in Fig. 17(a). Note that the term *pit* here refers to the void with well-defined sharp edges at the perimeter. Pit diameters were found to vary between 200 nm to 600 nm. Pits were found normally at vertices where multiple grain boundaries meet as shown in Fig. 17(b) and 17(c). The presence of these voids with sharp edges is understood to be harmful to RF performance of a cavity due to local current and magnetic field enhancement [23, 24]. SEM images with a magnification of 3500 - 5000 were sampled from 15-20 randomly selected areas of cutouts. Voids were counted from those images to get an estimation of void density in each cutout. The estimated average number of voids for all the samples was found to be (11 ± 2) .

per thousand square micron area, shown in Table I. Approximately one third of the observed voids were pits like as shown in Fig.17(b) or 17(c).

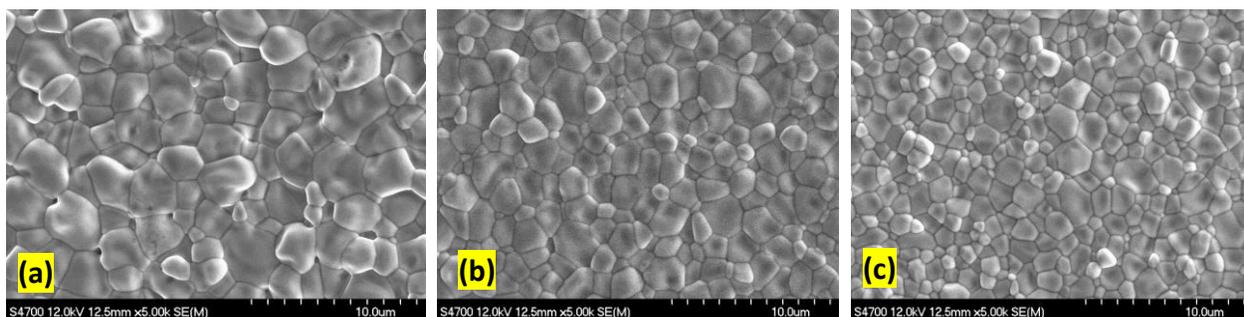
Fig. 18. SEM images obtained from CVT10 (a), bottom beam pipe (b) and top beam pipe (c).

The microstructure of samples extracted from the top and bottom beam pipes appeared different from those obtained from cavity regions, as shown in Fig. 18. The grain size in the beam pipe cutouts is smaller than that of the cutouts from the cell. No voids were observed in beam pipe cutouts. Local composition of

coatings from beam pipe cutouts was similar to that of cutouts from cavity region. Note that the cavity material had higher RRR (≈ 300), while beam pipes were made out of reactor grade niobium (RRR ≈ 40). The average grain size was determined for cutouts with different surface resistance characteristics by counting the number of grains in several SEM images. The estimated average grain size for cavity cutouts was $(4.07 \pm 0.04) \mu\text{m}^2$ per grain, which appeared significantly larger than those for beam pipes cutouts, see Table I. Furthermore, the average grain size for the top beam pipe, $1.35 \mu\text{m}^2$ per grain was smaller than that of the bottom beam pipe, $2.16 \mu\text{m}^2$ per grain.

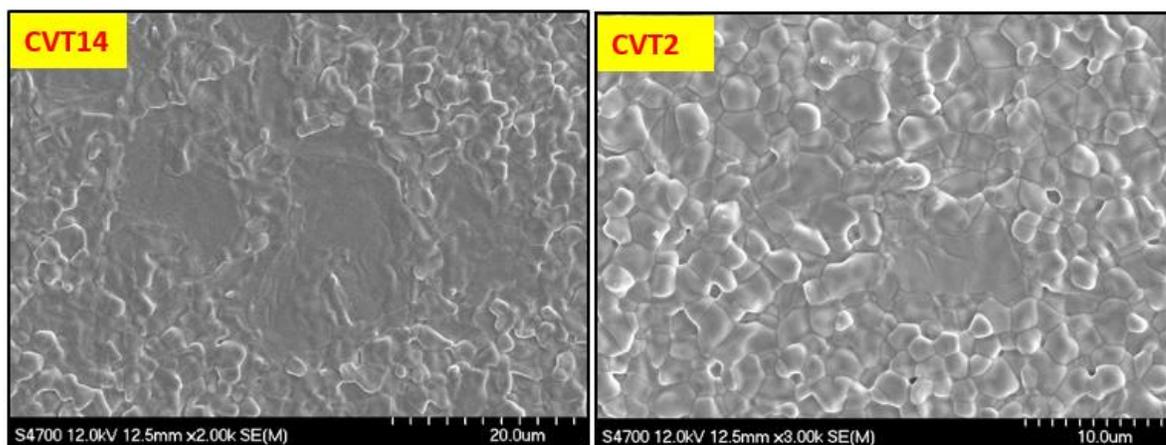
Fig. 19. SEM image of patchy areas obtained from CVT14 (left) and CVT2 (right).

“Patches” with larger irregular grain structures were found in CVT2, CVT4, CVT8, CVT12, and CVT14 and more rarely in beam pipe cutouts. These features were not very common. The size of individual patches varied from a few tens to a few hundred square microns. Small patches were seen at CVT2, CVT4, and beam pipes. Most of those areas had the size that was equivalent to the area covered by a few regular grains, as shown in Fig. 19 (right). Larger patches with the size of a few hundred square microns, as shown in Fig. 19 (left) were encountered in CVT12 and CVT14. Note that these samples showed more coverage of patches than any other cutouts. A few large patches were also observed in CVT8, mostly localized in an unusual area, which will be discussed later. EDS measurement on these smooth areas shows slightly less tin (≈ 21 atomic percent tin) than regular areas (≈ 24 atomic percent tin), a possible indication of a thinner coating. EBSD examination of similar surface obtained in coupon samples revealed that these patchy areas include large single crystalline grains of Nb_3Sn [25]. Finding similar patches in Nb_3Sn coated cavity was recently reported by other researchers [11, 28].

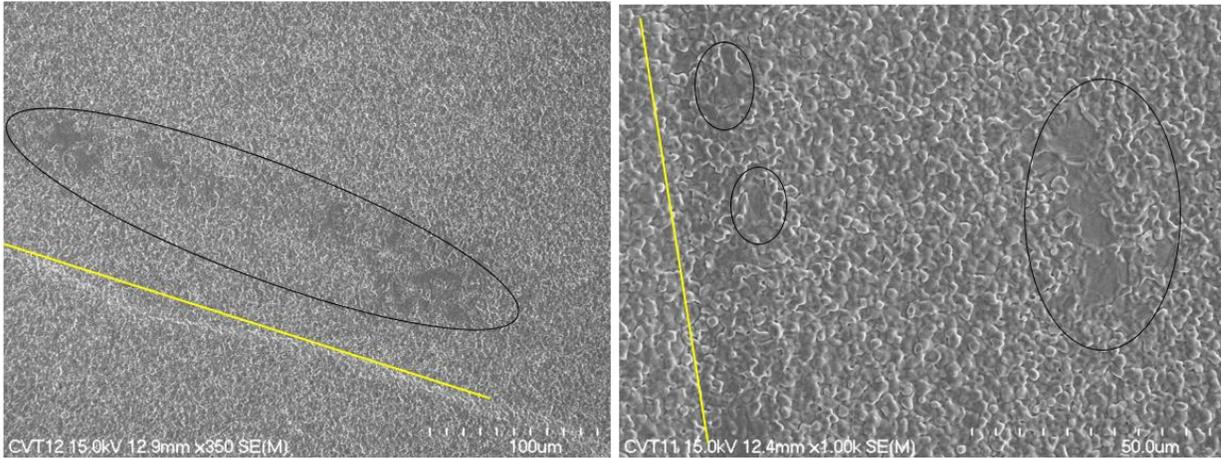
Fig. 20. Patchy areas near grain boundaries. Yellow lines indicate the grain boundaries. Patchy regions are marked with ellipses.

Patches were mostly observed close to niobium grain boundaries. Such patches are often large or appear to have many small patches close together, as shown in Fig. 20. In many cases, the occurrences of patches run parallel to a specific niobium grain boundary for several hundred microns. This was observed in CVT12 and CVT14. SEM images with a magnification of 300-500 were captured from several randomly selected areas of cutouts. The images were then used to locate and measure the size of patchy regions. Table I shows the estimated average area covered by patchy regions for each cavity cutout. Patchy regions contribute less than 0.5 % surface coverage in any cutout.

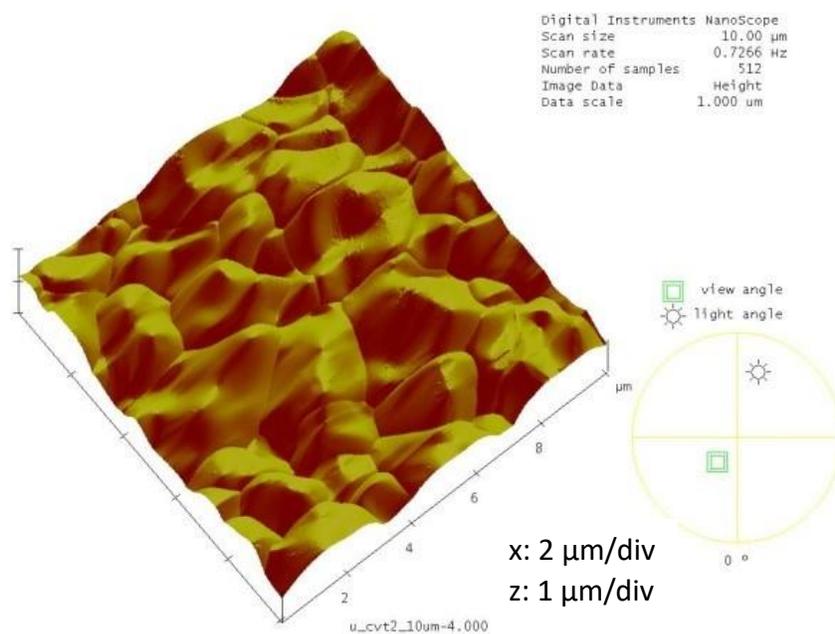
Fig. 21. AFM image of regular Nb_3Sn coatings on CVT2. Roughness is evident with curved convex facets.

AFM was successfully used only on a few samples due to the curvature of the cutouts. AFM results were consistent with SEM/EDS results to locate the pits and irregular grain structure in the coating. A typical illustration of coating topography on the cavity is shown in Fig. 21. The measurement was carried out in tapping mode using silicon tips with a resonant frequency of 300 kHz, a force constant of 40 N/m, and a tip radius of < 10 nm. Roughness was also measured from $5 \mu\text{m} \times 5 \mu\text{m}$ and $50 \mu\text{m} \times 50 \mu\text{m}$ scans. Four samples were scanned and average power spectral densities (PSD) were calculated for comparison. The surface height PSD was calculated by Fourier transform of the scan data as in [26, 27]. Note that the area under the PSD curve corresponds directly to root mean square (RMS) roughness. The difference of roughness was not found to be very significant, as shown in Fig. 22. AFM was attempted to obtain the depth profile of a pit. Pits were located in the AFM scans, and depth profile along a line was extracted from different directions as shown in Fig. 23. It has a very different profile than evident in Fig. 17, which can also be an artifact because of sharper edges of the void than the profiling tip. It was found that the depth of these pits varies between $0.5 \mu\text{m}$ to $1 \mu\text{m}$.

AFM images revealed depressions on Nb₃Sn grains formed by curved facets. These depressions were also visible in SEM images as a dark spot in the middle of Nb₃Sn grains. These depressions in many instances appear to be associated with local contamination, as seen in Fig. 29. The average RMS roughness was found close to 100 nm in the cutout samples for 5 μm x 5 μm scans, slightly higher than 70 nm in samples coated before [31]. The difference is expected because of relatively larger grains and thicker coating in cavity cutouts [30]. The variation of roughness between examined samples was not very significant when average PSDs from the data obtained with AFM were compared.

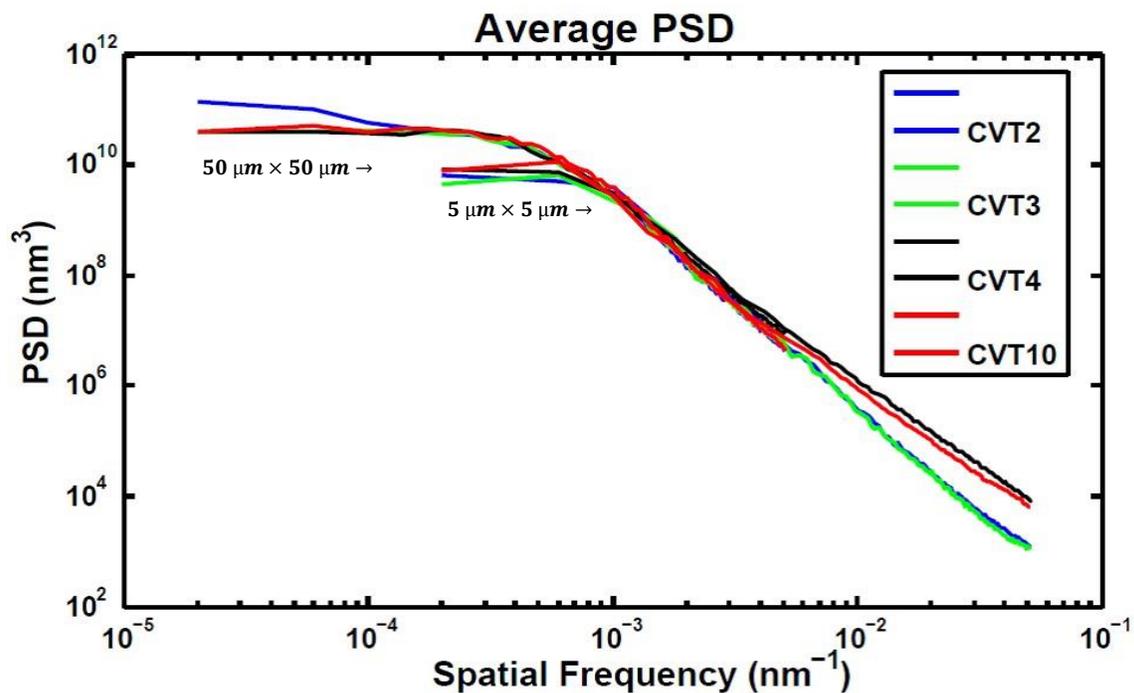
Fig. 22. Comparison of average PSDs of cutouts calculated using AFM data. CVT4 and CVT10 were rougher in the high frequency domain (lateral scale $0.1 \mu\text{m}$ and smaller) than CVT2 and CVT3.

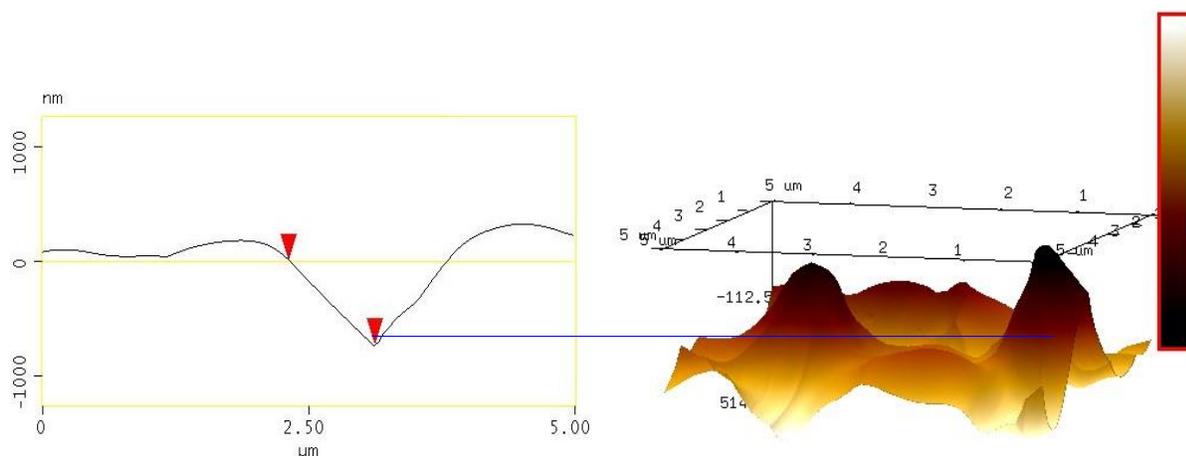
Fig. 23. Profile of a pit observed in CVT2. Pit appears to be ≈ 750 nm deep.

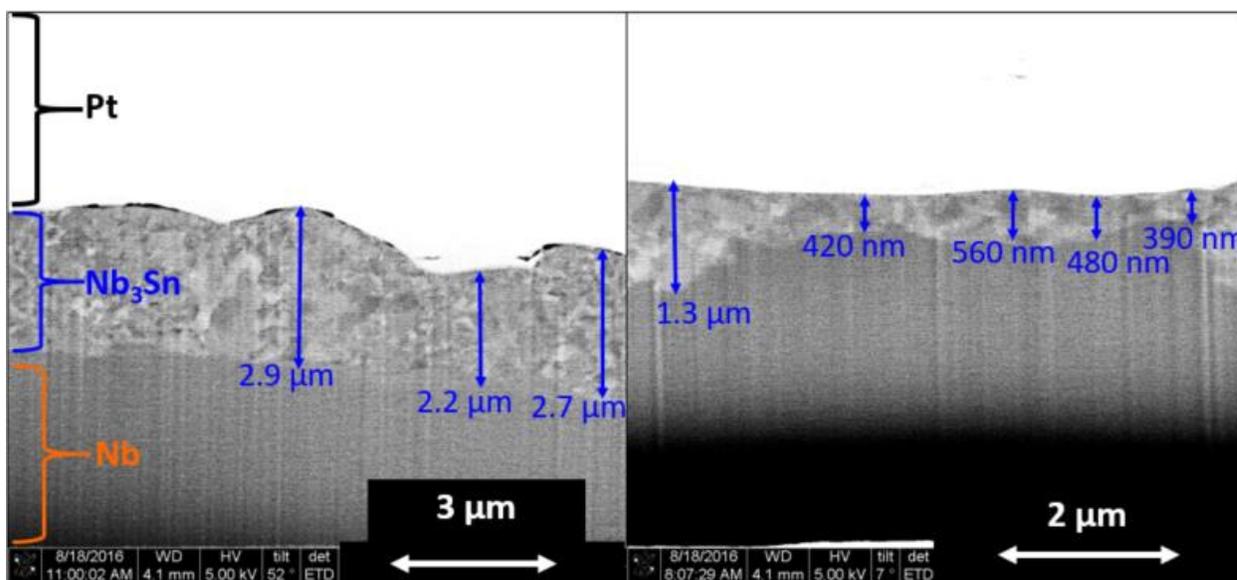
Fig. 24. SEM image of a FIB cross-section obtained from CVT 10 on the left. Thickness varied from 2.34-2.96 μm . FIB cross-section of a patchy area similar to Fig. 5 on the right. The coating is significantly thin (400-600 nm) compared to the neighboring area ($> 1.3 \mu\text{m}$).

Cross-sections from samples were prepared using a focused ion beam (FIB) after applying a protective layer of platinum onto the coating surface. The obtained cross sections were further polished using an ion mill. SEM images of cross-sections were then captured to measure the coating thickness, as shown in Fig. 24[left]. Coating thickness was measured at several locations of the cutout samples obtained from the cavity region and beam pipes. The coating thickness was found to be greater in cavity regions compared to beam pipes. The coating appeared to be thicker in the bottom beam pipe compared to that in the top beam pipe. The thickness of the coating was found to be as little as 400 nm in the patchy area, see Fig. 24[right], confirming thin coating on such areas.

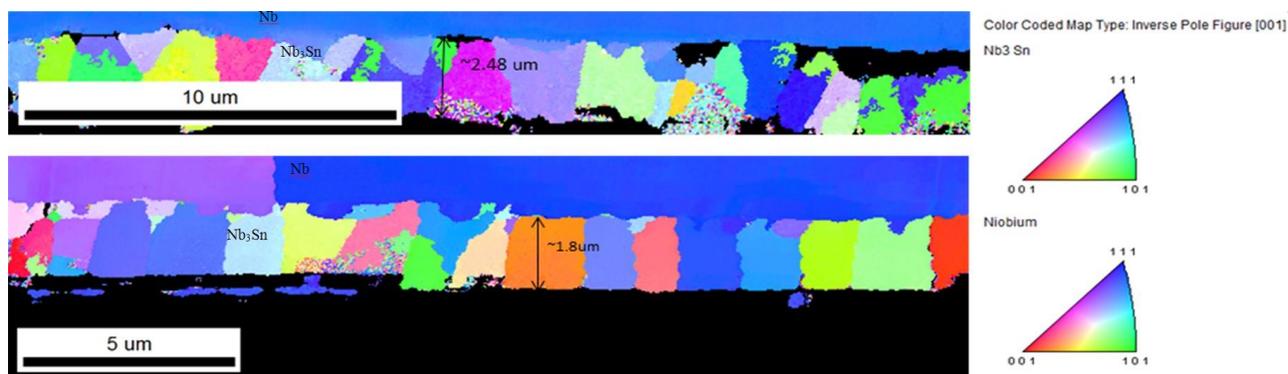
Fig. 25. EBSD image from sample CVT 10 at the top which is cut from the cavity region. The image at the bottom is from the beam pipe cutout. Beam pipe has a thinner coating with more columnar grains than CVT10. Some instrumental artifacts (dark area in between Nb-Nb₃Sn grains) are present.

EBSD images were captured from cutout cross-sections to further examine the structure of the coating. Representative orientation image maps (OIM) obtained are shown in Fig. 25. Columnar grains were normally observed, going from the surface at the top to the $\text{Nb}_3\text{Sn-Nb}$ interface at the bottom. We also observed the formation of non-columnar small grains at the $\text{Nb}_3\text{Sn-Nb}$ interface.

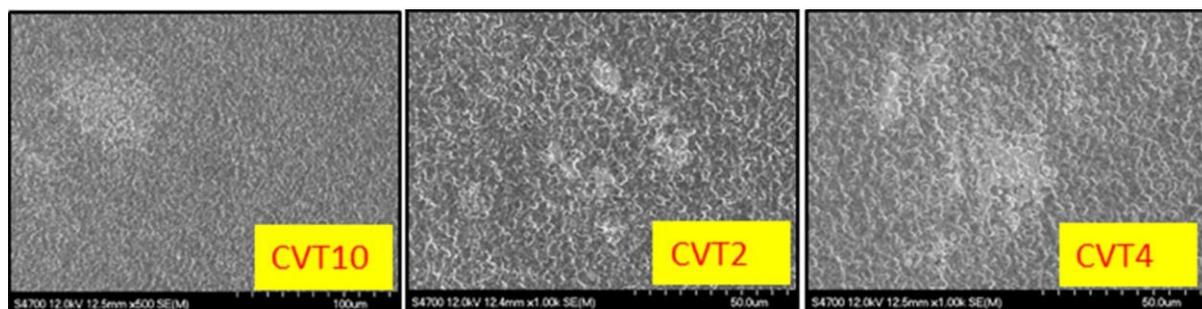
Fig. 26. Bright spots observed in different cutouts.

Besides patches and pits, other defects were found on some samples. One such defect is bright spots observed on coated surfaces by SEM, as shown in Fig. 26. The contrast difference might have arisen due

to the difference in topography. These features were found sometimes on CVT2 and CVT4, but frequently seen in CVT10. These spots were found to have different shapes with carbon-enriched boundaries as shown in Fig. 27. Note that the ratio of Nb to Sn was not altered within these bright spots when examined with EDS, suggesting that the SEM signature is due to very thin surface contamination. Unlike other cutouts, CVT10 had a large area with a different appearance than usual coating as shown in Fig. 28. It comprises the usual Nb_3Sn grains, but dark spots appear in each of those grains. Similar dark areas were also noticed in intergranular spots. EDS found an excess of carbon and oxygen from dark spots.

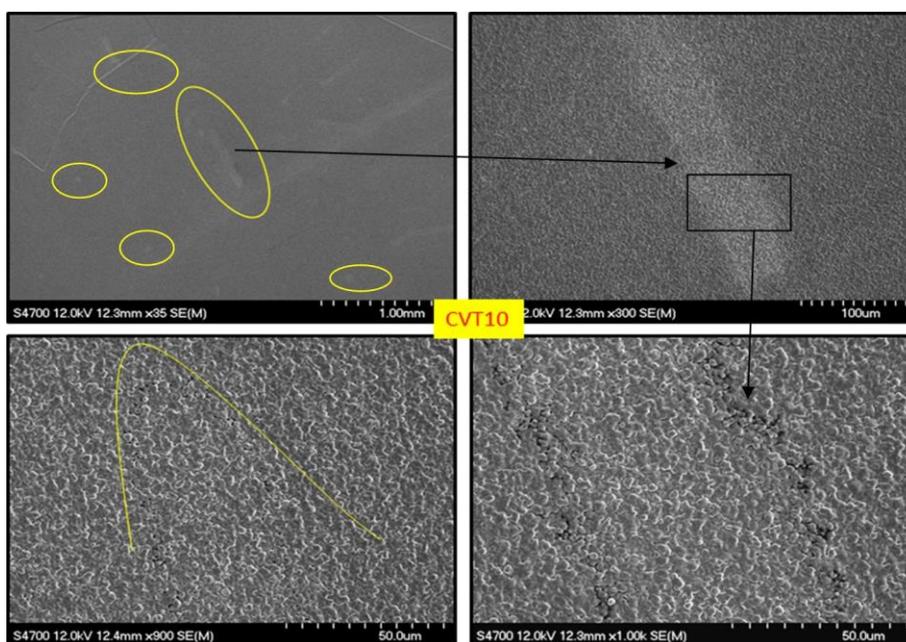
Fig. 27. Bright spots observed in CVT10. Note that the dark boundaries of these features show a clear presence of carbon.

Other carbon-enriched defects, similar to those depicted in Figs 28 and 27 indicate that some impurity was already present at these spots on the starting substrate niobium. If that is the case, it appears that impurity segregation to the surface can happen without a dramatic influence on Nb₃Sn growth. Unusual and big carbon enriched areas present in CVT8 and CVT10 are strong candidates for localized heating. The circular defect found in CVT14, Fig. 30, could be another similar case where the niobium might have a circular depression, susceptible to retaining carbonaceous impurities prior to the coating. Such defects might be present around the equator as welding artifacts. Residue, observed in CVT10 with AFM, Fig. 29, may not appear in SEM image because of the limited sensitivity of SEM/EDS, but it could be something that can also impair the RF performance. The higher density of patchy regions in CVT12 and CVT 14 appear to be well correlated with the observed surface resistance switch at ~ 4.5 MV/m. The carbon-rich features seem to correlate with strong field dependent resistance. The absence of such features results in a material with relatively field-independent surface resistance.
