Analysis of RF losses and material characterization of samples removed from a Nb₃Sn-coated superconducting RF cavity

Abstract

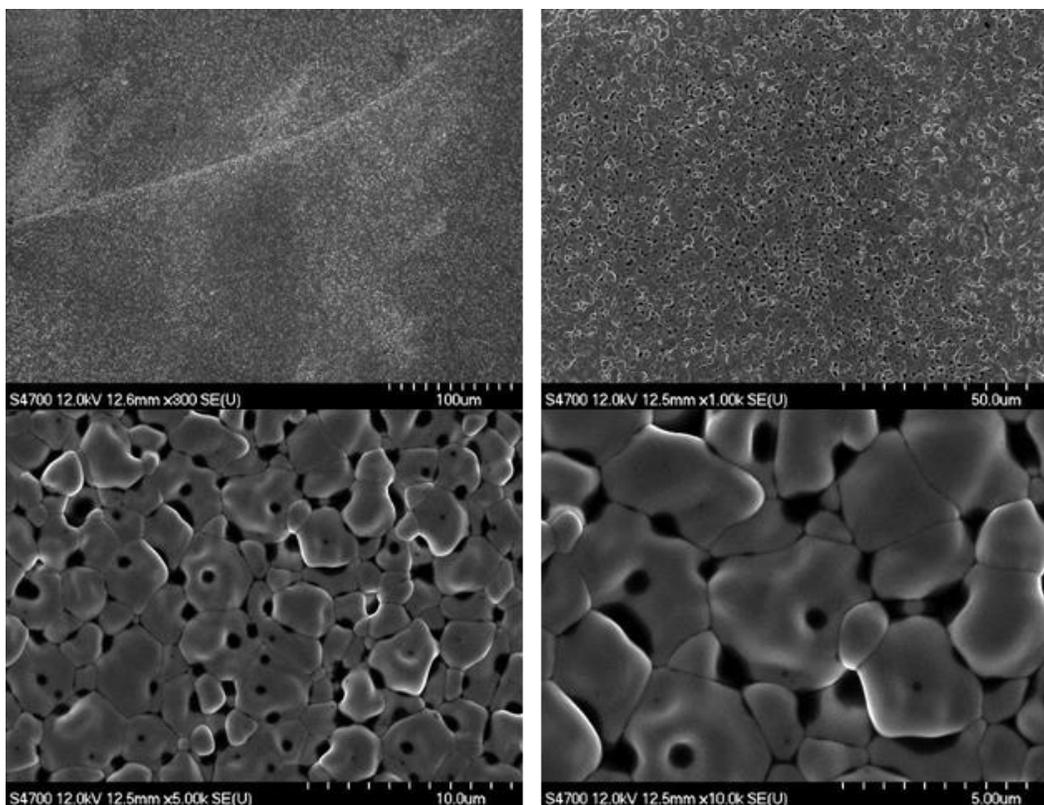
Fig. 28. An unusual appearance of coating in CVT10.

An AFM image collected from CVT10, see Fig. 29, also shows the presence of residues on the surface. A circular feature of 100um diameter was present in CVT14 as shown in Fig. 30. The circular area was found recessed compared to its adjacent areas, considering the contrast in the SEM image. The edge of this feature showed a significant presence of carbon and oxygen. The composition and grain structure were found similar inside and outside of this feature. Another noticeable area was discovered in CVT8. The area, which appeared relatively dark in SEM images is shown in Fig. 31(a). Note that the area covered by this constituent was more than $40000 \mu\text{m}^2$, that is, the diameter was $\approx 700 \mu\text{m}$. SEM images show well defined boundaries, see Fig. 31(b, c, and e) that distinguish this area from areas with usual looking coating. Large patches were also seen at the boundary, as shown in Fig 31(f). Fig 31(d) and 31(e) respectively show grains from the unusual area under discussion, and nearby area with usual appearances. Corresponding EDS spectra show significant amounts of carbon from dark areas compared to regular areas. This unusual area of CVT8 has similar characteristics of the unusual area found in CVT10, Fig. 28.

Other carbon-enriched defects, similar to those depicted in Figs 28 and 27 indicate that some impurity was already present at these spots on the starting substrate niobium. If that is the case, it appears that impurity segregation to the surface can happen without a dramatic influence on Nb₃Sn growth. Unusual and big carbon enriched areas present in CVT8 and CVT10 are strong candidates for localized heating. The circular defect found in CVT14, Fig. 30, could be another similar case where the niobium might have a circular depression, susceptible to retaining carbonaceous impurities prior to the coating. Such defects might be present around the equator as welding artifacts. Residue, observed in CVT10 with AFM, Fig. 29, may not appear in SEM image because of the limited sensitivity of SEM/EDS, but it could be something that can also impair the RF performance. The higher density of patchy regions in CVT12 and CVT 14 appear to be well correlated with the observed surface resistance switch at ~ 4.5 MV/m. The carbon-rich features seem to correlate with strong field dependent resistance. The absence of such features results in a material with relatively field-independent surface resistance.

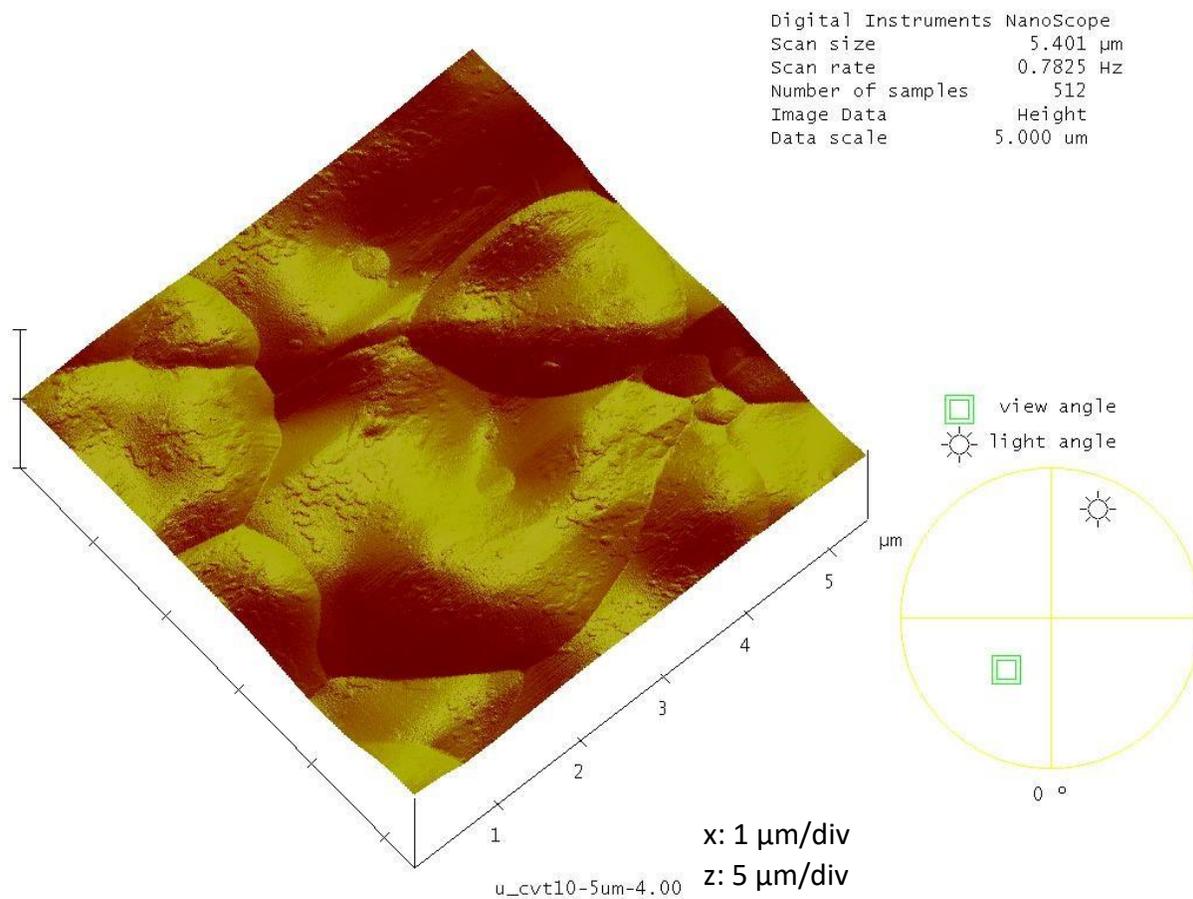
Fig. 29. AFM image from CVT 10. Note the residue covering the surface.

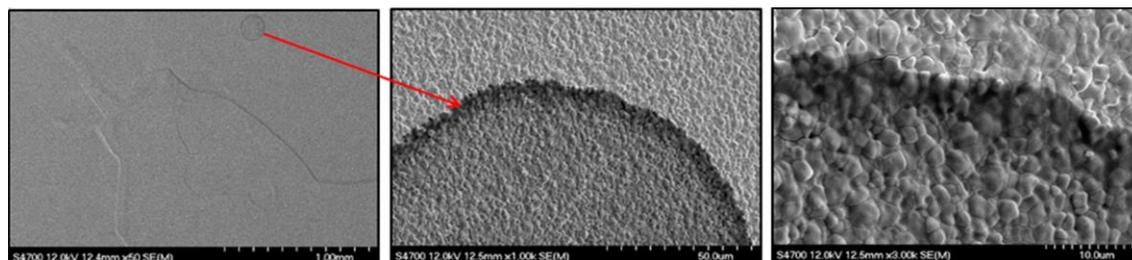
Fig. 30. Defect found in CVT14.

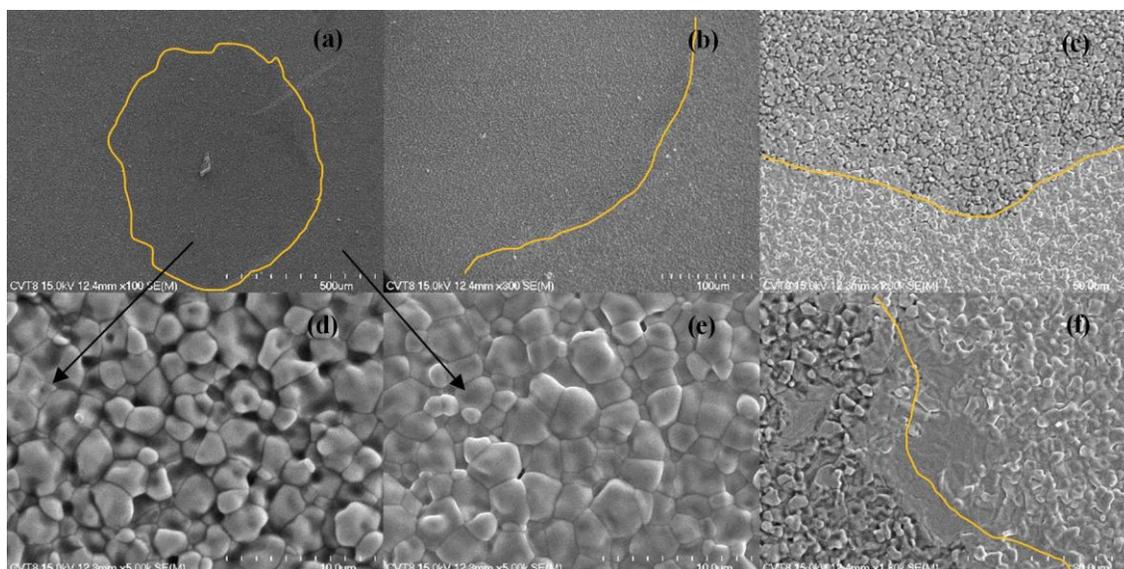
Fig. 31. Detailed structure within the defect found in CVT8. (a) shows the unusual area marked with yellow lines. (b), (c) and (e) shows the transition from unusual area to regular (c). (d) and (f) show close-up views of grains from unusual and regular areas respectively. Note the patchy region found close to the transition.

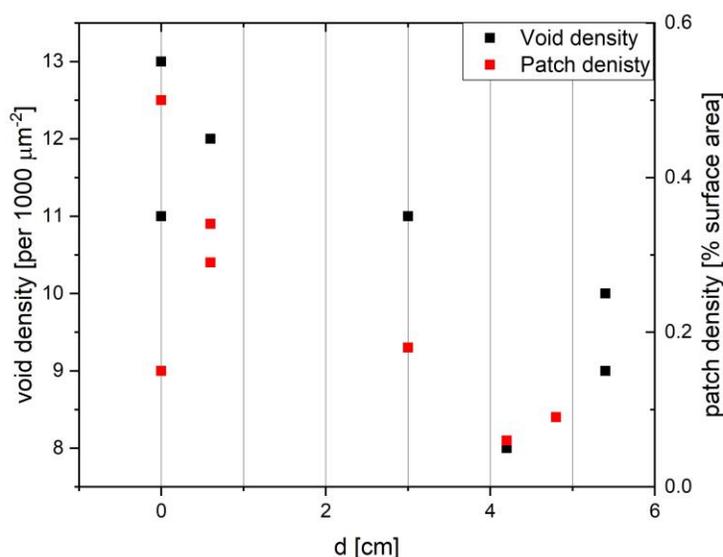
Fig. 32. Defect density as a function of distance from the equator. Note the negative correlation, i.e., defects are more likely to occur in the regions close to the equator.

yet. One observation is that all three cutouts CVT8, CVT12, and CVT14 are from the equator region of the cavity, which seems to be more likely to develop such features, Fig. 32.
