A&A Program in Structures

William E. Boeing Department of Aeronautics and Astronautics

**Micro-Computed Tomography Analysis of Damage in Notched Composite
Laminates Under Multi-Axial Fatigue**

INTERNAL REPORT No. 19-10/04E

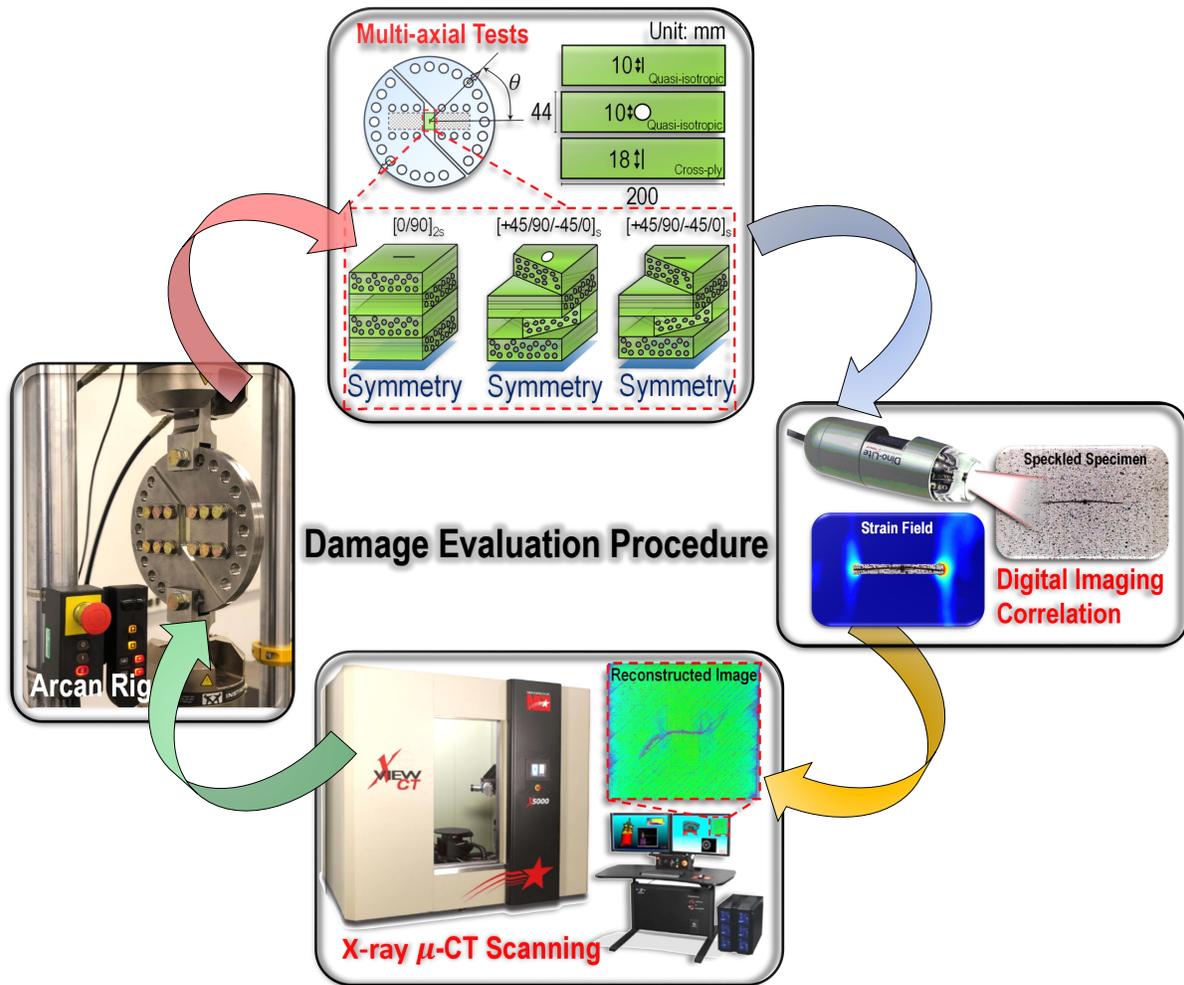
Figure 1: Notched specimen geometries and damage evaluation leveraging Digital Imaging Correlation (DIC) and X-ray micro-computed tomography (μ -CT).

The application of the combinations of nominal normal and shear stresses on notched laminates was achieved by using an Arcan rig (Fig. 1a). The multi-axial quasi-static and fatigue tests were performed in a servo-hydraulic 8801 Instron machine with closed-loop control. The load control with a stress ratio of $R = 0.1$ and a low frequency of $f = 5$ Hz was conducted for the fatigue tests. To describe the multi-axial loading configuration, multi-axiality ratio can be defined as $\lambda = \arctan(\tau_N/\sigma_N)$ where $\sigma_N = P\cos\theta/[(w-a_0)t]$ is the nominal normal stress and $\tau_N = P\sin\theta/[(w-a_0)t]$ is the nominal shear stress applied to the specimen. In the definition of stress, P is the instantaneous load, w is the specimen width, a_0 is the crack length or hole diameter, t is the specimen thickness and θ is the angle between loading direction and axial direction of the specimen. A detailed description on the test method and loading conditions can be found in [30].

To study the damage evolution of notched laminates under multi-axial tests, specimens with the same dimensions but featuring different types of notches were prepared as shown in Figure 1. The detailed description of the manufacturing of these notches can be found in the previous work by Qiao *et al.* [30]. The procedure of damage evaluation leveraging Digital Image Correlation (DIC) and X-ray micro-computed tomography (μ -CT) is illustrated in Figure 1 and described in the following sections.

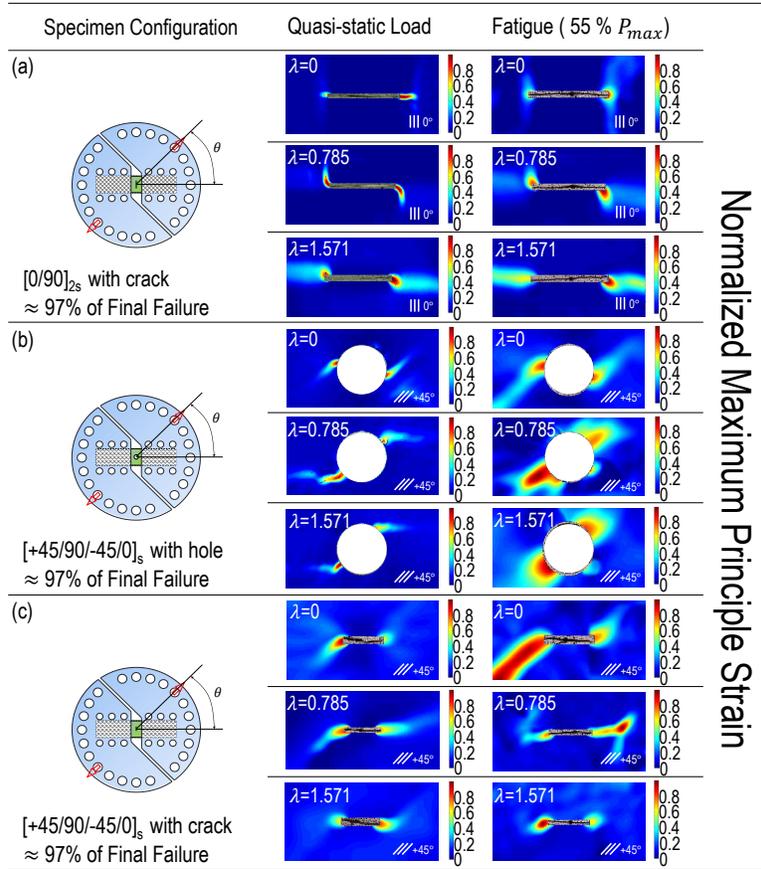
Figure 2: Digital Imaging Correlation (DIC) analysis of investigated notched specimens at 97% of total quasi-static or fatigue life. This figure compares three multiaxiality ratios. From the contour plots of the normalized maximum principle strain, it can be noted that the region of high deformation in fatigue is generally more spread compared to quasi-static loading. This is an indication that fatigue damage is generally more distributed than its quasi-static counterpart.

As illustrated in Figure 2 which compares the maximum principal strain distribution of the quasi-static and fatigue loading, the overall damage distribution under fatigue loading appears to be more diffuse compared to the quasi-static case. A similar phenomenon was found by Fujii *et al.* [39–41] who tested tabular specimens featuring a circular hole under the multi-axial fatigue loading of tension and torsion. This result is an indication of a larger non-linear Fracture Process Zone (FPZ) in the specimens subject to fatigue loading. It is worth mentioning that the maximum principle strains were normalized against their maximum values in the area of interest in order to have a comparison between quasi-static and fatigue loading condition. In fact, the focus was not on the magnitude of the strain field but the overall damage distribution.

leveraging DIC. As can be noted in Figure 2, the region of high deformation for notched laminates at various multi-axiality ratios does not show significant differences in terms of shape and location for quasi-static and fatigue case. For notched cross-ply laminates as shown in Figure 2a, the specimen under pure tension is characterized by a region of high deformation in 0° plies at the notch tip whereas the one under pure shear features a noticeable damage band in 90° plies ahead of the notch. This corresponds to splitting and fiber kinking for pure tension and pure shear case respectively. For notched quasi-isotropic laminates as shown in Figures 2b-c, the specimens at various multi-axiality ratios are mainly characterized by a highly-deformed region in $+45^\circ$ plies in front of the notch which is associated to significant splitting. In addition to this, a highly-deformed region due to shear strain almost perpendicular to the $+45^\circ$ plies was observed for the specimens under shear-dominated loading as shown in Figure 4. This indicates that the $+45^\circ$ plies are under compression leading to the potential micro-buckling of the fibers.

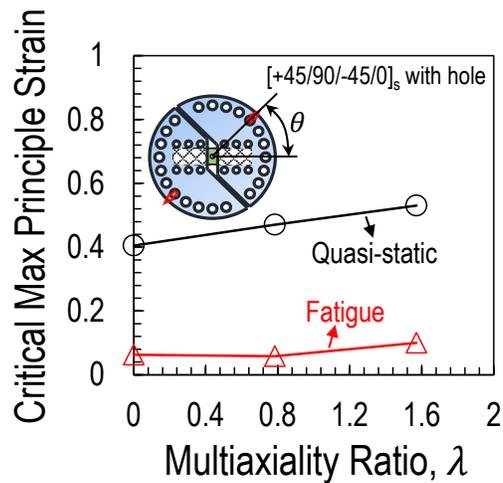
Figure 3: The evolution of critical maximum principle strain at 97% of final failure for the specimen weakened by a central hole as a function of multiaxiality ratio. The graph compares quasi-static and fatigue results.

However, the critical magnitude in the maximum principle strain field for quasi-isotropic specimens featuring a central hole under multi-axial tests provides an insightful information on the quasi-static and fatigue fracturing behavior. As can be noted in Figure 3, the critical magnitude of the maximum principle strain in fatigue case is significantly lower than the one in quasi-static case almost before catastrophic failure. This result is an indication of substantially different failure criteria for quasi-static and fatigue case which is typically reported in fatigue fracturing behavior of thermoset polymers showing that the Mode I critical stress intensity factor in fatigue case is generally lower than the one in quasi-static case [42–44].

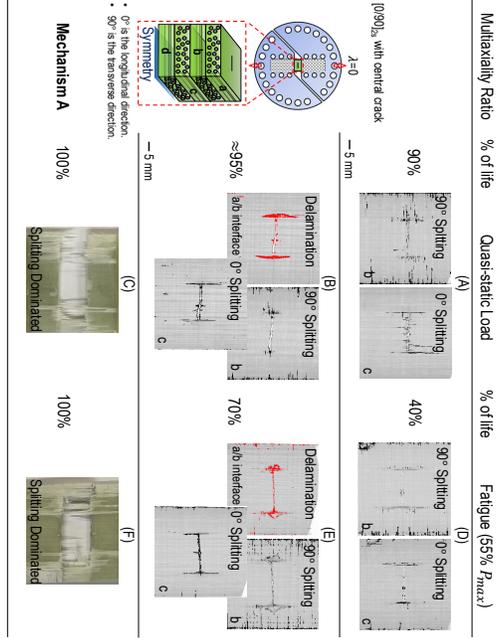
Figure 6: Analysis of quasi-static and fatigue damage mechanisms by micro-computed tomography. Comparison between quasi-static and fatigue damage in $[0/90]_{2s}$ specimens weakened by a 18 mm central crack for a multiaxiality ratio $\lambda = 0$ in the 0° , 90° layers and at the interface. Note that the original colors of the images were inverted for a better visualization on the damage.

In the case of specimens subjected to tension-dominated loading conditions ($\lambda = 0, 0.262$), the dominant mechanisms before sudden failure are the splitting in 0° plies at the notch tip and the splitting in 90° plies. The final failure is triggered by the additional splitting in 0° plies away from the notch tip and the breakage of 0° fibers. As illustrated in Figure 6, the damage evolution as a function of fatigue lifetime for mechanism A can be summarized as follows:

- (1) splitting initiates in 90° plies (Fig. 6D);
- (2) splitting initiates in 0° plies at notch tip (Fig. 6D);
- (3) splitting develops in the corresponding plies (Fig. 6E);
- (4) a small amount of delamination between 0° and 90° plies starts to initiate (Fig. 6E);
- (5) additional splitting in 0° plies away from the notch tip happens simultaneously with the breakage of 0° fibers (Fig. 6F).

With the comparison to the fatigue case, similar damage mechanisms were observed in the case of quasi-static loading for all the multiaxiality ratios as shown in Figures 6-8. However, the overall sub-critical damage during quasi-static loading is less diffused, consistent with the DIC results discussed in section 3 and the quantitative analysis via μ -CT. In Figures 15a-d, for all the multiaxiality ratios, both crack volume and delamination area for the quasi-static case above 90% of total quasi-static life are significantly less than the fatigue case at even lower percentage of the life. Only about 2.4% crack volume and 0.7% delamination area in average for different multiaxiality ratios were observed at 95% of total quasi-static life. Notwithstanding this, these sub-critical damage grows rapidly close to the end of total quasi-static life leading to the catastrophic failure of the specimen. It is worth mentioning here that the specimen only at 90% and even later stage of its quasi-static life was prepared for the quantitative analysis due to the less pronounced damage at the early stage of the quasi-static loading and the difficulties for the damage visualization.

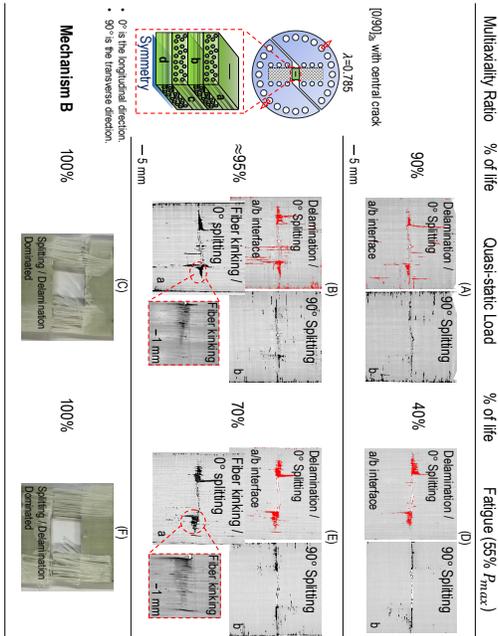
Figure 7: Analysis of quasi-static and fatigue damage mechanisms by micro-computed tomography. Comparison between quasi-static and fatigue damage in $[0/90]_{2s}$ specimens weakened by a 18 mm central crack for a multiaxiality ratio $\lambda = 0.785$ in the 0° , 90° layers and at the interface. Note that the original colors of the images were inverted for a better visualization on the damage.

When the multiaxiality ratio $\lambda = 0.785, 1.309$, a mix of nominal normal and shear stresses is applied on specimens and failure behavior follows Mechanism B. In this case, the dominant mechanism transitions from splitting to a combination of delamination and splitting. The final failure happens with the growth of splitting in 0° plies at the notch tip and the delamination between 0° and 90° plies. As illustrated in Figure 7, the damage evolution of mechanism B can be summarized by the following steps:

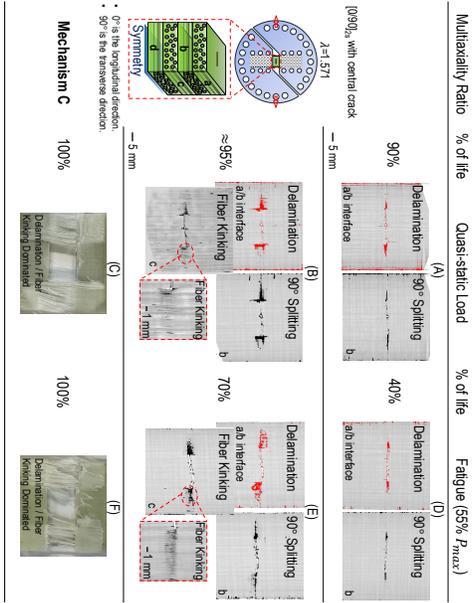
Figure 8: Analysis of quasi-static and fatigue damage mechanisms by micro-computed tomography. Comparison between quasi-static and fatigue damage in $[0/90]_{2s}$ specimens weakened by a 18 mm central crack for a multiaxiality ratio $\lambda = 1.571$ in the 0° , 90° layers and at the interface. Note that the original colors of the images were inverted for a better visualization on the damage.

When the specimens are only subjected to pure shear loading, the dominant mechanisms are the delamination between 0° and 90° plies and then fiber kinking in 0° plies. The final failure is due to the unstable growth of the inter-laminar crack enabling the splitting in 0° plies at notch tip. As illustrated in Figure 8, the damage evolution of mechanism C consists of the following phases:

(5) delamination grows dramatically and drives the significant splitting in 0° plies at notch tip (Fig. 8E-F).

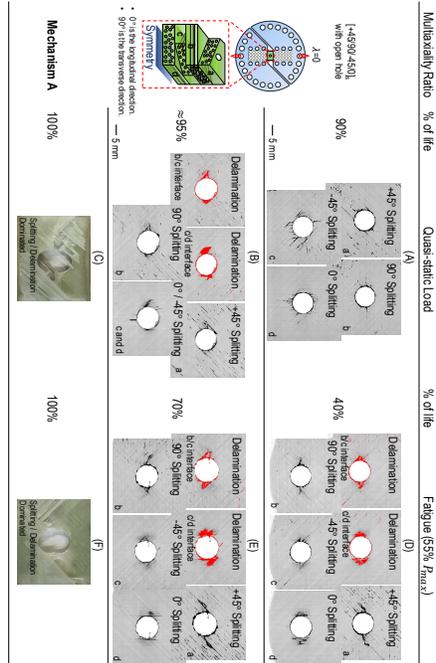
Figure 9: Analysis of quasi-static and fatigue damage mechanisms by micro-computed tomography. Comparison between quasi-static and fatigue damage in $[+45/90/-45/0]_s$ specimens weakened by a 10 mm open hole for a multiaxiality ratio $\lambda = 0$ in the $+45^\circ$, 90° , -45° , 0° layers and at the interfaces. Note that the original colors of the images were inverted for a better visualization on the damage.

In the case of specimens subjected to tension-dominated loading conditions ($\lambda = 0, 0.262$), the dominant mechanisms before the dramatic failure are the delamination between all the plies except for the middle plies and the significant splitting in $\pm 45^\circ$ plies. These damage is not the only contribution to the catastrophic failure and the breakage of 0° plies also plays a pivotal role. As illustrated in Figure 9, the damage evolution as a function of fatigue lifetime for mechanism A can be summarized in the following:

- (3) delamination between the foregoing plies initiates (Fig. 9D);
- (4) splitting and delamination develop in/between the corresponding plies (Fig. 9E);
- (5) splitting in $\pm 45^\circ$ plies grows significantly and delamination reaches critical condition accompanying the emergence of 0° plies breakage (Fig. 9E-F).

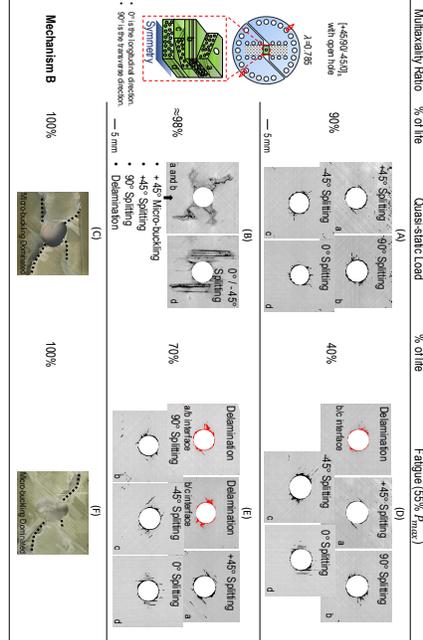
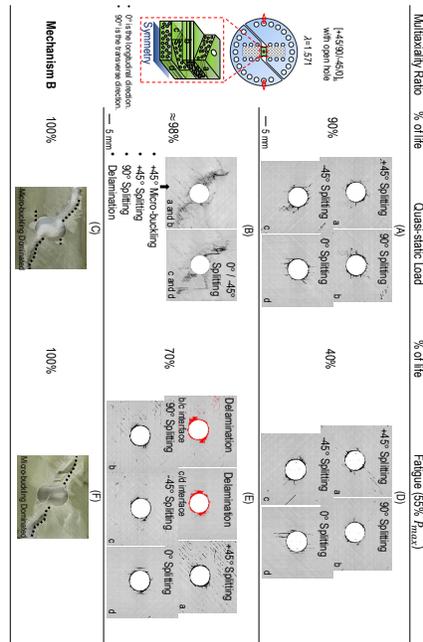
Figure 10: Analysis of quasi-static and fatigue damage mechanisms by micro-computed tomography. Comparison between quasi-static and fatigue damage in $[\pm 45/90/-45/0]_s$ specimens weakened by a 10 mm open hole for a multiaxiality ratio $\lambda = 0.785$ in the $+45^\circ$, 90° , -45° , 0° layers and at the interfaces. Note that the original colors of the images were inverted for a better visualization on the damage.

Figure 11: Analysis of quasi-static and fatigue damage mechanisms by micro-computed tomography. Comparison between quasi-static and fatigue damage in $[\pm 45/90/-45/0]_s$ specimens weakened by a 10 mm open hole for a multiaxiality ratio $\lambda = 1.571$ in the $+45^\circ$, 90° , -45° , 0° layers and at the interfaces. Note that the original colors of the images were inverted for a better visualization on the damage.

The specimens fail following Mechanism B when the shear load component is involved ($\lambda = 0.785, 1.309$ and 1.571). In contrast to mechanism A, a significant reduced delamination between all the plies was observed. On the other hand, the direction of shear loading was established so that the $+45^\circ$ plies are in compression while the -45° plies are in tension. Considering the fact that the compressive strength of an unidirectional ply is generally lower than its tensile strength, the dominant mechanism is the micro-buckling in $+45^\circ$ plies and the final failure is triggered by the significant growth of the micro-buckling due to the compression at the very late stage of the fatigue life. The paths of the micro-buckling usually start in a straight way at the two ends of the hole but not on the same line and then additional micro-buckling paths almost perpendicular to the $+45^\circ$ plies happen. These micro-buckling paths are usually in collaboration with the significant splitting in $+45^\circ$ plies as mentioned in the foregoing discussion of DIC analysis in Section 3. Similar conclusions were drawn by Tan *et al.* [45, 46] on the quasi-static fracturing behavior of notched Carbon Fiber Reinforced Polymer (CFRP) laminates. As illustrated in Figures 10-11, the damage evolution of mechanism B can be summarized in the following:

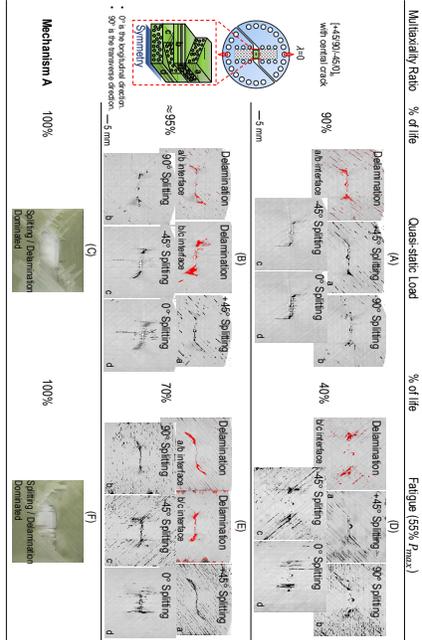
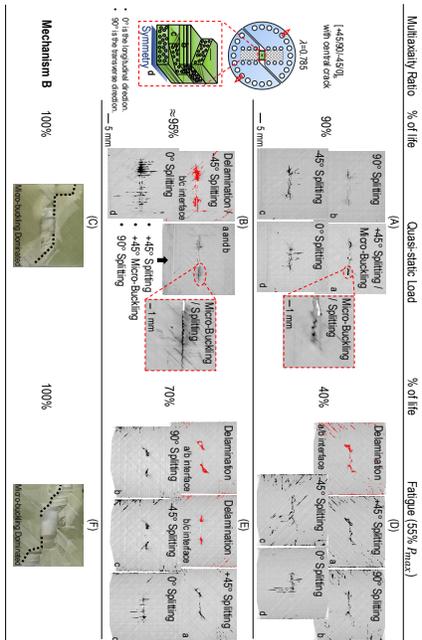
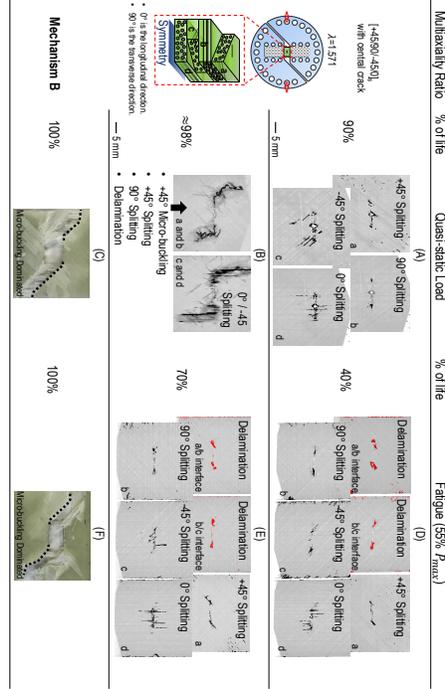
Figure 12: Analysis of quasi-static and fatigue damage mechanisms by micro-computed tomography. Comparison between quasi-static and fatigue damage in $[+45/90/ -45/0]_s$ specimens weakened by a 10 mm central crack for a multi-axiality ratio $\lambda = 0$ in the $+45^\circ$, 90° , -45° , 0° layers and at the interfaces. Note that the original colors of the images were inverted for a better visualization on the damage.

Figure 13: Analysis of quasi-static and fatigue damage mechanisms by micro-computed tomography. Comparison between quasi-static and fatigue damage in $[+45/90/ -45/0]_s$ specimens weakened by a 10 mm central crack for a multi-axiality ratio $\lambda = 0.785$ in the $+45^\circ$, 90° , -45° , 0° layers and at the interfaces. Note that the original colors of the images were inverted for a better visualization on the damage.

Figure 14: Analysis of quasi-static and fatigue damage mechanisms by micro-computed tomography. Comparison between quasi-static and fatigue damage in $[+45/90/-45/0]_s$ specimens weakened by a 10 mm central crack for a multi-axiality ratio $\lambda = 1.571$ in the $+45^\circ$, 90° , -45° , 0° layers and at the interfaces. Note that the original colors of the images were inverted for a better visualization on the damage.

Having discussed the fracturing features and damage mechanisms for the quasi-isotropic specimens in presence of an open hole, similar damage mechanisms were observed for the same layup but featuring a central crack as shown in Figures 12-14. The only difference in mechanism B (micro-buckling dominant) is the location of the micro-buckling paths ahead of the notch. As can be noted from Figures 13-14, the straight micro-buckling paths in front of the notch are on the same line for multiaxiality ratios related to shear-dominated loading.

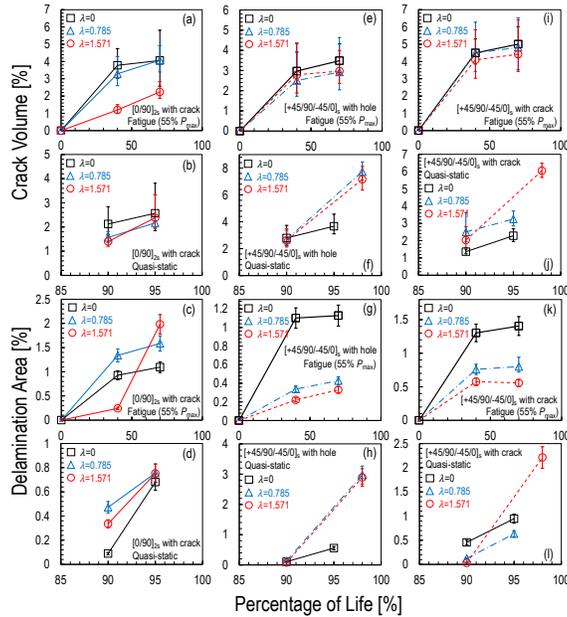
Figure 15: The evolution of the total crack volume and delamination area for all the investigated specimens weakened by a central crack or hole as a function of the percentage of life for three multi-axiality ratios. The graphs compare quasi-static and fatigue results.

The crack volume and delamination area as a function of the percentage life were plotted in Figures 15a-d for specimens under quasi-static and fatigue loading. As illustrated in Figure 15c, in the fatigue case, the specimens following mechanism B and C feature larger delamination area compared to the specimens following mechanism A at 70% of total fatigue life, with 1.6% for $\lambda = 0.785$ and 2% for $\lambda = 1.571$ but only 1% for $\lambda = 0$. This is an indirect evidence of the foregoing damage mechanisms showing that delamination contributes to most of the energy dissipation in notched cross-ply laminates under shear-dominated loading. However, this is not the case for total crack volume in specimens at the corresponding life as shown in Figure 15a, with the lowest value (2.2%) featuring $\lambda = 1.571$ but 4.1% for $\lambda = 0$ and 0.785. This lower crack volume explains the less pronounced stiffness degradation of specimens under the fatigue of pure shear as shown in [30] and is associated to the significant reduction of splitting in 90° plies.

The similar quantitative analysis on the sub-critical damage as discussed in section 4.1.2 was proceeded. As can be noted from Figure 15g for the fatigue case, the specimen following mechanism A has larger delamination area compared to the one following mechanism B at 70% of total fatigue life, with the highest value (1.13%) for $\lambda = 0$ and the lowest value (0.33%) for $\lambda = 1.571$. This is supported by the foregoing damage mechanisms showing that delamination takes less important role but micro-buckling dominates the fracturing behavior of notched quasi-isotropic laminates under shear-dominated loading. On the other hand, the evolution of total crack volume before 70% of total fatigue life is close for each multiaxiality ratio. This explains the observation, reported in the previous work by Qiao *et al.* [30], that the stiffness deteriorates

In the fatigue case as shown in Figure 15k, the larger delamination area was also observed for the specimen following mechanism A compared to the one following mechanism B before catastrophic fatigue failure. At 70% of total fatigue life, the delamination reaches approximately 1.4% for $\lambda = 0$ whereas a significant reduction characterizes the other multiaxiality ratios, with 0.8% for $\lambda = 0.785$ and 0.55% for $\lambda = 1.571$. This is similar to the quasi-isotropic specimens featuring an open hole as discussed in the foregoing section. Another similarity was found in terms of the evolution of total crack volume confirming a similar gradual stiffness degradation throughout the fatigue life for various multiaxiality ratios. Despite these similarities, the specimens weakened by a central crack have a significant larger amount of total crack volume compared to the ones weakened by an open hole.
