Optical Inspection of the Silicon Micro-strip Sensors for the CBM Experiment employing Artificial Intelligence

E. Lavrik^{a,*}, M. Shiroya^{b,c,d,*}, H.R. Schmidt^{b,e}, A. Toia^{b,c,d} and J.M. Heuser^b

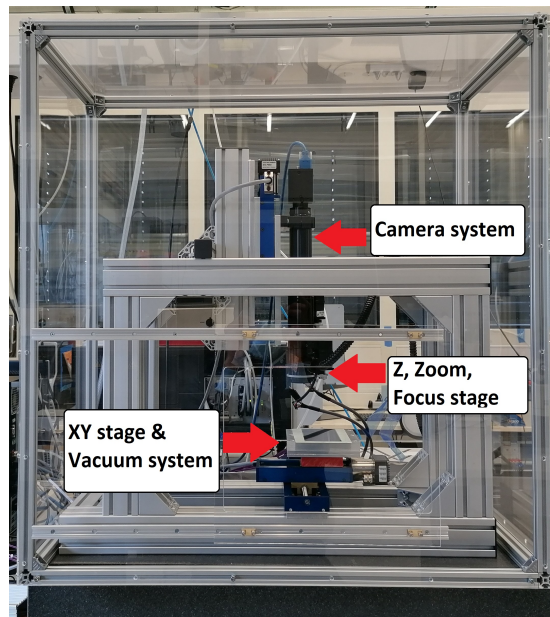
The surface scanning of every sensor was performed using a custom made, automated optical inspection setup shown in Figure 1. The sensor is placed on the XY-stage which is connected to the vacuum system to hold the sensors during their inspection. The XY-stage can move linearly with the

Figure 1: Optical inspection setup located in a clean room of the Detector Laboratory department at GSI.

help of Faulhaber/Movtec[®] SMC-300 servo motors within a range of 200 mm and 70 mm in X and Y direction respectively, with a precision 0.3 μm . Detailed technical information about the setup, sensor alignment procedure and the scanning process has already been discussed in [1, 10].

Metrological measurements such as warp measurement provide information about the actual geometry and irregularities of the sensor's surface. In this section, we present the warp measurement results obtained for different sensor variants using the same custom made optical inspection setup as shown in Figure 1. It uses the focus variation technique for the height profile measurement of the object under test. The conversion ratio motor steps to micrometer for the focus motor stage was used to convert the values of height profile

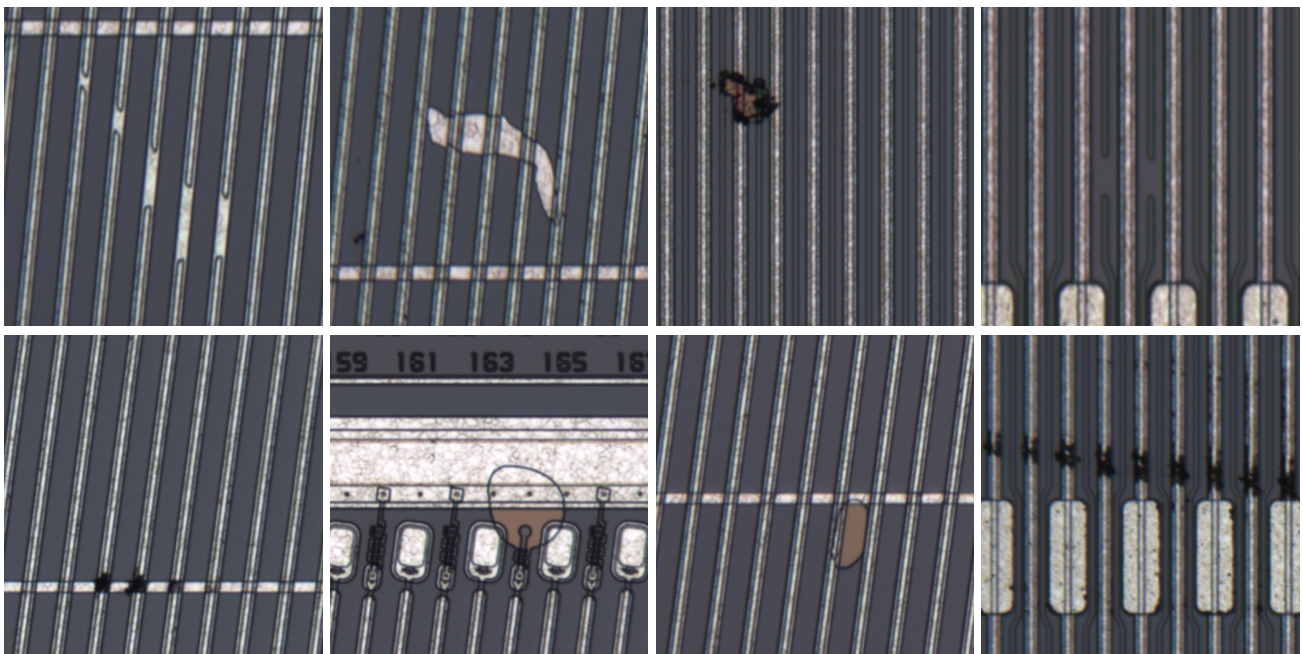
Figure 2: Source images of surface defects taken from the optical inspection setup. Top panel: Implant break, Aluminium short, Aluminium open, P-stop break (From left to right) Bottom panel: Double metal line break, Resistor fault, Passivation open, Scratch (From left to right).

Figure 2 shows the surface defects on the silicon sensors which were used as ground truth for the training of the neural network. The neural network used in the training the model is based on the Darknet implemented with the modified R-

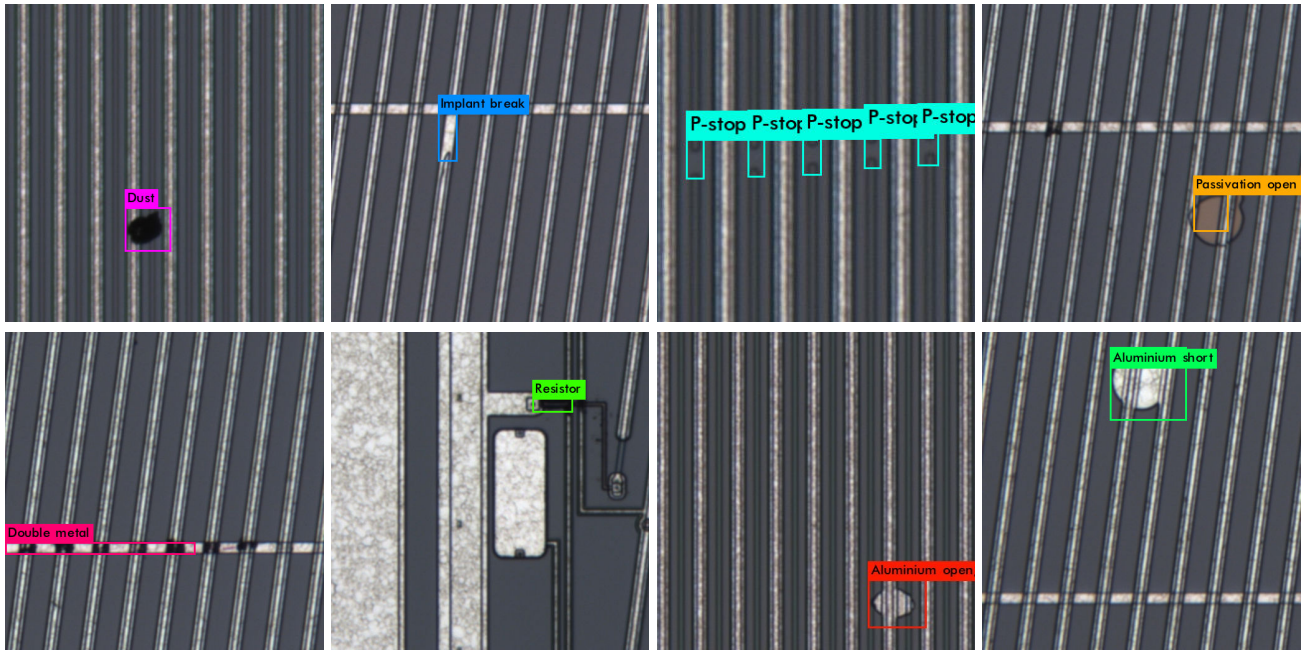
CNN framework model. It also allows to classify the object and to locate them in the images against the trained data. The key features of the neural network are convolutional layers, kernels, activation functions etc [1, 15, 16, 17]. Figure 3 depicts various surface defects detected by the trained neural network. The efficiency of the CDNN to locate the defects is achieved to be 91.5 % with an error of nearly 8.5 %. The equation 1 and 2 are used to calculate the efficiency and error of the CDNN respectively.

Figure 3: Various surface defects on the silicon sensor identified using convolutional deep neural network.

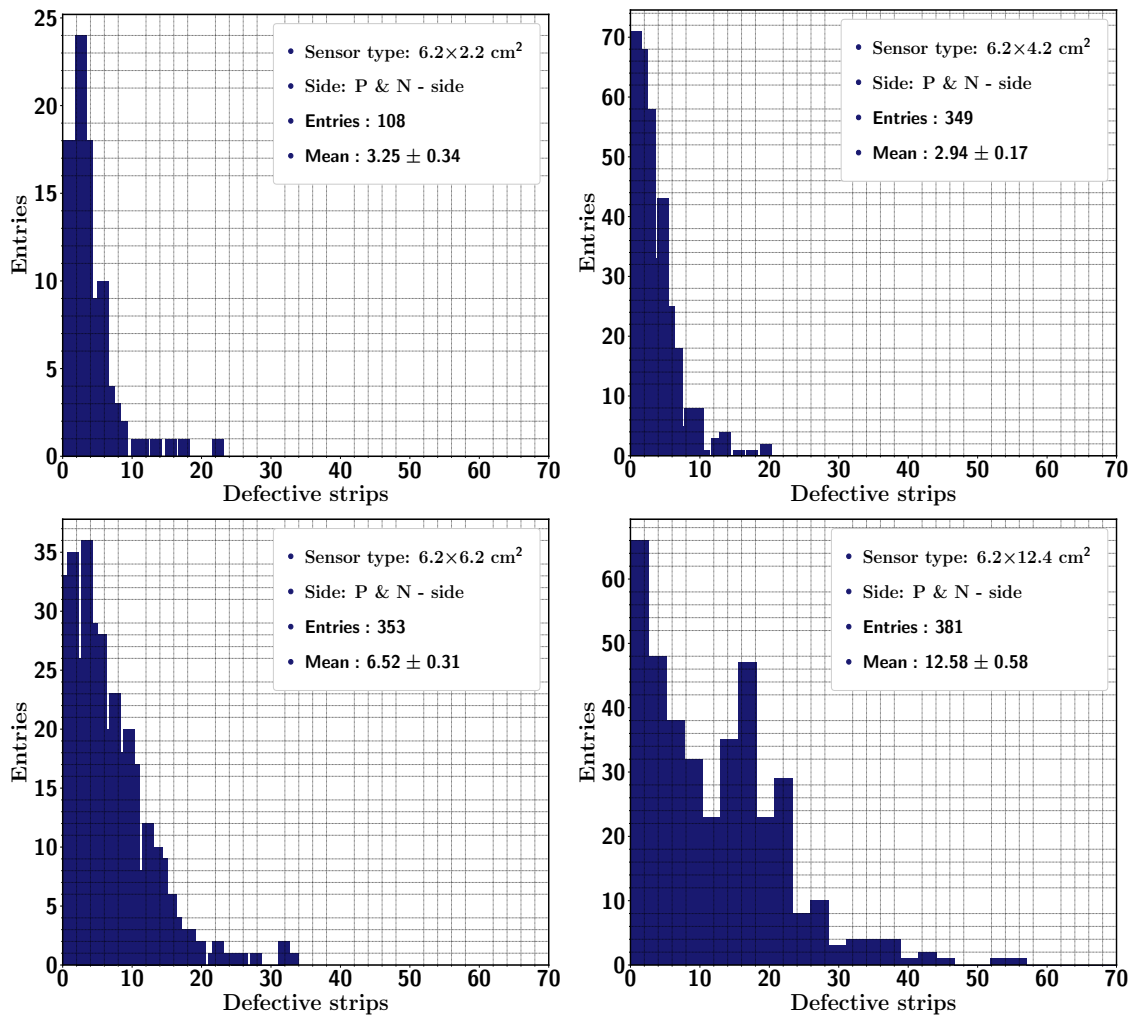
Figure 4 shows the total number of defective strips for individual sensor variants. It is observed that for the size $6.2 \times 2.2 \text{ cm}^2$ and $6.2 \times 4.2 \text{ cm}^2$, most of the sensors have less than 15 defective strips per sensor. On the other hand, for $6.2 \times 6.2 \text{ cm}^2$ and $6.2 \times 12.4 \text{ cm}^2$ sizes many sensors were found with more than 15 defective strips.

Figure 4: Distribution of the total number of defective strips per sensor based on the detected defects.

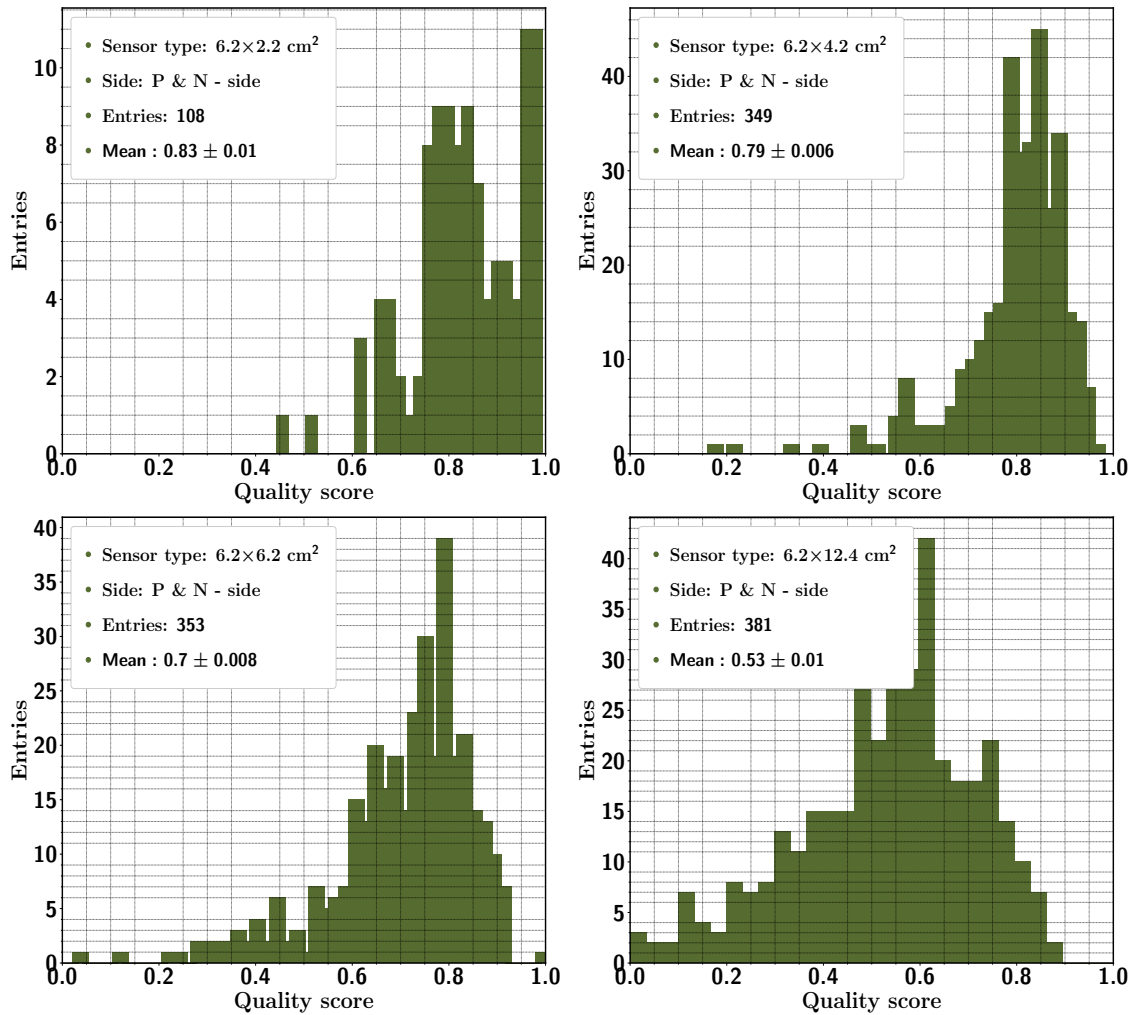
As can be seen from the Figure 5, the mean value of the quality score for each sensor variant was attained as 83%, 79%, 70% and 53% respectively. Apparently, the quality

Figure 5: Quality score of the sensor variants $6.2 \times 2.2 \text{ cm}^2$, $6.2 \times 4.2 \text{ cm}^2$ (Top panel) and $6.2 \times 6.2 \text{ cm}^2$, $6.2 \times 12.4 \text{ cm}^2$ (Bottom panel).

score is decreasing with increasing sensor size, with the amount of defects being evidently proportional to the sensor's surface area.

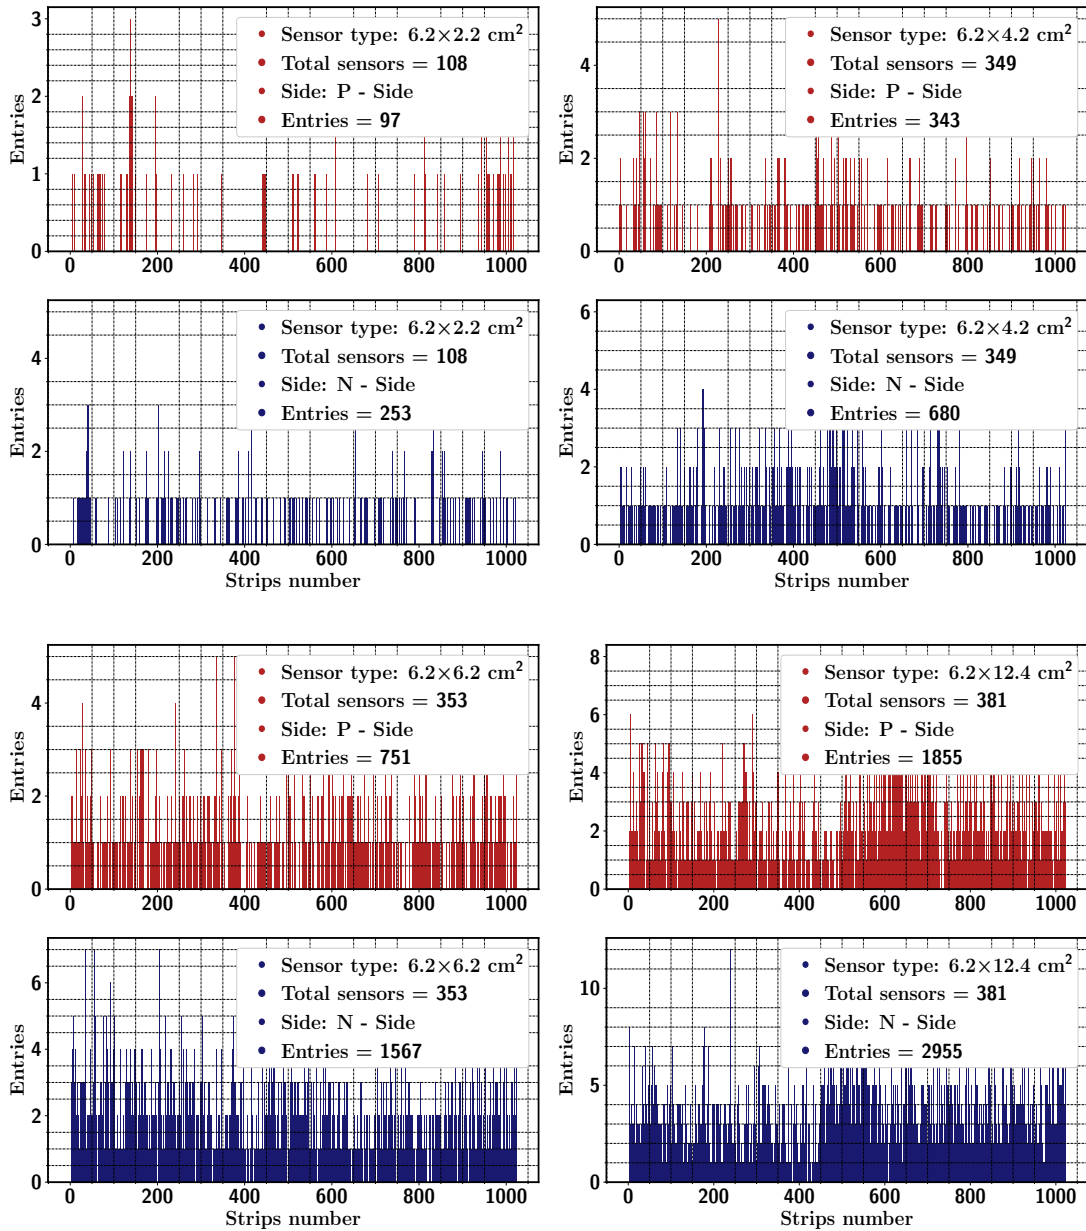
Figure 6 shows the defective strip maps, individually for both p-side and n-side, of the sensor variants $6.2 \times 2.2 \text{ cm}^2$, $6.2 \times 4.2 \text{ cm}^2$, $6.2 \times 6.2 \text{ cm}^2$ and $6.2 \times 12.4 \text{ cm}^2$. From the defective strip maps, it is evident that the number of defective strips on the sensor's p-side was found to be less than that of the n-side for each sensor variants. On the other hand, one can deduce that the distribution of defective strips is relatively uniform without any particular region on the sensor's surface with a high number of defective strips. However, there was a substantial amount of clusters of defective strips

Figure 6: Accumulated defective strip maps for both p-side and n-side of the sensor variants $6.2 \times 2.2 \text{ cm}^2$, $6.2 \times 4.2 \text{ cm}^2$ and $6.2 \times 6.2 \text{ cm}^2$, $6.2 \times 12.4 \text{ cm}^2$.

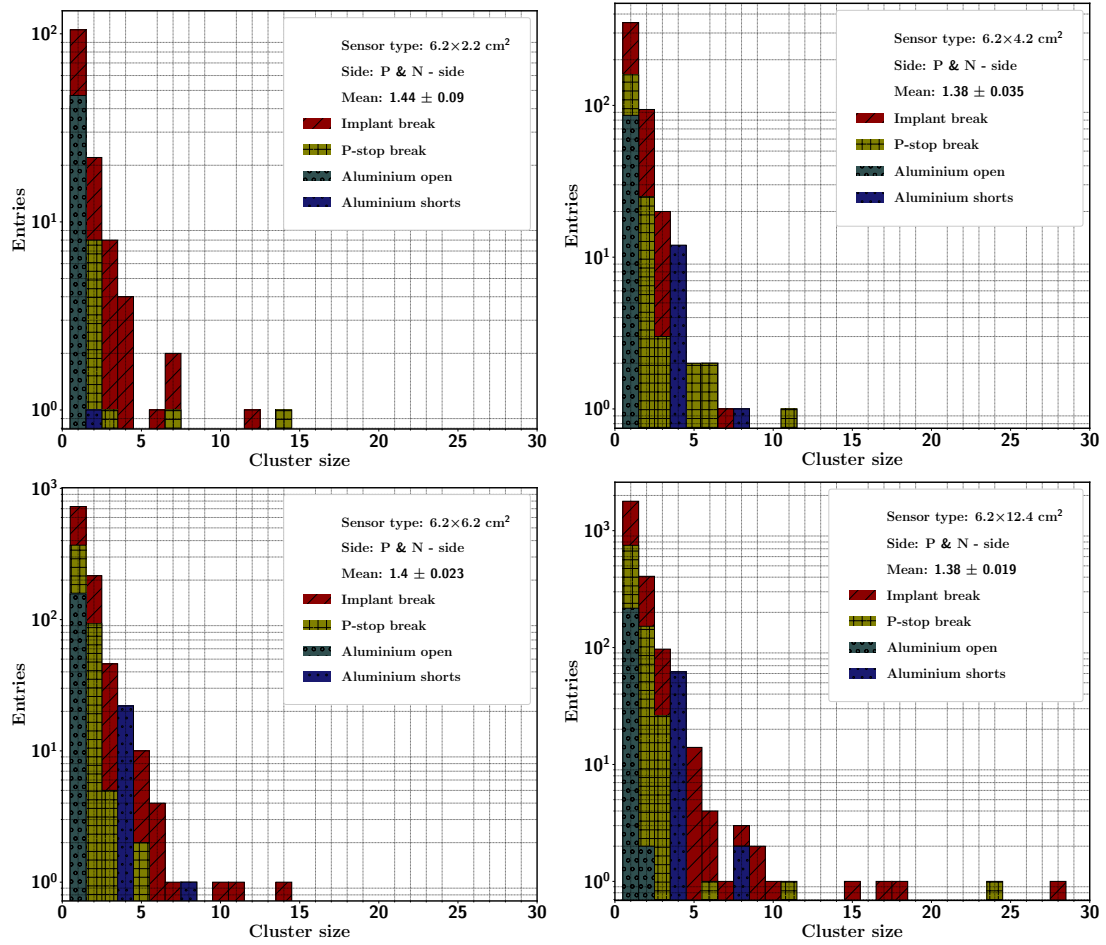
For finding defective strip clusters, only the defects of implant break, p-stop break, aluminium open, aluminium shorts on the consecutive strips were taken into consideration in the algorithm. Figure 7 illustrates the defective strip clusters for the sensor variants $6.2 \times 2.2 \text{ cm}^2$, $6.2 \times 4.2 \text{ cm}^2$, $6.2 \times 6.2 \text{ cm}^2$ and $6.2 \times 12.4 \text{ cm}^2$ respectively. It was found that the clusters of aluminium open, aluminium shorts defects are of negligible amount on the surface of all four sensor variants. Furthermore, only on a few sensors of the sensor size $6.2 \times 2.2 \text{ cm}^2$, $6.2 \times 4.2 \text{ cm}^2$ and $6.2 \times 6.2 \text{ cm}^2$ we have found clusters of more than 5 implant breaks and p-stop breaks defective strips. Many $6.2 \times 12.4 \text{ cm}^2$ sensors were found with more than five consecutive implant breaks and p-stop-breaks defective strips. Among all, the biggest clus-

ter of implant breaks (28 strips) and p-stop breaks (24 strips) was found on a $6.2 \times 12.4 \text{ cm}^2$ sensor.

Figure 7: Defective strip clusters observed on p- and n-sides of sensor variants $6.2 \times 2.2 \text{ cm}^2$, $6.2 \times 4.2 \text{ cm}^2$ (Top panel) and $6.2 \times 6.2 \text{ cm}^2$, $6.2 \times 12.4 \text{ cm}^2$ (Bottom panel).

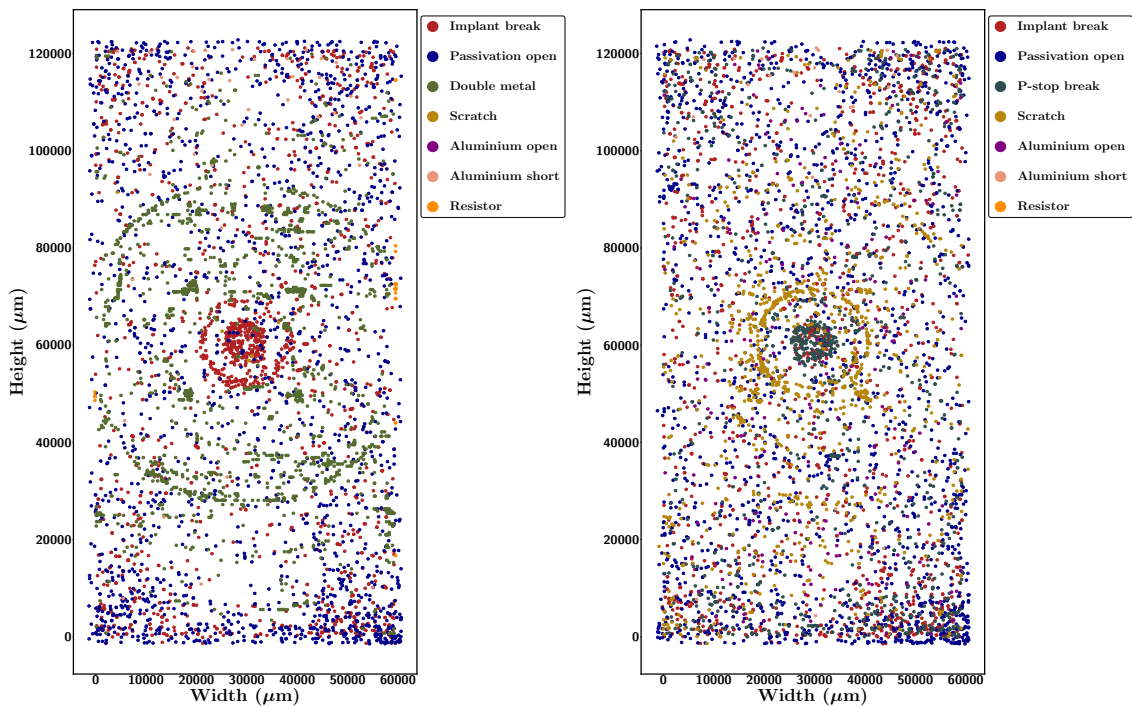
Figure 8 shows the 2D defect map individually for p- and n-side of the sensor variant $6.2 \times 12.4 \text{ cm}^2$. It is striking that some defects like double metal line and implant break are found to be forming a circular pattern. In a similar shape, the defects like scratch, p-stop and implant break defects are observed on the n-side of the sensor's surface. The pattern is

attributed to the usage of a vacuum tool to handle the sensor during production at the production site.

Figure 8: Defects map of the sensor variant $6.2 \times 12.4 \text{ cm}^2$ for p-side (Left) and n-side (Right).

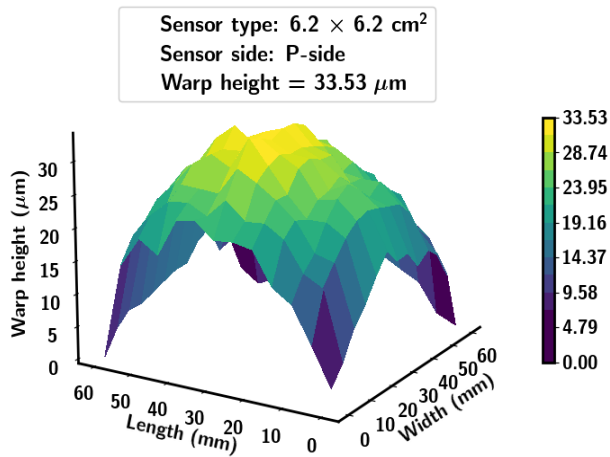
Figure 9: Warp profile of p-side of sensor size $6.2 \times 6.2 \text{ cm}^2$.

The warp height is defined as the difference between the maximum and minimum distances from the reference plane surface. As can be seen in Figure 9 the actual warp profile of the p-side of one of the sensors variant $6.2 \times 6.2 \text{ cm}^2$ and its warp height is obtained using the plane fit function.

The warp shape is the result of the mechanical stress induced on the silicon wafer during different manufacturing and polishing steps [12, 13].
