# Quality assurance test and Failure Analysis of SiPM Arrays of GECAM Satellites

**Abstract:** The Gravitational wave high-energy Electromagnetic Counterpart All-sky Monitor (GECAM) satellite consists of two small satellites. Each GECAM payload contains 25 gamma ray detectors (GRD) and 8 charged particle detectors (CPD). GRD is the main detector which can detect gamma-rays and particles and localize the Gamma-Ray Bursts (GRB), while CPD is used to help GRD to discriminate gamma-ray bursts and charged particle bursts. The GRD makes use of lanthanum bromide (LaBr<sub>3</sub>) crystal readout by SiPM. As the all available SiPM devices belong to commercial grade, quality assurance tests need to be performed in accordance with the aerospace specifications. In this paper, we present the results of quality assurance tests, especially a detailed mechanism analysis of failed devices during the development of GECAM. This paper also summarizes the application experience of commercial-grade SiPM devices in aerospace payloads, and provides suggestions for forthcoming SiPM space applications.

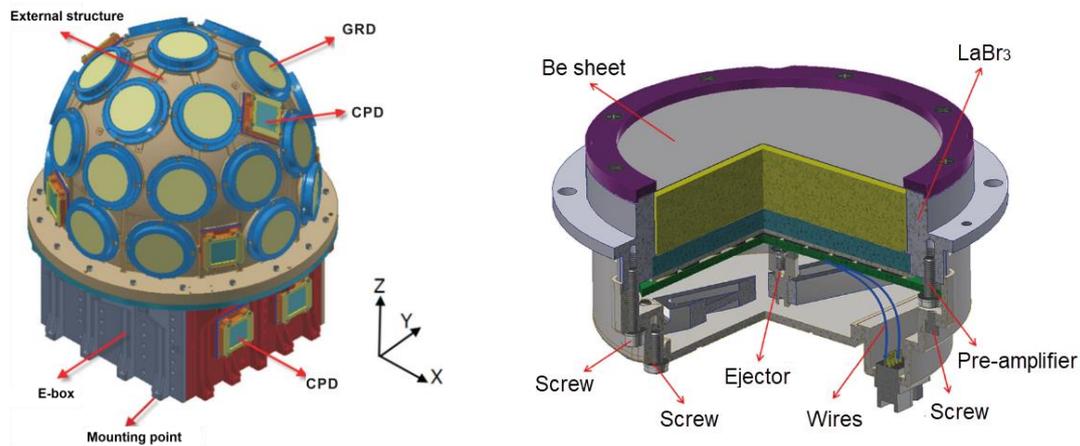
Figure 1 Schematic diagram of GECAM structure. Left: Installation drawing of GECAM GRD detector Right: GRD structure diagram.

GECAM is composed of two satellites with orbit height of 600 kilometers and inclination angle of 29°. Each GECAM satellite contains 25 gamma ray detectors (GRD) [4] (Figure 1) and 8 charged particle detectors (CPD)[5][6]. GRD is the main detector for measuring the gamma-rays and particles. The designed energy range is 8keV- 2MeV and tested result is 5.9 keV-4.3 MeV; CPD is used to identify gamma-ray bursts and charged particle bursts. localization algorithm based on the relative count rates and energy spectrum analysis of GRDs[7].

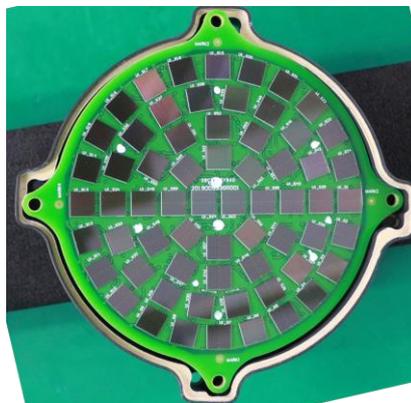
Figure 2 SiPM array of GRD

GRD is primarily composed of lanthanum bromide ( $\text{LaBr}_3$ ) crystals[8][9] and a pre-amplifier

board. In the front of the pre-amplifier board there is a SiPM array. GRD uses a novel device SiPM for large-size crystals readout. SiPM is widely used in the field of nuclear medicine imaging [10]. Due to its compact size, low operating voltage, and high quantum efficiency, SiPM has gradually been used in nuclear physics and related fields in recent years. The in-flight calibration detector of the Hard X-ray Modulation Telescope (HXMT) [11] apply silicon photomultiplier tube (SiPM) for the first time in China. The U.S. Naval Laboratory used SiPM as the SrI<sub>2</sub> scintillator signal readout in the SIRI-1 payload [12] launched in 2018. The detectors of Tsinghua University's "Gamma Ray Integrated Detectors" (GRID) CubeSat project [13] are mainly composed of a novel scintillator GAGG and a SiPM array. The above projects are all small-scale SiPM applications, and the quantity is only a few dozen pieces. Each SiPM array of the GECAM project consists of 64 SiPM chips (Figure 2), the quality grade of Model SensL MicroFJ-60035-TVS is commercial grade. In order to avoid the failure of the entire SiPM array due to the failure of single SiPM, SiPM's power supply network is divided into two parts that can switch each part separately. There are 3200 SiPM chips on GRDs and such a large-scale SiPM space application requires an efficient and reliable aging test to ensure the normal operation of the detector in orbit. Therefore, the quality assurance test is to test the entire pre-amplifier board as a whole. If one SiPM fails, the entire pre-amplifier board will be discarded. As one piece of SiPM failed in the joint payload test, a detailed failure analysis was carried out.

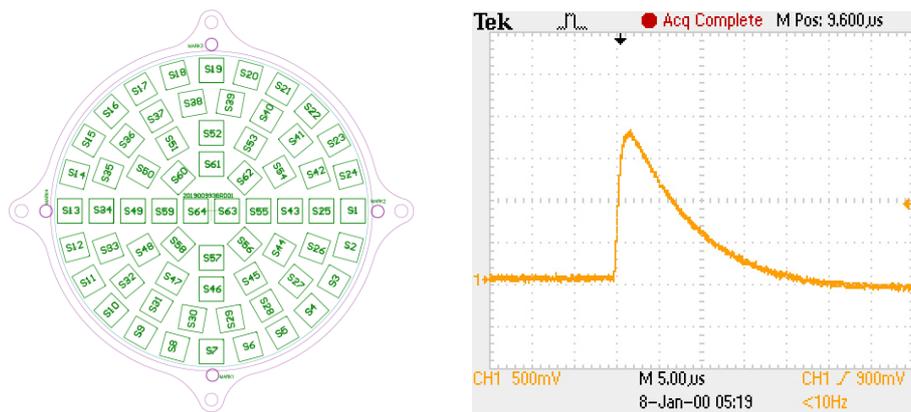
Figure 3 LED array test. Left: SiPM array number. Right: Oscilloscope waveform of pre-amplifier output signal.

In order to quickly judge whether the SiPM chip has false soldering or short circuit fault of SiPM microcell caused by surface glass layer fracture, a LED array is designed according to the SiPM arrangement in Figure 3. After the LED array, collimator and SiPM array are completely assembled, Microcontroller Unit(MCU) and analog switch controls the led array to emit light in the order of S1-S64, with an interval of 400  $\mu$ S. The right panel of Figure 3 shows the signal waveforms of each cell of SiPM array in turn. The output pulse amplitude of GRD preamplifier is different due to the difference of luminous intensity between LEDs. If the signal output of a SiPM chip is lower than the threshold of 200 mV, the whole SiPM array will be excluded. The test results of LED array can quickly determine the location of fault SiPM, which is convenient for further failure analysis. The data sheet shows that there is an optical uniformity of  $\pm 9\%$  among the SiPM[14]. However, because the 64 signal outputs of SiPM array are linked together, there is no strict requirement for the uniformity of SiPMs. The position response uniformity of the whole GRD is within 2% which is reported in a dedicated paper on the preamplifier of GRD[15].

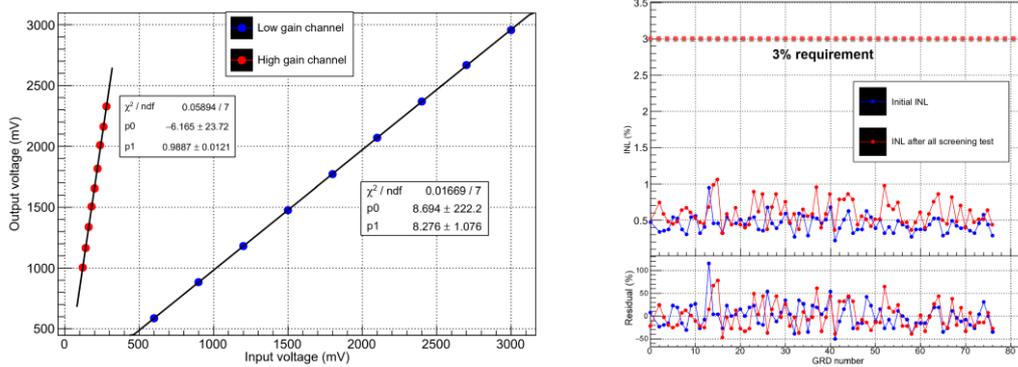
Figure 4 Left: Pre-amplifier linearity of high gain and low gain channels. Right: Integral nonlinearity (INL) of all GRD pre-amplifiers.

linear fitting results.  $Y$  is the full scale value. A signal generator is used to input the pulse waveform, and data acquisition system record the output signal amplitude for data analysis. Figure 4 left panel shows one set of the linearity test results of high gain channel and low gain channel. The fitting parameter  $p1$  stands for the gain of pre-amplifier. The central INL value of 76 GRD pre-amplifier board are 0.44 % and 0.59 % for the initial test and after screening test. In Figure 4 right, the INL is basically unchanged after all aging test and meets the requirements of  $< 3\%$ . The relative INL residual from the mean INL is also plotted in Figure 4 right. The residual more than 50% is come from experimental measurement statistical error. The corresponding energy ranges for high gain and low gain channel are 5.9-350 keV and 80 keV-4.3 MeV.

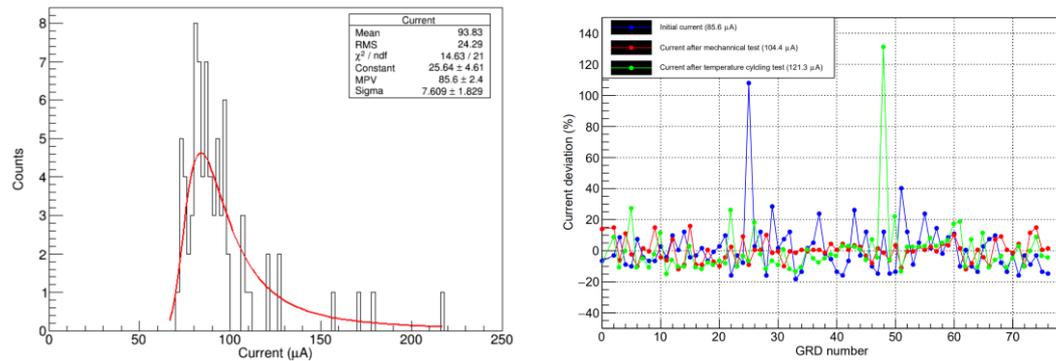
The initial tested dark current distribution of the SiPM array at a temperature of 25°C with an operating voltage of 28V can be fitted by Landau function as show in Figure 5 left. The 92.7% unilateral confidence interval of fitted Landau distribution function is 0-200  $\mu\text{A}$ . So SiPM array with current greater than 200  $\mu\text{A}$  are regarded as unqualified with a screening rate around 7%. The most possible values(MPV) of all SiPM arrays of initial test, after mechanical test and after cycling test are 85.6  $\mu\text{A}$ , 104.4  $\mu\text{A}$ , 121.3  $\mu\text{A}$  respectively. The dark current has a slight increase after the mechanical and temperature cycling test for SiPM arrays and the relative deviations are plotted in Figure 5 right. SiPM array of dark current variation more than 50% can only use as ground test sample. Such SiPM array has some defects before or after the aging test. The SiPM arrays are classified by dark current. 50 SiPM arrays of lower dark current is selected to assembly

Figure 5 Left: Distribution of SiPM array dark current before aging. Right: Dark current deviation after each aging test. The deviation is defined as the relative deviation of the tested dark current from fitted most possible value(MPV) of dark current among all the SiPM arrays.

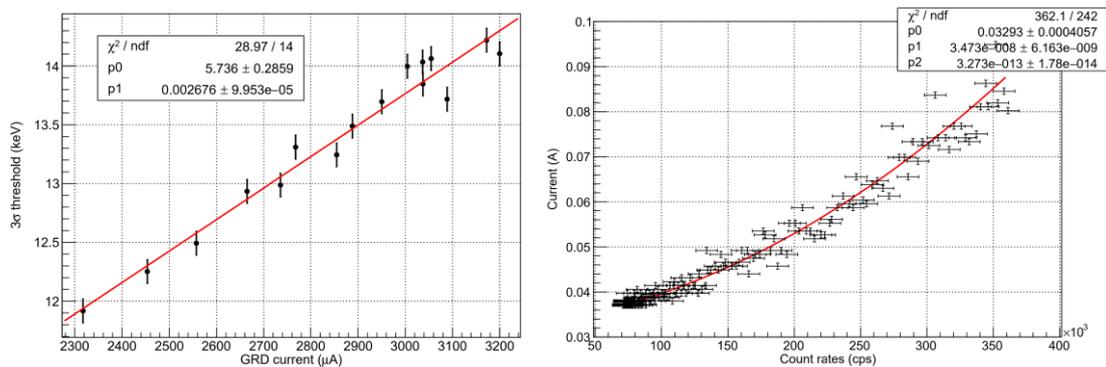
SiPM noise is related with dark current and has a total impact on the GRD low energy gamma-ray detection. The current in-flight results show that the dark current of SiPM array increases with time due to radiation damage[16]. The GRD noise threshold is three times the sigma value of the baseline fluctuation. Then the ADC value of threshold is convert to energy according to the in-flight calibration and temperature correction. The in-flight results in left panel of Figure 6 indicate that GRD noise threshold is proportion with SiPM array dark current. At -20 °C, the low energy detection limit is 6 keV with a dark current of 100 μA. Then the energy threshold increases by 0.26 keV per 100 μA.

Figure 6 Impact of SiPM array performance changes. Left: GRD threshold vs SiPM array dark current. Right: Dark current increase with count rates.

SiPM dark current is also increased with detection count rates. The right panel of Figure 6 shows an in-flight case of total SiPM dark current increase. In this case, all the SiPM arrays didn't shut down in time at the edge of South Atlantic Anomaly (SAA) area. The high charged particle flux in SAA region leads to the sharp rise of count rates and current. The maximum power supply capacity of the load is 0.2A. If the SiPM array can't be shut down during the whole time of SAA

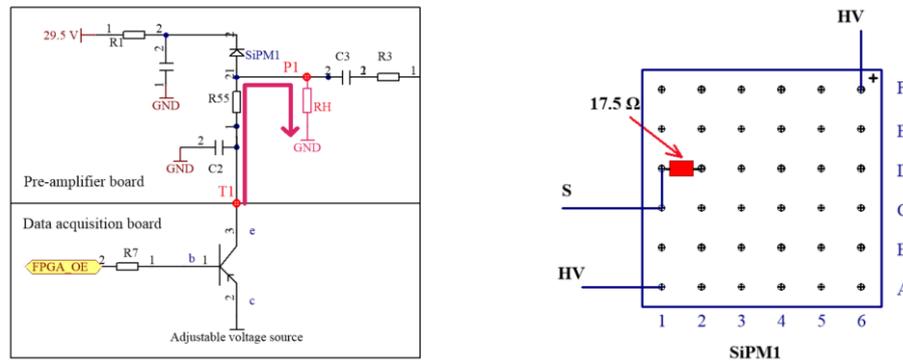
During the joint test of the GECAM payload, it was found that the power supply of No. Z01-40 GRD was uncontrollable. Afterwards, it was disassembled for inspection at Shandong Institute of aerospace electronic technology. As shown in Figure 7, the resistance between the 29.5V reference ground network T1 of the GRD and the power ground network was 68.5  $\Omega$ . After removing the R55 with a resistance value of 51  $\Omega$ , the resistance of test point T1 to ground was high resistance state, and the resistance of P1 to ground RH was 17.5  $\Omega$ (Figure 7 right). The resistance of point T1 to ground was R55 (51  $\Omega$ ) plus RH (17.5  $\Omega$ ), which is consistent with the T1 resistance to ground of 68.5  $\Omega$  measured before R55 was removed.

Figure 7 Left: Explanation of SiPM failure status. Right: Resistance value of SiPM failure pins

When the power ground network of the SiPM output P1 generated a leakage channel RH (a dozen ohms), an additional fault path of 29.5V reference ground (T1) to the power ground (blue line in Figure 7 left) would be generated. The fault path was: The current flowed from 29.5V through SiPM and equivalent fault resistance RH, and then to the power ground. The fault path made it impossible for the triode of the data acquisition board (connected to point T1) to control the switching of the power supply ground from point T1.

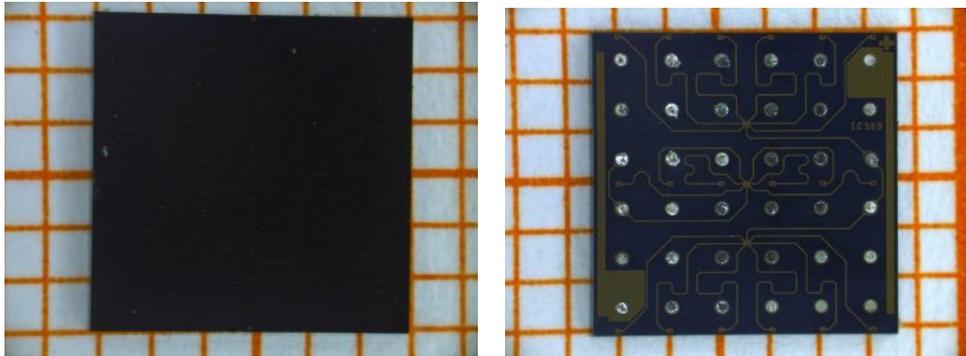
The fault SiPM was dismantled and delivered to the Space Center of the Chinese Academy of Sciences for device failure analysis. As shown in Figure 8, a microscope was used to inspect the SiPM surface. It was found that the front glass was not broken, and the FR4 layer on the back was visually intact.

Figure 8 Left: Photo of the front glass body of the malfunctioning SiPM. Right: Photo of the back of the malfunctioning SiPM.

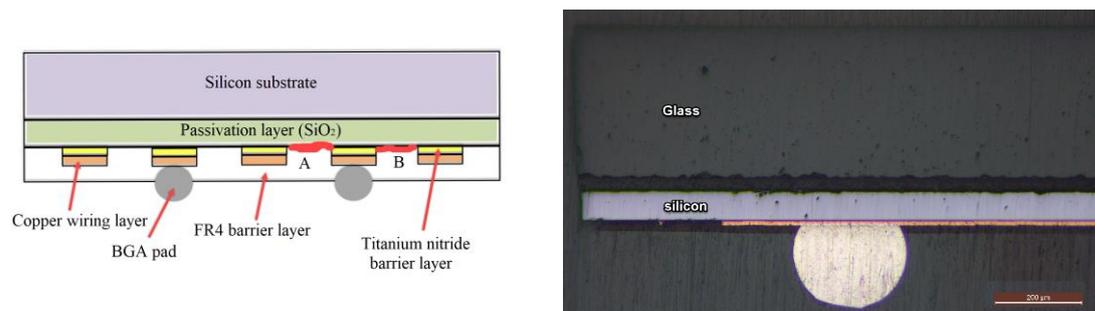
As shown in Figure 9 left, the SiPM device includes 5 layers: silicon substrate, passivation layer ( $\text{SiO}_2$ ), titanium nitride barrier layer, copper wiring layer and FR4 barrier layer (transparent) from top to bottom. The two channels (A and B in Figure 9 left) with reduced resistance are located on the surface of the passivation layer. The transparent FR4 barrier layer above the channel is intact. As the scratch position is below the FR4 barrier layer, it is determined that the scratch occurred during the SiPM production process.

Figure 9 Left: structure diagram of the longitudinal section of SiPM component. Right: metallographic sectioning photo of SiPM

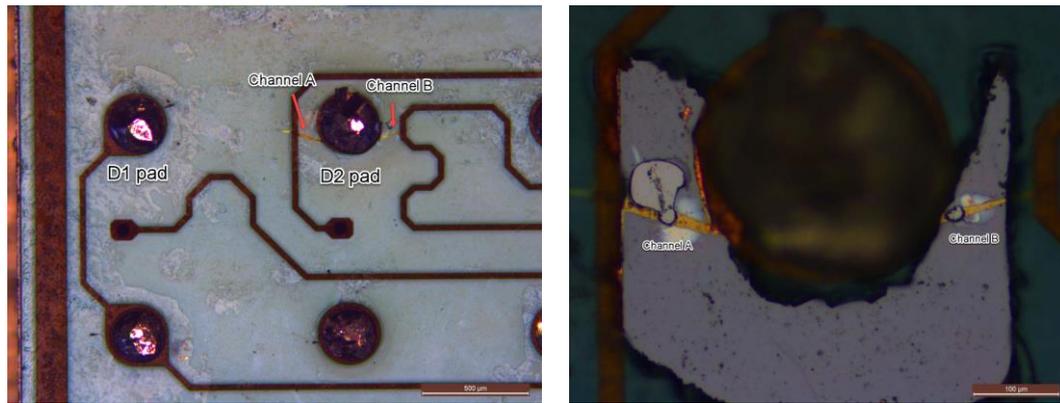
As shown in Figure 10 left, a clearer photo of SiPM was taken by metallurgical microscope, and there are two conductive channels between the D2 pad and the adjacent wire that is connected with D1 pad. The FR4 barrier layer was further rub down to completely expose the conductive path. As shown in Figure 10, after cutting off channel A on the left, the measured resistance of D1 and D2 changed from the original  $17.5 \Omega$  and  $1.147 \text{ k}\Omega$  respectively. After cutting off the right channel B, there was a high resistance between D1 and D2. Therefore, it can be judged that the D1

and D2 leakage channels of SiPM are caused by the A and B channels.

Figure 10 Left: Photomicrograph of faulty pad D2. Right: Photomicrograph after cutting off the conductive path Component analysis for Channel B.

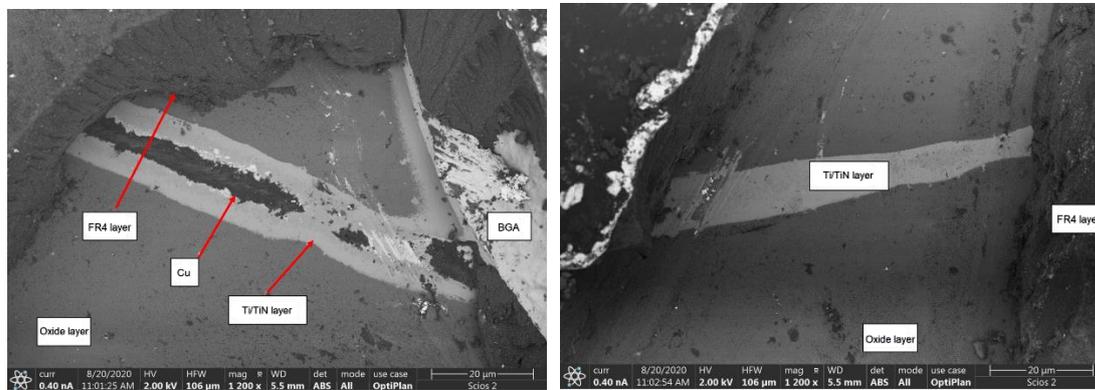
Figure 11 Electron microphotograph. Left: Channel A. Right: Channel B. Component analysis for Channel B.

Figure 11 shows the scanning electron tunneling microscope photo of channels A and channel B. In Figure 12 and Figure 13, the elements of each material at channel A and B were analyzed. The oxide layer was silicon dioxide ( $\text{SiO}_2$ ), the leakage channel A was titanium (Ti) or titanium nitride (TiN), and copper (Cu) was attached to the top of the film. For channel B, the leakage channel was composed of TiN. This scratch is the main reason for the fault of SiPM and the etching residue of the titanium barrier layer is the fundamental cause. Based on the above analysis, the titanium/titanium nitride film above the passivation layer ( $\text{SiO}_2$ ) has etching residues between the copper lines, which is the leading cause of the reduction of the isolation resistance between the device channels. The voltage difference between the D2 pad and the copper wire promotes the ionic migration [17] of the copper element in the wiring layer and the titanium element in the barrier layer at the scratch site, thus generating a leakage channel.

This failure was due to internal scratches and incomplete etching of copper wiring arising from a specific process defect in the production of SiPM. This defect was not exposed during the stress quality assurance experiment. In the GRD calibration experiment, the energy spectrum signal measured by the SiPM array was normal, but the current increased somewhat. During the test of the whole GECAM payload, the SiPM copper wiring had a leakage channel between the signal output terminal and the power ground due to ionic migration, and the SiPM bias voltage of the GRD detector was not controlled by the triode of the data acquisition board. Table 1 shows the current records of the faulty SiPM array at different times. As it was impossible to measure the current of a single SiPM array during of the whole GECAM payload, no current data was available. After the long time aging, the defects of SiPM can be detected. The defects can make the dark current increase. We contacted the SiPM manufacturer (SensL, Ireland), and the manufacturer responded that the failure probability of newly produced SiPM devices was  $1/10^9$  based on previous statistics. We finally replaced the whole failure SiPM array with a backup copy.

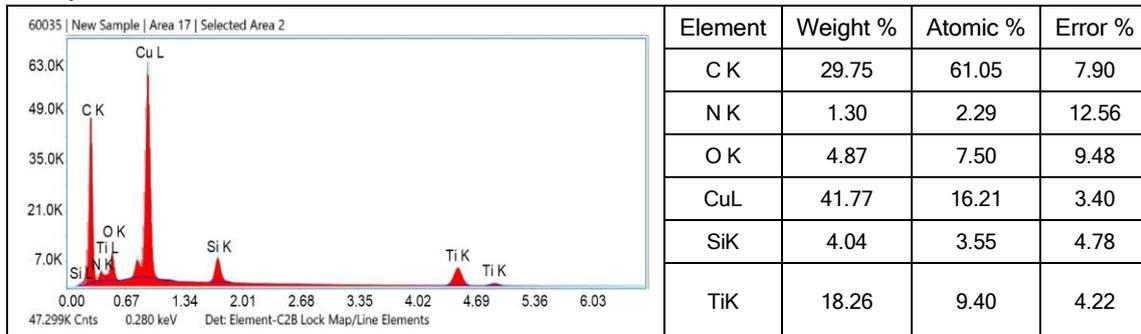
Figure 12 Component analysis for A channel. Component analysis for Channel B.

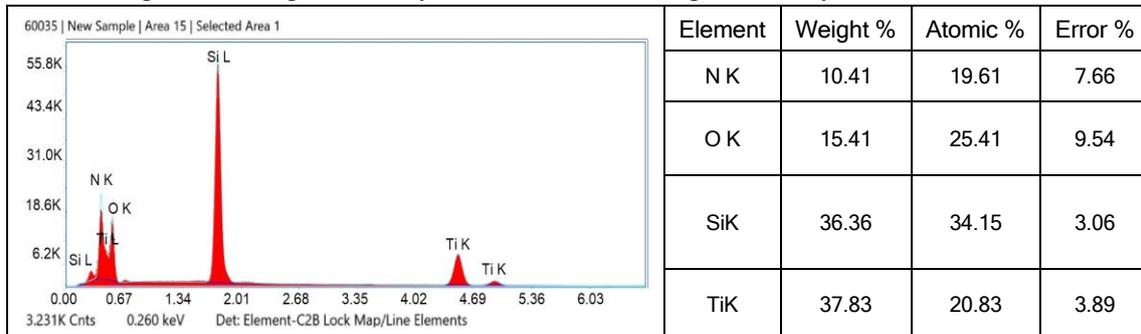
Figure 13 Component analysis for channel B. Component analysis for Channel B.
