Discovering the nanoscale origins of localized corrosion in additive manufactured stainless steel 316L by in situ liquid cell TEM

Mengkun Tian^{1*}, Jahnavi Desai Choundraj², Thomas Voisin³, Y. Morris Wang⁴, and Josh Kacher^{2*}

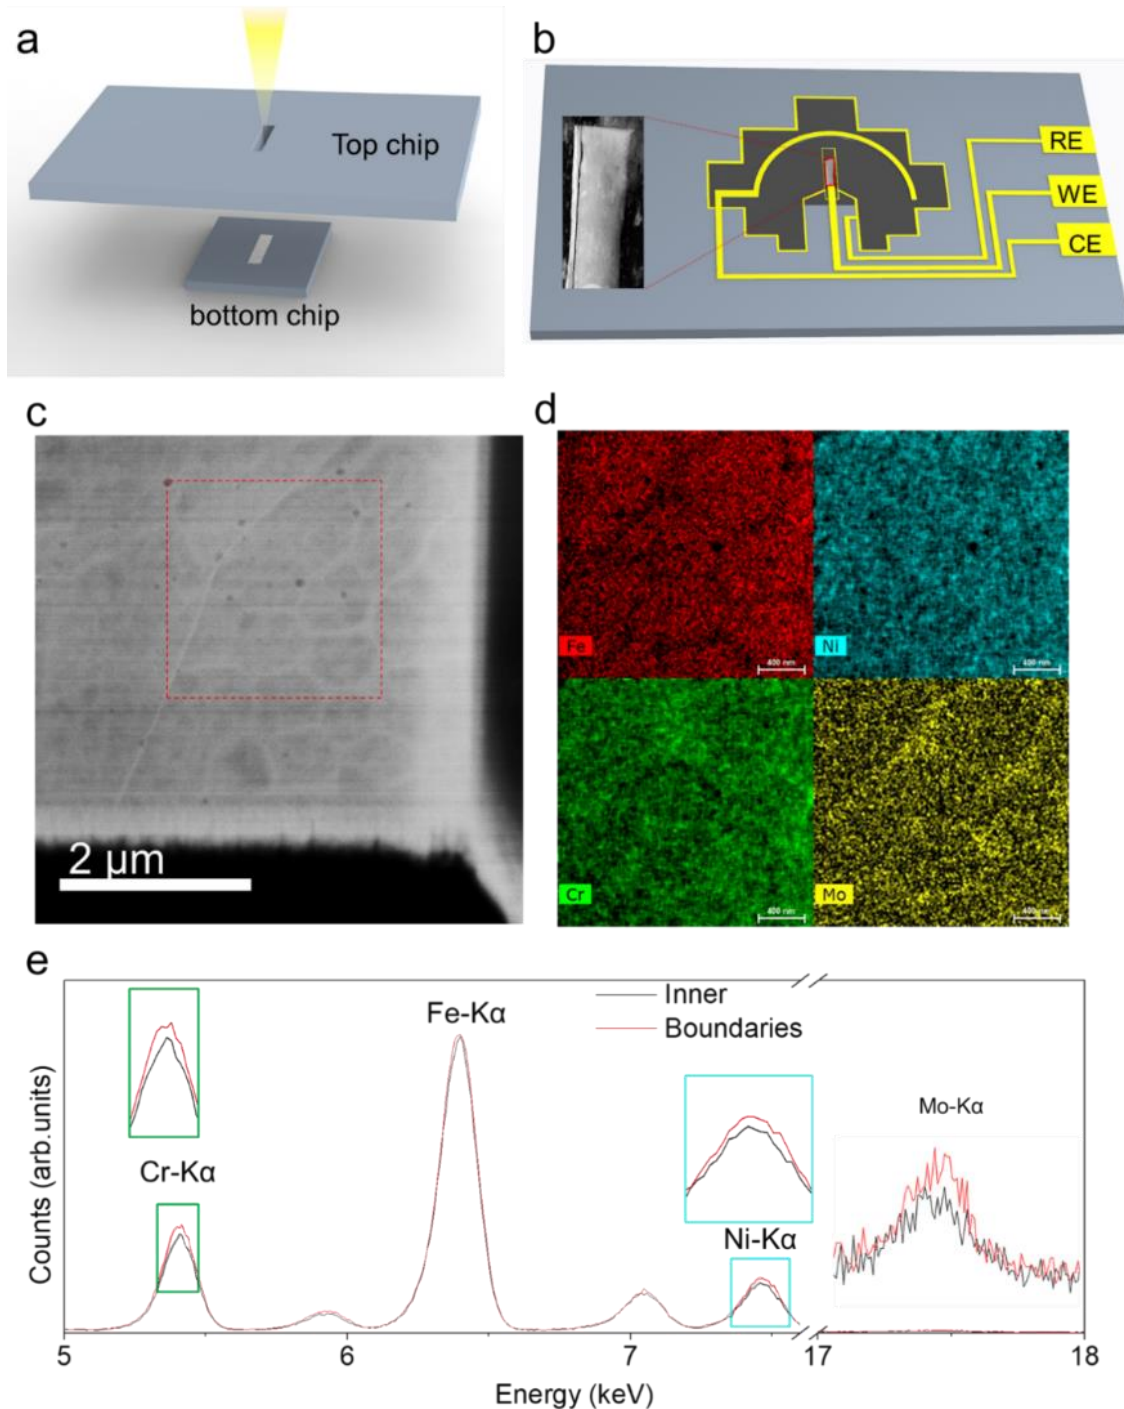
Fig. 1 Schematic illustration of LC-TEM chips and STEM-EDS characterization of the dislocation cellular structure. a) Schematic of the assembly of the chips. The yellow cone indicates the electron beam travel path. b) Schematic of the bottom chip with embedded working electrode (WE), reference electrode (RE) and counter electrode (CE). The inset is taken from the center part of the SiN_x window, showing the location of the TEM lamella. c) STEM-ADF image of a part of TEM lamella, showing dislocation cellular structure where the boundary is in brighter contrast. The red square represents the region where the EDS map was collected. d) Montage of EDS maps of Fe, Ni, Cr and Mo. e) EDS spectra taken from the boundaries and the interior of the cell. The intensities of Fe-Kα taken from boundaries and

interior have been normalized. The insets magnify the intensity difference between boundary and interior, showing Cr, Ni and Mo enrichment at the boundaries.

Figs. 1a-b shows the liquid cell chips used for mounting and testing the samples. In this setup, the sample is isolated from the surrounding vacuum by two Si chips with 50 nm thick SiNx windows separated by 500 nm spacers. The top chip has embedded Pt electrodes, to which a focused ion beam (FIB)-machined sample is directly attached using a Pt weld. Microfluidics channels allow liquid flow over the chip at controllable rates while applying a bias to the sample itself. Prior to exposing the samples to a liquid environment, we conducted annular dark field (ADF) in the scanning transmission electron microscope (STEM) imaging and energy dispersive X-ray spectroscopy (EDS) to determine the initial microstructure and elemental distribution (Figs. 1c-e).

The STEM-ADF image shows that the sample is composed of dislocation cellular structures, with each cell having an average diameter of approximately 700 nm. There are also multiple inclusions in the sample, ranging from 20-100 nm, which appear dark in the STEM-ADF image. Although we were not able to resolve the elemental composition of these inclusions, prior analysis on this same material showed that they are transition-metal-rich silicates with varying levels of Mn.[5] EDS analysis shows that Ni, Cr, and Mo segregate to the dislocation cell boundaries, leading to depletion of these elements in the cell interiors. To highlight the small concentration difference of Ni, Cr, and Mo, we normalized the Fe peak in the EDS spectrum (Fig. 1e).

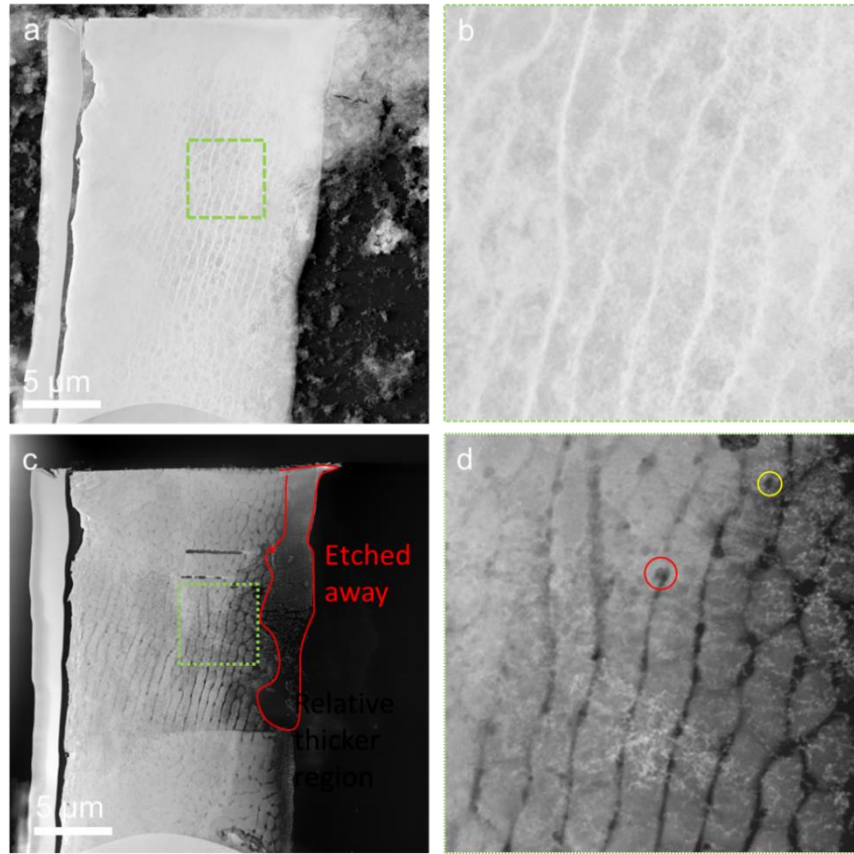
Fig. 2 Comparison of the corrosion before/after biasing. a) STEM-ADF image of the TEM lamella before biasing. b) Magnified image from the green dashed square in (a) showing the boundaries in brighter contrast. C) STEM-ADF image of the TEM lamella after biasing with etched away region indicated. D) Magnified image of the green dashed square in (d) showing the etched dislocation cell boundaries. Two regions of localized attack are highlighted by yellow and red circles showing pit-like features at a cell boundary (red) and cell interior (yellow).

Fig. 2 shows the initial results from the *in situ* LC-TEM corrosion experiments. STEM-ADF imaging before liquid was flowed over the chips clearly shows the presence of dense, dislocation bands, similar to the dislocation cell structures shown in Fig. 1c (Figs. 2a-b). After imaging, we flowed deionized (DI) water over the chip for 10 minutes to thoroughly wet the sample. We then switched the flow to a 1 wt.% HCl solution and measured the OCP, finding it to be -560±30mV. Figs. 2c-d shows the same location after applying a -100 mV bias (~460mV over-potential) for approximately 30 seconds. During OCP measurements and biasing, we blanked the electron beam to avoid any beam effects. As can be seen, the right side of the sample which was the thinnest part was almost etched away. Figs. 2b and 2d show a comparison of the same region before and after applying biasing. The bright contrast of the cellular boundaries shown in Fig. 2b changed to dark contrast in Fig. 2d, indicating the cellular boundaries were attacked preferentially. In contrast, cellular boundaries under strong HCl acid etchants are reported to be more corrosion resistant.[11, 12, 15-17] To our knowledge, no previous research have directly observed such boundary corrosion of AM stainless steel in HCl solution in TEM. In addition to boundary corrosion, we were able to identify 180 pit-like features in the images. Approximately 95% of these features were concentrated along the dislocation cell boundaries, with the remaining 5% located in cell interiors.

Two representative pit-like features are indicated by a red circle (cell boundary pit) and a yellow circle (cell interior) in Fig. 2d. Recent research showed that the AM stainless steel could be susceptible to pitting.[27] However, whether those pit-like structures are real pits need time-resolved in-situ LC test as following.

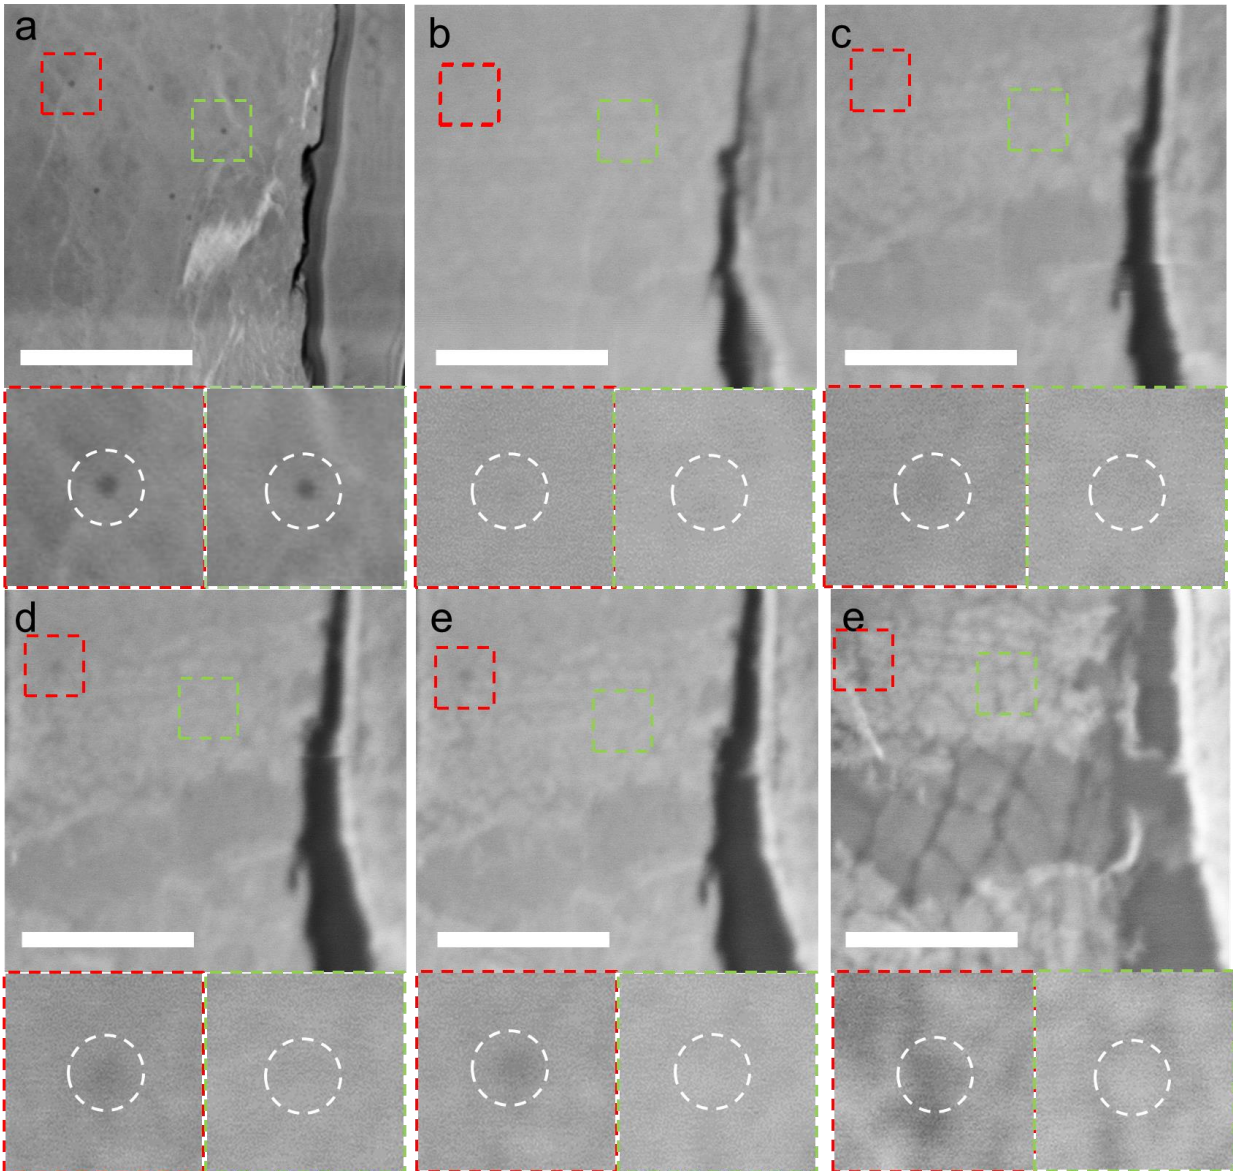
Fig. 3 Monitoring the evolution of the morphology of the lamella during corrosion. a) ADF-STEM image taken before sample was exposed to solution. b) Image taken after applying biasing at -400mV for 40s. c-f) Image taken after applying -300mV biasing for 4s, 9s, 14s and 20s, respectively. Highlighted show selective inclusion dissolution (red) and unattacked inclusion (green) Scale bar is $2\mu\text{m}$.

To decelerate the corrosion process and investigate the local corrosion mechanism, we adjusted the biasing potential and duration. Fig. 3a shows a STEM-ADF image of a lamella before exposure to the HCl solution. Two regions are highlighted for close inspection by red and green dashed squares. We selected these regions to track corrosion behavior at three different locations of interest: (1) at an inclusion at the intersection of dislocation cell boundaries and (2) at an inclusion

located inside a dislocation cell interior. The center points of the two regions are highlighted by white dashed circles. We measured the OCP to be -454 ± 7 mV, which is approximately 100 mV less than the OCP measured for the previous sample (-560 ± 30 mV). The OCP differences between the two experiments (-454 ± 7 mV vs -560 ± 30 mV) originated from the flow rates ($100 \mu\text{L/hr}$ vs $300 \mu\text{L/hr}$). [24] We then exposed the sample to HCl solution flow and applied a -400 mV potential, slightly higher than the OCP, for 4, 8, 12, 20 and 40 seconds. We blanked the electron beam again during applied bias to avoid any electron beam effects. As can be seen in Fig. 3b, taken after the 40 second interval, this over-potential did not initialize any corrosion. We then biased the sample at -300 mV for 4 seconds, resulting in the center of the red square to turn slightly darker, indicating localized attack at the inclusion site. The localized corrosion expanded somewhat over the course of 20 seconds at -300 mV (Fig. 3c-b). However, the corrosion front did not expand far beyond the initial inclusion area, suggesting that a dissolution process was occurring rather than pit formation. In Figs 3.c-f, shortly after corrosion attack of the inclusion, the dislocation cell boundaries were also attacked and corroded, with the corrosion front rapidly spreading throughout the dislocation network. In comparison, the inclusion in the dislocation cell interior, highlighted by the green square in Fig. 3, was not attacked, suggesting that the inclusions are only susceptible to dissolution when embedded in the dislocation cell wall. This could be due either to the high strain energy associated with the dislocation accumulation or to the elemental segregation at the cell boundaries.

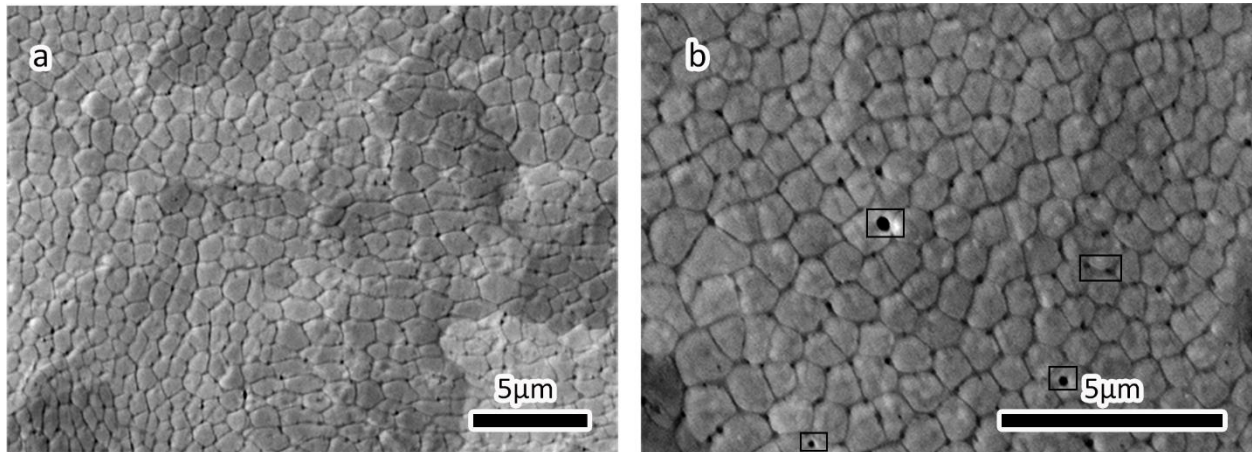
Fig.4 a and b SEM images of the AM Steel bulk sample after cyclic polarization scan showing cellular boundary attack and pits at the cellular boundaries and interiors.

To verify the observed behavior, bulk electro-chemical tests were run on the AM stainless steel sample. In agreement with the *in situ* TEM experiments, these tests showed that at high scan rates, 10mV/s , cellular attack was observed to dominate the response (Fig.4, scan data shown in Fig.S3). We also observed pit-like features distributed over the material surface, though primarily located along the dislocation cell networks, especially at the intersection points. By comparing the

sizes of these pit-like features in the bulk SEM analysis and *in situ* TEM tests, we can see that they are approximately the same size, ranging from 70nm-210nm in the SEM images and 70nm-200nm in the TEM images. Considering high pitting potential ($\sim 900\text{mV}$) from the polarization scan compared to the potential applied in the *in situ* experiments, this suggests that the pit-like features were not pits which should have significantly increasing sizes.. A systematic investigation of the influences that dictate cell boundary versus cell interior attack in bulk samples is currently ongoing. Here we take advantage of the unique liquid cell TEM capabilities to focus on the initial stages of attack.
