## **Advanced Analytics on 3D X-ray Tomography of Irradiated Silicon Carbide Claddings**

Fei Xu<sup>1,#</sup>, Joshua J. Kane<sup>2</sup>, Peng Xu<sup>1,#</sup>, Jason L. Schulthess<sup>1</sup>, Sean Gonderman<sup>3</sup>, Nikolaus L. Cordesa<sup>4</sup>

<sup>1</sup> Idaho National Laboratory, Idaho Falls, ID, United States

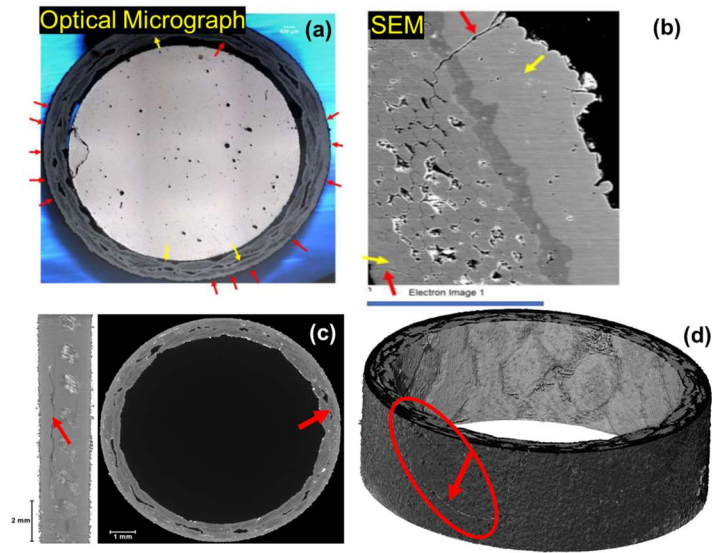
Fig. 1. a) optical micrograph of a fuel cross-section of Sample 1<sup>15</sup> with crack locations identified by the red and yellow arrows; b) high-resolution SEM image of local fuel cladding region of Sample 1<sup>15</sup> with crack locations identified by the red and yellow arrows; c) 2D cross-sectional images in the vertical (left) and horizontal (right) orientations, showing a vertical subsurface crack (red arrows) in the SiC-SiC cladding; d) 3D volume renderings, derived from the X-ray tomograms, of irradiated, defueled SiC-SiC cladding.

examination capabilities to collect non-destructive 3D microstructural data using a ZEISS Xradia 520 Versa X-ray microscope (Fig. 1(d)). This system is used to acquire a wide range of microstructural data over a wide length scale ( $10^1 - 10^{-2}$  cm) and can capture both the surface and interior material structure in 3D<sup>10</sup>. This is accomplished by taking hundreds of X-radiographs on a sample of interest as a function of sample rotation. Then the 3D reconstruction processing will conduct 3D images in a composed stack of material cross-section 2D radiographs. These high-resolution 3D models are then used to explore the sample's architecture and microstructure allowing for better determination of the samples' condition and improved understanding of how the material performance<sup>11-14</sup>.

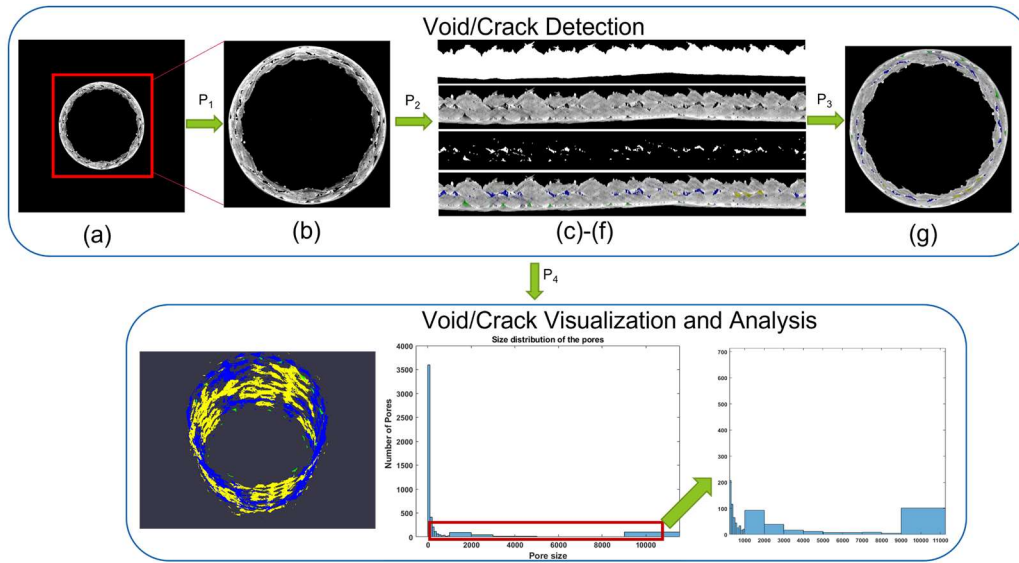
Fig. 2. The proposed workflow. (a) An image from Sample 3 with field of view representing  $3024 \times 3064$  with resolution  $6 \mu\text{m}/\text{pixel}$ ; (b) sub-image containing material annulus; (c)-(f) represent a spatially transformed coordinate system of Sample 3 showing from top to bottom a binary segmentation of the annulus, original grayscale reconstruction, segmented voids, and color-coded pore classifications. In (f): green denotes the voids/cracks connected directly to the outer surface of the annulus; blue identifies closed voids/cracks that do not touch the inner or outer surface of the annulus; yellow identifies voids/cracks touching the inner surface of the annulus; and red identifies voids/cracks touching the inner and outer surfaces. (g) Rewrapped image frame with corresponding classifications from (f).

In this paper, we developed a fully automatic workflow to detect and analyze cracks using image processing techniques on 3D X-ray images (Fig. 2). Void/crack detection, visualization, and analysis are the three major components, including four processing blocks, noted as P<sub>1</sub> to P<sub>4</sub>. P<sub>1</sub> spatially aligned the cylindrical axis orthogonal to the volumetric Z-axis and extracted the smallest possible volume of interest within a Cartesian coordinate system. P<sub>2</sub> was applied to unwrap the material annular by transforming the

volume from a Cartesian coordinate to a polar coordinate system.  $P_3$  detected and labeled the voids/cracks using image segmentation approaches.  $P_4$  generated the connected structures of 3D visualized voids/cracks and statistical results. SiC samples provided by General Atomics have been tested in TREAT and evaluated using the proposed workflow.

As shown in Fig. 2, the process of  $P_1$  was to align the volume and extract the cladding circulars. The flowchart of the process and the corresponding intermediate results are shown in Fig. 5. In the reorientation process, we applied an algorithm to align the cylindrical axis to the volumetric Z-axis. The algorithm has two inputs, the 3D volume and a 2D matrix consisting of  $(x_i, y_i, i)$ , namely *Center*, where  $(x_i, y_i)$  is the cladding center of the  $i$ th slice. The cladding center was generated automatically through the circular boundary detection results (Fig. 5(c)). The value of each pixel is named intensity in the image, and the brighter regions indicate higher intensity. As shown in Fig. 5(b), the cladding appears much brighter than the other regions. We detected the material circular by using a global threshold segmentation method<sup>21</sup>. The threshold method sets the pixel value to be 1s if the image intensities are greater than an adaptive threshold  $T_0$ ; otherwise, assigns 0s. The center of the cladding circular was calculated by using

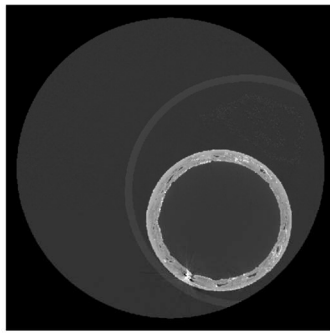
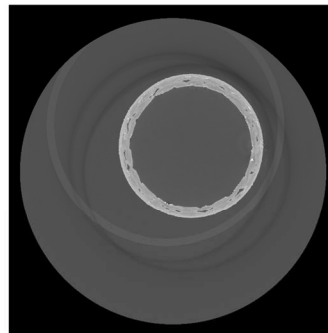
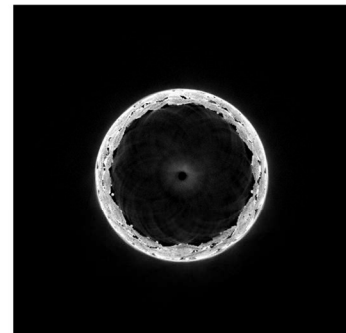
A Slice from Sample 1

A Slice from Sample 2

A Slice from Sample 3

Fig. 3. Image slices from the three samples

Non-destructive 3D imaging was performed using the ZEISS Xradia 520 Versa X-ray microscope (Carl Zeiss X-ray Microscopy Inc., Dublin, CA, USA) at INL's Irradiated Materials Characterization Laboratory (IMCL) at Materials and Fuels Complex (MFC). The Nordson DAGE tungsten X-ray source (Aylesbury, UK) was operated with a proprietary high energy filter, 110.9-kVp accelerating voltage, and 111.7- $\mu\text{A}$  target current. All projection radiographs were acquired over 360 degrees of sample rotation, and each radiograph had an average of 20 image frames. The frame size is 3024 by 3064 pixels. The reconstructed 3D slides are shown in Fig.3. Additional detail is listed in Table 2.

(Fig. 3). To compensate for this a reorientation method was applied to align the cylindrical axis orthogonal to the volumetric Z-axis and an automatic algorithm was designed to extract the sub-image containing the material part.

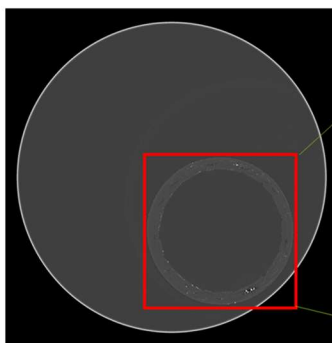
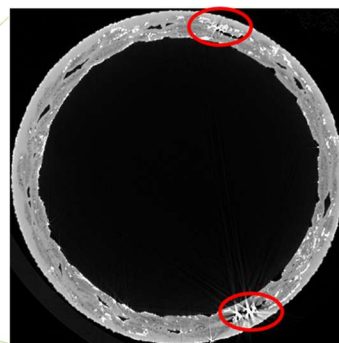
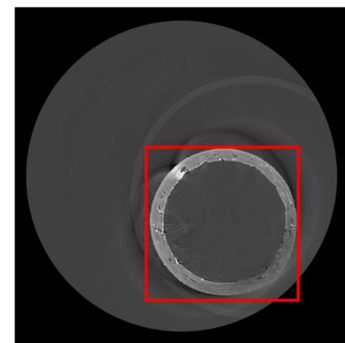
Fig. 4. Existing Challenges

(a) Slice#1156 (3024×3064)

(b) Cladding circular part (1351×1351)

(c) Slice#410

Although 3D X-ray rendering provided high-resolution and non-destructive data, slices of 3D X-ray exist rotating and drifting during reconstruction which will affect the pores/cracks 3D structure. As shown in Figs. 4 (a) and (c), the cladding circular centers of slice#410 and slice# 1156 from the same sample are (1973,1916) and (2038,1962), separately. Moreover, high-density artifacts were brought in the 3D images (Fig. 4(b)) which impacts the pores detection. Additionally, the material centers vary in different samples

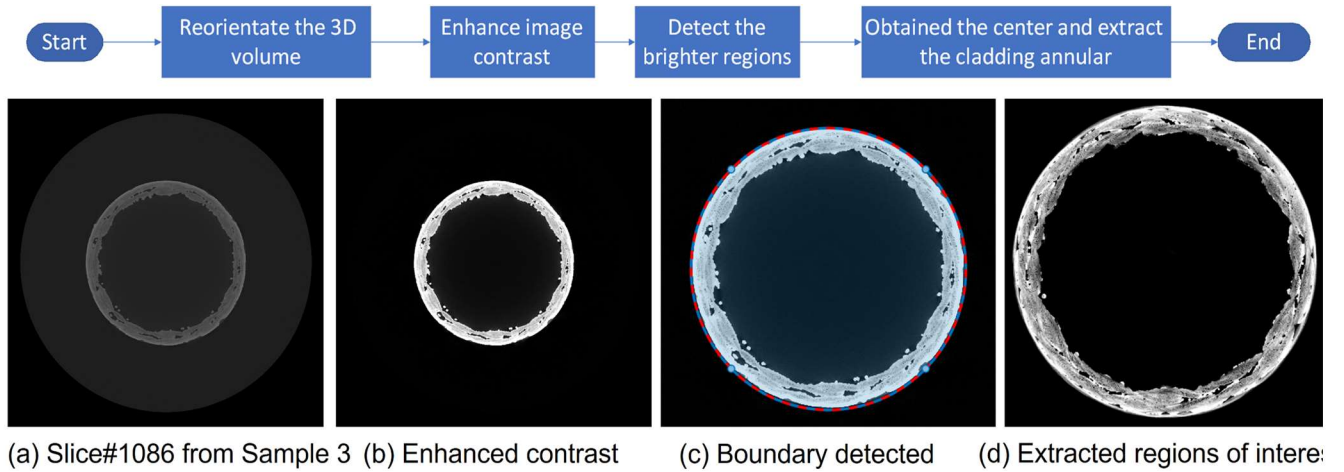
Fig. 5. Reorientation and ROI extraction. (a) original image with size  $3024 \times 3064$ ; (b) contrast enhancement; (c) zoomed-in cladding boundary detection result; (d) extracting the cladding circulars after reorientation with image size  $1351 \times 1351$

The reorientation process contains the three main steps: 1) Determine misorientation angles along  $x$ -axis and  $y$ -axis from *Center* by generating the slopes on  $x$  and  $y$ -axis along the  $z$ -axis (slice number); 2) assuming the orientation and drift changing are symmetric, generate the transform matrix linear translation on the first half volume steps by  $[mean(x), mean(y), the\ number\ of\ slices/2]$  and the second half volume by  $-[mean(x), mean(y), the\ number\ of\ slices/2]$  along  $x$ -axis,  $y$ -axis and  $z$ -axis respectively.  $mean(x)$  and  $mean(y)$  are the mean  $x$ -axis and  $y$ -axis values in *Center*; 3) apply a spatial transformation with the translation matrix to compute the corresponding locations in the original 3D volume transform subscript space for each location in the reorientated space as shown in Figs. 5 (c) and (d).

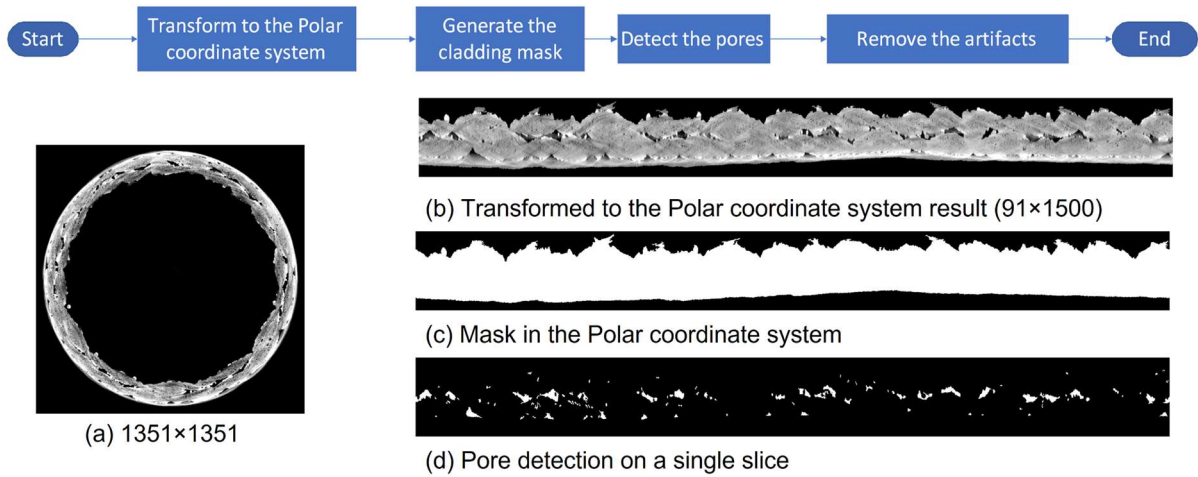
Fig. 6. Voids detection.

Fig. 6 showed the process of voids detection. First, the Cartesian coordinate system is transformed into the Polar system to reduce the computational complexity. Since the cladding material is an annular shape, the corresponding elements of the two-dimensional Cartesian coordinate arrays  $x$  and  $y$  are

transformed into polar coordinates  $\theta$  and  $\rho$ . The radius of the inner and outer boundaries of the cladding are nearly 550 and 650 pixels from the center. The thickness of the cladding is less than 100 pixels. 1500 angles with the radius range covering the inner and outer boundaries of the cladding in the Polar system are generated. The transformed image size is  $91 \times 1500$  as shown in Fig. 6(b), which reduced the computational size by nearly 7 times.

After transformation, the voids in the cladding regions are detected (Fig. 6(c)). The voids appeared darker than the other regions in the cladding. Noises is removed and the voids are detected using the adaptive threshold segmentation method<sup>21</sup> after adjusting the contrast of the image. However, the shadows, as marked in the red circles in Figs. 7(a) and (b), resulted from the high-density metal during X-ray scanning<sup>22,23</sup>. The shadows are inhomogeneous with and surround the voids and are not easily distinguished from the intensities, which will result in misdetection by the threshold segmentation method. , are . To solve the problem, the intensities' standard derivation for each connected object are calculated; and if the standard derivation is greater than  $d_1$ , an adaptive local threshold value in the connected void is generated, and the pixels with intensities greater than the value are removed (Fig. 7(c)).

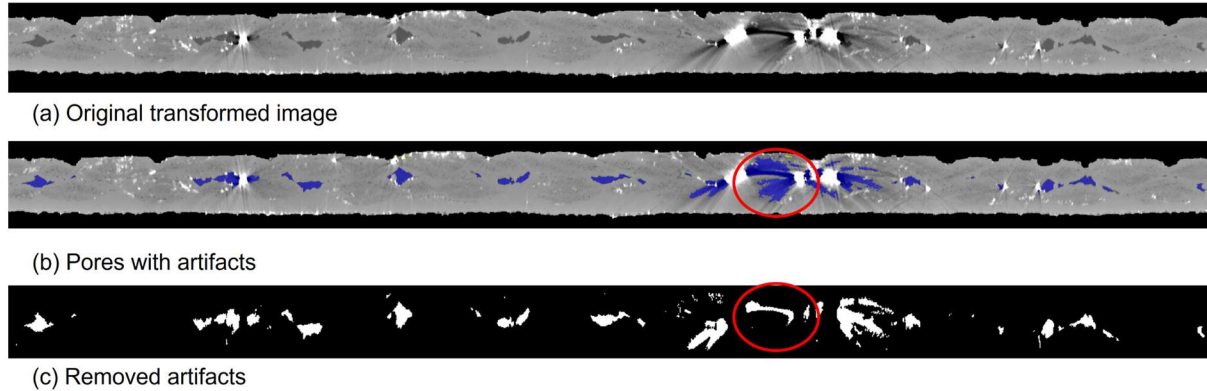
Fig. 7. Remove the shadow Voids detection.

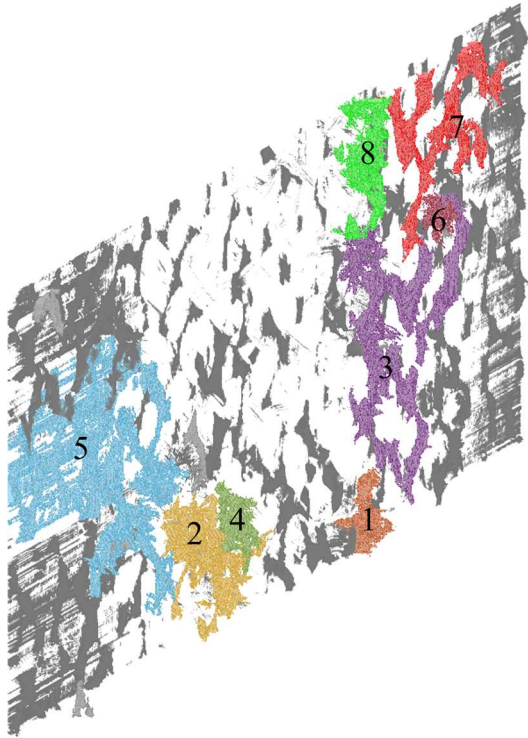
Fig. 8. Crack structure in unwrapped Sample 1

**Porosity statistical analysis.** The overall number of voids and cracks in the three samples is shown in Table 3. Sample 1 had the greatest number of voids, but Sample 2 had the most porosity ratio. Sample 1 and Sample 2 contained nearly or over twice the number of voids than the fresh Sample 3. As shown in column  $c_4$  in Table 4, no crack that crossed the inner and exterior boundaries of cladding was detected in Sample 3, while Sample 1 was founded the greatest number of individual cracks, and Sample 2 had the largest cracks. From the aspect of voids' locations, nearly all of the voids (>99%) of Sample 3 were inside the cladding ( $c_1$ ). While most voids of Sample 1 and Sample 2 were cracks that crossed the inner and exterior boundaries of the cladding ( $c_4$ ) and microcracks ( $c_2$ ), which matched the characterization observation in the previous study<sup>15</sup>. The crack structures of Sample 1 and Sample 2 are shown in Figures 8 and 9. The darker regions in the figures are voids. The colored components are the cracks. The properties of the cracks were generated as shown in Table 4, including the volume size of the crack, and principle axis length. The principle axis length is the length of the major axes of the ellipsoid that have the same normalized second central moments as the region, as a 1-by-3 vector. The data in Table 4 revealed that all the cracks have longer lengths in the vertical direction, especially crack 1 of Sample 2. Sample 2 had a less number of cracks, but each crack was larger than the cracks in Sample 1.

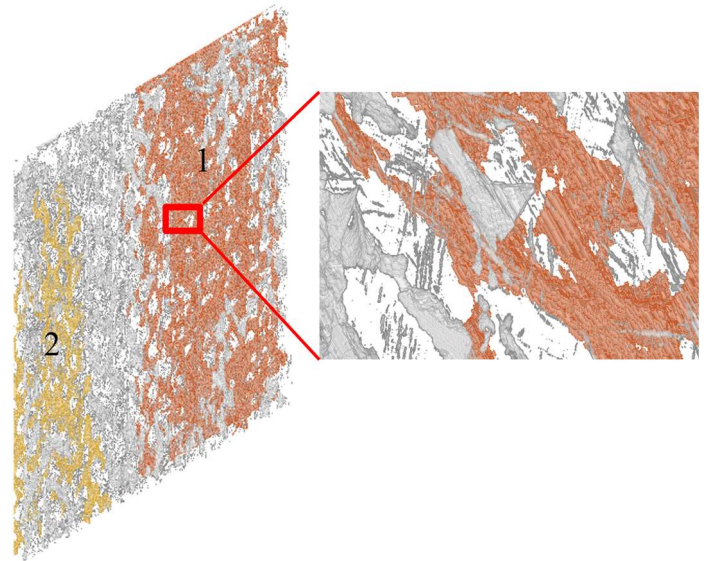
Fig. 9. Crack structure in unwrapped Sample 2

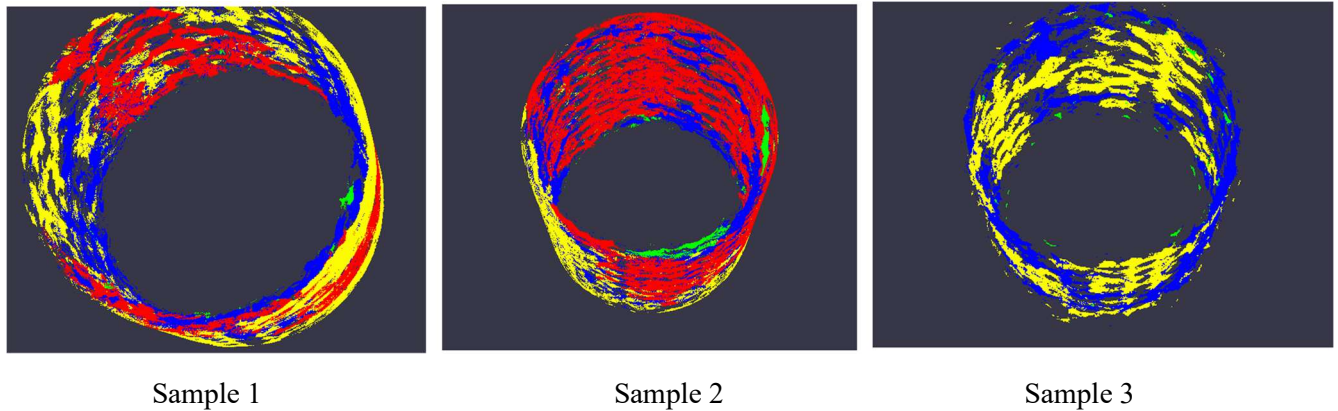
Fig. 10. Crack structure in unwrapped Sample 1, Sample 2 and Sample 3.

**PIE data analysis.** The SEM characterization of Sample 1 indicated that in the transverse section surface observed 14 radial cracks and 3 circumferential cracks, while 2 radial cracks and 3 axial cracks were found in the longitudinal section. The cracks was found interconnected through the cladding thickness from the cross-section.

Optical microscopy of Sample 2 revealed more radial and circumferentially cracks in the SiC cladding than in Sample 1<sup>15</sup>. On the sample surface, 31 radial cracks and 10 circumferential cracks in the transverse section, and 15 radial and 0 axial cracks in the longitudinal section are observed. At least 6 of the cracks were found to propagate through the wall thickness of the cladding. Many large pores ranging in size from ~300 to ~400  $\mu\text{m}$  were found. Interconnected cracks appeared along with branching cracks emanating from the main crack. Moreover, a crack network was observed on the inner surface, which may be from fabrication. More SEM investigation revealed more branching cracks and widespread micro cracks. All the findings from the sample surface matched the X-ray 3D results.

The experimental results demonstrated that Sample 1 (lower strain) and Sample 2 (higher strain) have cracks establishing a continuous path between the interior and exterior surface of the annulus breaking the desired hermiticity of the material, and no such cracks were observed in Sample 3 (fresh material). These results demonstrate the applicability of X-ray tomographic imaging capability in rapidly supporting post-irradiation examinations of non-fuel components X-ray tomography with advanced visualization methods and automated defect analysis. The workflow can be applied to other similar 3D X-ray data analysis tasks.
