On-orbit No-contact Anomaly Debug Procedure for the CuPID Cubesat *Root cause investigation*

Emil A. Atz
Brian M. Walsh
Connor J. O'Brien
*Boston University
Center for Space Physics
Mechanical Engineering
April 11, 2023*

The CuPID CubeSat Observatory was a 6U cubesat launched into low-Earth orbit with a ride-share opportunity in Fall 2021. The mission was supported by NASA's Heliophysics division and motivated scientifically with the objective to image X-rays produced in the magnetosphere. After launch, the team was unable to communicate with the spacecraft. This document presents the testing and analysis of attempts to contact the spacecraft and investigation to the likely cause of failure with the radio system.

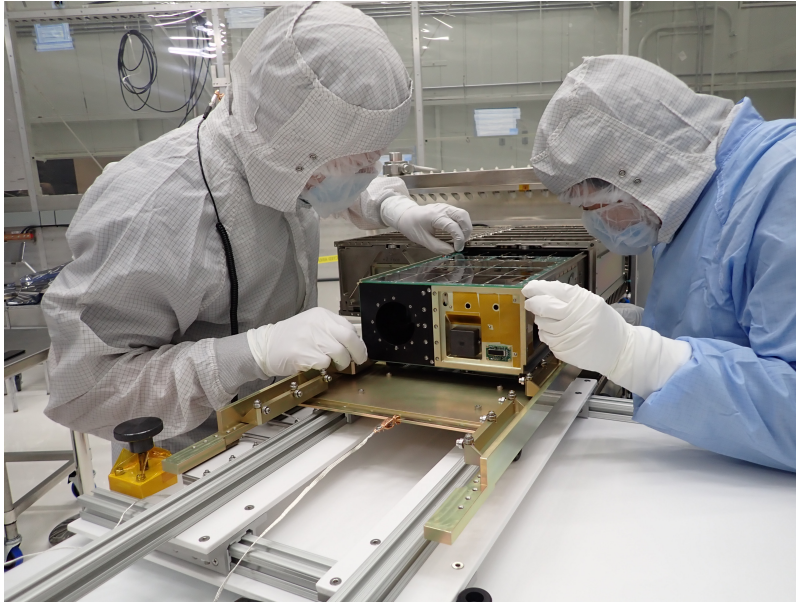
Figure 1: Two students install CuPID into the ESPA (EELV Secondary Payload Adapter) ring CubeSat deployer during integration with launch vehicle components.

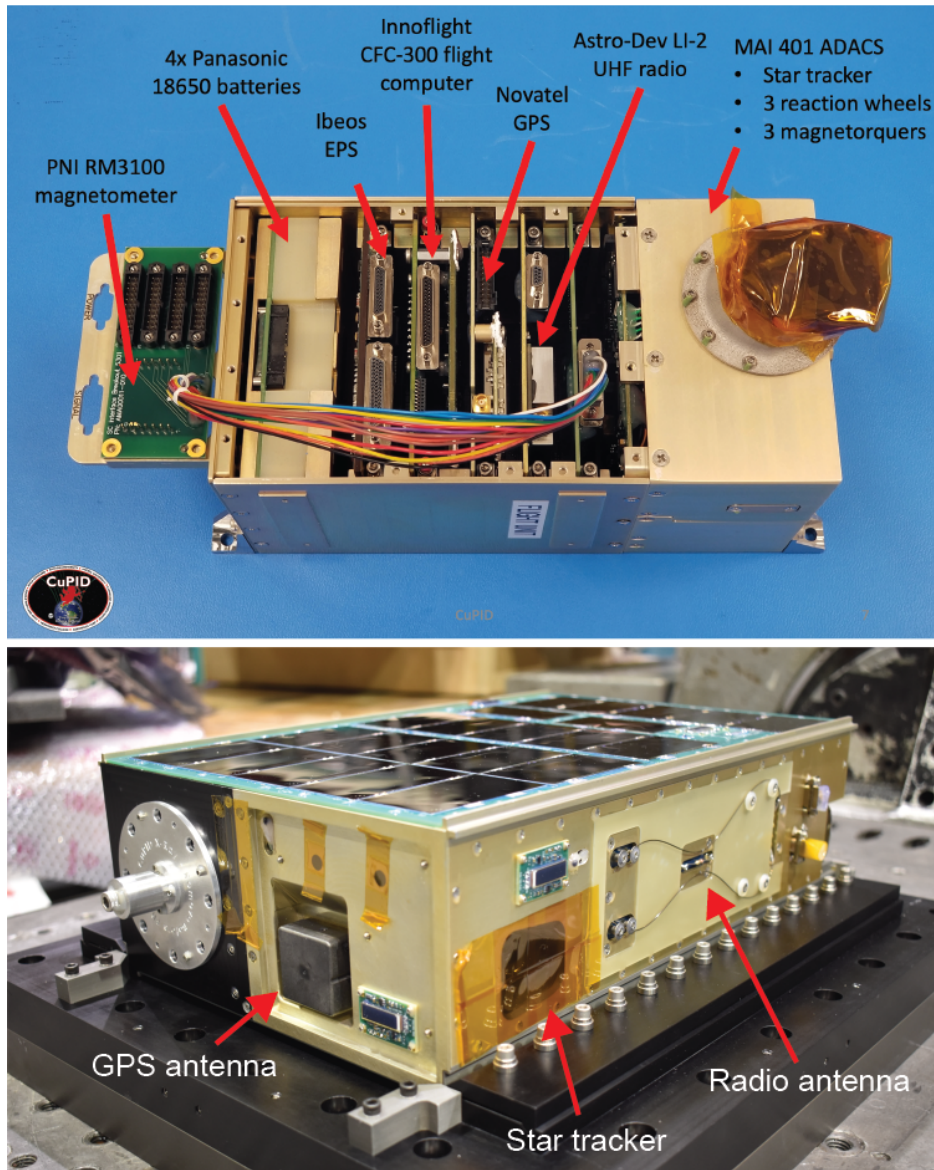
Figure 2: Top: CuPID's avionics system and enclosure on workbench without wiring harness. The magnetometer is mounted on the backside of the diving board. The batteries supply the EPS which distributes power to the rest of the sub-systems. The flight computer receives data from the GPS and ADACS to control the spacecraft pointing. Ground commanding and telemetry is transmitted through the UHF radio. Bottom: CuPID mounted to a vibration table during environmental testing. Elements to note include CuPID's largest solar panel with 22 cells, the stowed radio antenna, and covered star tracker aperture leading to the avionics inside.

CuPID used an avionics system developed by Adcole Maryland Aerospace (AMA) that incorporated a number of components built by the company and some integrated from other vendors. The avionics enclosure and sub-systems are shown in Figure 2. The avionics

included Adcole Maryland Aerospace's MAI401 for attitude determination and control (ADACS - Attitude Determination and Control System). The ADACS was designed to determine spacecraft attitude with a magnetometer, six coarse sun sensors, and a star tracker, and provide pointing and stabilization with three reaction wheels and three magnetorquer rods.

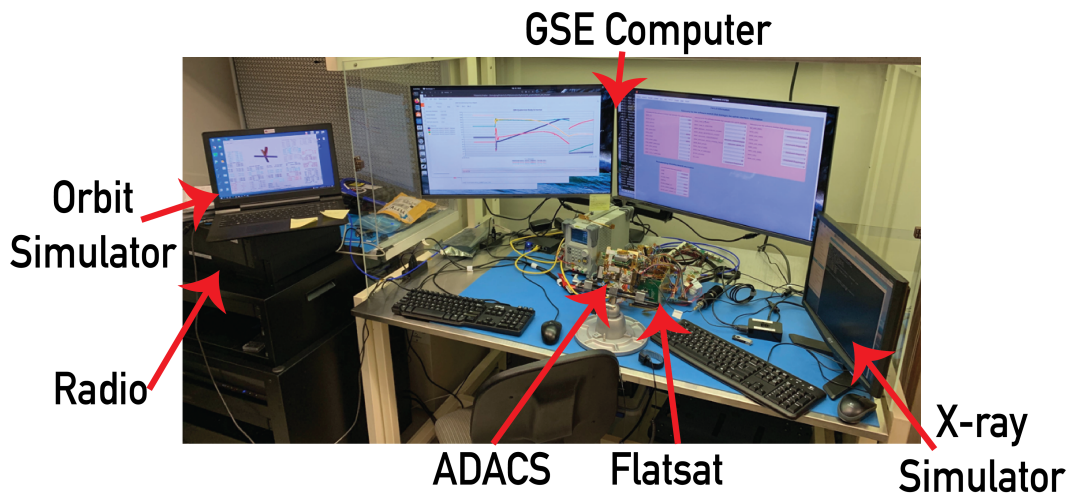
Figure 3: CuPID’s flatsat used to test mission operations and software changes. An orbit simulation was input to the ADACS. The flatsat and ADACS responded accordingly. The operator monitored flight-like telemetry on the computer output and commanded the satellite through the radio.

In addition to the development of a flight unit, a complete replica of the flight unit called the *flat-sat*, was used for software and operations testing. See Figure 3. Additionally, the flat-sat could be used for debug purposes after launch of the flight unit.

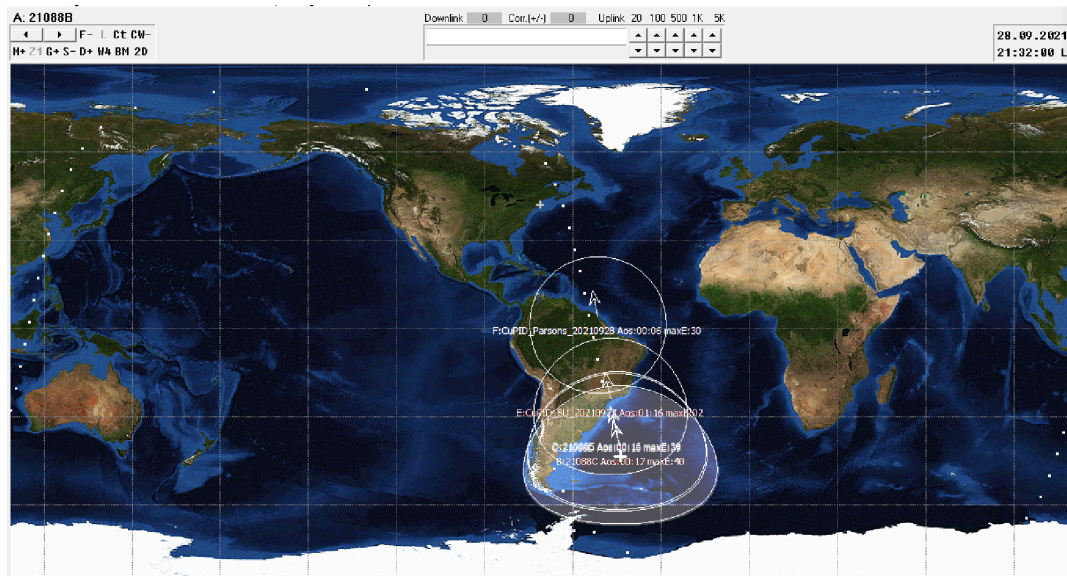
Figure 4: Computer ground track of potential TLE's for CuPID two days after launch.

Figure 4 shows the SatPC ² map of the possible CuPID locations shortly after launch. Although all are relatively in track, the sequence of them proved challenging for ground

A ground pass with multiple TLE's to track will have one satellite inside the RF beam, and multiple outside of it, leaving limited time to track each TLE. CuPID's ground station used two two yagi antennae to produce a beam width of about 30° and RF gain of 15 dBi. One antenna has a beam of about 60° and RF gain of 11.5 dBi.

One antenna was removed to open the beam width, at the cost of RF power. This wider beam width allowed for greater inaccuracies in pointing and TLE knowledge. After a few days, the TLE's matured from accurate radar measurements. In addition, some of the objects were claimed by other institutions. CuPID's TLE was well known after a week but did not respond to commanding.

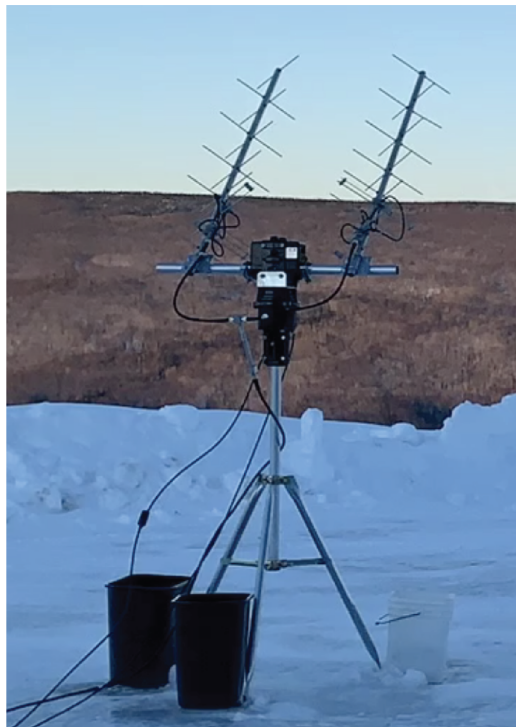
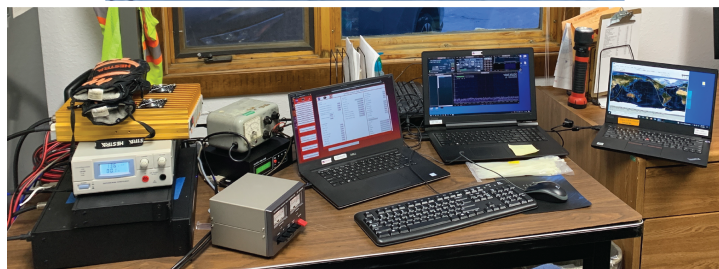
Figure 5: The mobile ground station during testing at Poker Flat in Jan. 2022. TOP: Tripod, rotator head and antennae. BOTTOM: Radio, RF amplifier, power supplies and laptop setup inside.

Solution/Result: Ground passes were conducted from Fairbanks, AK, with a mobile ground station to change the location, and increase the number of passes in a day.

In order to decrease the likelihood that this was the cause of no-contact, multiple sequential orbit ground passes needed to be conducted. At higher latitudes, the 97.6° orbit inclination allowed for up to 8 sequential orbit passes, although some were at elevations below 10°. The team developed a mobile ground station with a small antenna rotator head, tripod and some power supplies, see Figure 5. The rotator was a Yaesu G5500 controlled by an EA4TX ARS-USB rotator controller. This mobile station was brought to Poker Flat Research Range outside of Fairbanks, AK in January, 2022 for six days of testing. Seven consecutive passes were conducted on two out of the six days of operation from Poker Flat Research Range. Although multiple sequential passes were conducted, CuPID did not respond to commanding.

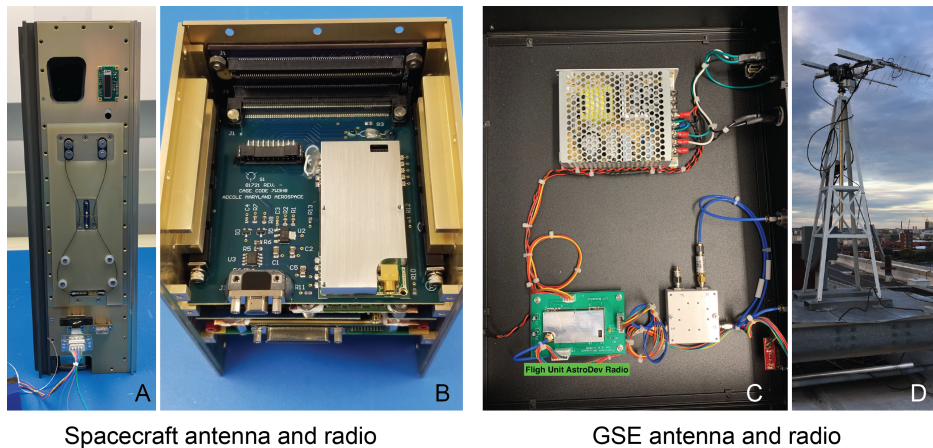
Figure 6: CuPID's spacecraft radio (left) and ground radio (right) systems. A: CuPID with stowed antenna. B: CuPID's LI-2 radio and board inside avionics. C: Ground radio system. D: Ground antenna.

CuPID's communication system was based around a matched pair of Astro-Dev LI-2 radios. One radio was configured for the CubeSat, the other for the ground station. Licensed to communicate at 400.5 MHz, the ground radio transmitted at 9,600 bits/s and received at 38.4 kbits/s. The spacecraft transmitted and received the opposite baud rates. The spacecraft's 1/4 wavelength deployable antenna (Figure 6A) was deployed by a burn wire resistor. The spacecraft flight computer was configured to communicate with the radio at 115,200 baud.

Discussions with the radio manufacturer days before the delivery of CuPID illuminated a possible cause of failure. The radio's default interface baud rate was 9,600, whereas the flight computer was configured to communicate with the radio at 115,200. On the ground, the radio was configured, and stored to communicate at 115,200 baud. Should the radio reset to default values (for example, from a single event upset), the flight computer had no means to determine and reset the baud rate to re-establish the interface.

Testing of the radio on the ground consistently showed an offset to the transmit frequency. Although configured at 400.5 MHz, the radio transmitted at 400.531 MHz. This was originally presented to the radio manufacturer in March of 2020, but was not answered until the discussion days before delivery of CuPID. The frequency offset was described as a signature of a mismatch between the firmware and hardware on the radio due to a version control setback from supply chain issues during manufacturing.
