Fault Localization in a Microfabricated Surface Ion Trap using Diamond Nitrogen-Vacancy Center Magnetometry

In this paper, we describe our work using a QDM to locate short-circuit faults in an ion trap chip, leading to the discovery of the root-cause explanation for these faults. We studied an ion trap chip of the Sandia Roadrunner design [20] with several short-circuit faults (electrode shorts to ground). Initial use of traditional test methods was unable to narrow down the root cause from candidates such as electrostatic discharge (ESD), scratches at the bond pads, scratches at the electrodes, conducting particles shorting the metal layers, and others. After imaging the magnetic fields from probe currents applied to the device, we found that every current path dissipated at a trench capacitor, indicating

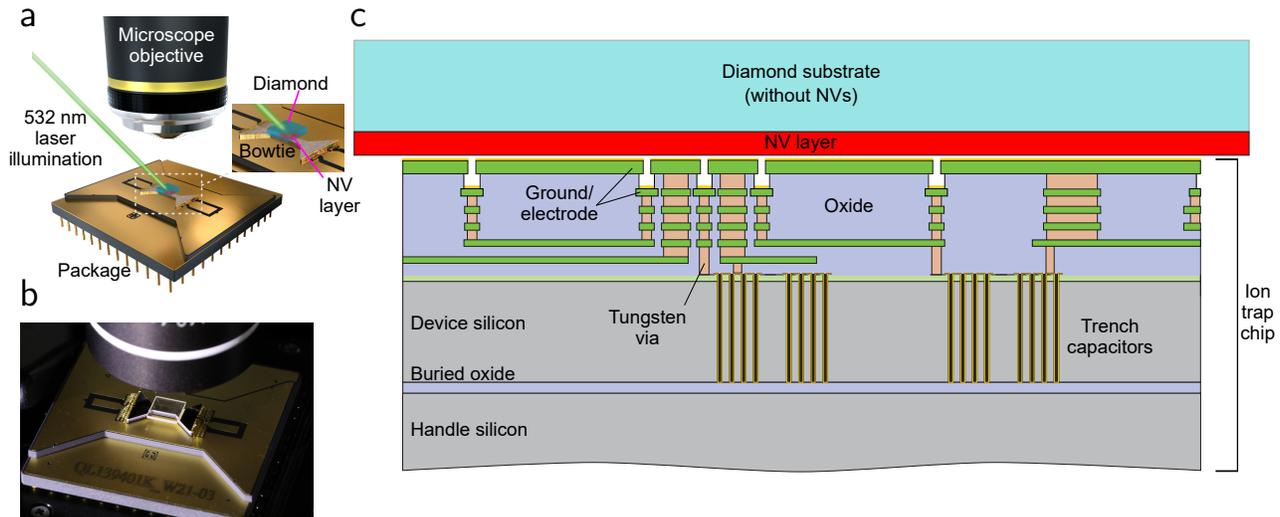
FIG. 1. (a) Schematic drawing of the diamond on top of an ion trap chip in a QDM setup. A 532 nm laser beam illuminates the NV layer, and the red NV fluorescence is collected by a microscope objective and imaged onto a camera with an optical microscope (not shown). (b) A photo of an example ion trap chip in a QDM setup. (c) Cross-section drawing of the Roadrunner ion trap chip, showing the metal and insulating layers, tungsten vias, trench capacitors, and the device and handle silicon. For the MFI experiments, the diamond sample (containing an NV layer) is mounted on top.

Our QDM setup is a home-built optical fluorescence microscope, with a kinematic sample stage to mount devices for MFI measurements. The ion trap chip was mounted in a zero insertion force (ZIF) electrical socket on the sample stage, through which a probe current (typically ± 20 mA) was applied to the ion trap chip. We placed a $4 \times 4 \times 0.5$ mm³ diamond sample with a 4 μm sheet of magnetically-sensitive NV centers on top of the device (Fig. 1). The NV electronic ground-state magnetic sublevels are sensitive to the magnetic field B_{111} along the N-V axis (the [111] crystallographic direction) through the Zeeman effect. This leads to the $m_s = 0$ to $m_s = \pm 1$ transition frequencies being shifted by $\pm\gamma B_{111}$, where $\gamma \approx 28$ GHz/T is the NV gyromagnetic ratio (Fig. 2a). We used 200-400 mW of 532 nm laser light to illuminate the NV layer from the side of the microscope objective, which pumps the NVs into the $m_s = 0$ sublevel. A resonant microwave field from a nearby wire loop (not shown in Fig. 1) transfers NV population from the $m_s = 0$ “bright state” to the $m_s = \pm 1$ “dark state” sublevels, reducing the NV fluorescence intensity. Scanning the microwave frequency across the NV resonance frequencies and imaging the NV fluorescence with the microscope, we collect an optically-detected magnetic resonance (ODMR) spectrum for each camera pixel (Fig. 2b). We fit the ODMR spectra for each pixel, extract the lineshape center frequencies, and obtain a resulting B_{111} map detected by the NV layer [9, 10].

We used a pair of permanent magnets (not shown in Fig. 1) to apply a 1.4 mT bias magnetic field along the

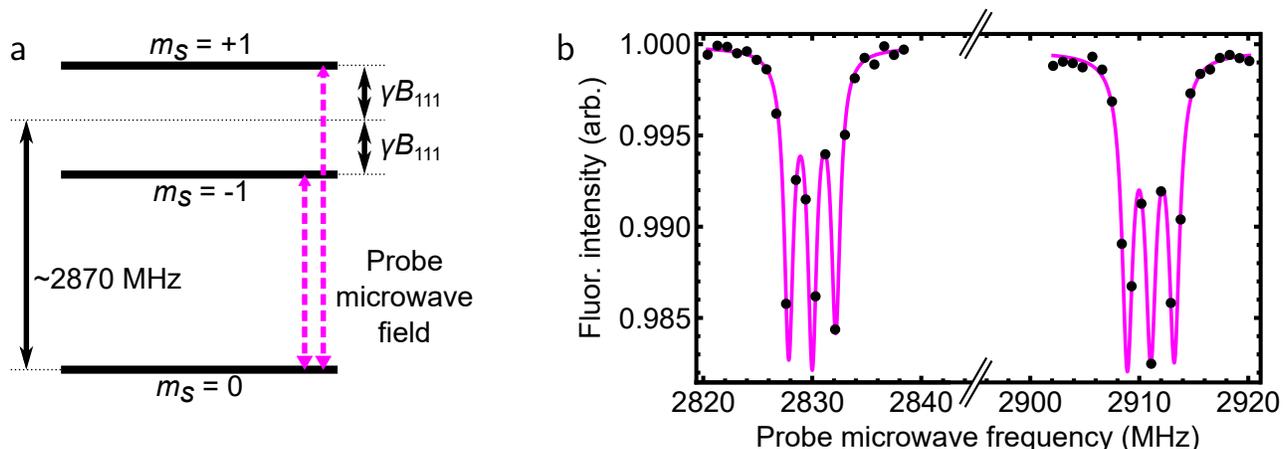
FIG. 2. (a) An energy-level drawing of the NV ground-state magnetic sublevels. Given a magnetic field B_{111} along the NV axis, the $m_s = \pm 1$ sublevels shift by $\pm\gamma B_{111}$ in frequency. (b) An example single-pixel ODMR spectrum. We fit each lineshape to extract its center frequency, which yields the measured B_{111} for that pixel. The lineshapes are split into three peaks, due to the NV ^{14}N hyperfine interaction.

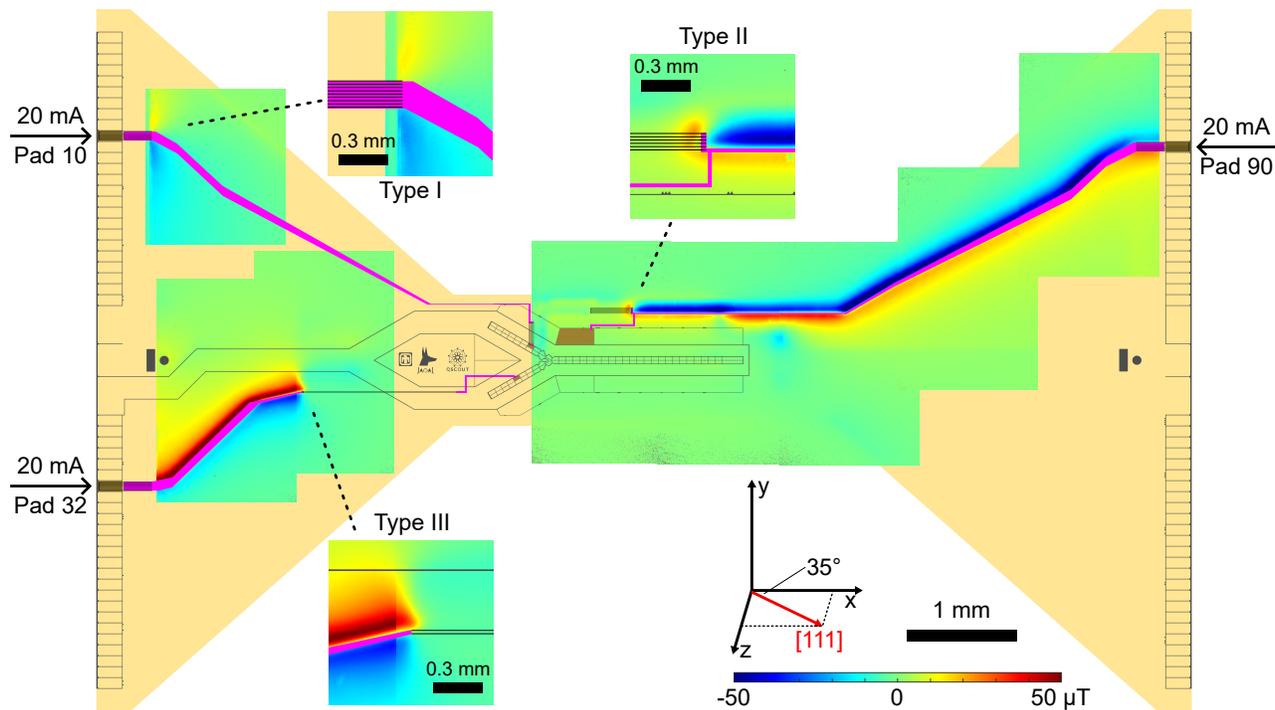
Figure 3 shows magnetic images from three faults, overlaid on the ion trap chip. The magnetic images show the applied probe currents traveling along internal traces (magenta) towards their respective electrodes (brown) before shorting to ground and dissipat-

FIG. 3. Magnetic field maps (measured along the NV [111] direction) for natural shorts in the ion trap chip, superimposed on the top metal layer. The magenta traces show the paths between the bond pads and the trapping-region electrodes, which the applied currents follow until they short to ground. We include three examples faults (one for each category): one near the bond pads (Pad 10), one in the center isthmus (Pad 90), and one at a capacitor bank (Pad 32). The insets show the $1 \times 1 \text{ mm}^2$ fault locations enlarged, indicating that the faults occur at trench capacitor edges (black).

ing. Measuring magnetic images for the nine faults, we found these faults fell into three categories:

- Type I: Five faults near the bond pads (e.g. Pad 10). These occur at trench capacitors (black) next to the electrodes, as illustrated by the inset.
- Type II: Three faults in the center isthmus (e.g. Pad 90). These occur at trench capacitors (black) in the center isthmus, as illustrated by the inset.
- Type III: One fault $\sim 2 \text{ mm}$ from the bond pads (Pad 32). This occurs at a trench capacitor bank (black) along the path between the bond pad and the electrode.

As indicated by the insets in Fig. 3, the locations where the probe currents dissipate to ground suggest that trench capacitors are the culprit. To further investigate this finding, we introduced intentional short-circuit faults into the device, then measured their corresponding magnetic field images.

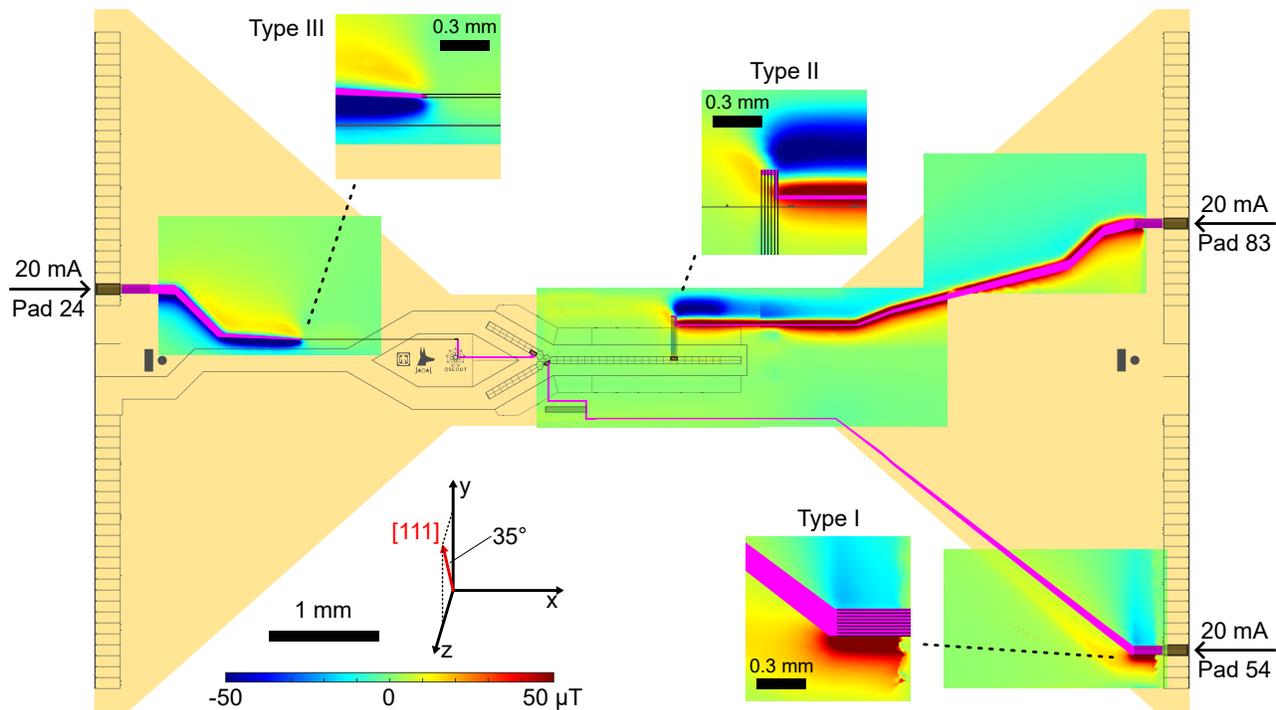
To validate the hypothesis that trench capacitors are the root-cause explanation for the faults, we overloaded several other capacitors (connected to previously intact pins), causing them to short to ground, then measured their magnetic images for comparison. As seen in Fig. 4, the capacitor-overload intentional-short magnetic images resemble those of the natural shorts, with Pads 54, 83, and 24 resembling faults of Types I, II, and III, respectively. The similarities between Fig. 3 and Fig. 4 supports the trench capacitor failure root-cause explanation.

FIG. 4. Magnetic field maps for intentionally overloaded capacitors in the ion trap chip, superimposed on the top metal layer. The magenta traces show the paths between the bond pads and the trapping-region electrodes, which the applied currents follow until they short to ground. We include three example faults (one for each category): one near the bond pads (Pad 54), one in center isthmus (Pad 83), and one at a capacitor bank (Pad 24). The similarities here to Fig. 3 supports the hypothesis that trench capacitors (black) are the culprit.

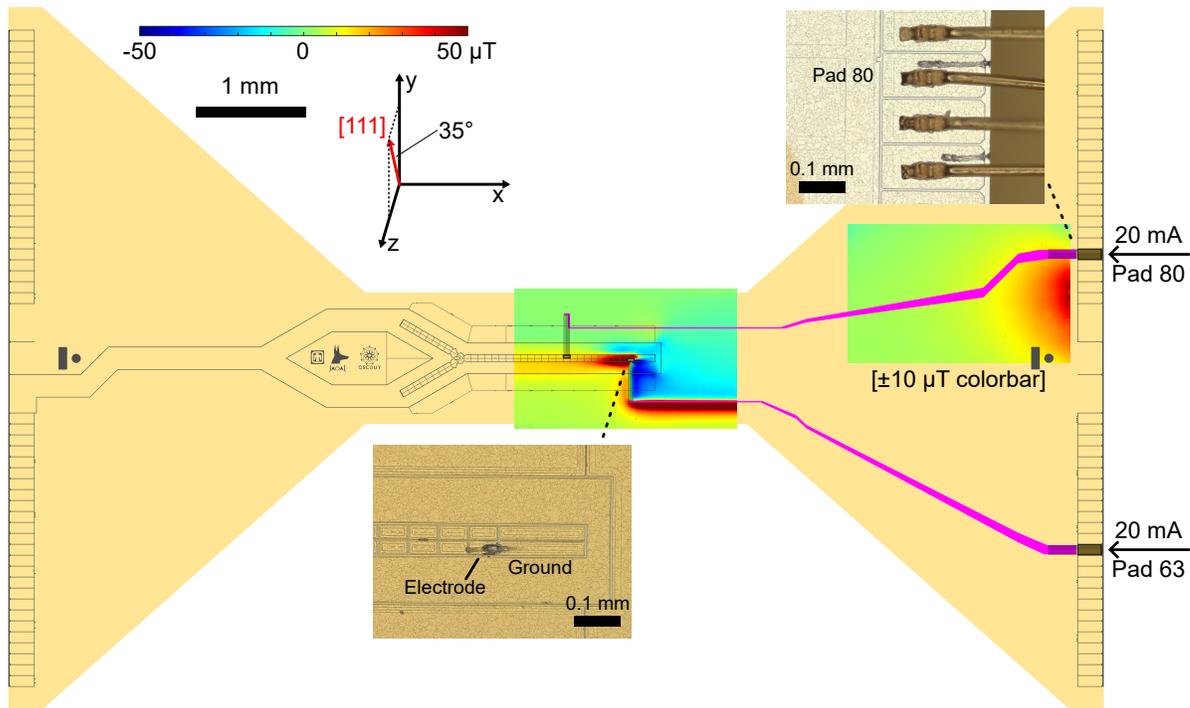
To rule out the other fault root-cause explanation possibilities, we also added additional faults by scratching the top metal layer with a probe tip (Fig. 5), again on previously intact pins. MFI above the bond pads was not attempted because of the bond wires in the way [13]. However, after scratching Pad 80, the resulting magnetic field map shows the fringe of a magnetic feature to the right of the field of view. This differs from the natural Type I faults, where current dissipates

more inland with stronger and more compact magnetic features. Conversely, for the scratched electrode in the center isthmus (connected to Pad 63), the probe current traces the entire path before dissipating at the electrode itself. This differs from the natural Type II faults, where the current dissipates before reaching the electrode. Since there are no bond pads or electrodes ~ 2 mm from the bond pads, Type III faults are unlikely to be reproduced by these intentional scratches. Finally, we note that scratches on the top metal layer should be visible with an optical microscope, while shorts in a trench capacitor (in the deeper layers) should be invisible. While it is difficult to create intentional shorts to ground due to conducting particles between the metal layers, these hypothetical shorts should occur in random locations, which is inconsistent with the fault/trench capacitor co-location. These arguments provide a convincing case that trench capacitor faults are responsible for the shorts in this ion trap chip.

FIG. 5. Magnetic field maps for intentional scratches on the top metal layer of the ion trap chip, superimposed on the top metal layer. The magenta traces show the paths between the bond pads and the trapping-region electrodes, which the applied currents follow until they short to ground. We include two examples: a bond-pad scratch (Pad 80, shown with a zoomed-in $\pm 10 \mu\text{T}$ colorbar) and an electrode scratch (Pad 63). The inset photos show the scratches, including one on Pad 78 that was not measured. Comparing to the characteristics seen in Fig. 3, these magnetic images indicate that the natural faults were probably not caused by scratches on the top metal layer.

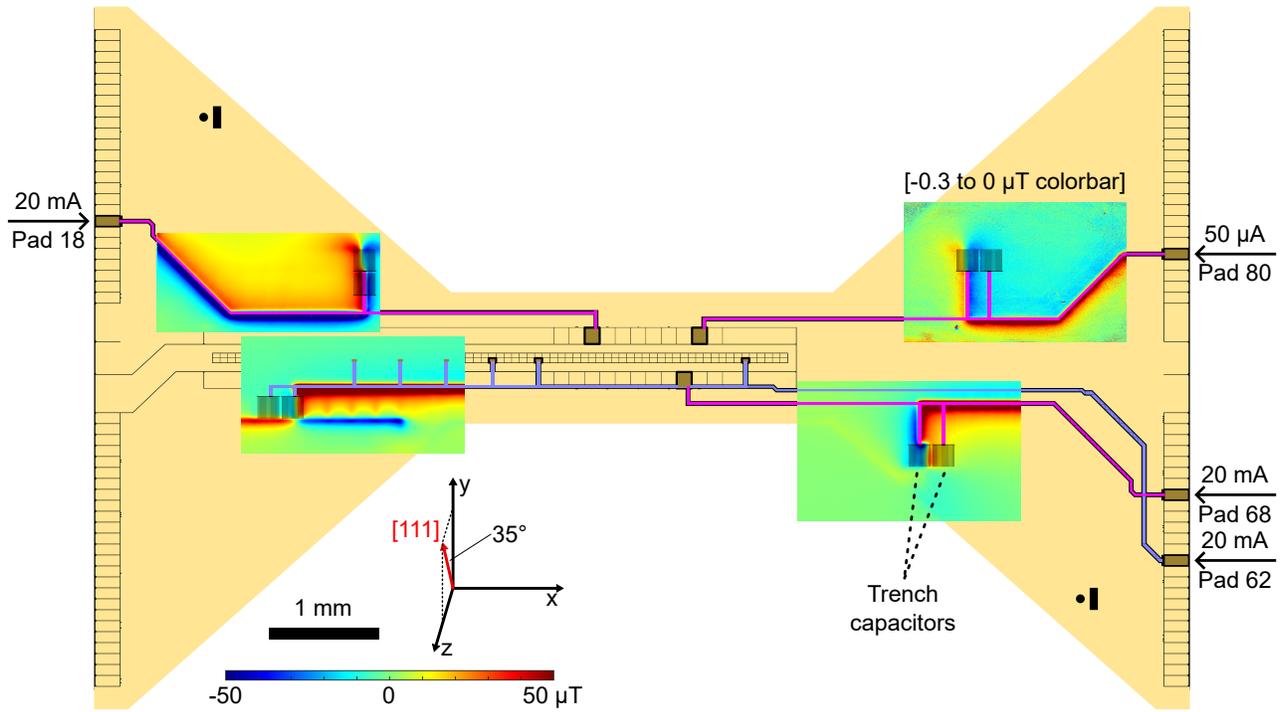
Figure S1 shows magnetic images for three low-resistance shorts (Pads 18, 62, and 68) and a high-resistance short (Pad 80). We applied a $\pm 50\ \mu\text{A}$ test current for the high-resistance short (instead of $\pm 20\ \text{mA}$) to avoid the possibility of arcing through air. As seen in the overlays, all of the shorts are located at trench capacitors, which appear as black squares. This suggests that the trench capacitor faults persist over multiple ion trap chip designs and fabrication runs (meaning there could be a possible common underlying root-cause explanation), and that trench capacitor faults can manifest as high-resistance shorts as well.

Supplementary Figure S1. Magnetic image of current in three low-resistance shorts (Pads 18, 62, and 68) and high-resistance short (Pad 80) of a Perigrine trap. The overlays show shorts to ground at trench capacitors, which is consistent with what was observed in the Roadrunner ion trap chip in the main text.

Measuring a second ion trap chip of a different design (a Peregrine trap [21]) with natural shorts spanning $\sim 100 \Omega$ to $\sim 1 \text{ M}\Omega$, we also found that its faults were also located at its trench capacitors [23]. Since two different ion trap chip designs made in different fabrication runs having different short resistances *have the same fault root-cause explanations*, this suggests a possible common underlying mechanism. Furthermore, the combination of these results informs future ion trap chip designs to either avoid trench capacitors (replacing them with external chiplet trench capacitors that can be tested separately before assembly) or to spend additional effort troubleshooting the fabrication process. Overall, these results inform future designs and fabrication attempts, enabling a more robust fabrication process for better yield.

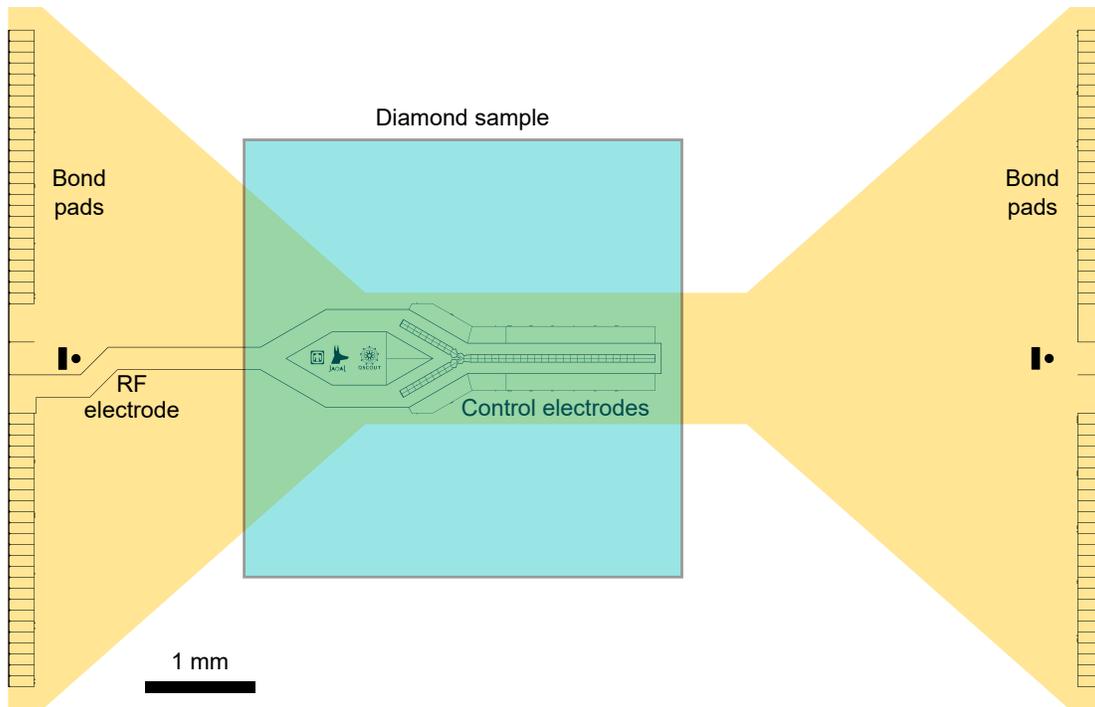
Figure S2 shows the Roadrunner ion trap chip top metal layer, with a $4 \times 4\ \text{mm}^2$ diamond sample for scale.

Supplementary Figure S2. The Roadrunner bowtie top metal layer, showing the bond pads, control electrodes, and RF electrode. The diamond sample is placed on top for MFI experiments, shown here at an example position on the bowtie.
