Radiation Tolerance of the LHCb Outer Tracker: in the Lab and in the Forward Region at the LHC ¹

Abstract

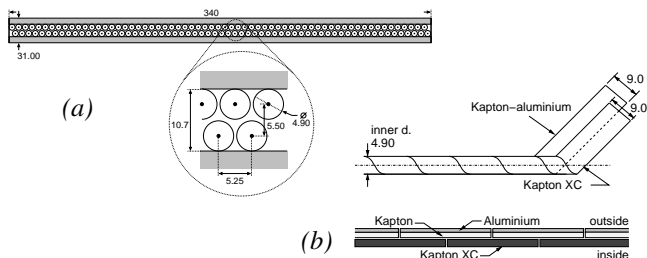
Figure 1: (a) Module cross section. (b) The straws were wound using two foils, kapton-XC and a laminate of kapton and aluminium.

The straw tubes were 2.4 m long and 4.9 mm in diameter, and were filled with a gas mixture of Ar(70%)-CO₂(30%). The anode wire was made of 25µm gold plated tungsten wire, whereas

the cathode consisted of an inner foil of 40 µm electrically conducting carbon doped Kapton-XC and an outer foil of 25 µm Kapton-XC with 12.5 µm aluminium. The straws were glued to sandwich panels with 120 µm carbon-fibre skins and a 10 mm Rohacell core. Finally, the panels were joined by 400 µm thick carbon fibre sidewalls, resulting in a standalone detector module. A sketch of the module layout is shown in Fig. 1. The panels and the side walls were covered by a laminated foil of 25 µm Kapton and 12.5 µm aluminium to guarantee gas-tightness of the box and to provide a closed Faraday cage. Spacers at the ends of the module separated the two panels apart and pass the gas to the module. All glueing steps were performed using Araldite AY103-1 with the hardener HY991, cured at room temperature. To enhance the viscosity silica bubbles are added.

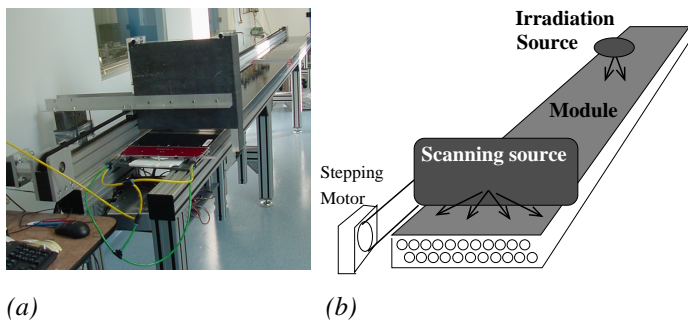
Figure 2: (a) Photograph of the irradiation setup. The scanning source with which the performance before and after irradiation is measured is also shown. (b) Schematic view of the irradiation and scanning setup.

Irradiation tests were carried out on a small selection of final modules using a 2 mCi ^{90}Sr source. The high voltage on the anode wires was set at 1600 V and the gas flow (with a mixture of 70/30 Ar/ CO_2) was 20 l/hr, corresponding to approximately one volume exchange per hour. The source was collimated by a hole with a diameter of 6 mm at a distance of 5 mm from the module, resulting in an irradiated area of approximately $6 \times 6 \text{ cm}^2$.

Before and after irradiation the response of each wire in the module was checked with a 20 mCi ^{90}Sr source. The full module width was irradiated in steps of 1 cm along the length and the corresponding wire current was measured and recorded. The setup is depicted in Fig. 2. A typical example of the gain loss after an irradiation of 20 hours is shown in Fig. 3b. The gain loss was quantified by comparing the 2-dimensional current profile before and after irradiation, by means of dividing the two current profiles. The observed gain loss shows several distinguishing features:

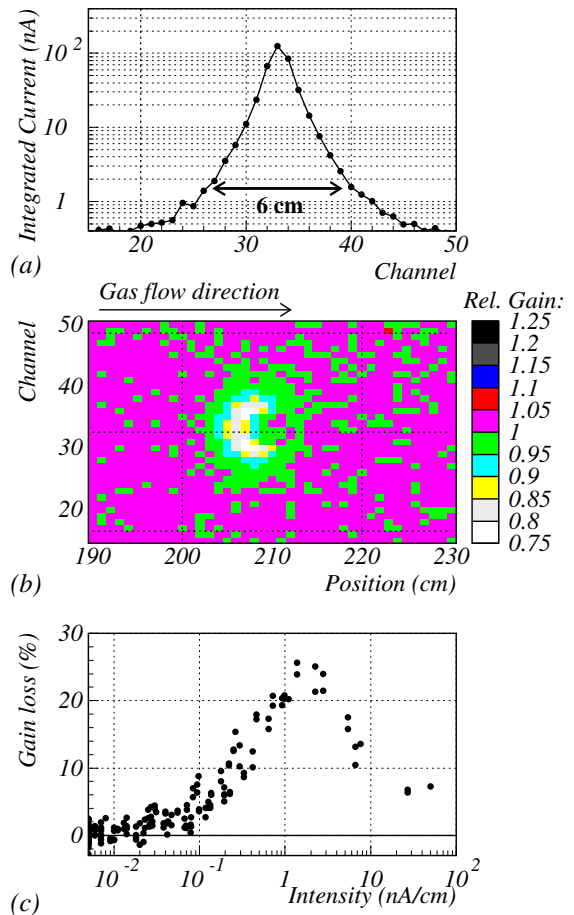
Figure 3: (a) The integrated current per wire during irradiation. (b) The ratio of two ^{90}Sr scans before and after irradiation shows the relative gain loss after an irradiation of 20 hours. The source was centered on channel 32 on position 208cm. (c) The gain loss is shown for each measurement (pixel of $0.5 \times 1 \text{ cm}^2$) as a function of the source intensity in that pixel. The gain loss was highest at moderate intensity, around 2 nA/cm .

- The gain loss was not proportional to the source intensity: directly under the source the gain loss was less severe compared to the periphery. The gain loss for each measurement (corresponding to a pixel of $0.5 \times 1 \text{ cm}^2$) is shown as a function of the irradiation intensity in Fig. 3c. This dependency was unchanged when the module was irradiated at different values of the high voltage, or with different source strengths.
- The gain loss occurred mainly upstream the source position, and was worse for larger gas flow. Presumably due to the creation of ozone in the avalanche region, the gain loss was prevented downstream, see Section 4.2.
- The gain loss was large, upto 25% for an integrated dose of 0.1 mC/cm at an intensity of 2 nA/cm .

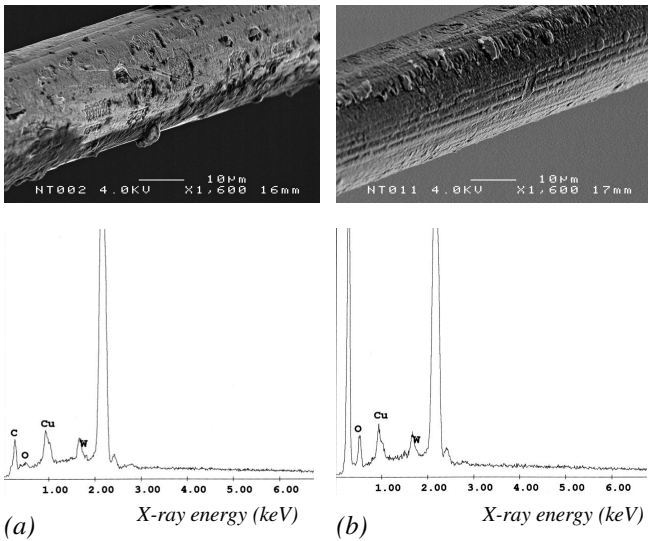
Figure 4: (a) A SEM picture and EDX spectrum is shown for a sample of unirradiated outer tracker anode wire. (b) The same for an irradiated wire sample. A layer with a wax-like structure is observed, and a large amount of carbon is seen in the EDX-spectrum, indicating the presence of carbon-hydrates.

Samples of the anode wire were removed from an irradiated module for inspection with a sampling electron microscope (SEM). An irradiated wire with observed gain loss as described in the previous section, was compared with an unirradiated wire. An electrically insulating coating was found on the irradiated wire, see Fig. 4. The deposits were analyzed by means of energy-dispersive X-ray spectroscopy (EDX) which revealed the presence of carbon and indirectly that of hydrogen.

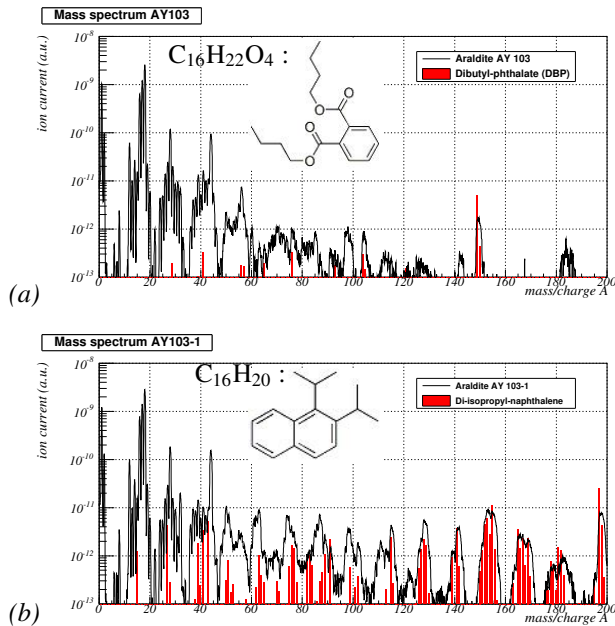
Figure 5: (a) In the mass spectrum of AY103 traces of the plastifier dibutyl-phthalate (CAS nr. 84-74-2) are identified. (b) In the mass spectrum of AY103-1 traces of the plastifier di-isopropyl-naphthalene (CAS nr. 38640-62-9) are identified. The molecular structure of the plastifiers is also shown.

The outgassing of AY103 and AY103-1 was investigated by placing cured glue samples in a vacuum chamber. The residual gas emitted by the glue was analyzed with a quadrupole mass spectrometer. The quadrupole mass filter sorts the produced ions according to their mass/charge ratio up to a value of 200 u/e . The resulting spectra are shown in Fig. 5. The traces of DBP and di-isopropyl-naphthalene are identified in the mass spectra of AY103 and AY103-1, respectively.

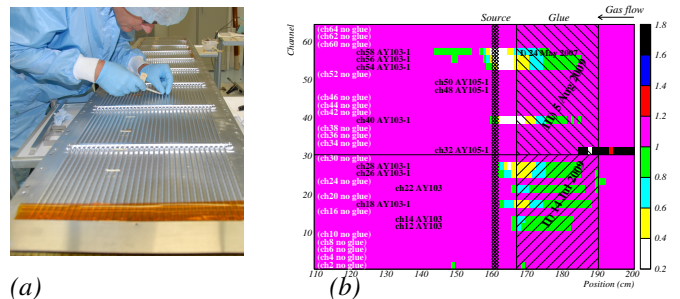
Figure 6: (a) Photograph of the openable module during glue injection into a straw using a syringe. (b) The ratio of the response before and after the first irradiation in August 2009 is shown for the full module. The type of injected glue is indicated per straw. The glue was injected between positions 167 cm and 190 cm on three different dates, as indicated in the figure. The source illuminated the module over the full width at position 161 cm. The gas flows from right to left.

In total seven straws were injected with AY103-1, three straws with AY103 and three straws with AY105-1 (Fig. 6a). The remaining 19 straws do not contain glue and are used as reference.

The summary of all results for the 32 straws irradiated in the first session is given in Fig. 6b, that shows the ratio of the response before and after irradiation. Different straws were injected with glue at three different dates, (1 week, 4 weeks and

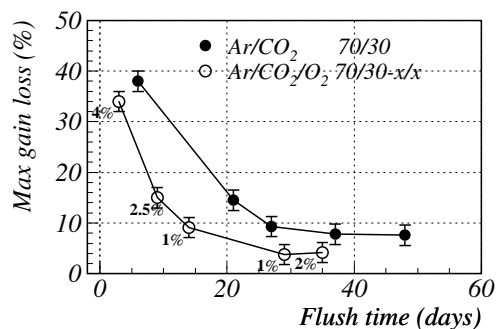
Figure 7: The maximum gain loss decreased as a function of flushing time. Also, the aging rate was smaller when a few percent of oxygen is added to the gas mixture, varying between 1% and 4%. The improvement did not strongly depend on the exact amount of oxygen.

Given the fact that the araldite AY103-1 glue used in construction was a necessary ingredient to cause the gain loss in the OT detector, long term flushing was expected to transport away the vapours originating from outgassing of the glue. Indeed, Fig. 7 shows the maximum gain loss caused by an irradiation of 20hrs as a function of flush time. The aging rate decreased significantly. All OT modules had been flushed continuously since the completion of installation in the LHCb experiment in Spring 2007.

Oxygen has been used in other HEP experiments in the context of irradiation damage and gas detectors [? ?]. Tests with the OT show that the aging rate for gas mixtures with O_2 is reduced by approximately a factor two. The improvement in aging rate with flushing time was similar for the nominal gas mixture Ar/CO_2 70/30, as compared to the gas mixture with a few percent O_2 added, see Fig. 7. The amount of oxygen had

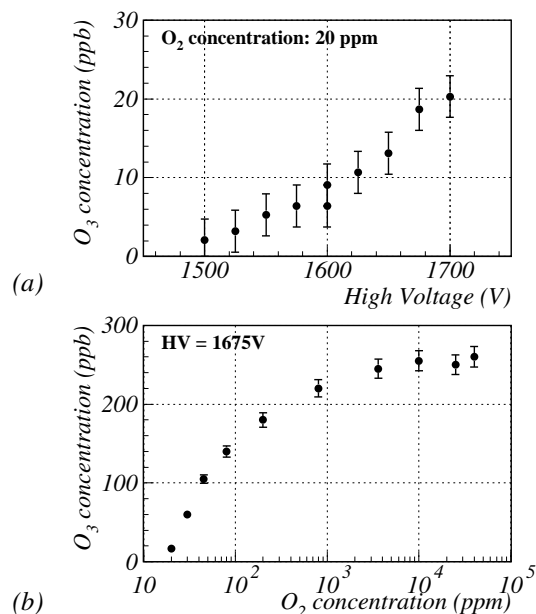
Figure 8: (a) The ozone concentration increased for larger values of the high voltage, i.e. for larger amplification, indicating that ozone was produced in the avalanche. (b) The ozone concentration as a function of oxygen concentration. Above 1% O_2 the ozone concentration was constant.

A sensitive ozone (O_3) meter had been placed at the gas outlet during irradiation tests of OT modules. The ozone concentration increased with increased high voltage (Fig. 8a), indicating that ozone was formed in the avalanche region. The production of ozone under the source was presumably the reason that

The concentration of O_3 had also been determined for various oxygen concentrations, see Fig. 8b. For increasing oxygen concentration, larger amount of ozone had been measured, which might explain the beneficial effect of oxygen on the aging rate. Above 1% of oxygen, the ozone concentration did not increase, supporting the observation that no difference in the aging rate was observed between 1% and 4% O_2 .

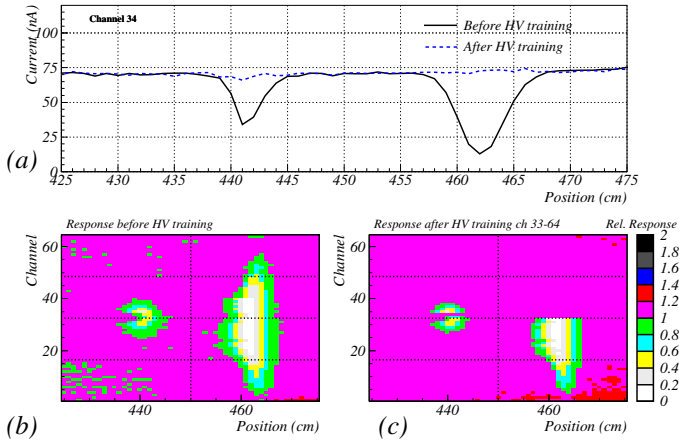
Figure 9: (a) The signal response is shown for one channel before and after applying a large positive high voltage of 1940 V. The signal decrease around 441 cm and 462 cm is due to gain loss induced by irradiation tests. (b) The signal response is shown for all 64 channels before the high-voltage treatment. (c) The signal response is shown for all 64 channels after applying a high voltage of 1940 V to channels 33-64. The full signal gain is recovered in most places.

Once the detector suffered from gain loss caused by the irradiation, the insulating deposits could be removed by applying an high voltage at elevated values. Applying a reverse bias around -1450 V leads to fluctuating large dark currents above 1 μA . After a period of 24 hrs the gain was recovered. Similarly, a positive bias between 1850 V and 1920 V leads to dark currents of about 10 μA per wire. The gain was recovered in most cases after 20 hours. The microscopic mechanism was unclear, and could have been related to plasma sputtering of the wire surface or elevated temperatures at the location of the discharges.
