Cyclic behavior of masonry barrel vaults strengthened through Composite Reinforced Mortar, considering the role of the connection with the abutments

Ingrid Boem^{a*} and Natalino Gattesco^a

^aDepartment of Engineering and Architecture, University of Trieste, p.le Europa 1, 34127, Trieste, Italy

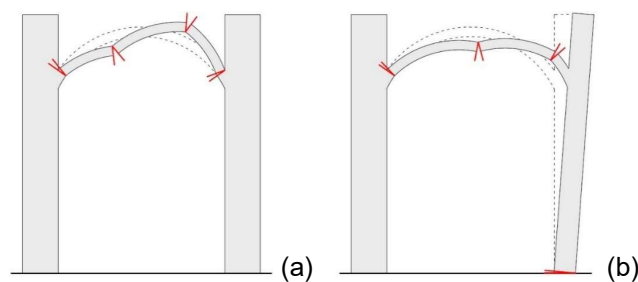
Figure 1. Typical four-hinges collapse mechanism of the masonry arch system (a) on fixed abutments or (b) with moving support.

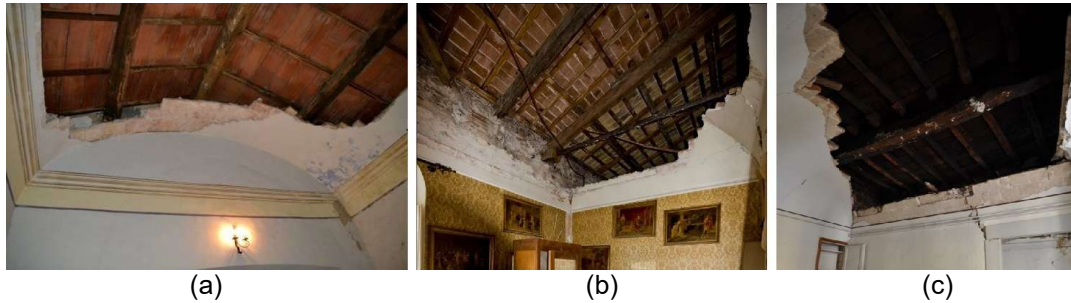
Figure 2. The failure of masonry vaults occurred during the 2016 earthquake in Central Italy, (a) in the St. Egidio's Church in Guardea [2] and (b)-(c) in some residential buildings (ph. courtesy of prof. A. Borri, University of Perugia).

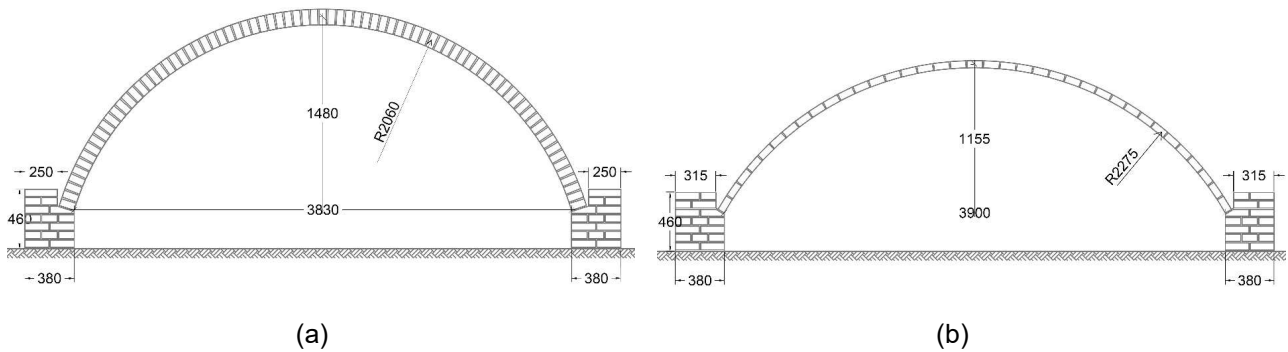
Figure 3: Main geometric characteristics of the vault samples (a) with bricks arranged in running bond pattern or (b) with bricks laid *in folio*.

- the vaults of the former group (identified with prefix “v”) were made of bricks arranged in a running bond pattern and had a rise-radius ratio $f/r = 0.75$, radius $r = 2060$ mm, span $s = 3830$ mm and thickness $t = 120$ mm (Figure 3a);
- the latter group (prefix “vt”) concerned brick *in folio* vaults with $f/r = 0.5$, $r = 2275$ mm, $s = 3900$ mm and $t = 55$ mm (Figure 3b).

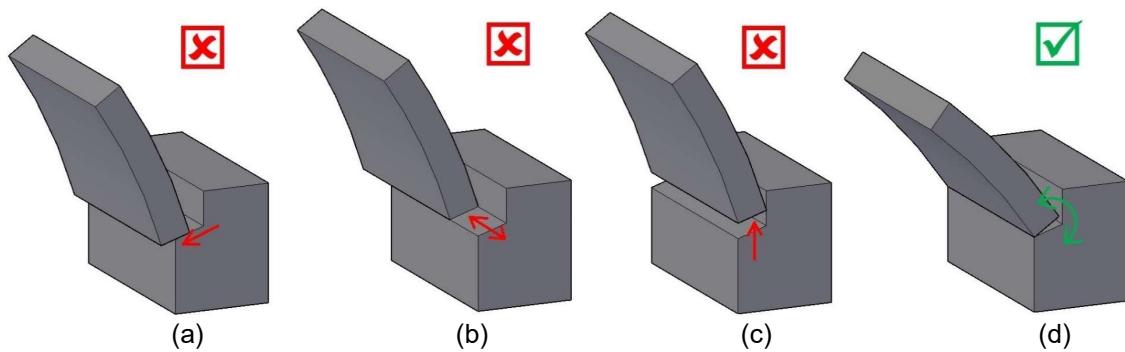
Figure 4: Requirements for the design of the connection of the reinforced vaults with the abutments: contrast the sliding at the skewbacks in the (a) transversal and (b) longitudinal direction and (c) the uplift; (d) permit some rotation.

The specific requirements for the design of the connection of the reinforced vaults with the abutments are individuated in Figure 4: to guarantee an adequate support, sliding in both the transversal (Figure 4a) and in the longitudinal direction (Figure 4b) has to be prevented, as well as the uplift (Figure 4c). However, for the intervention optimization, some rotation at the skewback section should be allowed: this permits the vault to deform significantly and to dissipate energy through the widespread cracking of the CRM layer.

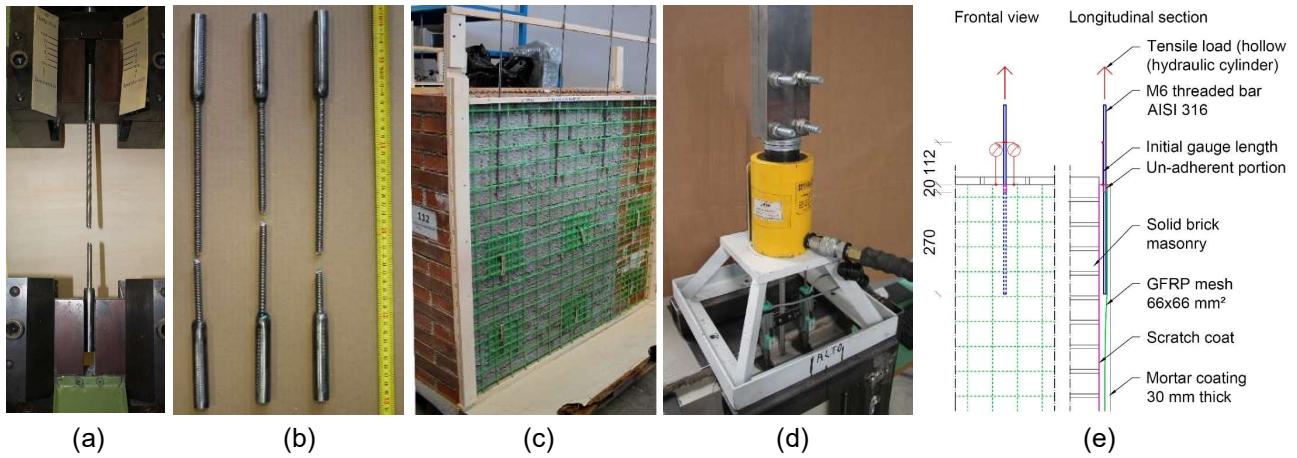
Figure 5. Characterization of M6 stainless steel threaded bars: (a, b) tensile tests and (c, d, e) pull-out tests.

considered (net cross section 20.1 mm²). The tensile characterization tests performed on three samples [34] (Figure 5.a-b) provided an approximately elastic-perfectly plastic behavior (dotted lines curves in Figure 6), with mean axial stiffness $EA_b = 3417$ kN (Cov. 13%) and resistance $T_b = 16.4$ kN (Cov. 1.0%). Moreover, to exploit the ductility of the steel bars, allowing some rotation at the vaults skewbacks (Figure 4d), their resistance has to be lower than that of the GFRP wires (which, on the contrary, have a brittle behavior). Thus, considering a GFRP grid pitch of 66 mm with a tensile strength of 4.49 kN for the single GFRP wire (Table 3), three M6 bars were introduced at both skewbacks (global tensile strength of the bars $3 * 16.4$ kN = 49 kN < 52.4 kN = 4.49 kN * 770 mm / 66 mm). Obviously, to allow the bars to yield, it is necessary to guarantee an adequate bond length. Pull-out tests were performed to evaluate the behavior of M6 bars embedded in a 30 mm thick CRM layer applied on a masonry wall (Figure 5c-e). The load, T , was applied by a hand pump through a hollow hydraulic cylinder (200 kN capacity, 50 mm stroke) equipped with a pressure transducer. The displacement between the bar and the mortar coating edge, Δl , was monitored by two displacement transducers (stroke 50 mm); the initial measurement base length (the free length from the jacketing) was 112 mm. The load-displacement graphs of the pull-out tests referred to a bond length equal to 270 mm (45 times the bar nominal diameter) are plotted in Figure 6, in comparison with those obtained from the tensile tests, in which the initial gauge length was the same. The two sets of curves overlapped in the first part of the tests, but then gradually diverged from about 5-6kN, likely due to the progressive detachment of the bar from the mortar. A sudden load decrease then occurred as the bar, once completely detached from the mortar, was extracted. The pull-out tests attained to a mean load value of 15.2 kN (Cov. 3.2%), which resulted very close to yielding strength of the bar (Figure 6). It can thus be deduced that the provided bond length is approximately the limit value to be ensured. It was therefore decided, for the vault samples, to set the bond length to 320 mm (50 times the bar nominal diameter) and to apply an end nut to the bar so to provide further residual contrast to its extraction from the mortar.

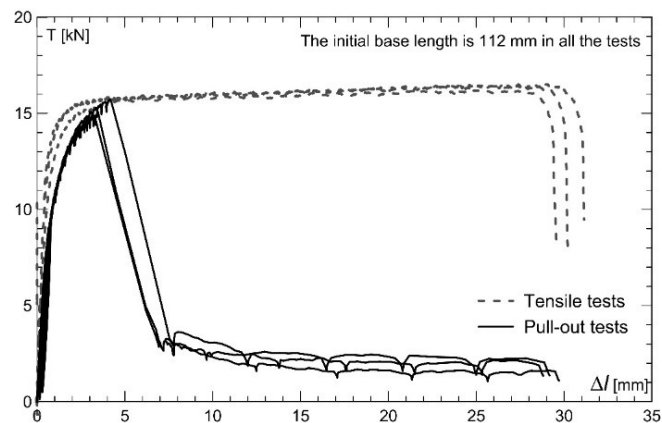
Figure 6. Load-displacement graphs of M6 stainless steel threaded bars subjected to tensile tests (dotted lines) and to pull-out tests from CRM layer, with bond length 270 mm (solid lines).

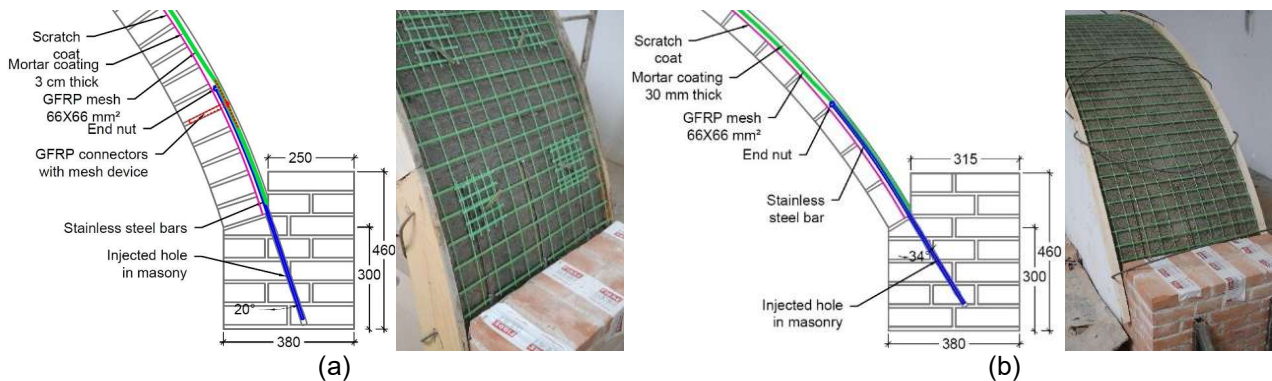
Figure 7. Abutments configuration, in case of CRM reinforcement applied at the extrados: samples (a) vRE and (b) vtRE.

The detail of the skewback configuration for the vaults reinforced at the extrados is reported in Figure 7, for both the 120 mm and the 55 mm thick samples. Each bar was injected in the masonry abutment with tixotropic epoxy resin (300 mm bond length) and embedded in the mortar coating (320 mm bond length). To be noted that the GFRP mesh is placed above the bars, to better counteract the possible mortar splitting (the bonding of the steel bars is guaranteed by the indentation of the threads in the mortar, which causes tensile stresses

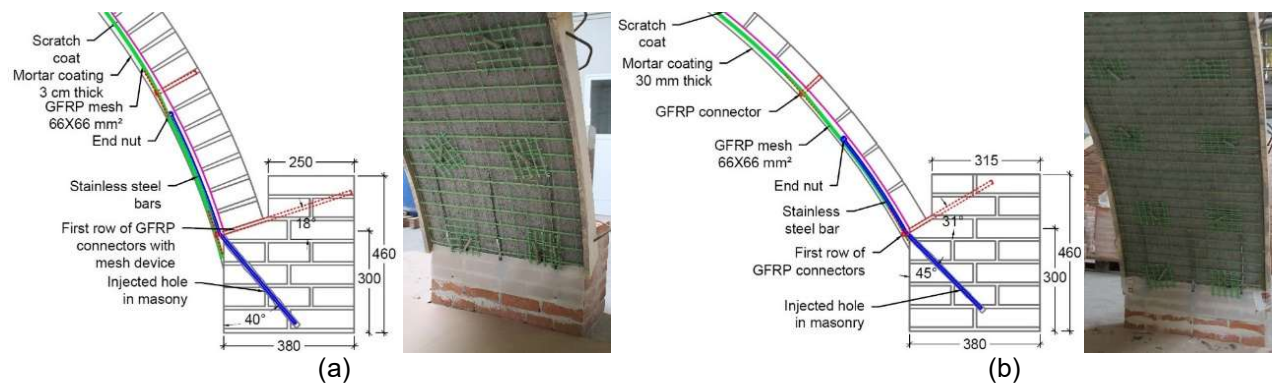
Figure 8. Abutments configuration, in case of CRM reinforcement applied at the intrados: samples (a) vRI and (b) vtRI.

Also the configurations with the CRM reinforcement applied at the intrados were provided with 3 M6 steel bars at each skewback, preventing longitudinal sliding and uplift (Figure 4b-c) and permitting some rotation (Figure 4d). Moreover, it was necessary to introduce further elements to prevent the inward sliding (Figure 4a), as it is not adequate to rely only on the dowel effect of these bars. In particular, the transversal L-shape GFRP connectors closest to skewback sections were deeply injected in the masonry abutments (Figure 8); two GFRP connectors at each skewback section thus resulted. Two pull-out tests were carried out to evaluate the

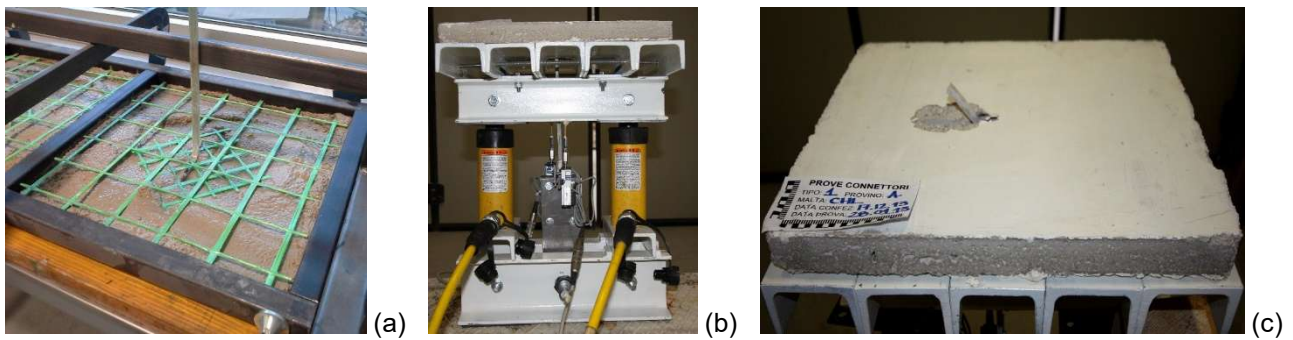
Figure 9. Extraction tests of the GFRP connectors from the CRM layer: (a) sample construction, (b) test setup and (c) example of the configuration at the end of the test

behavior of these elements: the samples consisted in a 380x380x30 mm³ mortar slab with the GFRP mesh and a single L-shaped GFRP connector embedded; also the 33 x 33 mm² piece of GFRP mesh was utilized (Figure 9a). The sample was placed over a rigid flat support and the quasi-static extraction force was applied to the free connector edge through two hydraulic jacks (150 kN, 101 mm stroke) connected in parallel and activated by a hand pump (Figure 9b). During the tests, as the load increased, a mortar splinter cracked close to the connector embedded edge (Figure 9c). Then the load was almost maintained since the connector was gradually extracted from the slab. The average failure tensile load was $T_c = 5.6$ kN (Cov. 12.8%). So, at the skewback section of the vaults reinforced at the intrados, it was awaited an inward shear resistance of about 11.2 kN, due to the presence of 2 GFRP connectors (= 2·5.6 kN).

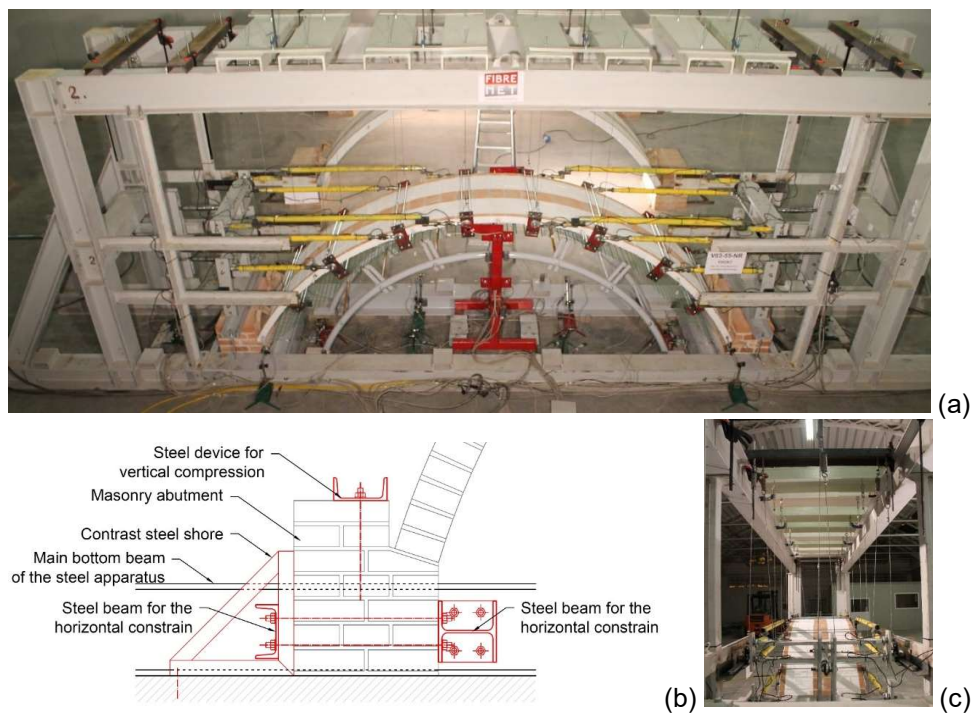
Figure 10: Test setup for the vaults: (a) global view and details (b) of the abutment arrangement and (c) of the hanging system

The test setup (Figure 10a) was aimed to reproduce a transversal load pattern proportional to the vault mass so to represent the effect of the horizontal inertial forces induced by an earthquake on masonry vaults lying on fixed abutments and supporting their own weight only. Quasi-static cyclic tests were carried out: forces of identical magnitude and direction were applied at eight different points along the vault length, equally spaced, through pinned frame systems installed at the two halves of the vault and supported by sliding guides. The horizontal load was modulated through two hydraulic actuators connected in parallel, applied at the opposite sides of the contrast structure and activated by a hand pump. Flow control valves permitted loading, unloading and the inversion of the loading direction. The steel apparatus was designed adequately stiff, so to assume negligible its deformation in respect to that of the sample; loading cells and potentiometer transducers allowed the real-time monitoring of the load/displacement story. The horizontal displacements of the masonry abutments were constrained through transversal steel beams bolted to the main apparatus (Figure 10b). Moreover, a vertical pre-compression was applied, reproducing the axial load transmitted by the upper wall and avoiding the abutment failure for horizontal shear. Thin layers of gypsum were applied along the masonry surface and the front faces, so to facilitate to view the occurrence of the cracks during testing.

More details were reported in [15], as the test apparatus and method were the same as those adopted in previous tests. However, it is observed that, due to the thinness of the brick *in folio* vaults, the vertical forces transmitted by the loading arms, induced by their weight, can modify appreciably the vault stress state. Thus, in this new testing campaign, the loading arms were hanged on the upper beams of the contrast frame through steel cords equipped with a preloaded tension spring at the upper end (Figure 10b). The initial elongation of

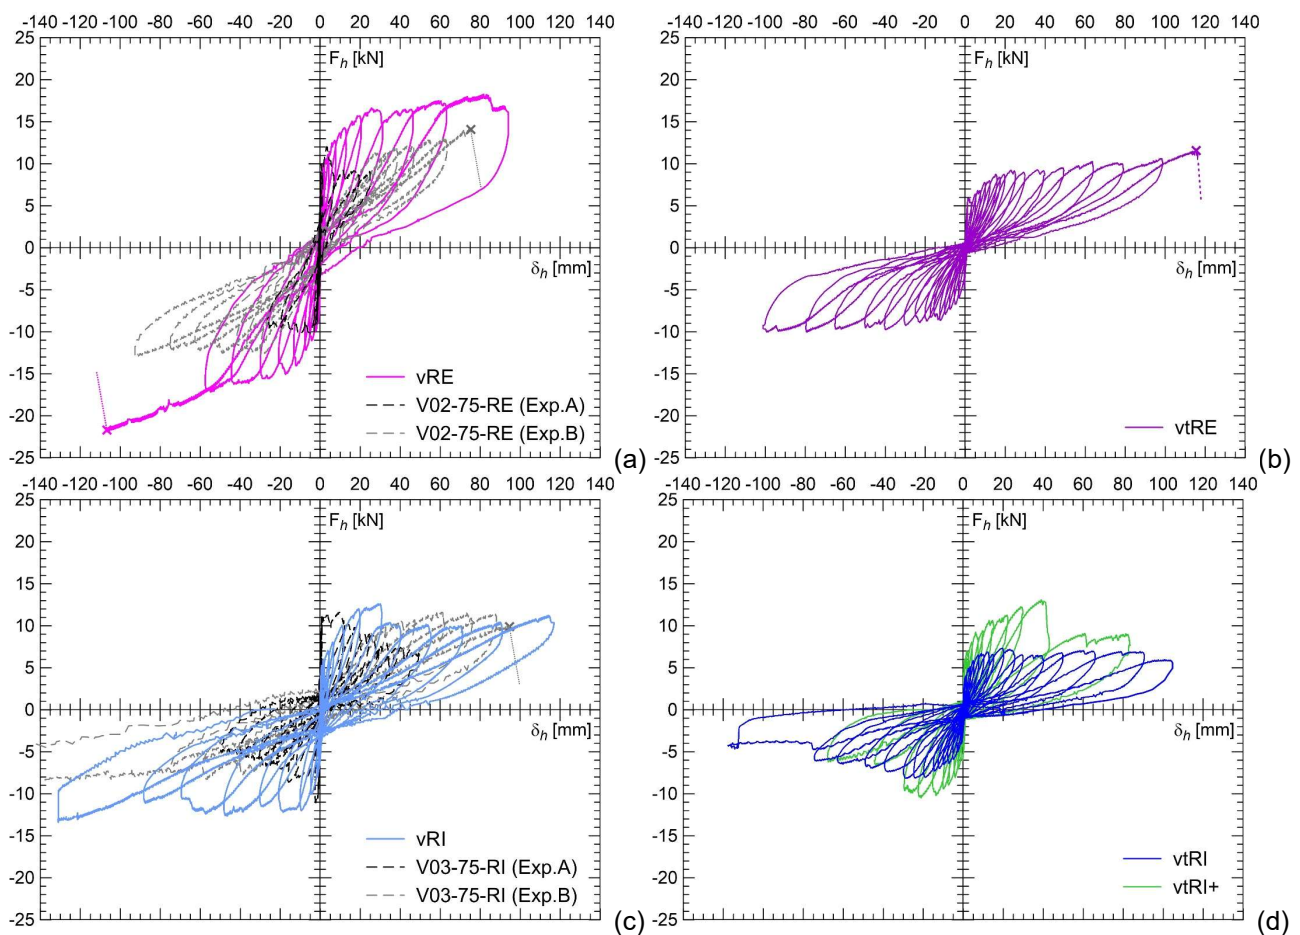
Figure 11. Capacity curves of samples (a) vRE, (b) vtRE, (c) vRI, (d) vtRI and vtRI+. The capacity curves of the previous experimental tests on samples V02-75-RE and V03-75-RI are also reported in (a) and (c), for comparison.

The performances of the CRM reinforced vaults are reported in Figure 11a-d, as capacity curves expressed in terms of global horizontal load, F_h , against the mean horizontal displacement monitored at keystone δ_h .

To allow comparisons, also the results of some previous tests, detailed and described in [15], are reported in Figure 11a, c: in sample V02-75-RE the CRM reinforcement was applied at the extrados, in V03-75-RI at the intrados. The samples had the same geometric and mechanic characteristics of type “v” vaults, but were built of fixed steel supports and the CRM reinforcement was interrupted in correspondence of the skewback sections (Figure 16a, c). In the first part of the tests on strengthened samples (dotted black curves “Exp.A” in Figure 11a, c), just after the bending cracking at the vault skewbacks, some slide at the skewbacks occurred, inducing a significant resistance decrease. In fact, the high lateral load produced a consistent shear action at the vault skewbacks, but reduced significantly the compression at one skewback (and, thus, its shear resistance, mainly due to friction).

(dotted grey curve “Exp.B” in Figure 11c). The GFRP mesh failure at an haunch section was attained at $F_{h,max} = 11.6$ kN ($\delta_{h,u} = 92.9$ mm).

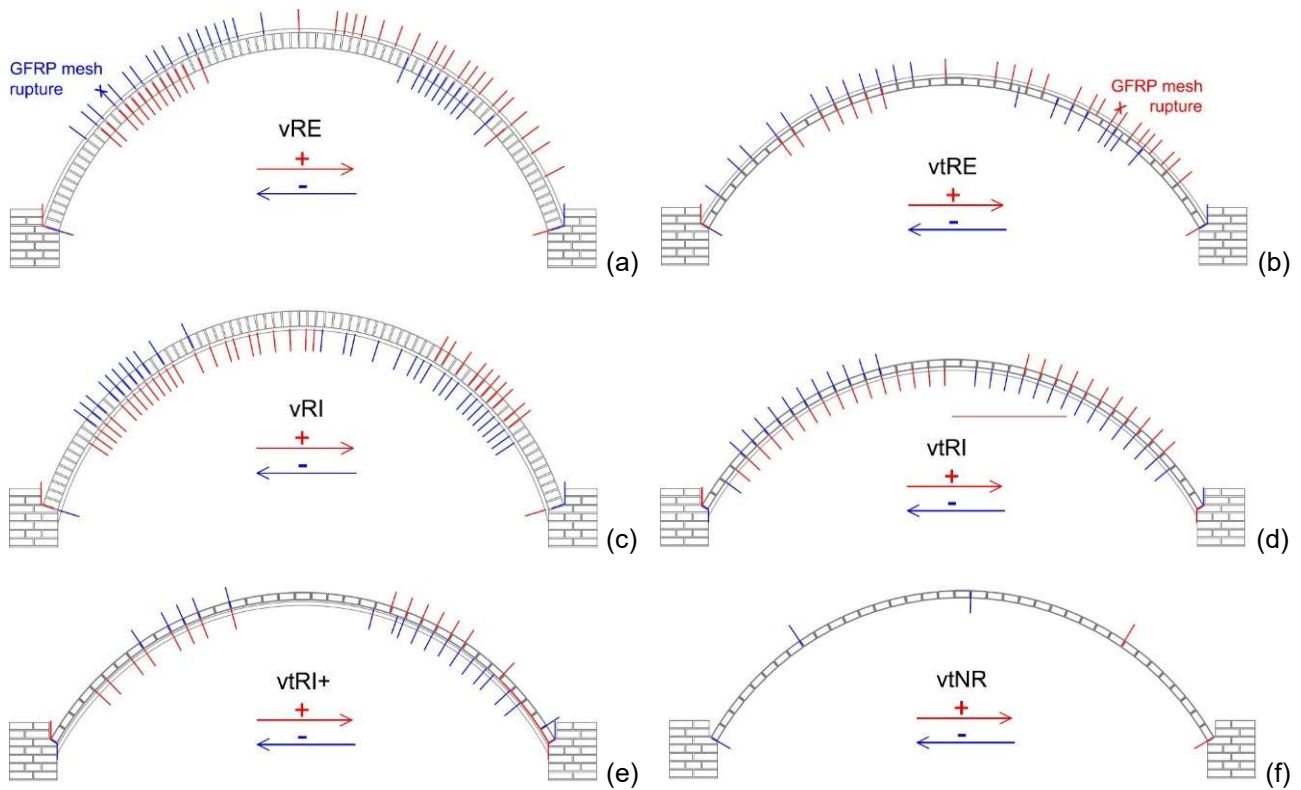
Figure 12. Crack pattern of samples (a) vRE, (b) vtRE, (c) vRI, (d) vtRI, (e) vtRI+ and (f) vtNR

Moreover, the crack patterns of the vaults are schematically represented in Figure 12a-e, distinguishing cracks formed for the two opposite loading directions (red and blue colours in agreement with the load direction). In general, in the test on reinforced samples, the two skewback sections and two opposite haunch sections cracked in alternate position intrados-extrados. However, after the attainment of this “first significant damage” configuration, the GFRP mesh and the steel bars connection with the abutments avoided the opening of structural hinges in the sections where the reinforcement was located on the side subjected to tension. Subsequently, in the “post-damage” stage, a gradual stiffness degradation was observed, as cracks widespread in the mortar coating at the two haunches, alternately (Figure 13b and Figure 14b). At the opposite haunch, several cracks formed also on the masonry side, mainly in the bed joints (Figure 13c and Figure 14c).

In the unreinforced vault, vtNR, the cracks occurred in few sections (Figure 12f). At first, in the negative loading direction, three cracks opened in the left vault side: one at extrados, at a haunch section, and two at the intrados, at the skewback and near the keystone. Then, when the loading direction was inversed, one crack at the extrados (at right haunch) and one at intrados (at the right skewback) formed. The presence of at least four hinges, in alternate position extrados-intrados, was thus achieved and the vault failure mechanism activated. The maximum load, $F_{h,max} = 0.55$ kN, was attained in correspondence of an horizontal displacement at the crown section $\delta_{h,u} < 1$ mm. So, due to the very low performances in terms of both resistance and displacements, the capacity curve of the unreinforced masonry sample was omitted.

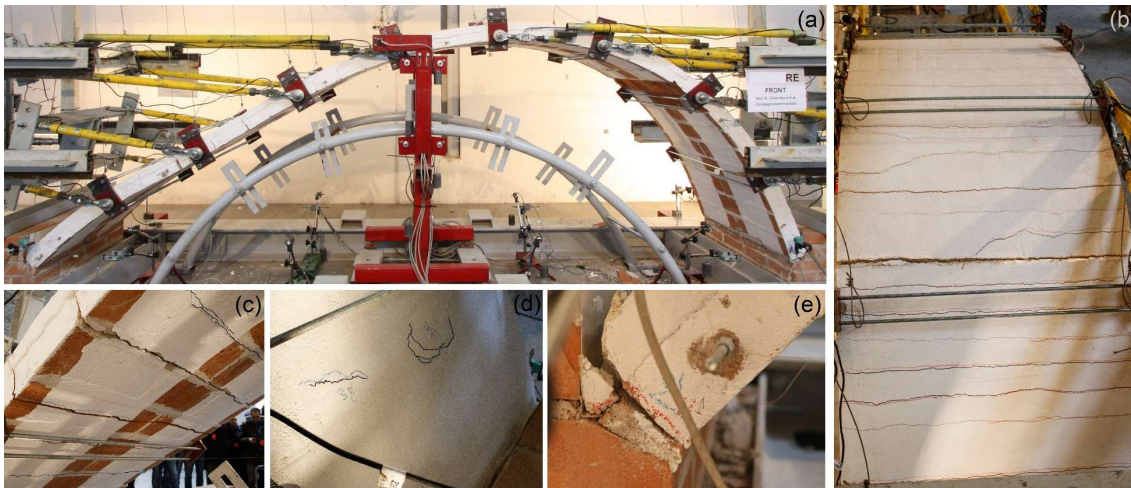
Figure 13. Vault samples reinforced at the extrados, at the incipient collapse (example of vtRE): (a) global view and typical crack pattern details concerning (b) diffuse cracking of the mortar coating at the extrados, right haunch, (c) cracking of the masonry at the intrados, left haunch, (d) local cracking of the mortar in correspondence of the connection steel bars and (e) rotation in correspondence of the left skewbacks, with no evident inward slip.

In the vaults reinforced at the extrados, vRE and vtRE (Figure 13), at the increasing of the deformation, the load kept increasing. The collapse was due to the rupture of the GFRP wires in the vault in correspondence of a haunch section (at the extrados). No evident slips at the skewbacks were noted during the tests (Figure 13e), but conic splinters in correspondence of some steel bars, close to the end nuts, were observed, as likely caused by their partial extraction from the coating (Figure 13d). Sample vRE reached a peak value $F_{h,max}$ of 22.9 kN, in correspondence of a displacement $\delta_{h,u} = 108.1$ mm; sample vtRE reached a maximum load $F_{h,max} = 11.8$ kN at $\delta_{h,u} = 115.5$ mm.

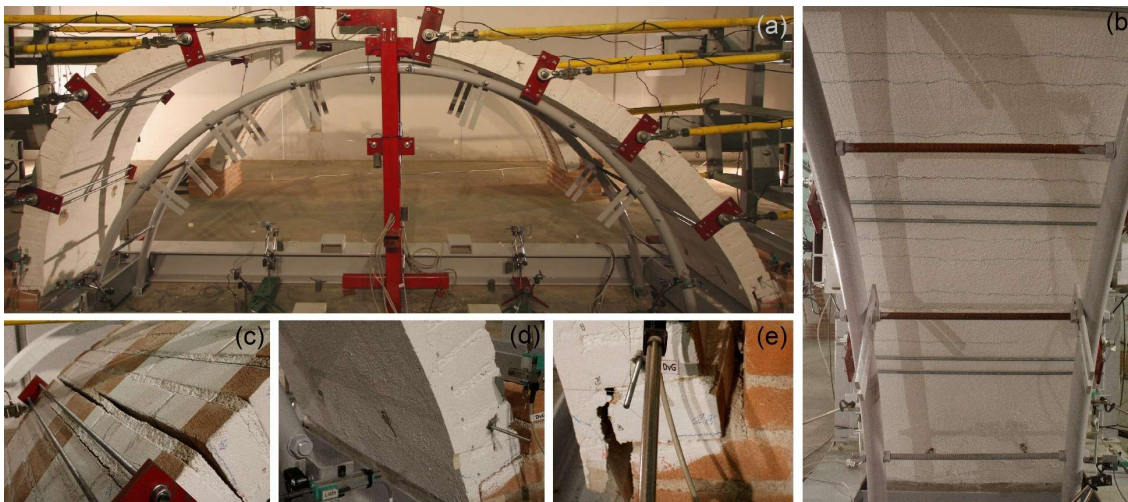
Figure 14. Vault samples reinforced at the intrados, at the incipient collapse (example of vRI): (a) global view and typical crack pattern details concerning (b) diffuse cracking of the mortar coating at the intrados, right haunch, (c) cracking of the masonry at the extrados, left haunch, (d) local mortar pull-off in correspondence of the first row of GFRP connectors and (e) rotation in correspondence of the right skewbacks, evidencing some inward slip.

Differently, in the samples reinforced at the intrados (Figure 14), vRI, vtRI, and vRI+, some inward slip occurred (Figure 14e), as evidenced also by the partial pull-off (mortar splintering) of the first row of GFRP connectors in sample vRI (Figure 14d). Moreover, a conic mortar splinter in correspondence of some steel bars, close to the end nut, detached. These damages in correspondence of both the GFRP connectors and the steel bars did not allow further load increases. In addition, in vtRI+, a detachment surface formed between the pre-existing mortar layer and the masonry substrate, starting from the right skewback and reaching the haunch section (Figure 15). The peak load of sample vRI ($F_{h,max} = 13.4$ kN), was reached at the ultimate cycle ($\delta_{h,u} = 130.9$ mm); then the test was interrupted due to the considerable displacement achieved. However, at these displacement values, some signals of the GFRP wires incipient breakage were clearly perceived. Differently, sample vtRI attained to +7.3 kN at $\delta_h = +19.6$ mm and to -8.2 kN at $\delta_h = -27.9$ mm; then the load was approximately maintained in the positive direction, till about +105.3 mm, while gradually decreased in the negative one, due to the accidental, premature damaging of one GFRP connector, which emphasized the

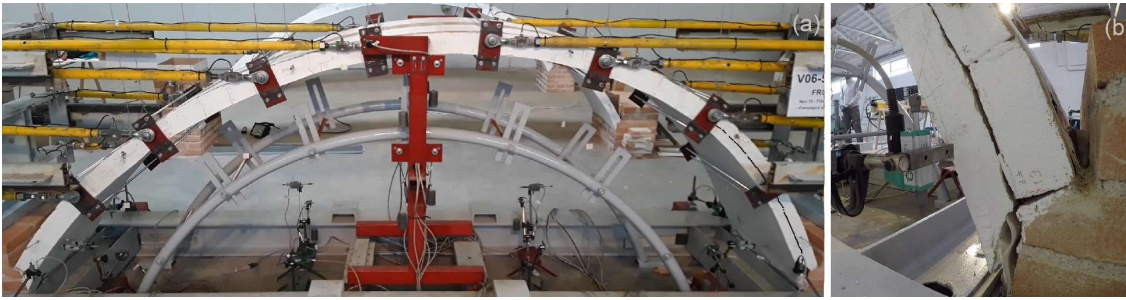
Figure 15. Configuration of sample vtRI+ at the incipient collapse, evidencing the partial detachment of the pre-existing plaster layer from the masonry, on the right side: (a) global view and (b) detail at the right skewback.

inward sliding. Sample vtRI+ attained to -10.5 kN (at $\delta_h = -21.0$ mm) and to +13.1 kN (at $\delta_h = +39.0$ mm), when the detachment of the pre-existing plaster layer formed and the load suffered an abrupt partial drop down.

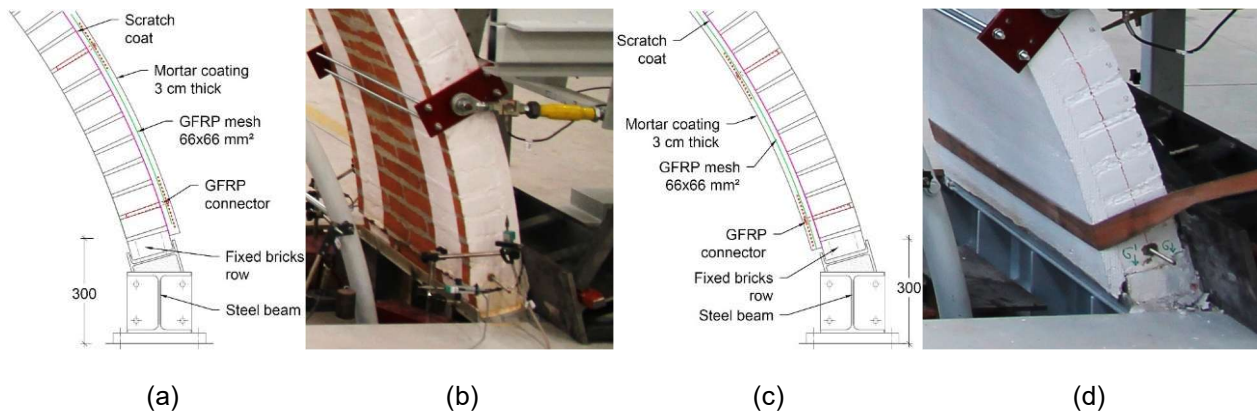
Figure 16. Previous tests on masonry vaults: detail of the skewback configuration (a) in V02-75-RE, with (b) introduction of the external steel profile to contrast outward sliding, and (c) in V03-75-RI, with (d) introduction of the polyester belt to contrast inward sliding

In particular, the outward slip of the vault skewbacks was observed in the sample V02-75-RE; so, external steel profiles were introduced to effectively oppose it, reproducing the presence of a masonry wall (Figure 16b). This allowed, in the second phase of the test (dotted grey curve “Exp.B” in Figure 11a), the load recovery and the exploitation of the CRM resistance, till the GFRP mesh failure at an haunch section (maximum horizontal load $F_{h,max} = 14.1$ kN, at $\delta_{h,u} = 76.0$ mm). Moreover, it is observed that the inward slip at skewback sections did not occur, as it was contrasted by the presence of the end portion of the CRM layer, in the fixed bricks row (Figure 16a).

In sample V03-75-RI, besides the installation of the external steel profiles, polyester belts were introduced to contrast also the inward slip (Figure 16d). Actually, a lower belt tightening at the right skewback determined less restraint effectiveness in the negative loading direction, resulting in an unsymmetrical capacity curve

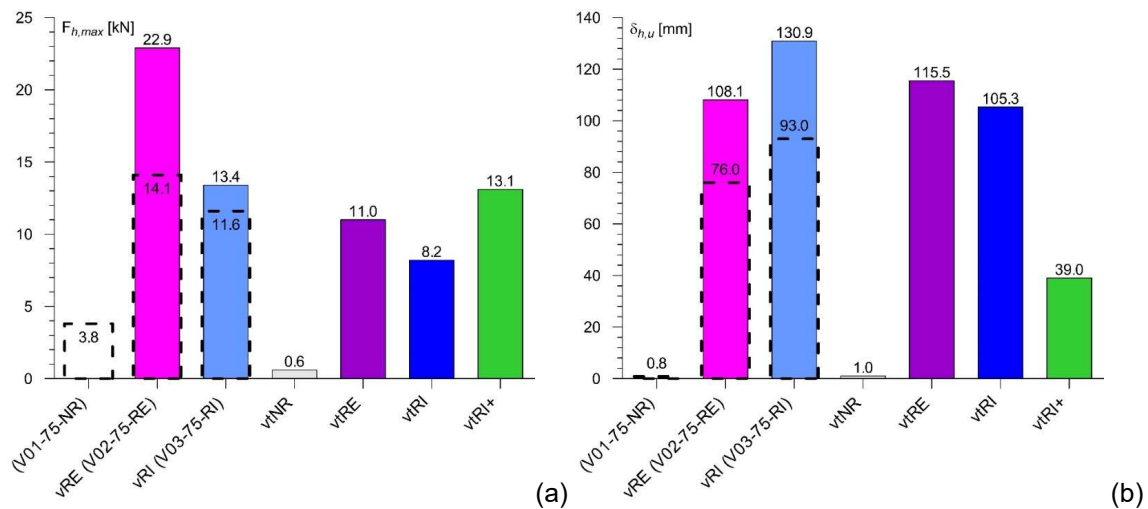
Figure 17. Experimental results in terms of (a) lateral resistance $F_{h,max}$ and (b) ultimate displacement $\delta_{h,u}$.

Dotted line columns refer to the results of the three previous tests (samples ID in round brackets) [15].

The results are summarized in Figure 17 in terms of peak load, $F_{h,max}$, and ultimate horizontal displacement $\delta_{h,u}$ at the crown section (the dotted line columns and the samples ID in round brackets are referred to the three specimens tested in the previous experimental campaign).

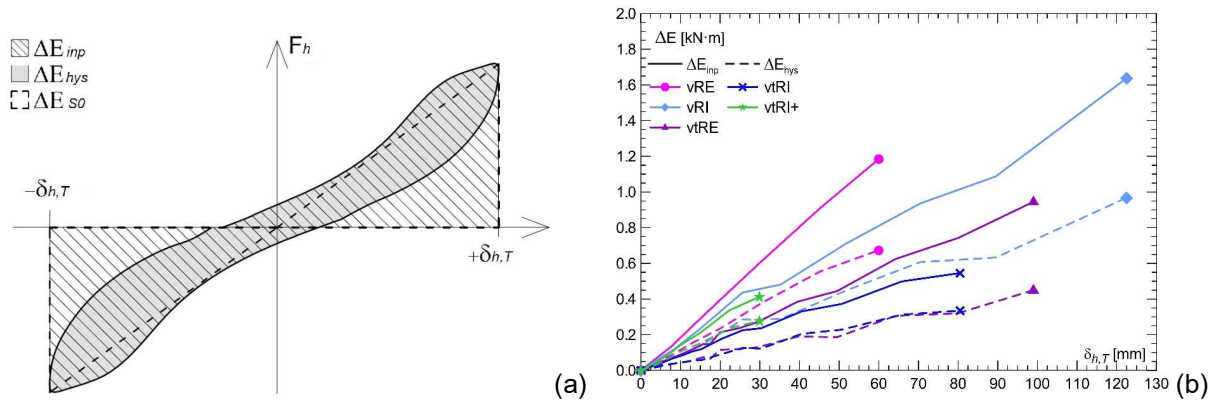
Figure 18. Dissipative performances of the samples: (a) individualization of the input energy ΔE_{inp} , of the hysteretic energy ΔE_{hyp} and of the strain energy ΔE_{S0} in a cycle and (b) trends of ΔE_{inp} and ΔE_{hyp} at the increasing of the target displacement.

where the strain energy, ΔE_{S0} , was individuated by the area of the right triangles having a vertex in the axis origin and a vertex in correspondence of the target point (evidenced by the dashed lines in Figure 18a).

The ratios $\Delta E_{hys}/\Delta E_{inp}$, as well as β_0 , resulted very similar for both vRE and vRI, with average values of 0.61 and 12.4%, respectively. Differently, some variations were observed in the brick *in folio* vaults: lower values emerged for the sample reinforced at the extrados, vtRE (0.48, 8.1%), in respect to vtRI (0.56, 10.4%). Moreover, the presence of the pre-existing mortar layer, in vtRI+, determined higher dissipation performances (0.72, 16.3%), compensating the lower displacement capacity.
