PROCESSING STUDIES OF X-BAND ACCELERATOR STRUCTURES AT THE NLCTA*

C. Adolphsen, W. Baumgartner, K. Jobe, F. Le Pimpec, R. Loewen, D. McCormick,
M. Ross, T. Smith, J.W. Wang, SLAC, Stanford, CA 94309 USA
T. Higo, KEK, Tskuba, Ibaraki, Japan

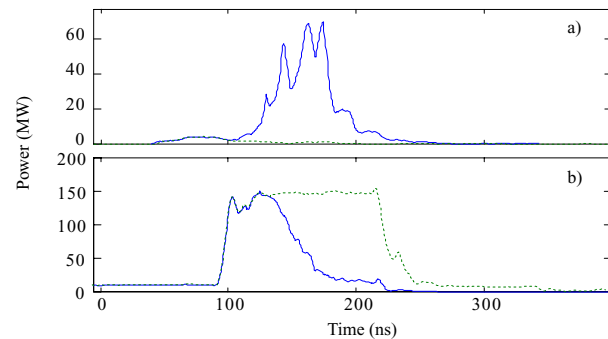
Fig. 1: Example of (a) reflected and (b) transmitted power for a breakdown pulse (solid) and normal pulse (dashed).

The most detailed information on breakdown has come from analyzing the transmitted and reflected rf from the structures. Figure 1 shows an example. Such information can be used to determine the breakdown time during the pulse, the breakdown location in the structure and the amount of rf power absorbed after breakdown. In general, the transmitted power falls to essentially zero about 100 ns after breakdown. It fully recovers several microseconds after the main rf pulse, when the power from the continued discharge of the NLCTA pulse compression system is many orders of magnitude smaller. The distribution of peak reflected power is broad and peaked at low values: the mean is typically 10% to 20% of the input power. Up to about 80% of the incident rf energy is absorbed after breakdown begins, although only a very small fraction (10^{-5}) of the rf energy, if converted to heat, is needed to produce a pit of the size observed on the cell irises. Simulations using particle-in-cell codes of the rf interaction with breakdown-generated electrons and ions are

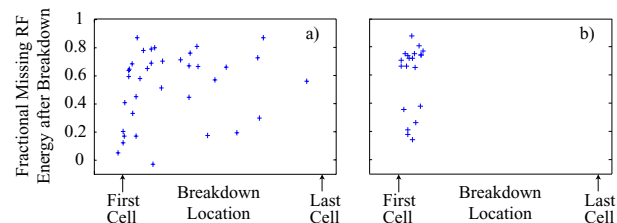
Fig. 2: Fractional missing energy versus breakdown location when (a) processing to a higher gradient and (b) running at a gradient lower than the maximum achieved.

The distribution of breakdown times during the pulse is fairly uniform. One puzzling result is that about 10% of the breakdowns occur after the main pulse, when the power is less than 10% of maximum. The distribution of breakdown locations in the structure is generally skewed toward the upstream end. It differs depending on whether the structure is being processed to a higher gradient for the first time or it is running at a gradient lower than has been achieved. Figure 2 shows a plot of fractional missing energy versus breakdown location in each case. A common feature is the clustering of events near the input coupler. At the highest gradients, breakdown occurs deeper into the structure, mostly with high missing energy (> 40%). The events near the coupler include a distinct set of ‘soft’ events with lower missing energy, slower falloff in transmitted power, and a common iris origin (probably the input cell iris) as evidenced by the phase of the reflected rf. A new coupler design that increases group velocity in a two-step transition from the input rectangular waveguide to the structure cells will be tested shortly in an attempt to eliminate the events near the coupler.

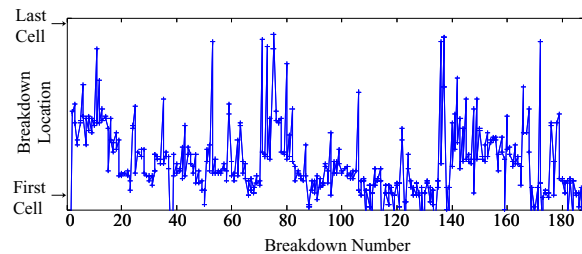
Fig. 3: Sequence of breakdown locations during ‘spitfests.’

Perhaps the most important observation from the rf measurements is that for the longest pulse, highest gradient operation, breakdown tends to occur clustered in time in localized regions of the structure (so called ‘spitfests’). Figure 3 shows an example of the breakdown location history when operating in this regime. In general, the breakdown location propagates to the upstream end of the structure, where the breakdowns are mainly ‘soft’ and occur at a low rate. This migration process tends to repeat after a large-missing-energy breakdown occurs deeper in the structure. Such cycles suggest that breakdown can cause secondary damage that lowers the threshold on subsequent pulses. Evidence for secondary damage is seen on the irises after processing in that the number of pits is much larger (10-100 times) than the number of rf trips that had occurred during processing. Also, the occurrence of spitfests increases with pulse length, and the distribution of breakdown times during the pulse is surprisingly flat after the pulse has been lengthened. If such collateral damage depends on group velocity, it would explain why cell irises with the same surface field both damage and process differently in low and high group velocity structures.
