# An investigation of the Brumadinho Dam Break with HEC RAS simulation

Arun Raman<sup>1</sup>, Fei Liu<sup>2</sup>

<sup>1</sup> *New Jersey West Windsor - Plainsboro High School N*

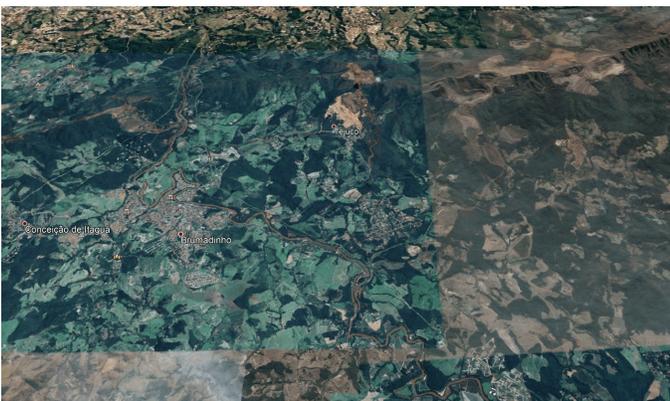
Figure 4: The Brumadinho dam in January 2019 before collapse

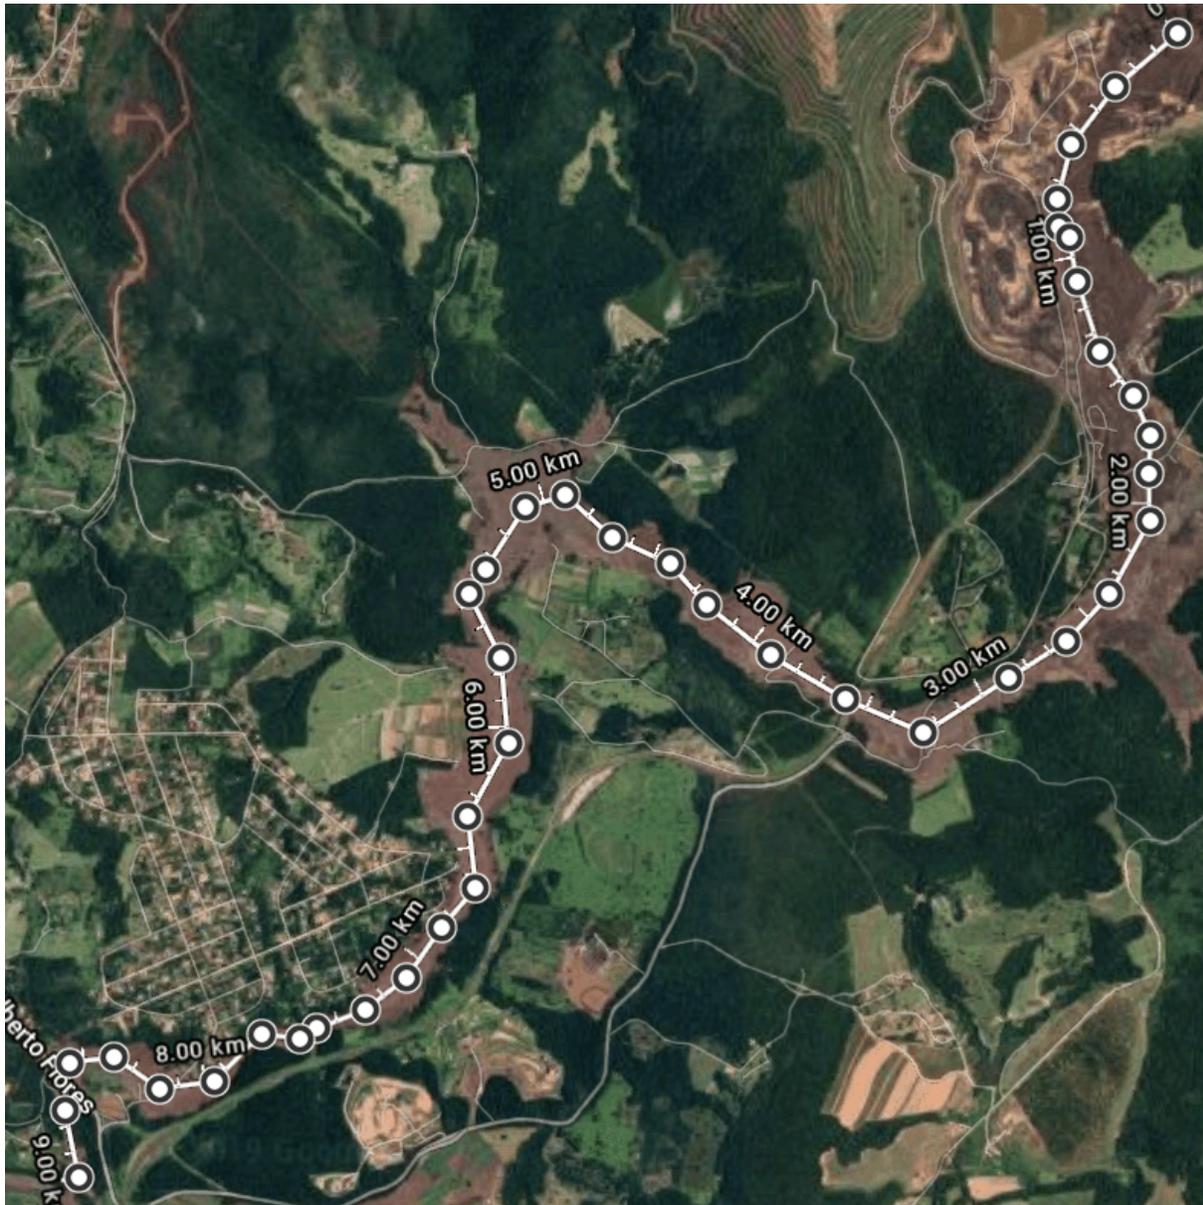
The Digital Elevation Map (DEM) of the Brumadinho area was made available by NASA's Shuttle Radar Topography Mission (SRTM). This mission produced global 1 arc-second, or about 30 meters resolution, topographic data sufficient for the Brumadinho dam break simulation. As seen in Figure 6, the distance between the Brumadinho dam and Paraopeba river, the primary area where the flooding simulation is carried out, is approximately 9km which is the main area. The European Petroleum Survey Group (EPSG) code 29101 projection correctly geo-references the DEM to Google Satellite images over Brazil.

Figure 6: The measure distances of the flow path taken by the mud flow

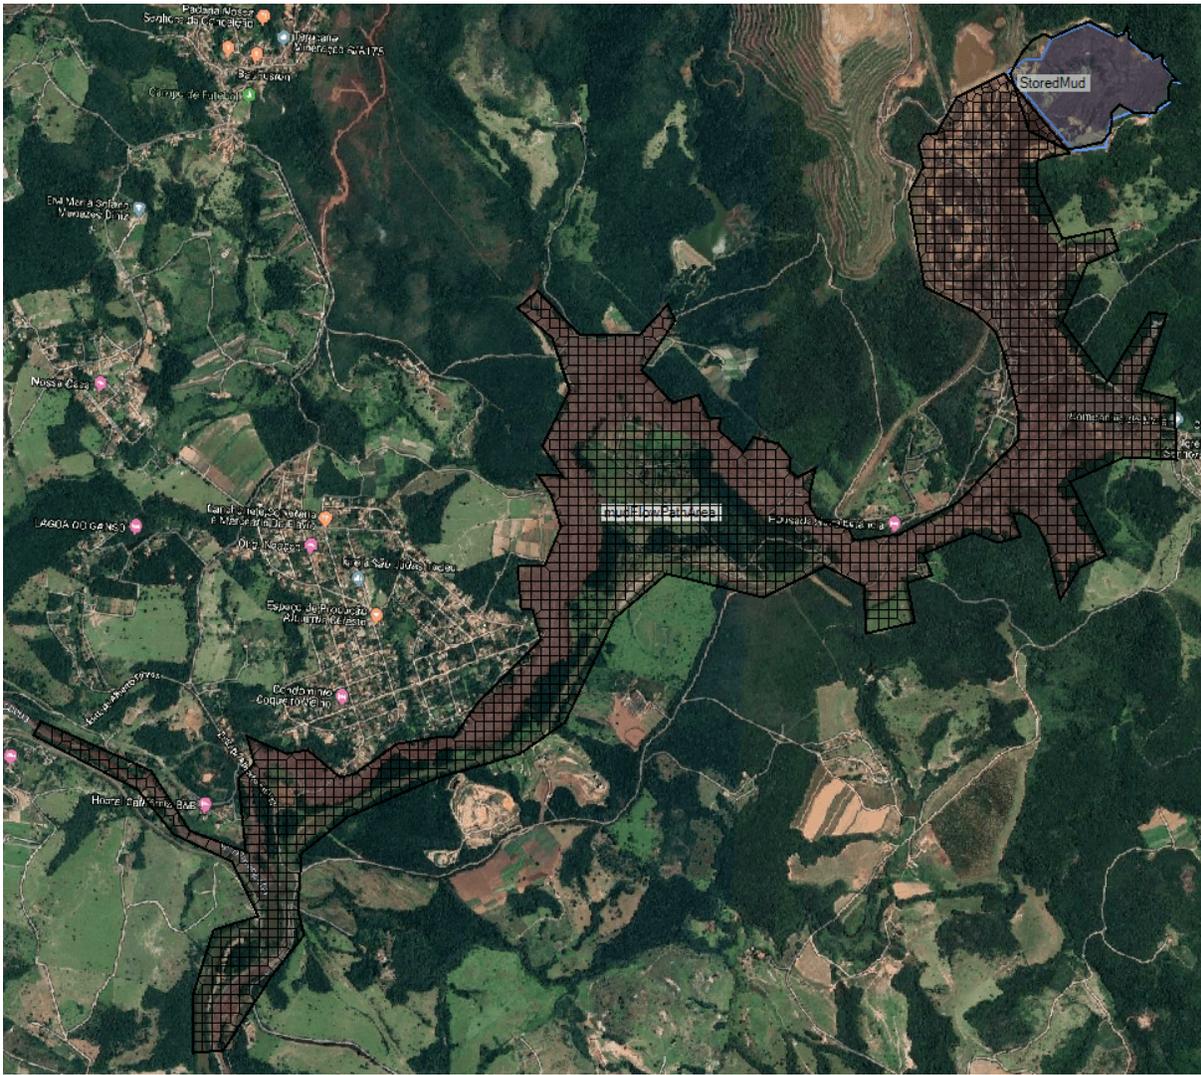
A 2D flow area is set up with a 50 meter by 50 meter cell size resolution as show in Figure 7, resulting in a computational mesh with 2258 cells to carry out the shallow water equation calculations. A storage area is set up to store the mud with a 2D flow area and storage area connection in between to represent the dam.

Figure 7: Computational mesh used in HEC-RAS for representing the assumed flow area of the simulation

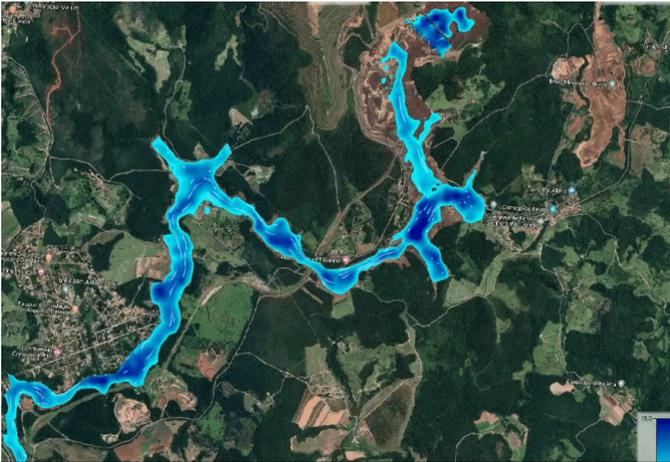
The Manning value for the flow area is set to 0.3 which led to the observed 3 hour flow time from the Brumadinho dam to Paraopeba river. The Coriolis effect is turned off due to the relatively small scale (9 km) and short time (3 hours) involved in the simulation. Figure 9 and Figure 10 show the result of the flooding pattern from the HEC-RAS simulation overlaid on top of the flooded region seen in the satellite image. The correlation between the observed flooding pattern and simulated pattern can be seen from the Figures to be extremely strong.

Figure 9: A simulation of the tailings flow area post-collapse

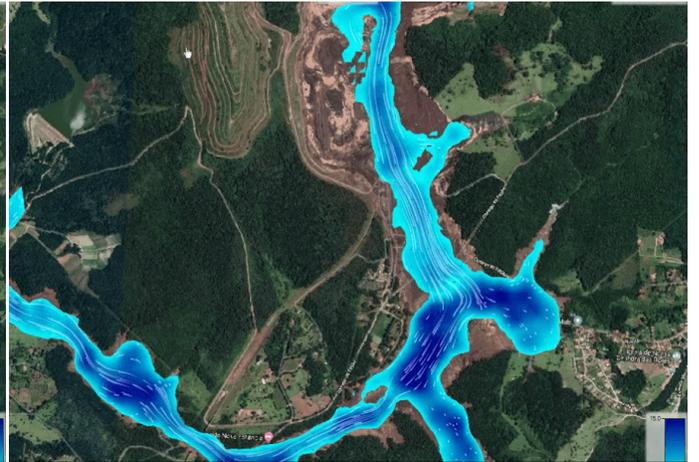
Figure 10: A closeup of the simulated tailings flow near the dam

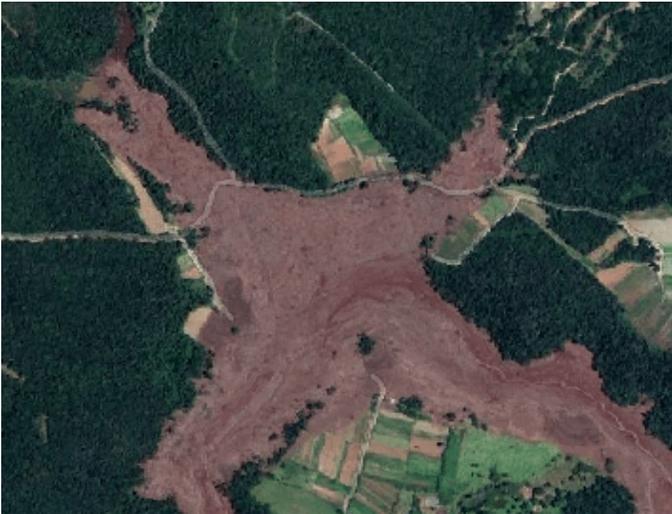
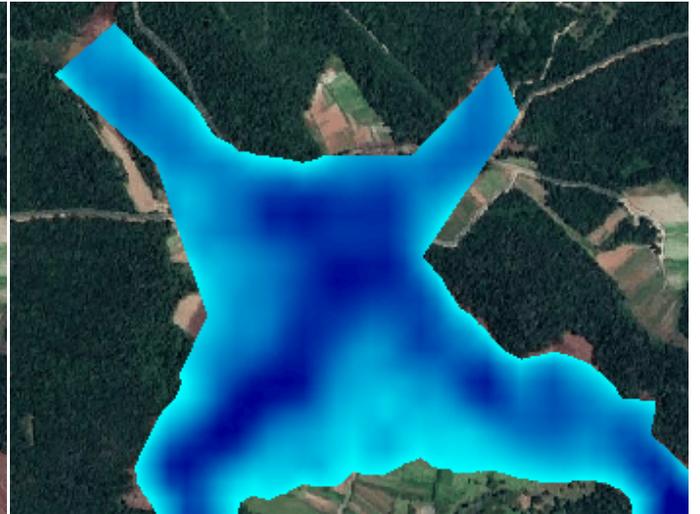
A few isolated locations downstream from the broken dam are selected where we zoom in to examine the actual flooding and simulated pattern. These can be seen in Figure 11, 12, 13, and 14. The images on the left are satellite images of the locations after the dam break; the images on the right are simulated flooding patterns. This level of similarity is seen in both the overall pattern comparison and at the individual locations examined.

Figure 11: Loc. 1: Satellite Imagery

Figure 12: Loc. 1: HEC-RAS

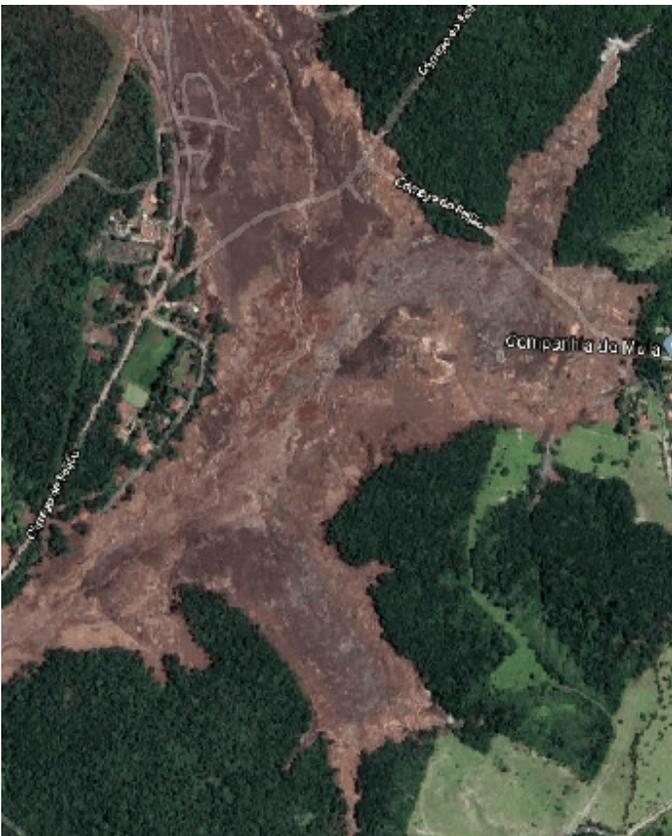
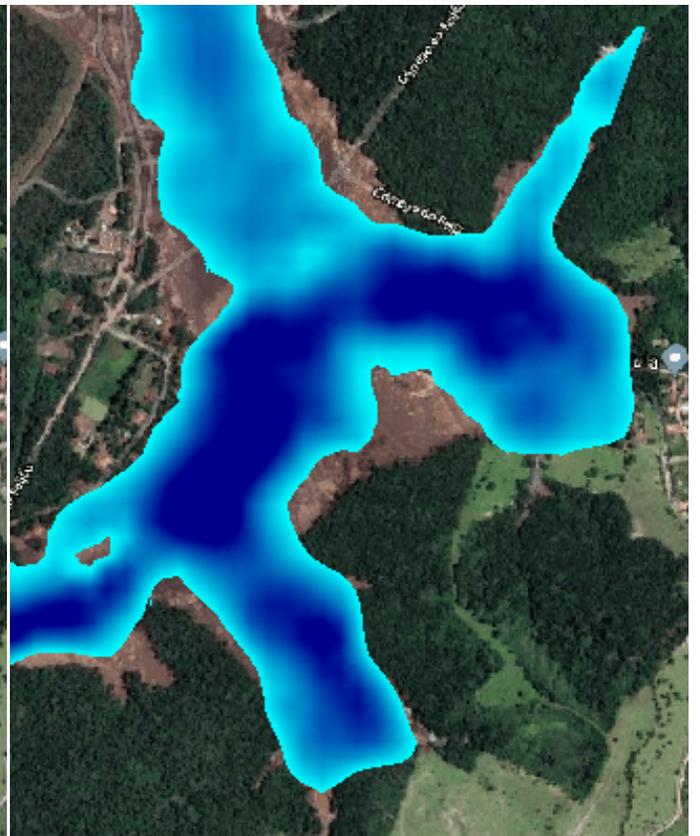
Figure 13: Loc. 2: Satellite Imagery

Figure 14: Loc. 2: HEC-RAS

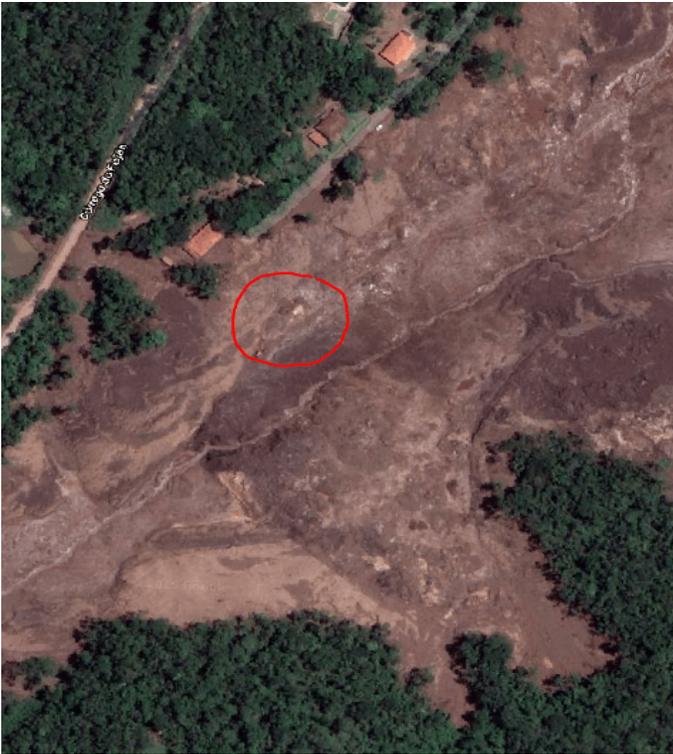
A location of interest is shown in Figure 15 and 16. It can be seen that in the image of the simulated result 16, there is a small area without flooding. Upon closer examination of the

satellite image and the bottom topography height along the line in 16, a local high ground is revealed 17 at this spot that pushes mud flow to circumvent around the local high ground.

Figure 15: Loc. 3: Satellite Imagery

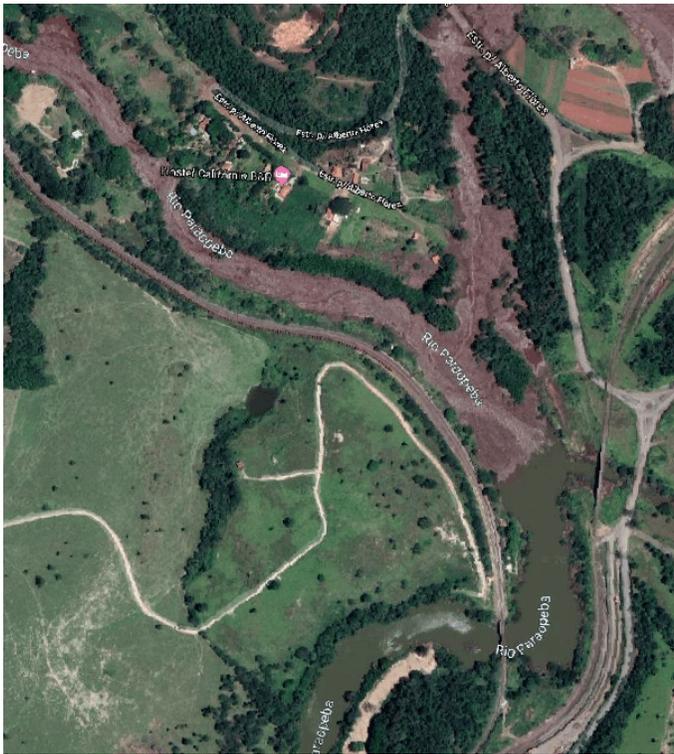
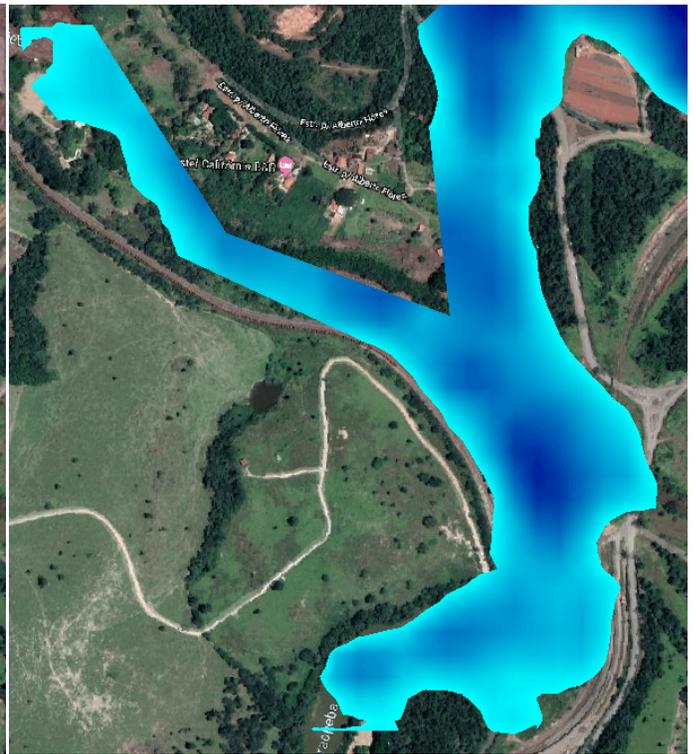
Figure 18: Location 5: Satellite Imagery

Figure 19: Loc. 5: HEC-RAS
