# Reconstruction of the collapse of the ‘Azure Window’ natural arch via photogrammetry.

## Abstract

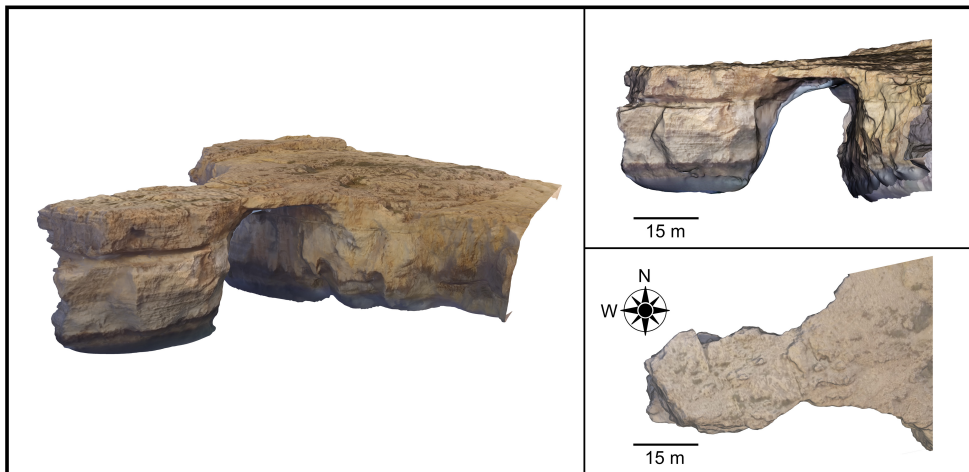
The interpretation that follows of the deposits and layout described above is based upon familiarity with the site via dives carried out prior to the collapse, a comparison of features against images and a 3D reconstruction of the Azure Window prior to its collapse (Fig. 10), as well as observation of exposed rock segments in the submerged remains.

Figure 10: On the left, a 3D-model (created from drone footage) of the Azure Window prior to its collapse. On the right, two scaled ortho-images derived from the model using the software Metashape and Cloud Compare, showing the arch (top) and a bird's-eye view (bottom). (Note: the 3D-model on the left is not to scale with respect to the ortho-images on the right.)
