VISUAL, OPTICAL AND REPLICA INSPECTIONS: SURFACE PREPARATION OF 650 MHz NB CAVITY FOR PIP-II LINAC*

V. Chouhan[†], D. Bice, D. Burk, M. K. Ng, G. Wu, Fermi National Accelerator Laboratory, Batavia, USA

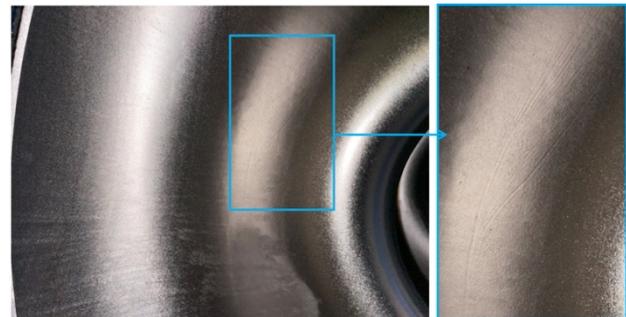
Figure 2: A part of the half-cell of an as-received HB650 cavity: Photograph captured with a digital camera inserted manually inside the cavity (left). Zoom-in image showing minor scratches (right).
