Tests of cosmic ray radiography for power industry applications

J. M. Durham^{1*}, E. Guardincerri, C. L. Morris¹, J. Bacon¹, J. Fabritius¹, S. Fellows¹ D. Poulson¹, K. Plaud-Ramos¹, and J. Renshaw²

LA-UR-15-22129

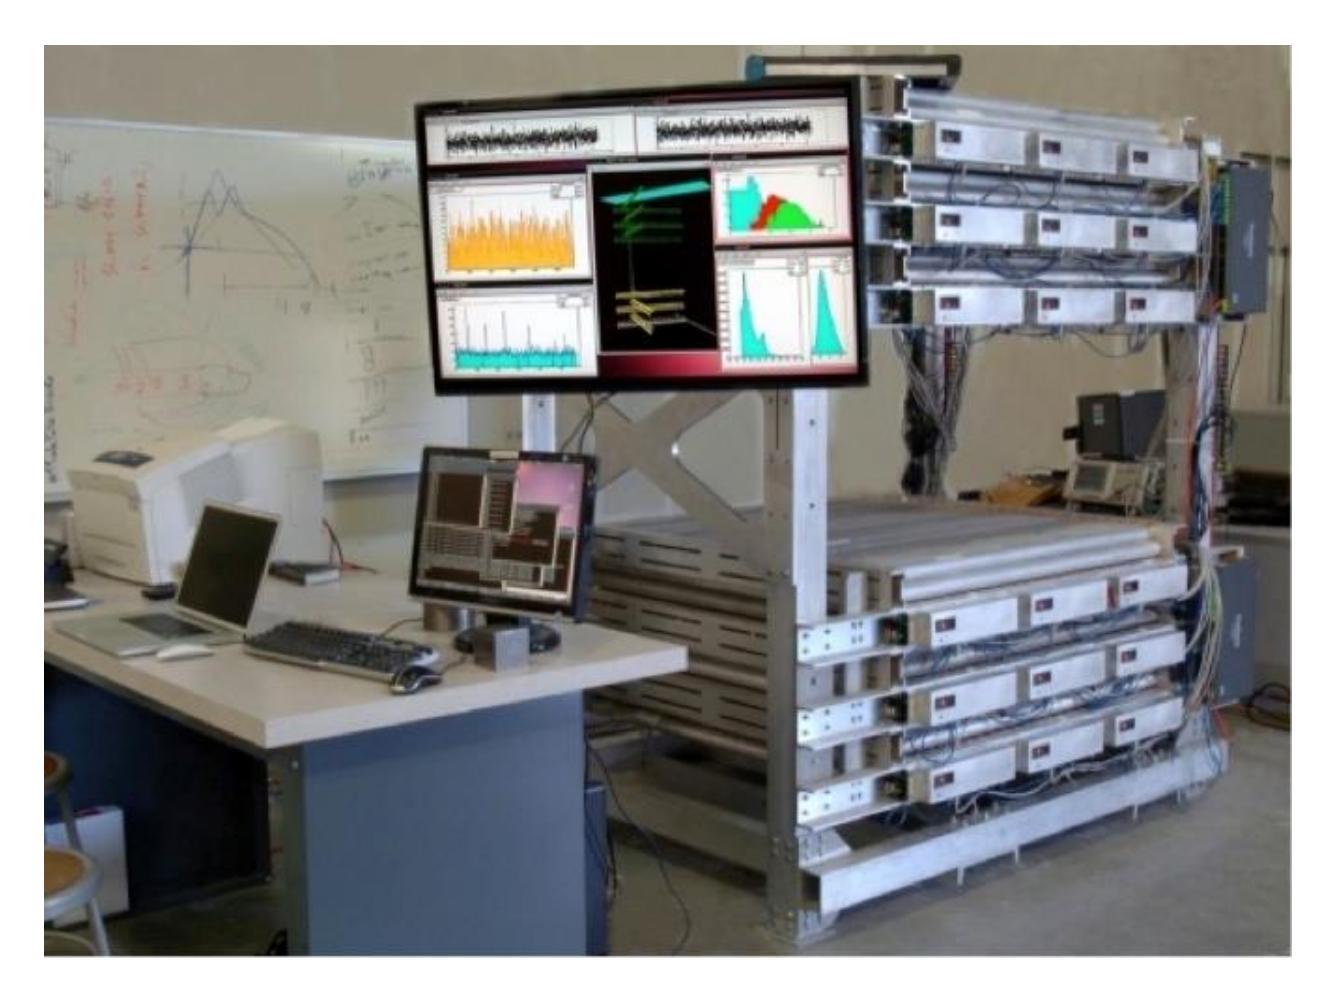
Figure 1: The Los Alamos Mini Muon Tracker. Two identical muon tracking modules are used to determine the scattering angle of muons that pass through objects placed in between them.

To assess multiple scattering muon tomography as a non-destructive infrastructure inspection technique, muon multiple scattering imaging was performed on several representative test objects. All data described herein were obtained using the Los Alamos National Laboratory mini muon tracker (MMT). The MMT consists of two charged particle tracking detectors, one above and one below the test volume, that are each composed of 12 layers of 1.2 m long, 5 cm diameter drift tubes (see Fig. 1). The MMT was configured to measure vertical going cosmic rays with a test volume of approximately $100 \times 100 \times 60$ cm³. Objects under investigation are placed in between the two tracking modules, and the incoming and outgoing cosmic ray tracks are measured. The volume between the detectors is divided into voxels, and images are reconstructed based on the deflection of tracks passing through each voxel. For more details on the image reconstruction algorithms, see [10].

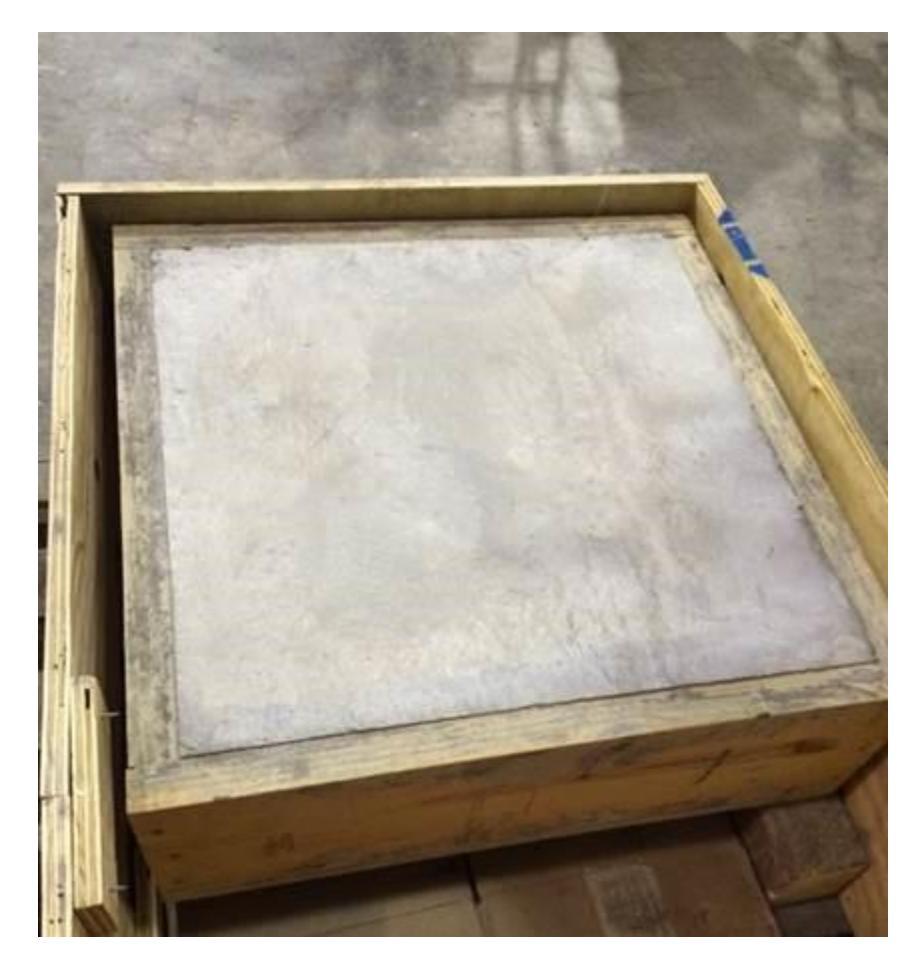
Figure 2: The concrete test object.

As concrete is a common construction material that is subject to erosion, techniques that can distinguish differences in concrete thickness without disturbing the object under investigation have a variety of applications. As a test of muon tomography, the first object to be evaluated was a set of four contiguous concrete tiles of thickness 7.6, 10.2, 12.7, and 20.3 cm, enclosed inside a plywood case (see Fig. 2).

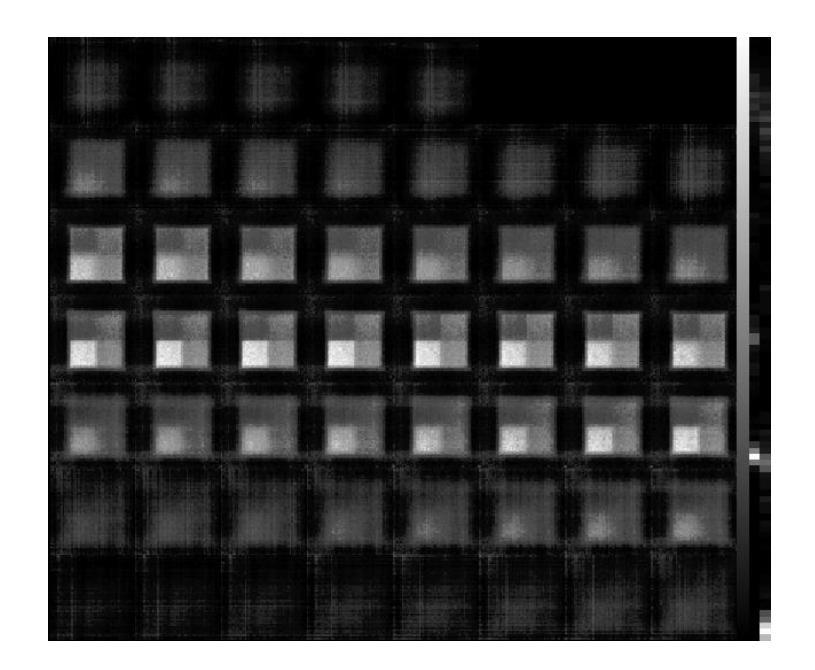
Figure 3) Stereo x-y slices of the concrete test object. Each panel is a step of 2 cm in the direction between the two muon tracking modules (z).

Data from cosmic ray tracks passing through the tiles was recorded for a total of 65 hours. Fig. 3 shows a series of stereo images of the concrete, moving through the concrete in 2 cm steps in the direction between the two detectors. The contrast of the images denotes the magnitude of the muon scattering in that voxel, which is related to the total radiation length experienced by the muon track. The object is observed to be constructed of 4 squares, each 30.5 cm on a side, and each with a different thickness.

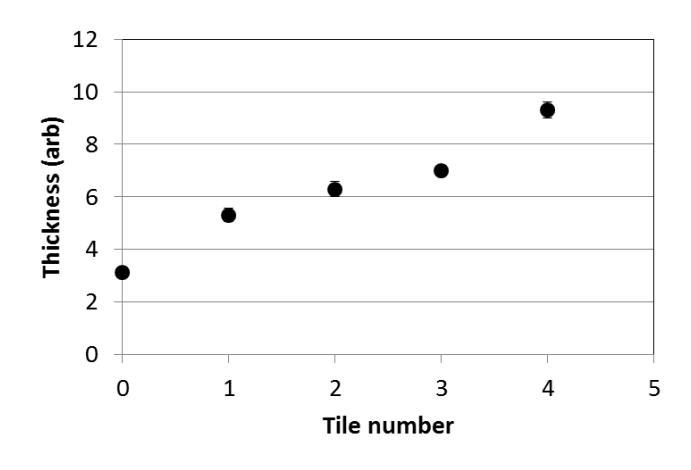
Figure 4) Concrete thickness for each of the tiles. Tile number 0 is an analysis of an empty spot in the detector volume, and represents the instrument background.

The data were analyzed using the multi group method described in [10]. This provides a quantitative measure of the object thickness in radiation length weighted areal density, ρ_A/X_0 . These results are shown in Fig. 4. Clear differences are seen between each tile.

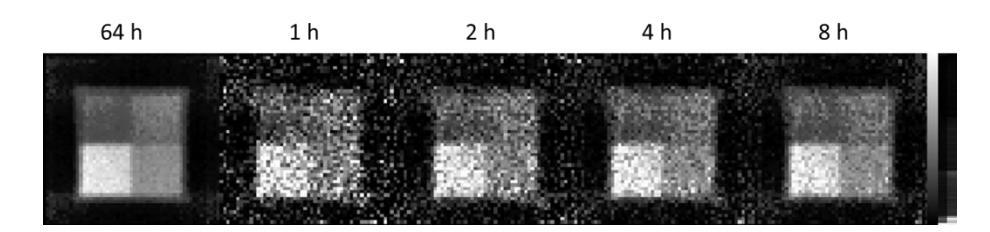
Figure 5) Image as a function of exposure time.

Fig. 5 shows the development of the image on an x-y slice through the center of the concrete as a function of exposure time. One hour exposure is sufficient to quantitatively distinguish the different concrete thicknesses.

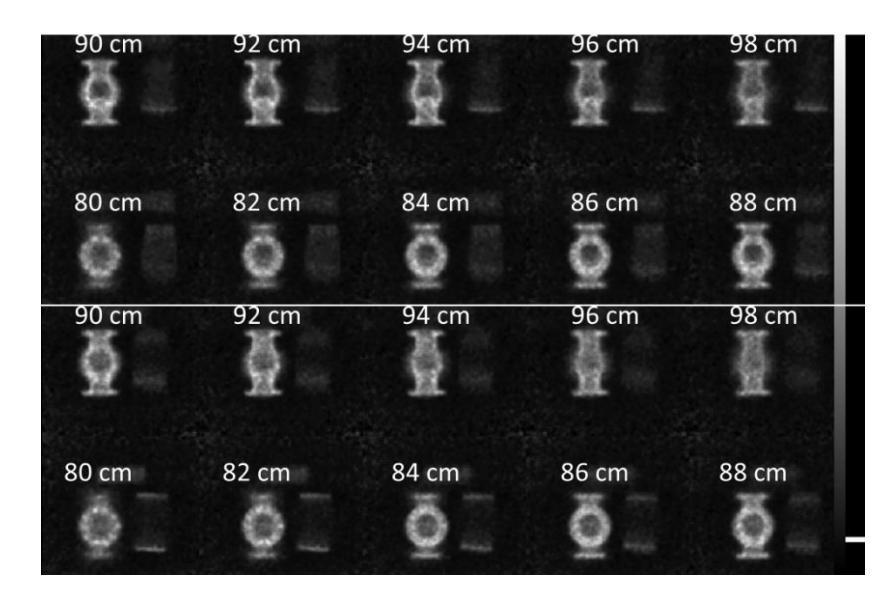
Figure 6) Tomographic reconstruction of the closed (bottom) and open (top) valve. The reconstructed images are shown as x-y slices as a function of depth between the two muon tracking modules (z). The object to the right of the valve is a section of pipe.

A 7.6 cm check valve was imaged, with the goal of determining whether the position of the gate could be resolved and, if so, how long an exposure time was required. Tomographic images from a 4 hour exposure are shown in Fig. 6, for both closed and open gates. A side by side view of the slice at 94 cm is shown in Fig. 7, where the gate location is labeled.

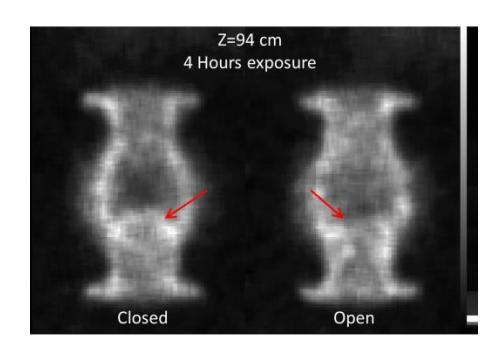
Figure 7) Expanded tomographic x-y slice at z=94 cm for closed (left) and open (right). The red arrow points to the region of the gate. A clear difference can be seen with a 4 hour exposure.

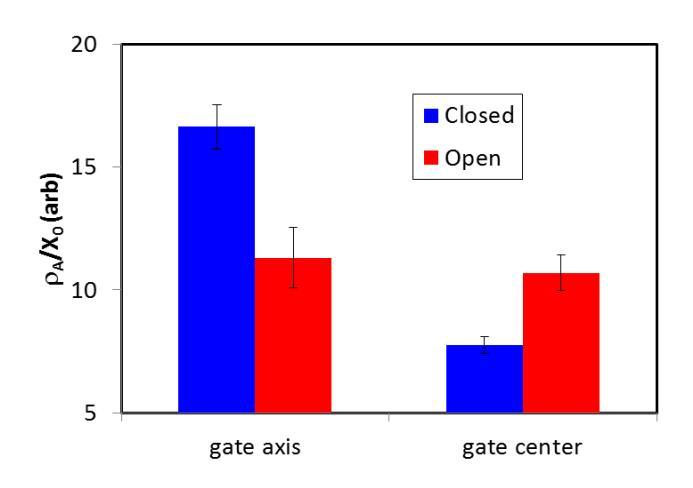
Figure 8) The mean (bars) and the standard deviation calculated for the densities measured on the gate axis (left) and the gate center (right) for the open (red) and closed positions (blue).

We analyzed 7 statistically independent one-hour-long runs by calculating the density in two 5 cm wide, 2 cm high patches of the image, one near the axis of rotation of the gate and one in the center of the opened gate. The mean and the standard deviation of the value of the radiation length weighted densities (ρ_A/X_0) were calculated for each of these regions. For both locations, the difference between open and closed is about a 3.5 standard deviation effect. The combination of the two gives a determination of the state of the gate at the 5 standard deviation level (the probability of an incorrect determination is 2.5×10^{-7}), proving that the gate condition can be accurately measured with a 4 hour exposure.

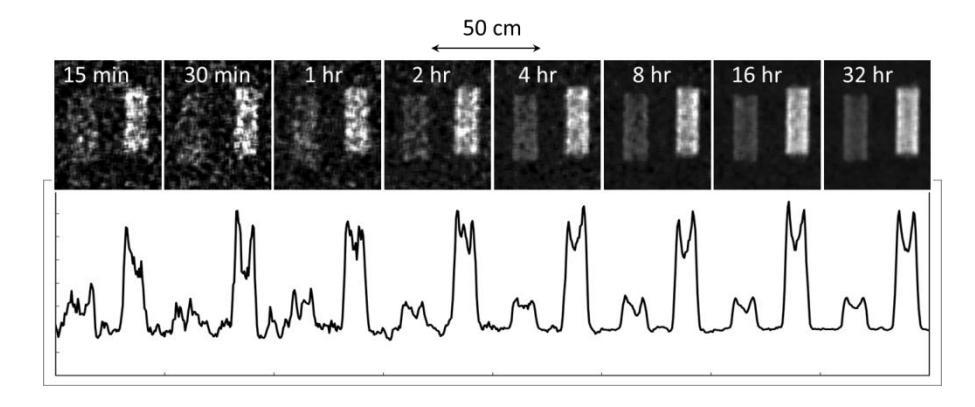
Figure 9) Images of scattering density showing the two stainless steel pipe sections. The line plot at the bottom is from a 10 cm wide slice.

To assess the ability of muon tomography to determine the thickness of pipes, we made measurements on lengths of stainless steel pipes with an outer diameter of 10 cm. Fig. 9 shows the time development of scattering data from two stainless steel pipes with different wall thicknesses, 4.1 mm and 13.3 mm. The outlines of the two pipes are distinguishable with only 15 minutes of exposure, and the contrast reflects the difference in areal density due to differing wall thickness. The data displayed are a center slice from the muon tomograph made with 1.5 cm wide overlapping pixels on 0.5 cm centers. At longer exposures the pipe walls can be observed in spite of the 1.5 cm pixel width.

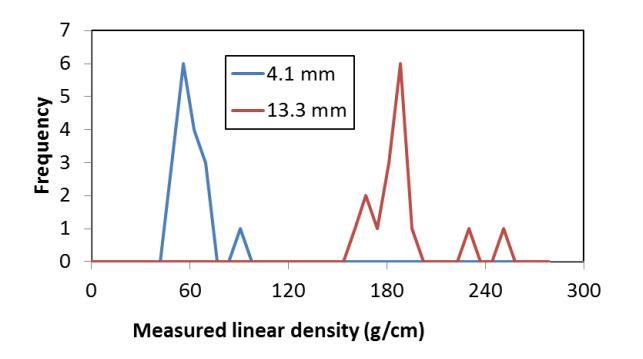
Figure 10) Histograms of the measured linear density of the two different thicknesses for 16 independent 1 hour long runs.

Histograms of the results are shown in Figure 10. The standard deviation, SD, of the determination is 18% for the thin wall and 12% for the thick wall pipe. This variance arises in part from the background scattering signal induced by the ~4 cm of aluminum detector materials the muons must pass through. We estimate that by using thinner detectors and instrumenting four sides around an object can reduce the exposure times needed for a given measurement by more than a factor of 4.

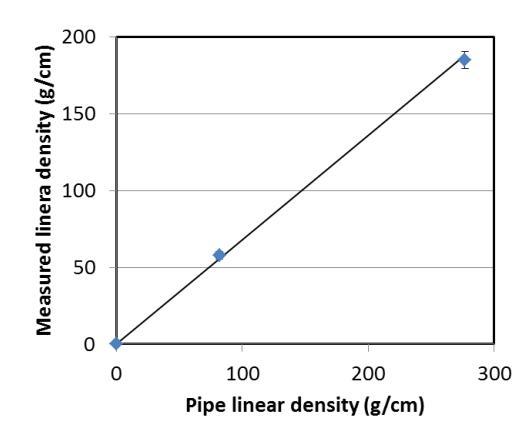
Figure 11) Measured vs actual pipe density. The line shows a linear fit to the data.

In Fig. 11 the measured vs the actual linear density of the pipes is shown. Here the averages of the 16 values are shown as the data points and the uncertainty, $\Delta = SD/\sqrt{16}$, is shown as the error bar. The data are linear within the several percent uncertainties. The slope of the line is 0.75, indicating that the absolute densities determined from the experiment are about 25% low. We attribute this discrepancy to an incomplete knowledge of the cosmic ray muon momentum spectrum, which is not directly measured with this technique. However, we note that the difference between the two pipes is readily apparent, making the technique useful for finding corroded sections.
