Three-Dimensional Damage Characterisation in Dual Phase Steel using Deep Learning

Keywords: Dual phase steel, damage, scanning electron microscopy, three-dimensional characterisation, deep learning

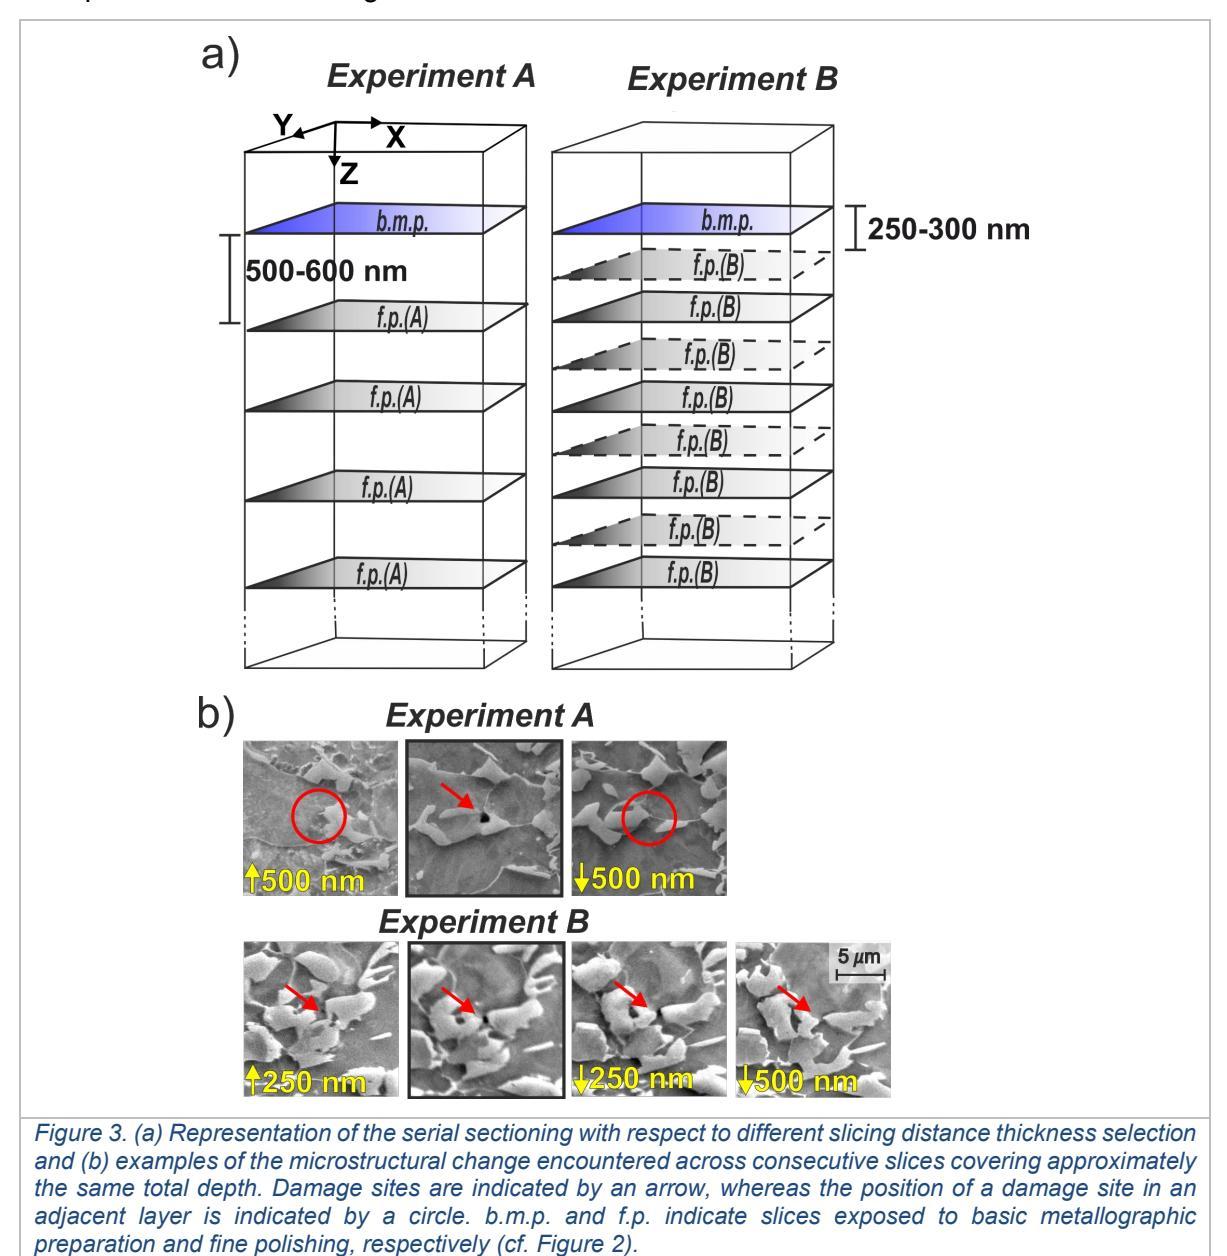
Essentially, after image acquisition (described below), we have two sets of images: In experiment A (for the sample with 19% elongation), we cover a larger volume in z-direction as the 10 slices are 500-600 nm apart, whereas in experiment B (for the samples with 14% and 25% elongation), we obtain a finer resolution in z-direction as the 10 slices are only 200-300 nm apart as indicated in Figure 3.

We chose the depth of each slice in the following way: In experiment A, we used the specimen subjected to 19% elongation, i.e., the intermediate strain level, and ablated the material between the successive images such that 500-600 nm of material was removed. In experiment B (samples with 14% and 25% elongation), we reduced the thickness of each slice to 200-300 nm to be able to track fine structures as we go from the surface deeper into the material (z-direction). This is particularly important for damage sites with a small volume or extension in z-direction (most commonly those referred to as 'notch effect'), as we saw in a preliminary analysis of experiment A that these damage types are at or below the resolution limit of the experiment. Reducing the thickness of the slices further would introduce too many artefacts and was, therefore, not done here: First, more surface artefacts are introduced due to insufficient flattening of the surface when the polishing time becomes too short and, second, the etching procedure required to obtain sufficient contrast for the microstructure to be visible in the electron micrograph would either approach the slice thickness or become too short as

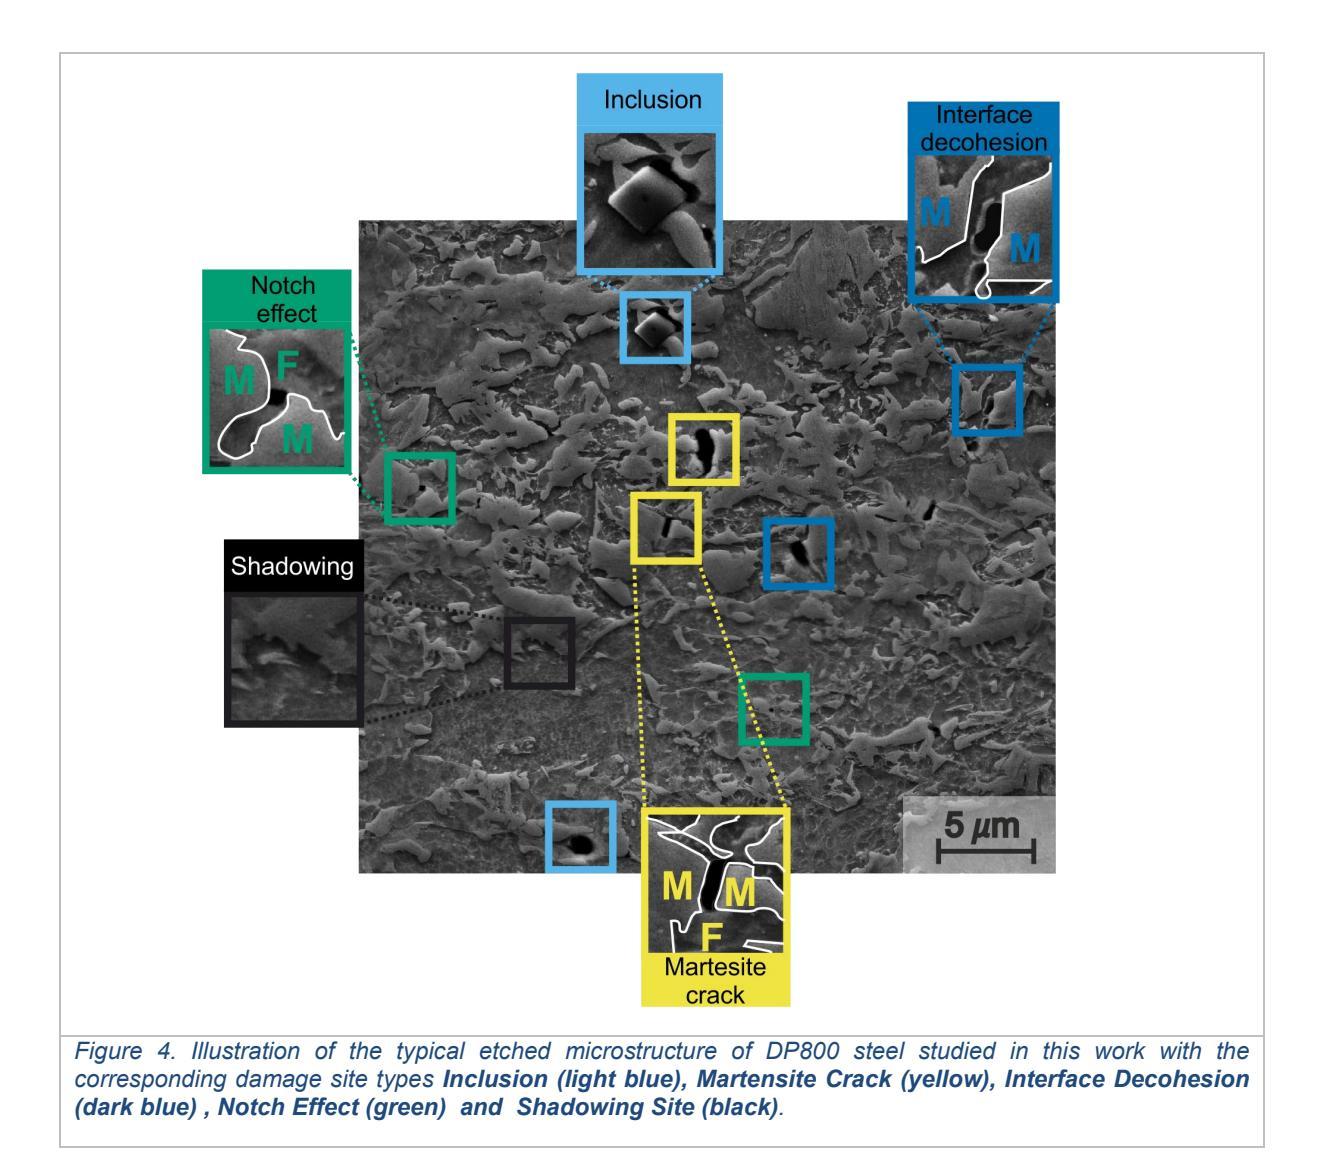
A typical example of an electron micrograph showing the relevant damage classes used in the image analysis is shown in Figure 4.

We follow the procedure established in [11] for the detection and identification of damage sites in each recorded slice of the material for each of the three samples with 14%, 19%, and 25% elongation, respectively. Essentially, each potential damage site appears as a black region in the panoramic electron micrograph. Damage site candidates are first identified using the DBSCAN clustering algorithm [48]. Then, a threshold is applied to remove small artefacts and only images with greyscale values exceeding this threshold are kept and extracted from the panoramic image. These individual images are then classified using a sequence of two convolutional neural networks. First, we identify inclusions, where a foreign particle used to be stuck in the local microstructure and may then have fallen out of the sample during the preparation process or not. These inclusions are notably different from the other damage classes regarding size and shape and are therefore identified first. Furthermore, inclusions are not deformation induced damage and are therefore of limited or, where they may be found to induce damage formation, separate interest in understanding the response to the material to an applied stress. In a second classification step, we then use a second neural network to distinguish between the physical damage classes: martensite cracking, interface decohesion and notch effect. Further, we also include image artefacts such as shadows in the list of categories to improve the accuracy of the algorithm [12]. An example of each class is shown in Figure 4.

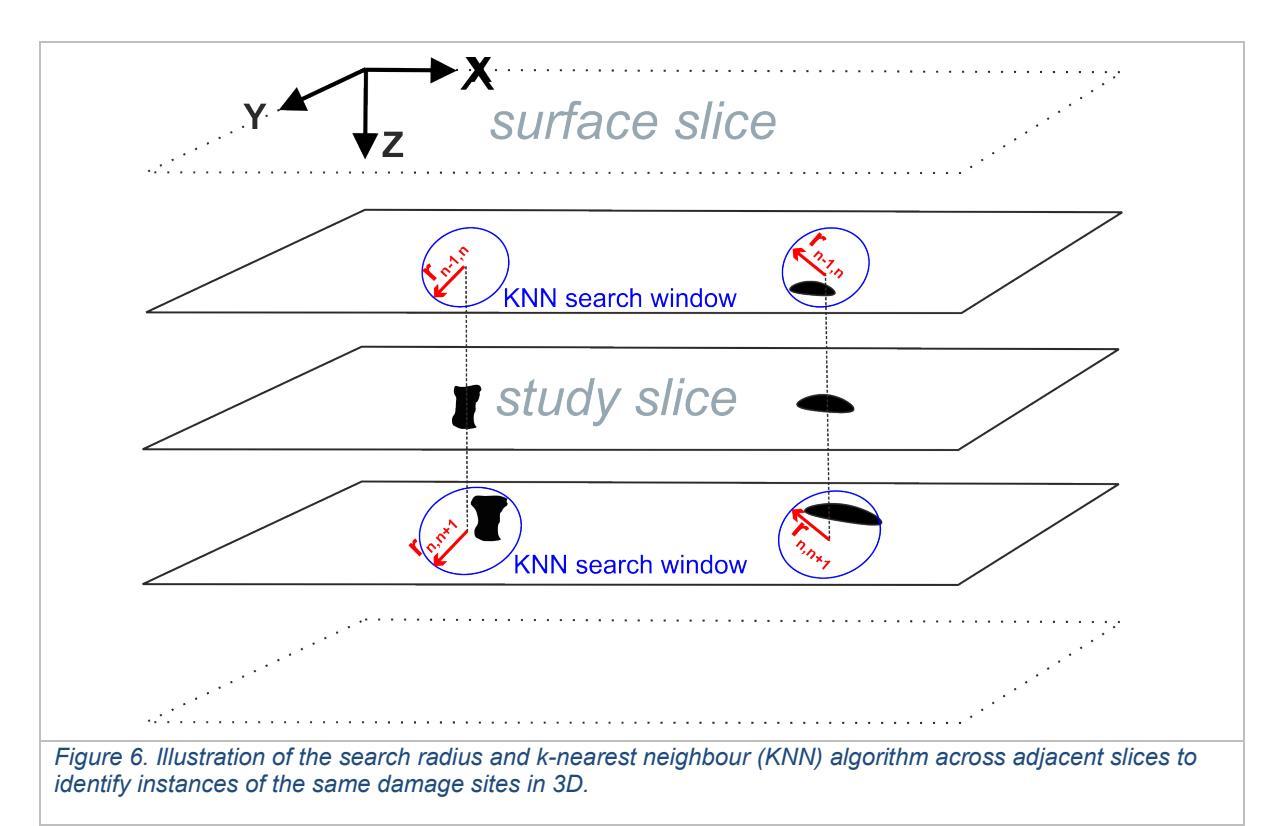
In the next step, we relate the now identified and classified damage sites across the stack of images obtained from the slices of the experimental sample. In the simplest case, where all slices are aligned perfectly by the registration procedure and each damage could be described by a circle in a homogeneous material, we would find that the centres of each circle have the same (x,y) coordinates and only differ in z-direction across the slices or stack of images. However, in a real sample, we have to account for the following effects: First, the material is not necessarily homogeneous but has a distinct microstructure. This in turn can influence where damage occurs and how it evolves through the depth of the material. Then, depending on the type of damage and the local microstructure, the shape of the damage is not necessarily circular. As the shape changes with the evolution of the damage site and throughout the stack of images, the centre of gravity of each damage site will also necessarily shift across the slices. Additionally, new damage sites can emerge in any of the slices. Finally, since the registration procedure is a numerical optimisation, small uncertainties in the procedures are to be expected. To account for these effects, we apply the following procedure: As the occurrence of damage is relatively rare, even in the sample elongated by 25%, the individual damage sites are relatively far apart from each other. This means that there are no multiple damage sites in close proximity to each other, and we can therefore treat any damage site found in adjacent slides as related to the damage in the current slice if they are found within a certain search radius. This radius is defined by the registration procedure and given by the effective shift in (x,y) coordinates between two adjacent slices: $S = \sqrt{(\Delta x)^2 + (\Delta y)^2}$ where Δx and Δy are the effective shift in coordinates of the two adjacent slices, namely the Euclidean distance. For example, if the effective shift is -10 pixels in x-direction and +5 pixels in y-direction, the search radius for a potential damage site in the adjacent slice would be r=11 pixels as illustrated in Figure 6.

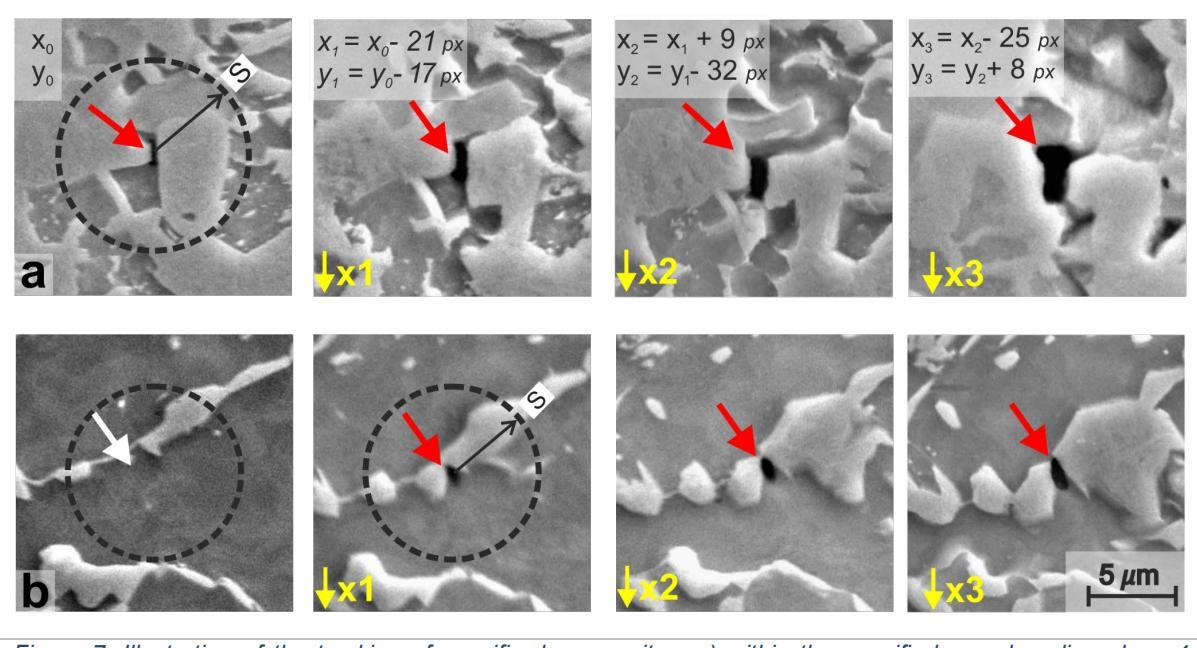
A concrete example of this procedure is shown in Figure 7, again for two cases. In the top row (a) we identify a damage site in the first slice with coordinates x_0 and y_0 and then follow the procedure across the next three slices ($\downarrow x1, \downarrow x2, \downarrow x3$). Here we can identify the damage across the slices within the search radius r. Note that an additional damage occurs only in Figure 7.a) in slice $\downarrow x3$ at the bottom right. However, this damage is outside the search radius r for the current damage site under consideration and is therefore not attributed to the current damage site. The bottom row (b) illustrates the case where we identify a damage site in the second slice (x1) that extends to the two subsequent slices $\downarrow x2$ and $\downarrow x3$, but is not visible on the surface, meaning that this is a new damage site that emerges in slice x1.

Figure 7. Illustration of the tracking of specific damage sites, a) within the specified search radius along 4 successive slices. The damage site in the first slice appears with slightly translated coordinates within the next slices (measured by pixel values in the image), b) a new damage site is initiated from the second slice (S is the effective shift between the slices).

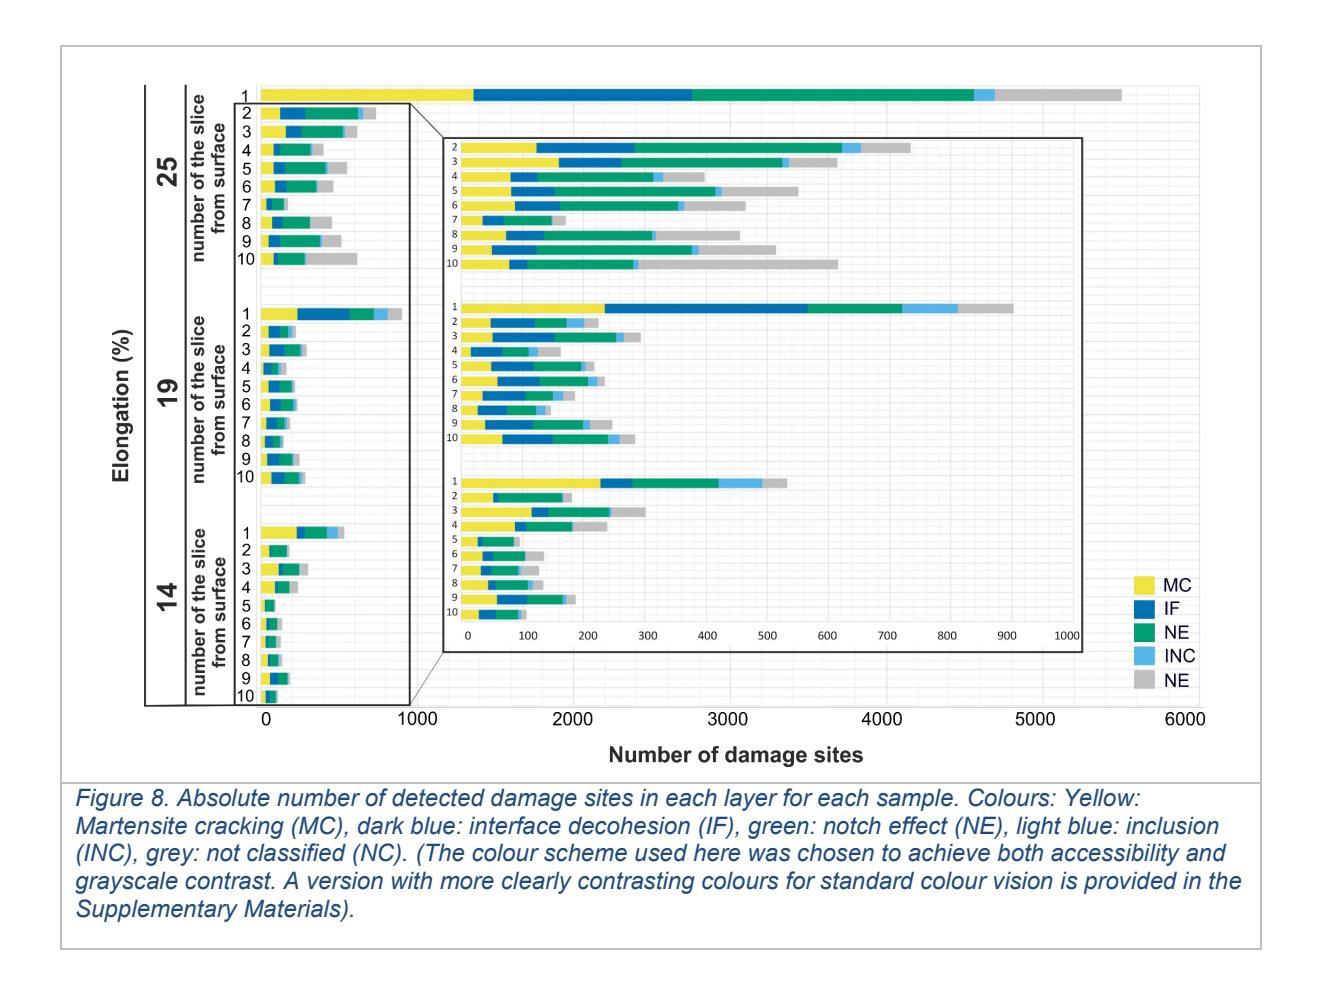
First, we investigate the number of sites of each type of damage per slice separately for each of the three samples. This is visualised in Figure 8, where each damage type is indicated by the following colours: martensite cracking (MC) in yellow, interface decohesion (IF) in dark blue, notch effect (NE) in green, inclusion (INC) in light blue and "not classified" (NC) damage sites in grey. The case "not classified" refers to the cases where a damage site candidate has been identified but the algorithm did not attribute this candidate to either of the physical damage classes (martensite cracking, notch effect, interface decohesion, inclusion) or imaging artefact (shadowing).

At first glance, we notice that the number of damage sites in the surface layer is considerably higher compared to all subsequent slices, independent of applied strain. Most of this effect is likely due to the initial, more aggressive basic metallographic preparation step of the sample and therefore an artefact of the handling of the sample, as we will discuss later. To avoid unintended bias, the damage sites found in this slice are therefore not used in the later analysis.

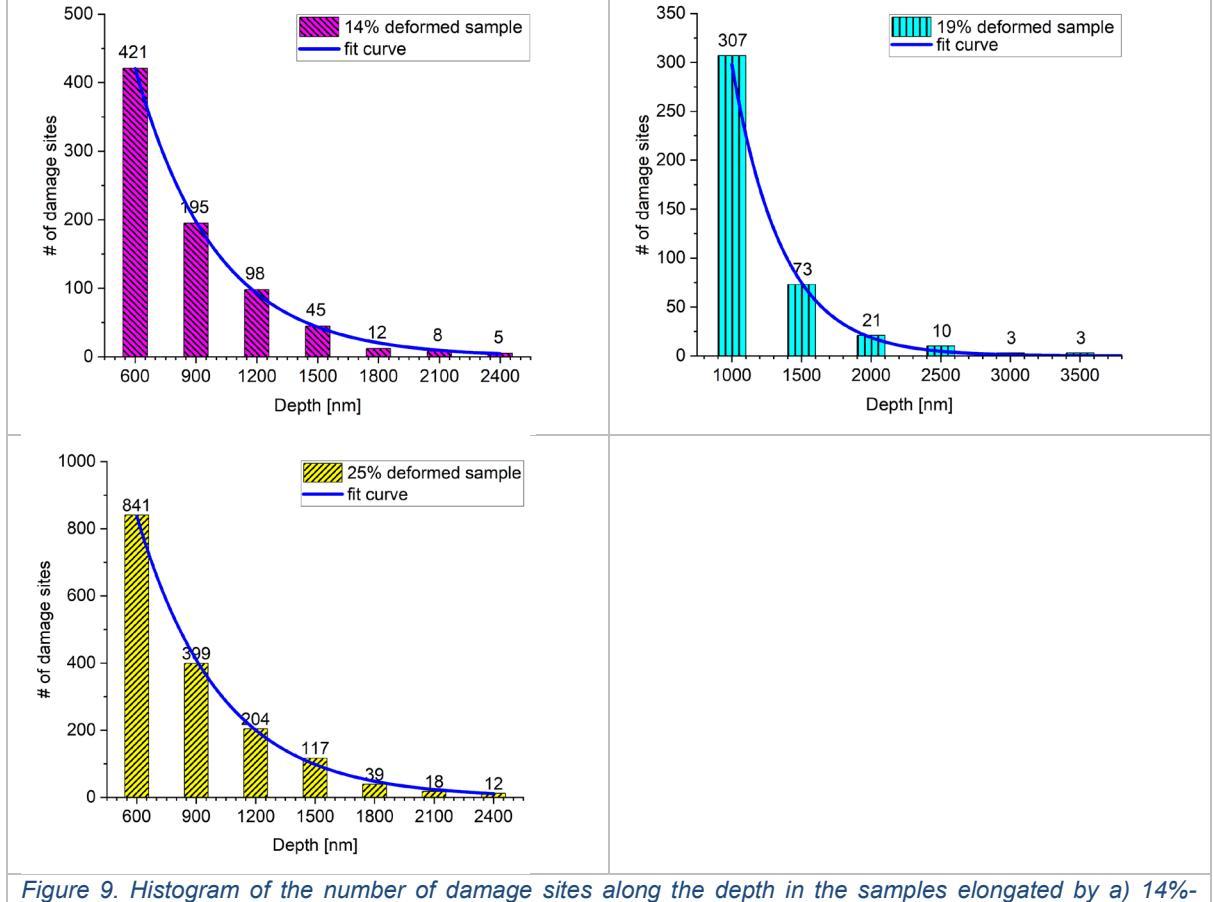
Next, we look at the occurrence of damage for the cases that a damage site extends over two, three or more slices. Overall, we find that the more slices the damage sites extend over, the smaller their number, i.e., most damage sites are two slices deep, followed by damage sites three slices deep, etc., as illustrated in Figure 9. The data for all three experiments are very well represented by an exponential fit, that is using a function of the form $f(x) = a \cdot exp(b x)$, where *a* and *b* are the fit parameters and *x* the damage site depth, as shown in Figure 9.

Figure 9. Histogram of the number of damage sites along the depth in the samples elongated by a) 14%-Experiment B, b) 19% - Experiment A, c) 25% - Experiment B. The data can be represented by an exponential fit, as indicated by the blue lines.

We found that the distribution of damage sites according to their size (represented here by their depth) is well represented by an exponential fit (Figure 9), in agreement with previous reports in the literature [13, 50]. The exponential fit would be consistent with a stochastic distribution. Here, this rather implies that the observed microstructure contains no dominant length scale within the range investigated, i.e., between the order of 200 nm and a few microns. A possible length scale would be, for example, a common martensite island diameter that would give rise to many sites of similar depth in case of through-thickness cracks. We note that we do indeed observe a drop in damage sites towards smaller depths of 1 slice (200 nm thick), consistent with this observation and a preliminary analysis of the cross-sectional view but cannot quantify depth further below this threshold.

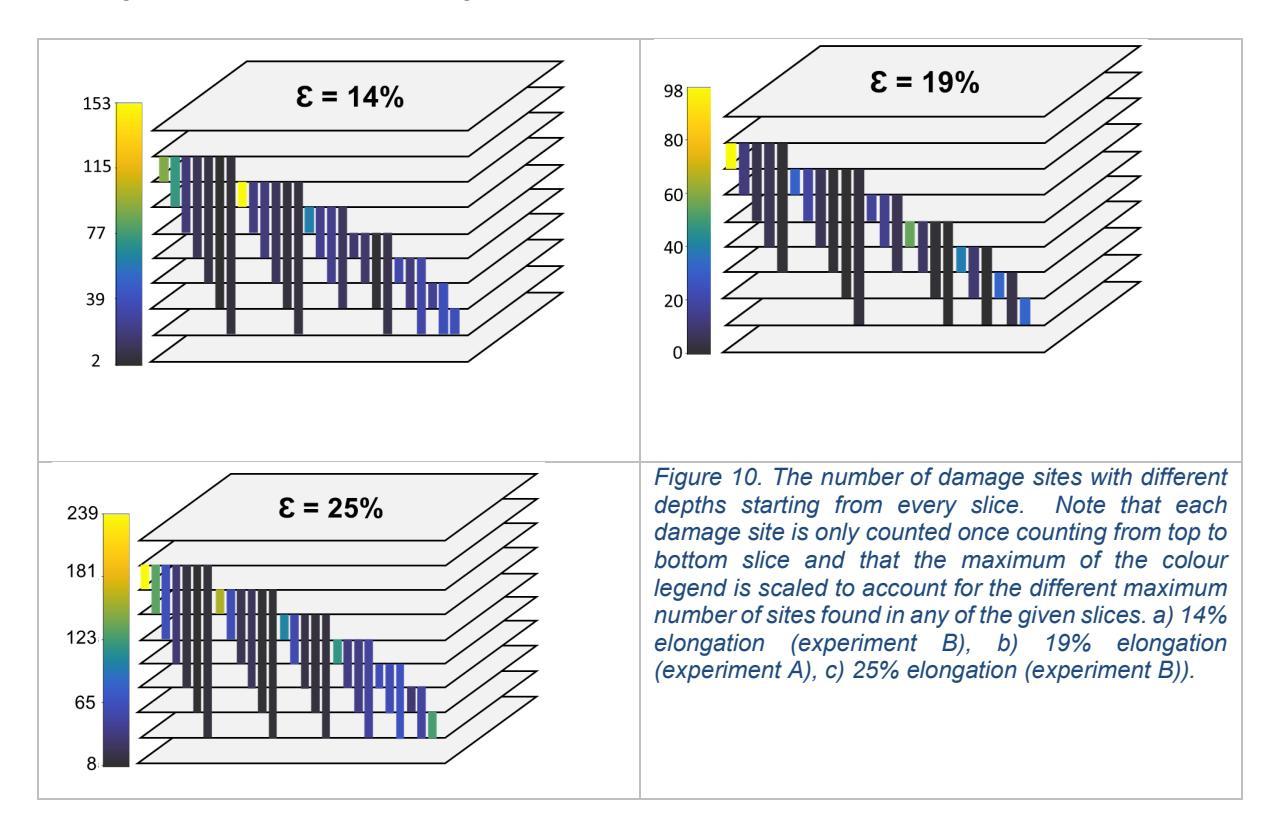
in slicing direction. We observe the same trend in Figure 10. In this figure, the number of damage sites that exist in any given slice are shown together with the depth to which these damage sites extend. The lighter colour of the short bars highlights the majority of the damage sites occupying up to two slices in depth. In these visualisations the colour scheme always remains the same, but the maximum value differs to account for the different maximum number of sites found for a given depth. In this way, we identify that the distribution of damage sites appears largely homogeneous, i.e., fluctuations are not systematic, with the exception of the larger number of small damage sites towards the surface.

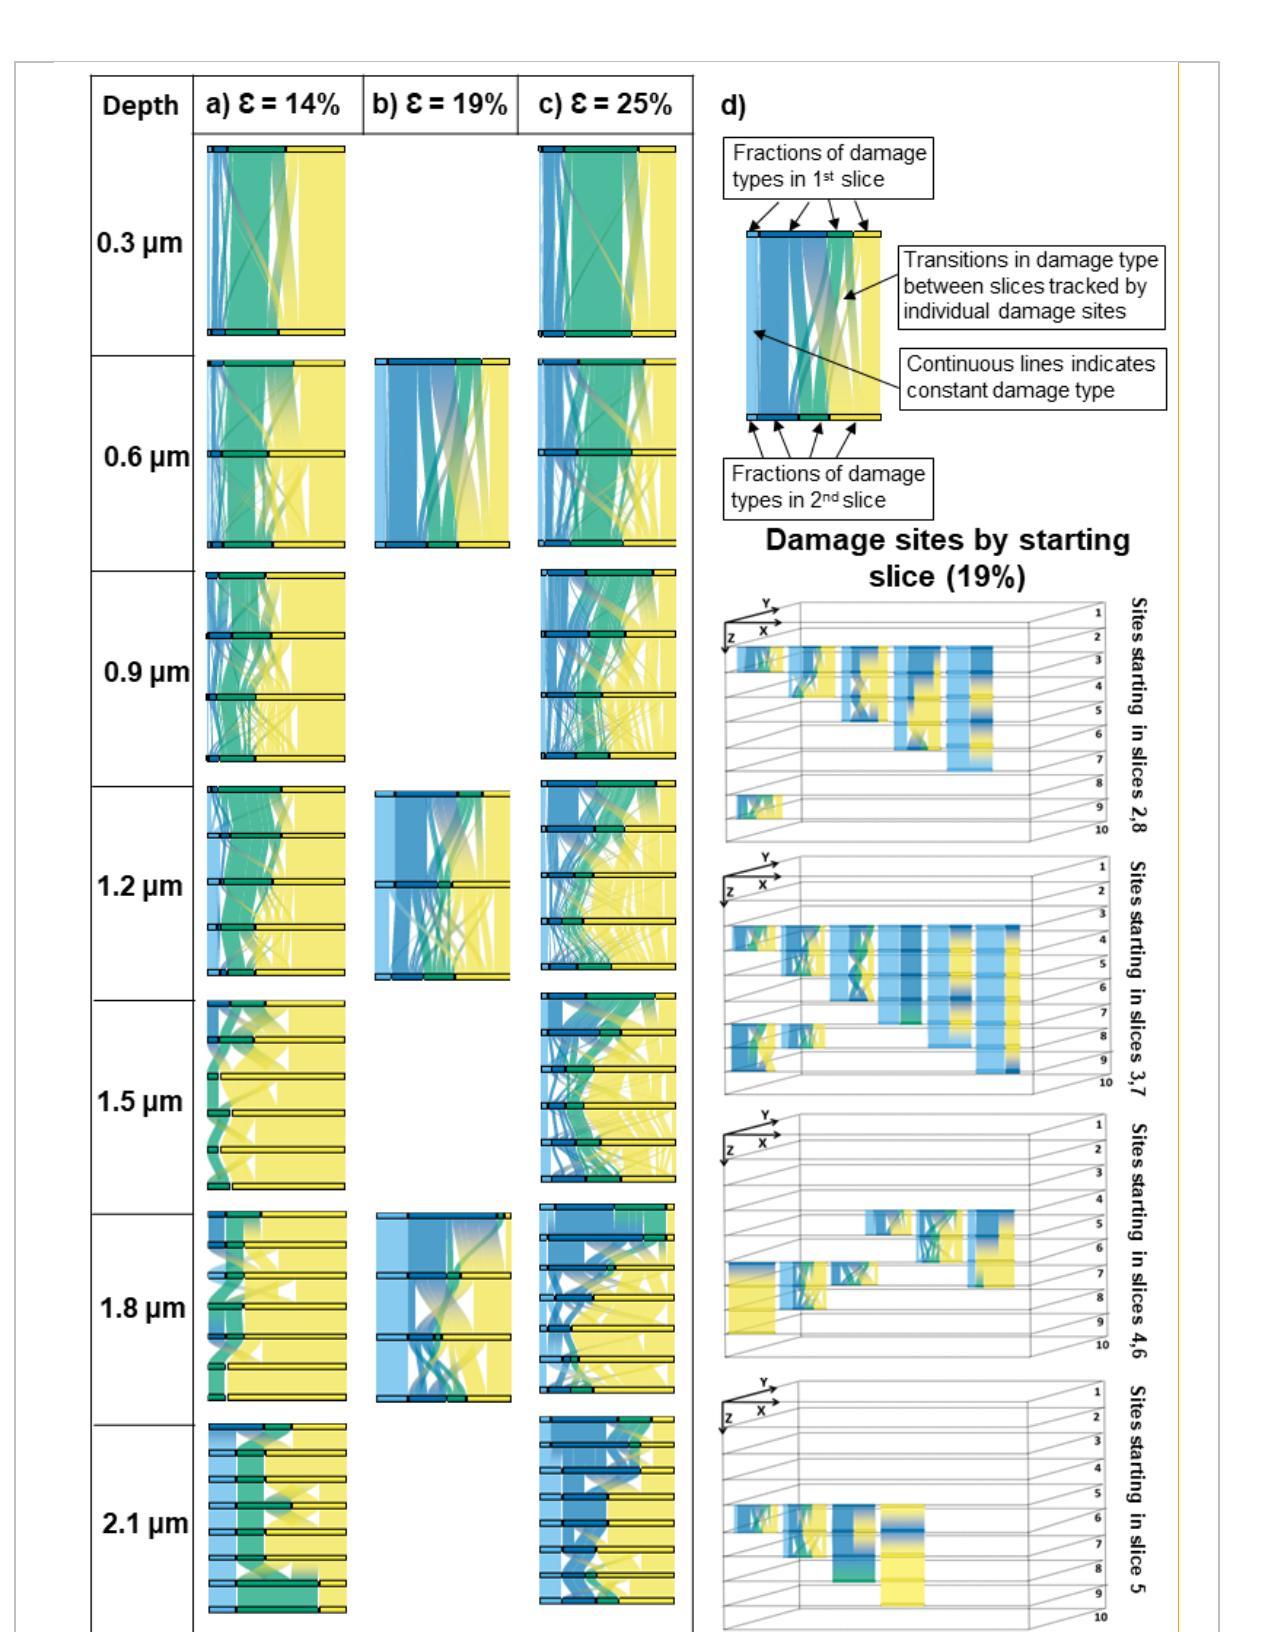
Figure 11. Sankey diagrams by sample elongation and damage site depth tracking the 2D classification of damage sites in 3D. Colours identify damage type, horizontal bar width indicates type fraction at the given site depth and vertical connections trace damage type evolution along the depth for all damage sites individually. Colours (from left to right): Light blue: inclusion, blue: interface decohesion, green: notch effect, yellow: martensite cracking.

Figure 11.a,b, and c show the corresponding details in Sankey diagrams for the samples subjected to 14%, 19% and 25% strain, respectively. As an example, consider the case of all damage sites in the volume that are two slices deep in the sample subjected to 19% elongation, that is the topmost plot shown in Figure 11.b Each damage type occurs both in the first and in the second slice. The overall fraction of inclusions (light blue) and sites classified as 'notch effect' (green) remain approximately constant. However, while nearly all inclusions preserve their types along the depth, about half the notch sites present as either interface decohesion (dark blue) or martensite cracking (yellow) in the adjacent slices. Interface decohesion is more prevalent at the top of those damage sites which are two slices deep, whereas martensite cracking is more prevalent in the lower half. This is reflected in the connections between the colours indicating the damage type with the thickest connections running from the blue interface decohesion sites to the yellow martensite cracking sites. We will assess the implications of these plots in the discussion but note here that for the small damage sites continuing through only two slices, these plots can then be interpreted as follows: small inclusions do not induce ductile damage vertically in the surrounding slices which are at a distance of approximately 500 nm above and below. This is in contrast to the deformation induced damage, which shows frequent type transitions. Considering the deformation induced damage sites, we see that the microstructure, containing a complex martensite morphology that is far from globular (Figure 1), leads to many instances of 'notch effect' sites. They can be either small in all dimensions or they can be small within the x-y plane in which they were classified only but extend far into the z-dimension. The first is to be expected for the shallowest damage sites associated with thin martensite struts. Accordingly, the majority of these sites remains thin also in the z-direction, reflecting the branched martensite structure. However, there are also a large number of these sites that are associated with thicker parts of a martensite island above or below. In these cases, the damage mechanism can therefore be identified more clearly as interface decohesion or martensite cracking in the adjacent slice and both of these occur in conjunction with notch sites. As expected, the class 'notch effect' therefore necessarily comprises two sub-classes which cannot be distinguished based on 2D analysis alone: instances of very small damage sites where the martensite becomes very thin and instances that only look small in crosssection, where the slice runs through a thin part of a bigger martensite island. We also note that there are fewer martensite cracking sites in the top layer than in the bottom layer, which in contrast exhibits more interface decohesion sites. The reason for this may not be deduced from knowledge of the microstructure and the individual diagram alone and must be investigated later after considering the entire dataset.

The following phenomena have been generally observed in Figure 11:

The inclusions, as the material's inherited damage from synthesis and processing, remain mostly isolated, that is they are not usually associated with deformation induced damage above or below, regardless of their size. We also note that the different fractions of inclusion sites, with the sample strained to the intermediate strain of 19% showing the highest value, remain approximately constant in their relative number. That is, inclusions tend to become more frequent towards larger sizes and, in the sample with higher inclusion density, their fraction remains higher throughout.

Comparing the distribution of the damage sites at different strains, that is from left to right in Figure 11a-c, reveals that there is transition from martensite being dominant at small strain to interface decohesion making up an increasing fraction of damage sites with increasing strain.

In looking at the data from top to bottom, which is from shallow to deeper sites extending through several slices, we note that shallower damage sites show a higher fraction of sites classified as notch effects. As the damage sites become deeper, several transitions between different types become more frequent. Considering these transitions, we note two further observations: First, that in general there appears to be an imbalance in the distribution of interface decohesion sites with them becoming more pronounced towards the top of the analysed damage sites and , second, that across those damage sites which extend through several slices, a 'yellow belly' tends to develop, indicating that the centre of the damage sites consists of a cracked martensite island while above and to an apparently smaller extent also below, the martensite cracks extend into interface decohesion sites.

Comparing the proportion of the identified mechanisms at damage sites in Figure 11, we observe that with increasing strain, the dominant mechanism changes from initial martensite cracking to interface decohesion. This is consistent with previous observations elsewhere [11, 14, 51]. In addition, at the highest strain, a larger fraction of sites is identified as notch effect as a result of localised plastic strain at the ferrite regions between closely spaced martensite islands and thin martensite particles surrounding ferrite matrix, as shown by Ahmadi et al. [30]. In addition, this highlights that, as straining proceeds, further sites of local stress concentration are activated. Overall, this finding is in agreement with the findings of Avramovic-Cingara et al. [32], in that for microstructures with banded martensite, cracking rather than interface decohesion appears to govern damage formation.

Next, we consider not only individual, exemplary sites, but many sites - all analysed in 3D and with identified mechanisms tracked for each site individually. In the results shown in Figure 11, containing Sankey diagrams of damage site evolution arranged by strain and void depth, we explore the additional dimension our method offers, namely that we go beyond statistical evaluation of many sites in consecutive slices towards tracking the evolution of each site through the volume, so that transitions in prevalent mechanism appearing in the 2D views are physically connected rather than purely statistical. Owing to the large number of sites contained in our 3D volumes, we can then in turn study the underlying trends revealing the most common 3D morphologies of damage sites and with them the likely interplay of mechanisms giving rise to them.

The distribution of the type of the damage sites along the depth in Figure 11 shows that martensite cracking is not only present as a major mechanism in terms of its fraction at all strains, but we also note that it tends to occur at the centre of damage sites. In almost all cases where the damage site extends to more than two slices, the middle slices are predominantly occupied by martensite cracks, and the relative proportion changes to mostly interface decohesion or notch effect towards the upper or lower boundaries of the damage sites. This

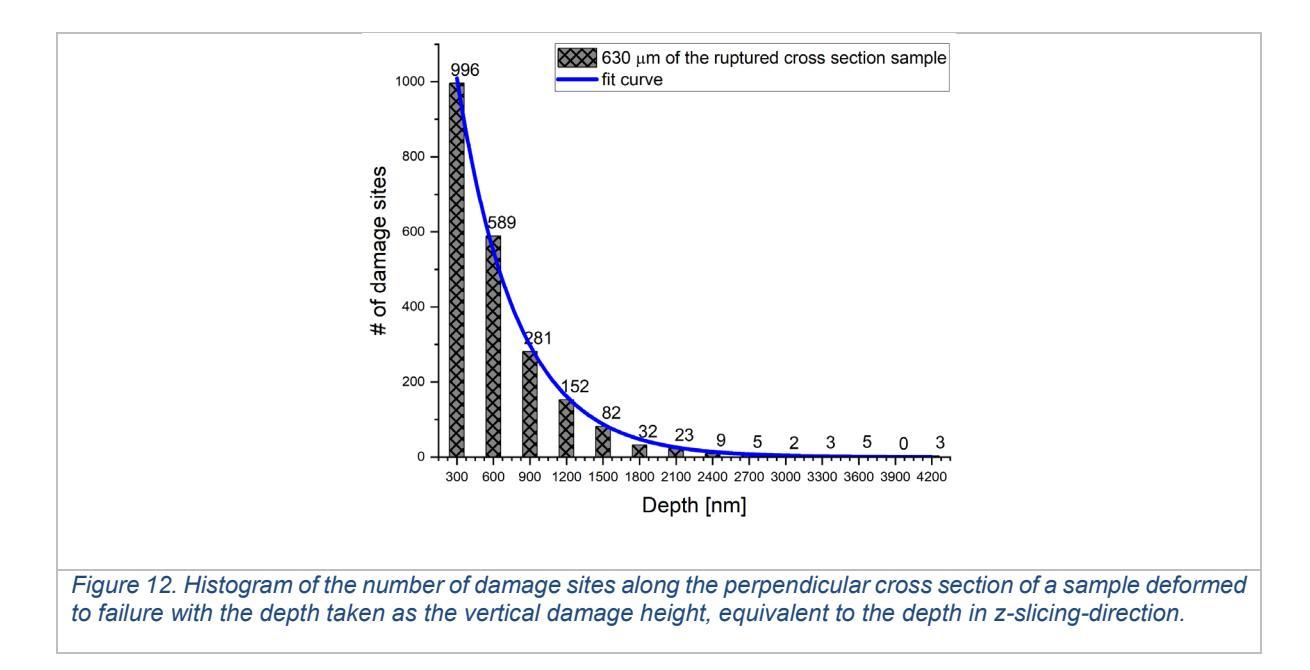
to the same physical dimension as analysed from the sliced volume. The cross-sectional analysis of the number of damage sites is shown in Figure 12 An exponential function again fits this data of the number of damage sites as a function of their depth well. More importantly, we also note that towards large damage depths, the number of sites exceeding our analysed depths of the order of $2 - 4 \mu m$, depending on slice thickness, is very small. While the coalesced sites leading to material failure may therefore escape this kind of analysis, for the description of damage evolution during plastic deformation at plastic strains well before failure, as is the intention here, the investigated depth contains a representative distribution of damage sites in terms of their depth. Encountering again an exponential distribution of depths for damage sites is in fact consistent with the particular microstructure present in the DP800 steel, which is characterised by a highly inhomogeneous and branched out martensite distribution, e.g. where martensite islands of similar dimensions exhibit through-thickness cracking. In other dual phase microstructures this may well occur and should be easily revealed by a similar analysis.

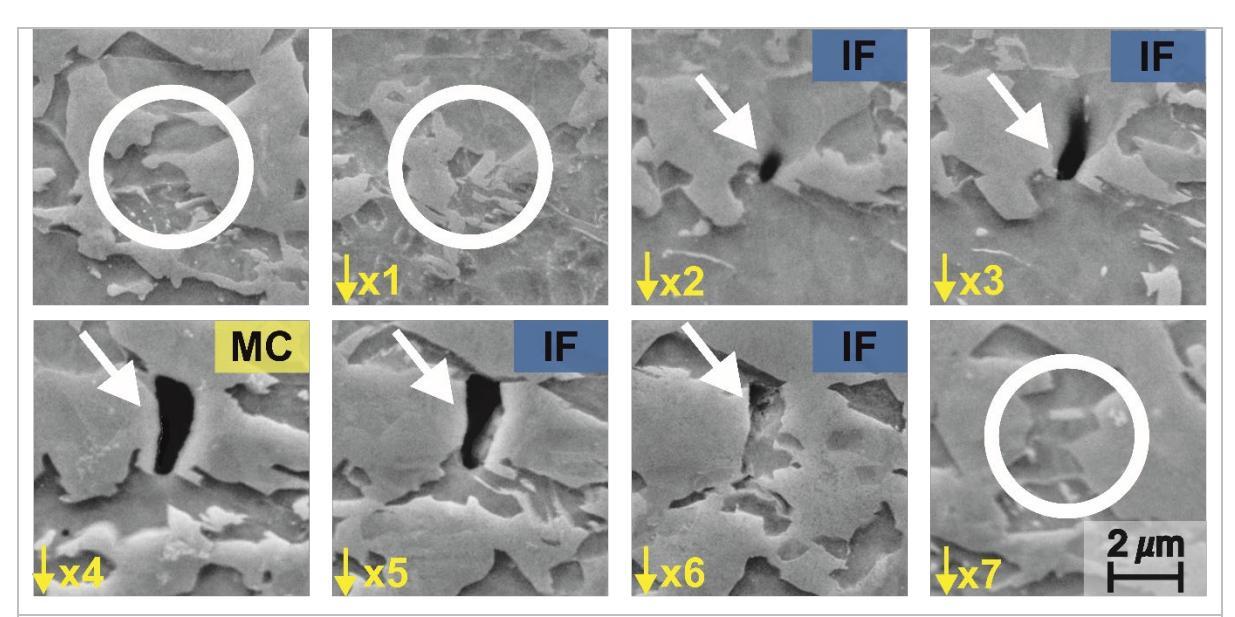
Figure 13 illustrates the local information and changing damage type identified in 2D across 8 slices for a damage site extending across five slices that were 0.5 µm apart in the sample strained to 19%. There is no apparent damage in the uppermost two slices (the number of slices in z-direction are indicated in each successive image taking the top left as the reference slice, e.g., \downarrow x1). As we go deeper, a damage site appears at the depth of 1 µm, in the slice marked with \downarrow x2. The damage continues to the next slice, marked with \downarrow x3, and appears as a black pore in both slices showing the characteristics of interface decohesion, i.e. a rounded appearance with clear flow into the ferrite phase. Hence, if we were to analyse each of these slices, we would attribute these damage sites to interface decohesion, where the damage is surrounded partly by the martensite island. However, as we ablate further material, we find that underneath, the two islands appear to have formed a larger block that fractured by a through thickness martensite crack (\downarrow x4, \downarrow x5). The damage is again identified as interface decohesion in the lower of these slices (\downarrow x5), highlighting the difficulty in classifying evolved damage sites that show signatures of both cracking (parallel fracture surfaces) and flow into the ferrite from the interfaces (at the bottom end of the void imaged in slice \downarrow x5). In the last

slice containing the void, $\downarrow x6$, it is adjacent to only one martensite island, giving again an interface decohesion site in 2D, before finally disappearing in slice $\downarrow x7$.

Figure 13. An example of a damage tracking along the z-axis and illustration of its varying appearance in different slices of the same site. The images belong to the sample with 19% strain and 500 nm slicing thickness. The white circles indicate the damage free surfaces at that specific depth, where the damage is found in the other slices at the same coordinate.

If we were to look at only individual slices in this case, then the top slice as well as $\downarrow x1$ and $\downarrow x7$ would suggest that in spite of the closely positioned martensite islands, no damage is induced in the vicinity. In contrast, slices $\downarrow x4$ and $\downarrow x5$ suggest fracture of a large, blocky martensite island, while slice $\downarrow x6$ would imply a plastic decohesion of the ferrite from only one of the two martensite islands. However, the analysis across the three-dimensional evolution of the damage site reveals that the underlying cause of damage is a crack in the central martensite component. We note that, in spite of this, three to four out of the five slices through the damage site suggest flow in the ferrite to dominate. There is therefore a clear difference between what we find is the likely nucleation site and mechanism of damage here and how the site spreads into the volume. This is to be expected and commonly considered as the two stages of damage nucleation and growth. However, a clear challenge arises when these stages cannot be told apart in an analysis. We propose that in 2D view this is not possible and that counting of damage sites alone in individual or independent slices will invariably conflate nucleation and growth.
