The version of record of this article, first published in Diamond and Related Materials, Volume 146, June 2024, 111247, is available online at Publisher's website: https://dx.doi.org/10.1016/j.diamond.2024.111247

Evolution of radiation-induced damage in nuclear graphite – a comparative structural and microstructural study

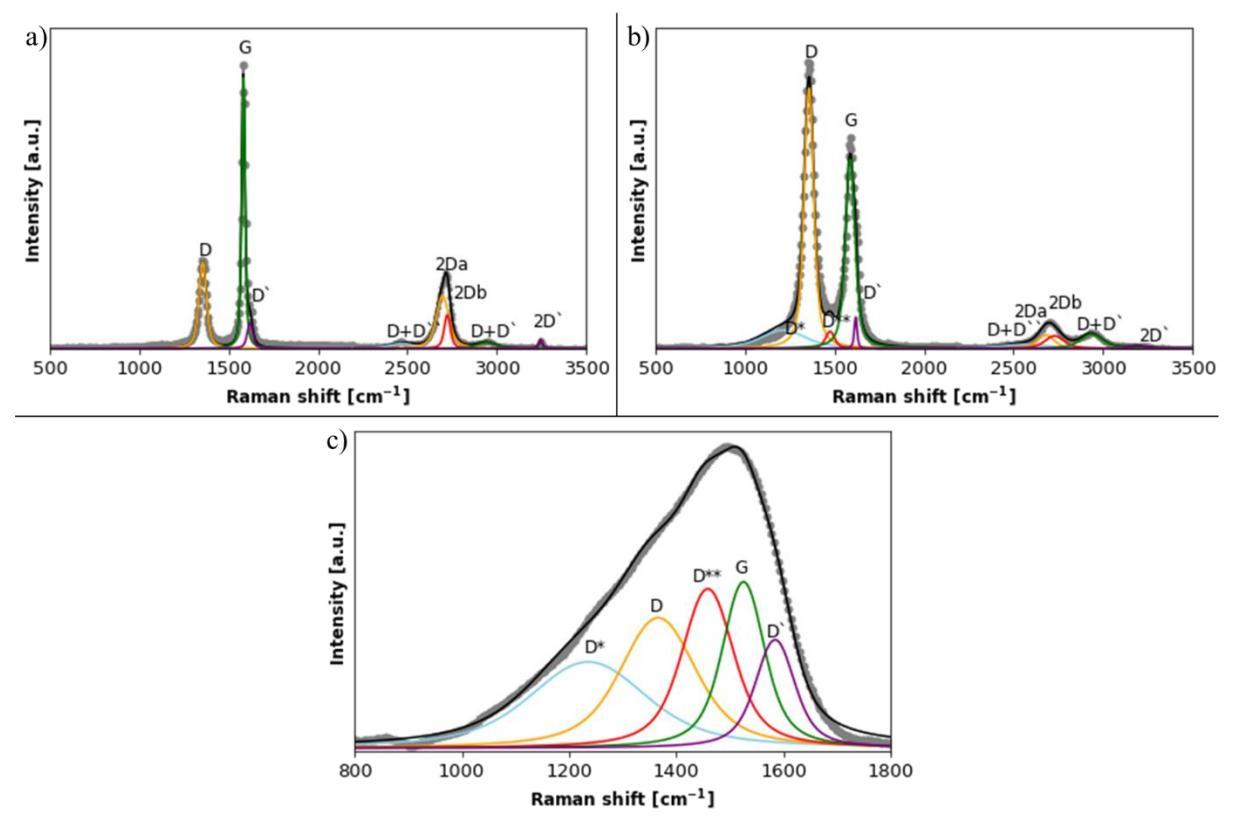
Figure 1. Exemplary Raman spectra of IG-110 graphite irradiated with Ar⁺ ions with fluence of 1E12 ion/cm² (a), 3E13 ion/cm² (b) and 2E17 ion/cm² (c) fitted with Voigt function, presented with bands assignment.

Changes in the studied materials' structure resulting from irradiation were observed ex-situ using a confocal Raman microspectrometer WITec alpha 300R (Oxford Instruments, UK), equipped with a CCD camera. Samples were excited with 532 nm Nd:YAG laser with 2.4 mW power applied to avoid inducing additional structural changes and surface damage. Spectra were collected using x100 lens in the range from 100 to 3600 cm⁻¹ with 30 s acquisition time operated by the Control 5.2 software. Multiple point measurements were conducted on the samples, facilitating the selection of the most representative spectrum reflecting the impact of ion implantation on the sample with ease. The first stage of data processing covered the cosmic ray removal (CRR) and the baseline correction, using polynomial functions in the WITec Project FIVE 5.2 PLUS software. Then the spectra were exported and further analysed in Python environment. In order to accurately determine the parameters of the spectrum, Voigt functions were fitted to individual bands, the convolution of which coincided with the shape of the obtained Raman spectra [18]. The adopted fitting assumptions resulted in 97% compliance level, calculated using the least square method. To ensure an adequate and repeatable fit, the range of wavenumbers corresponding to the occurrence of individual bands was determined by referencing literature values and expanded to accommodate potential shifts of these bands. Accordingly, the D band must fall within the range of 1300 1420 cm⁻¹, the G band within 1500-1610 cm⁻¹ and the D' band within 1600 1650 cm⁻¹[19]. Exemplary spectra with fitted functions are presented in Figure 1. For non-irradiated samples and low doses (Fig. 1a), three Voigt functions were fitted to first-order bands (range between 1300 to 1700 cm⁻¹) and five Voigt functions to second-order bands (2400 to 3300 cm⁻¹) [20], [21]. However, the analysis of spectra of highly defective samples (e.g., irradiated at fluences higher than 3E13 ion/cm², Fig. 1b-c), demanded taking into the account two additional bands, D* and D**, in the fitting process. Therefore, within the range of first-order Raman bands (between 1300 and 1700 cm⁻¹), five Voigt functions were applied. According to findings in the literature, the D** band originates from amorphous graphite and typically appears between the D and the G bands, thus the range was limited to 1450-1520 cm⁻¹. On the other hand, the D* band can be attributed to graphite lattice defects, sp³ vibrations, or the presence of oxygen groups, and typically appears in range of 1000 -1300 cm⁻¹[21], [22], [23], [24]. For the most defective samples (such as those irradiated at 2E17 ion/cm²), it was impossible to achieve a good fit for the second-order bands due to their enormous width, very low intensity and overlapping.

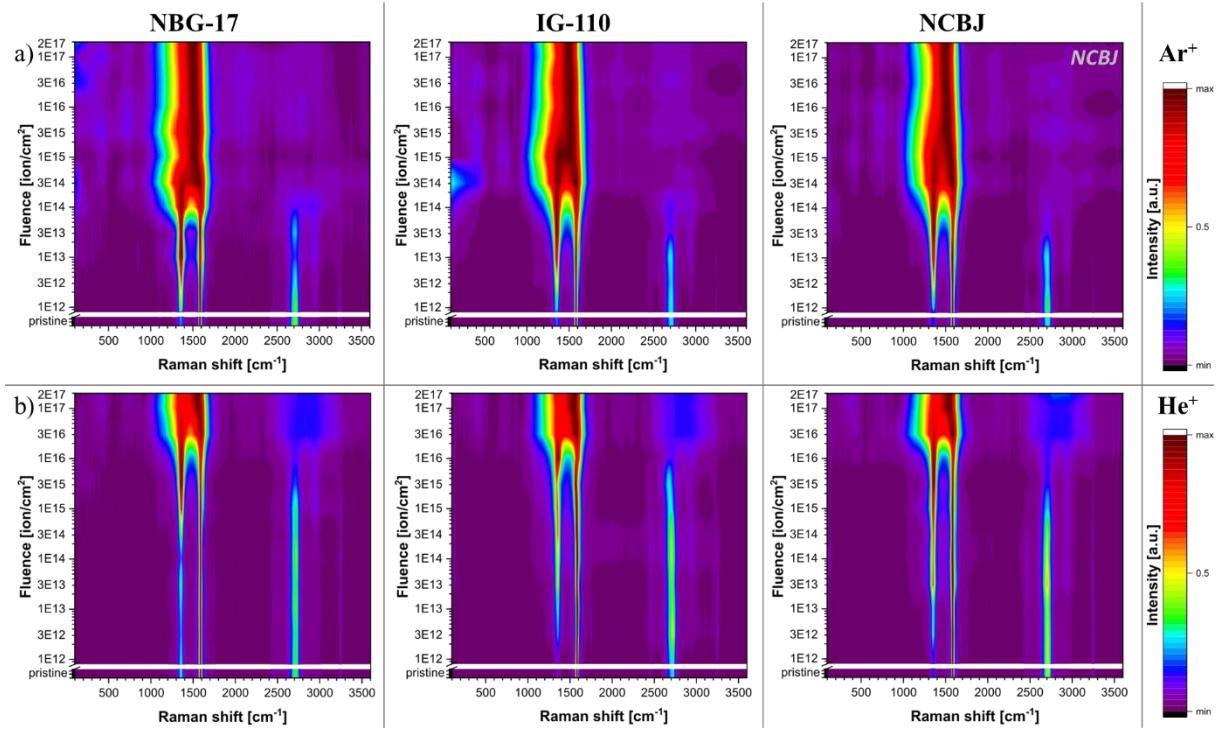
Raman spectra of nuclear graphites before and after irradiation were presented in the form of topographic plots (Fig. 2). The OY axis represents rising radiation dose, whereas, the colour evolution indicates intensity. Before plotting, spectra were normalised for easier evaluation. Structural evolution of the material is clearly visible by increase of the intensity of the D band approx. at 1350 cm⁻¹, shift of both D and G bands, their broadening up to the point where only one broad complex band is visible. This is assisted with second-order bands fading. Moreover, these effects may be observed at lower value of fluence for the heavier Ar⁺ ions (Fig. 2a), whereas structural deterioration for lighter He⁺ ions irradiation requires a significantly higher dose (Fig. 2b). The fluence and dpa corresponding to the key points of Raman spectra profile evolution are gathered in Table 2. It may be noticed, that the significant broadening of the D and G bands and further combining of the bands (associated with amorphisation) occurs at significantly higher dose and dpa for He⁺ than for Ar⁺, with the exception of IG-110 graphite.

Figure 2. Topographic plots of Raman spectra evolution of nuclear graphites under irradiation with Ar^+ (a) and He^+ (b) ions.

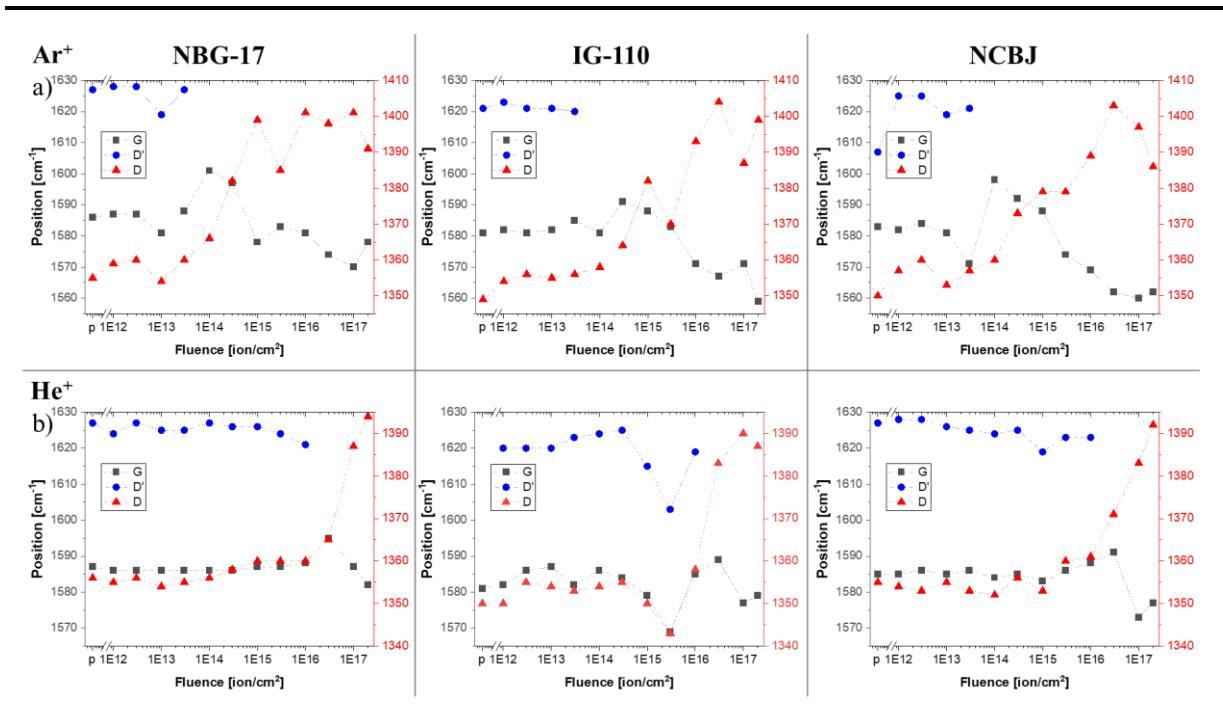
Figure 3. Plot of G, D and D' bands positions as a function of irradiation fluence for samples irradiated with Ar⁺ (a) and He⁺ (b) ions.

The results of the positions, intensity and FWHM of Raman bands (particularly G, D and D') were obtained by fitting the Voigt function to the individual spectra in the Python environment for three types of graphite at every fluence (Fig. 3-4). By comparing them, one can observe that the tendency of spectral changes with increasing fluence has the same character. For low doses, the D and G bands can be clearly distinguished. The graphite-derived G band is narrower and has higher intensity than the D band. However, with an elevation in fluence, the relative intensity of the D band experiences a noticeable surge. With higher fluence, analysed bands become broader. Moreover, a shift of the position of the D band towards higher values of wavenumbers can be clearly observed. The increase in intensity of the D band at approximately 1350 cm⁻¹, along with the shift and broadening of both the D and G bands in the Raman spectrum of irradiated graphite, suggests significant structural alterations in the material. Specifically, the D band intensity enhancement often indicates the presence of defects, disorder, or the introduction of sp³hybridized carbon domains within the graphite lattice due to ion irradiation. These alterations indicate an increasing level of defects and disorder between the graphite layers after irradiation, accompanied by a diminution of crystallite size towards nanocrystalline graphite. Furthermore, the shift and broadening of the D and G bands imply changes in the carbon bonding environment and the formation of disordered carbon structures, possibly arising from lattice distortions, or vacancies, which contribute to the further amorphisation of the structure induced by irradiation. Nevertheless, position fluctuation of the G band is more complex: it remains stable or slightly rises with low irradiation dose, and after reaching a threshold value shifts strongly towards lower wavenumbers. The dynamics of these effects differ among the used ions. In case of Ar⁺ ion irradiation, broadening and, hence, overlapping of the D and G bands occurs above the fluence of 3E14 ion/cm². Changes in Raman spectra obtained from graphites irradiated with He⁺ ions begin to occur at higher fluence of 1E16 ion/cm². Up to this level, the D' band and the G band are clearly distinguishable, and second-order bands can also be decomposed from the spectra profile. As the positions of the D and G bands shift, and their FWHM widen, they consequently overlap. It indicates an increasing level of defects and disorder between the graphite layers after irradiation, diminish of size of crystallites towards nanocrystalline graphite (detailed description in the following sections of the article) and further amorphisation of the structure [25], [26]. The observed discrepancies in spectra of samples implanted with different ions result from size and mass differences of used ions. Irradiation with He⁺ ions, which are much lighter than Ar⁺ ions, introduces a smaller amount of defects. This is also confirmed by the 25 times higher number of displacements per atom (dpa) after irradiation with Ar⁺ compared to He⁺ (Table 1). Despite the diverse paths and kinetics of defect formation, at the highest fluence, the level of structural damage is similar for both types of bombarding ions. This similarity is evidenced by comparable values in both the positions (Fig. 3) and FWHM (Fig. 4) of the G band.

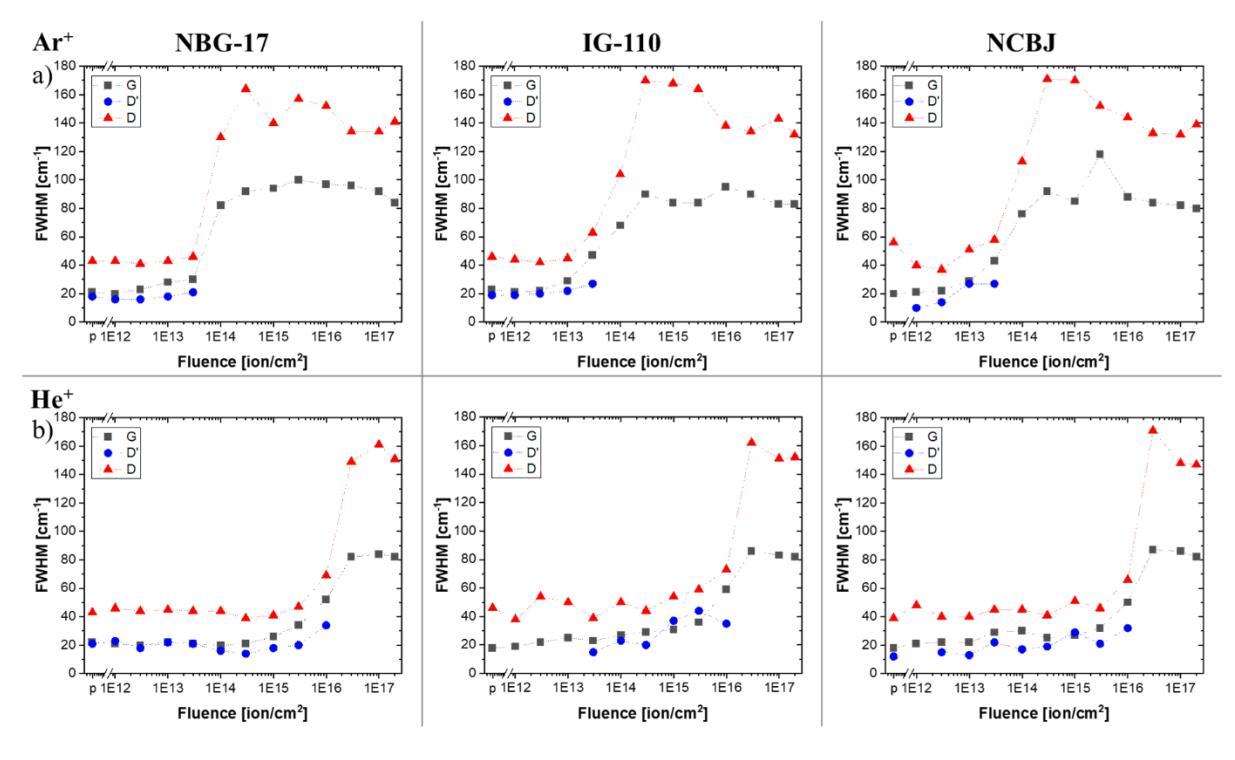
Figure 4. Plot of the full width at half maximum (FWHM) of G, D and D' bands as a function of irradiation fluence for samples irradiated with Ar⁺ (a) and He⁺ (b) ions.

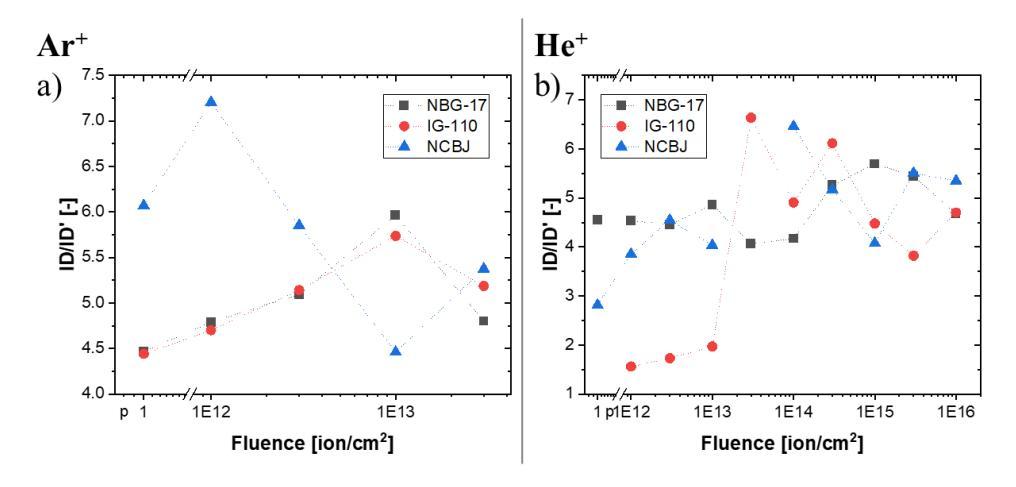
of defects and their evolution with ion irradiation fluence were determined (Fig. 5). It should be emphasised that the presented graphs were generated only for fluences at which the determination of the D' value was possible (for samples with fluence smaller than 1E14 ion/cm² for Ar⁺ and 3E16 ion/cm² for He⁺).

Figure 5. Dependence of the $\frac{I_D}{I_{D'}}$ ratio on the irradiation dose for Ar^+ (a) and He^+ (b) ions.

The evolution of the $\frac{I_D}{I_{D'}}$ ratio becomes apparent already at low fluences of Ar⁺ ion (Fig. 5a) and it can be stated that irradiation with Ar⁺ ion introduces both types of defects: vacancies and edge defects. The presented results suggest differences in the types of defects in non-irradiated graphite samples. For pristine IG-110 and NBG-17, boundary-like defects ($\frac{I_D}{I_{D_r}} \approx 4.5$) were prevalent. The presence of different types of defects in nonirradiated graphite samples, such as boundary-like defects in IG-110 and NBG-17, and vacancy-like defects in NCBJ graphite, has significant implications for the overall structural stability of the materials. Boundary-like defects, typically observed in IG-110 and NBG-17, may indicate the presence of structural imperfections at the boundaries of crystalline regions. These defects could potentially weaken the material's structural integrity, making it more susceptible to damage under irradiation. On the other hand, vacancy-like defects prevalent in NCBJ graphite suggest the presence of vacancies within the graphite lattice, which can lead to localized distortions and dislocations. While these defects may not inherently compromise the material's structural stability, their presence could facilitate the nucleation and propagation of damage under irradiation. As the fluence increased, the point defects started to be created and become predominant in these materials at fluence 1E13 ion/cm². However, at higher fluence this ratio started to decrease, suggesting that vacancies began to agglomerate, forming dislocation loops and increasing the amount of edge defects [27]. In contrary, for NCBJ graphite, the vacancylike defects were prevalent $\left(\frac{I_D}{I_{D'}} \approx 6\right)$ for a non-irradiated sample. Similarly like in case of the other materials, initially the number of vacancies multiplies. However, the evolution of the vacancies into clusters and dislocation loops took place at lower doses. This suggests that the process of defects generation and their evolution is much more dynamic in NCBJ graphite than in other studied materials. This indicates the less stable and more defective structure of the NCBJ graphite compared to other materials.

In the case of He⁺ irradiated graphites (Fig. 5b), the evolution of the $\frac{I_D}{I_{D'}}$ ratio with increasing fluence is more gradual. This is associated with the slower damage rate of the material at increasing fluences, attributing to the smaller mass and size of Helium atoms. Moreover, the dispersion of value in this ratio is much greater, indicating the continuous evolution of defects. The analysed materials exhibit a similar trend of changes as observed under Ar⁺ irradiation: vacancies appears initially ($\frac{I_D}{I_{D'}}$ ratio raises up to 7) and then they start to agglomerate, forming dislocation loops ($\frac{I_D}{I_{D'}}$ ratio drops). Then this process repeats. However, pristine graphites show discrepancies from the previous analysis, suggesting the inhomogeneity of the measured materials. Nevertheless, this issue does not affect the observed trend of changes. Furthermore, the creation of vacancies takes place at higher fluences compared to Ar⁺ ions and varies among the different materials. NBG-17 reaches the maximum number of vacancies later than the other samples, and the evolution of the $\frac{I_D}{I_{D'}}$ ratio is smoother, indicating the most stable structure among the studied materials.

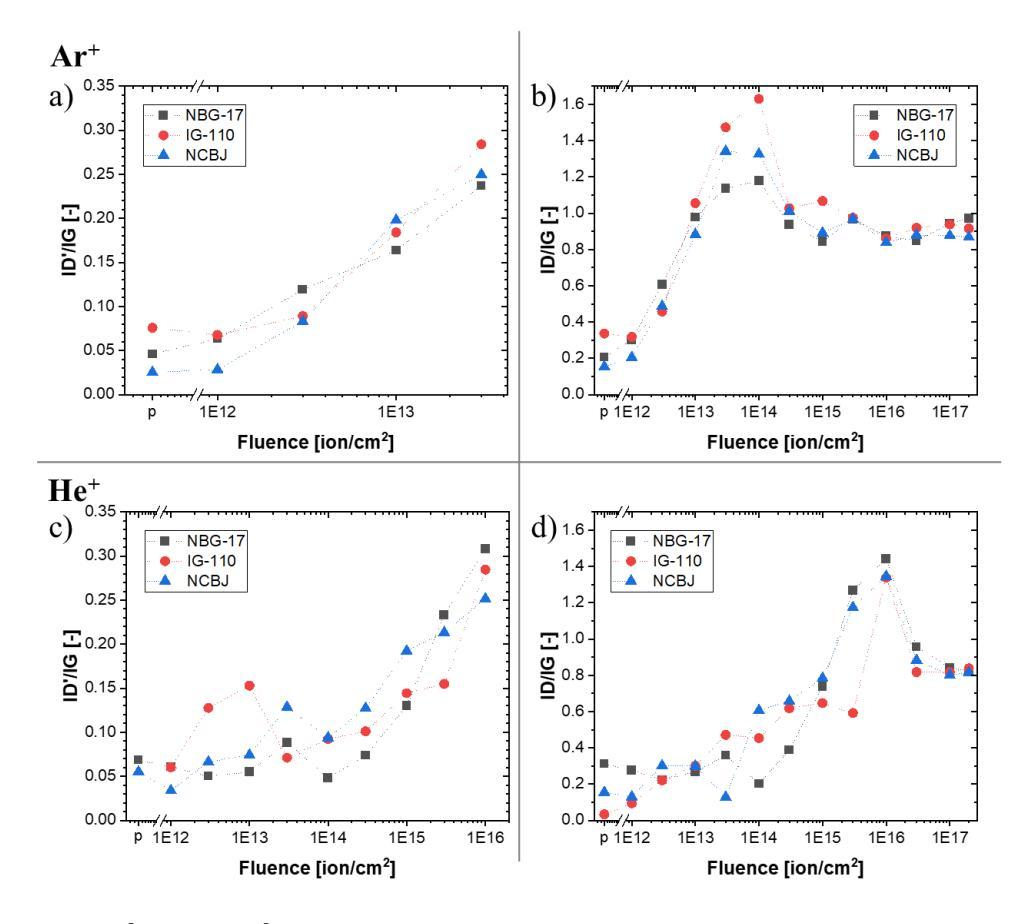
A broader analysis of the level of damage in the structure in each of the nuclear graphites was conducted based on the relationship between the intensity of $\frac{I_D}{I_G}$ and the applied fluence of irradiation (Fig. 6). According to the work [28], in the case of a small defect

Figure 6. Plot of the $\frac{I_{DI}}{I_G}$ (a, c) and $\frac{I_D}{I_G}$ (b, d) intensity ratios as a function of irradiation fluence after irradiation with Ar^+ (a, b) and He^+ (c, d) ions.

concentration, when the average distance between the atoms is large, ion bombardment reduces the dimensions of the ordered structure, but does not significantly affect the number of hexagonal rings. This causes the intensity of the D band to rise with increasing fluence. On the other hand, at high fluence, if the long-range order is reduced to a short-range order with dimensions comparable to those of hexagonal rings, a significant reduction in the D band intensity is expected. These results confirm that for Ar⁺ ion irradiation a lower number of defects was formed in NBG-17 at low fluences (to the value of 1E14 ion/cm²) than in the case of NCBJ and IG-110 graphite. For higher doses, the amount of defects in all three types of graphite is similar. In case of He⁺ ions, the $\frac{I_D}{I_G}$ ratio in

NBG-17 graphite begins to enlarge at higher fluences, so defects occur at higher fluences compared to other graphite samples. However, at high fluences, the $\frac{I_D}{I_C}$ ratio converges to

a similar value for all types of graphite. This indicates a lower impact of low fluence of He⁺ ions on the amount of structural defects in the case of NBG-17 graphite than in other samples, and a similar degree of defect for high fluences in all types of samples. Referring the obtained information to the results after irradiation with Ar⁺ ions, it can be seen that in all samples the level of defects escalates faster (at lower fluences) and finally reaches a higher value than for He⁺ irradiation. This is in line with the simulated structural failure (dpa), which is significantly lower for He⁺ than Ar⁺ ion irradiation. He⁺ ions, being lighter, introduce a smaller amount of defects per ion impact compared to Ar⁺ ions, resulting in a delayed onset of structural changes. This is attributed to the greater energy deposition per ion collision, leading to the formation of larger defects and increased structural disorder within the graphite lattice [29]. Based on the graph, it can be concluded that after He⁺ irradiation loss of crystallinity is achieved by NBG-17 graphite at the latest.

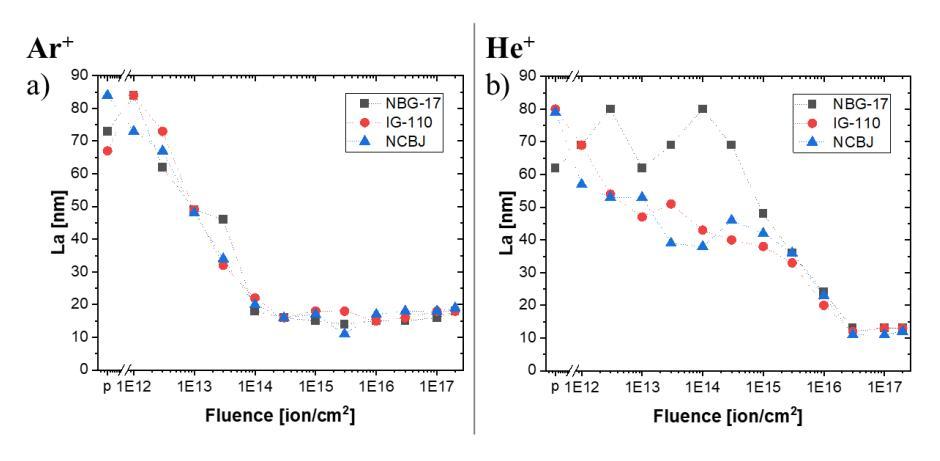
Figure 7. Evolution of size of crystallites after irradiation with Ar⁺ (a) and He⁺ (b) ions.

The evolution of nuclear graphite structural disorder after ion irradiation can be assessed by depicting the relationship between the crystallite size and fluence (Fig. 7). Analysing the results obtained for Ar^+ ions irradiation (Fig. 7a), the minimal size of crystallites is achieved at a fluence of 1E14 ion/cm² and higher. Prior to this point, a steady linear decrease can be observed from the lowest fluence. This implies a rapid transition of the material into nanocrystalline form and subsequent amorphisation. This indicates that the damage induced by irradiation leads to the fragmentation and dissolution of crystalline regions within the graphite lattice, resulting in the formation of smaller crystallites and eventual loss of long-range order. In contrast, He⁺ (Fig. 7b) irradiation resulted in a stepwise plot of the La curve, indicating a delay in the materials' transition into nanocrystalline graphite and amorphisation occurring at a fluence of 3E16 ion/cm². This indicates path and rate of amorphisation, consistent with other presented results. However, NBG-17 exhibits the largest crystallite size up to fluence of 1E15 ion/cm². This also confirms previous results, that NBG-17 presents the slowest loss of crystallinity. Despite differences in the dynamics, the final size of crystallites is coherent for all three types of graphite under irradiation with both ions. Although the calculation of crystallite size in Figure 7 may still yield a value at the highest damage level, it is important to note that this measure represents the size of the remaining crystalline domains rather than the overall structural state of the material. Even in heavily damaged samples, there may still be localized regions or domains with some degree of crystallinity, which can contribute to the observed crystallite size measurement. However, the broadening and merging of the D and G bands indicate that the majority of the material has lost its long-range order and has transitioned into an amorphous or nanocrystalline state, despite the presence of residual crystalline domains.

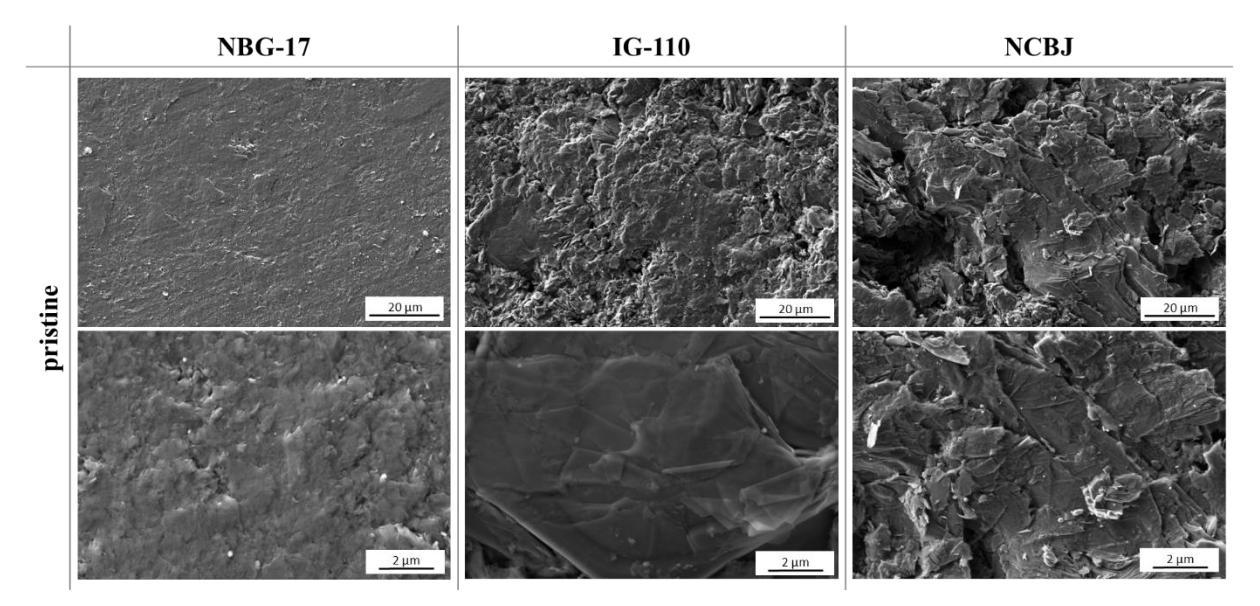
SEM observations covered pristine samples and materials after irradiation (Fig. 8-10). The focus was put on the fluence values where crucial structural and morphology changes were induced by ions. Figure 8 presents SEM images of pristine nuclear graphites, namely NBG-17, IG-110, and NCBJ, at low and high magnification. Clear differences in morphology are evident among these materials. At lower magnifications, NBG-17 exhibits the lowest surface roughness, followed by IG-110 and NCBJ with increasing roughness. Upon closer examination at higher magnifications, the pristine NBG-17 sample possesses a distinct microstructure consisting of numerous small, compact flakes. IG-100 presents a microstructure characterised by large, flat areas, while NCBJ graphite exhibits more pronounced surface heterogeneity.

Figure 8. SEM images of the pristine nuclear graphites.

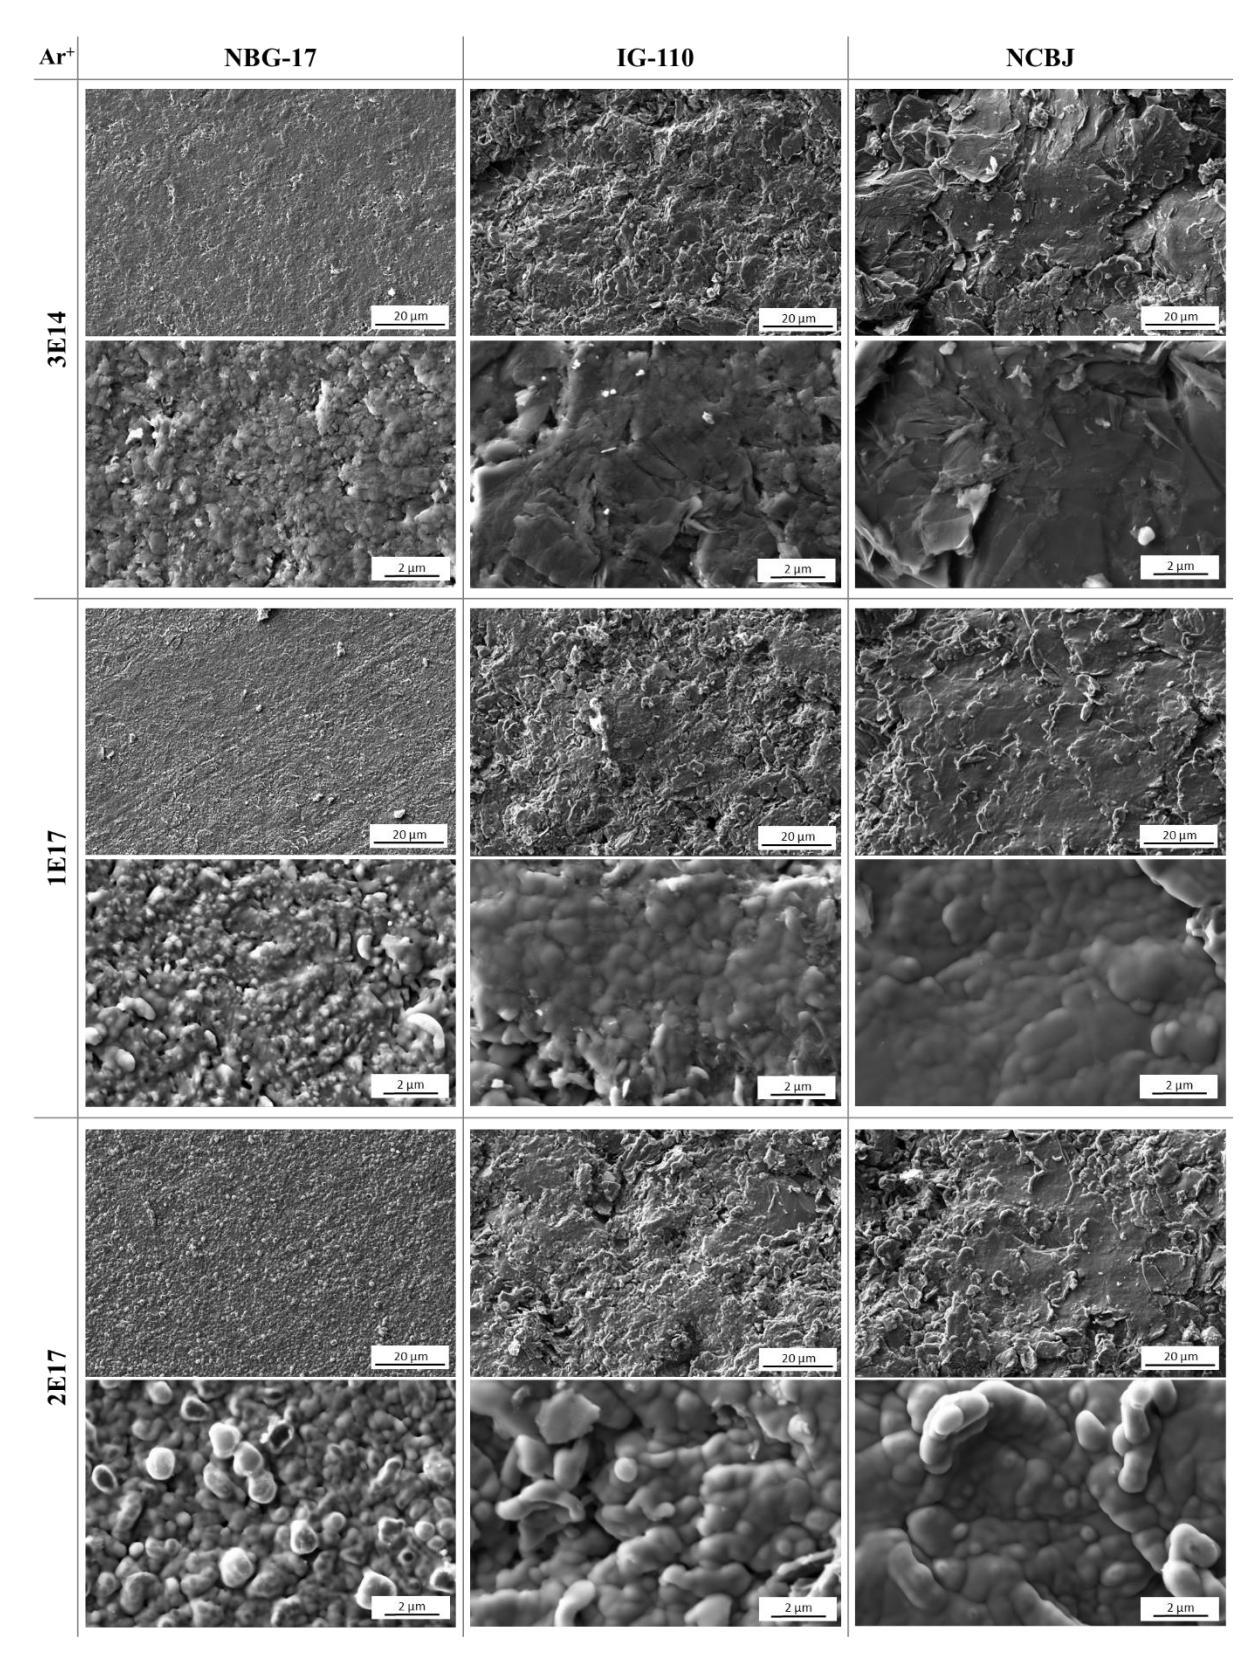
In Figure 9, where nuclear graphites after irradiation by Ar⁺ ions are shown, graphite samples reveal microstructural heterogeneity with increasing value of irradiation fluence. At a fluence of 3E14 ion/cm², NBG-17 shows the emergence of round-shaped objects, a phenomenon less pronounced in other samples. The round-shaped objects observed in the NBG-17 graphite samples at a fluence of 3E14 ion/cm² are likely

pores resulting from ion irradiation. When energetic ions penetrate the graphite lattice, they can induce the creation of defects, including vacancies and interstitials. The accumulation and coalescence of these defects can lead to the formation of voids or pores within the material. At a higher fluence of 1E17 ion/cm² in NBG-17 graphite, these objects begin to increase slightly but maintain a compact and round shape. Notably, IG-110 and NCBJ display larger corrugations than NBG-17, at a lower fluence value, a discernible degradation in microstructural integrity becomes evident. Upon morphological examination of the IG-100 sample at reduced magnification, regions devoid of round-shaped objects persist, whereas the NCBJ sample exhibits comprehensive coverage with corrugations formation. At the pinnacle implantation dose of 2E17 ion/cm², discernible characteristics include the compact and more spherical nature of round-shaped objects within the NBG-17 sample, distinguishing it from other graphite samples. While NCBJ graphite manifests the most substantial alterations in microstructure, NBG-17 graphite emerges as the most resilient, corroborating findings derived from Raman spectroscopy analyses.

Figure 9. SEM images of nuclear graphites under irradiation by Ar⁺ ions with fluence of 3E14 ion/cm², 1E17 ion/cm² and 2E17 ion/cm² corresponding to the crucial morphology changes.

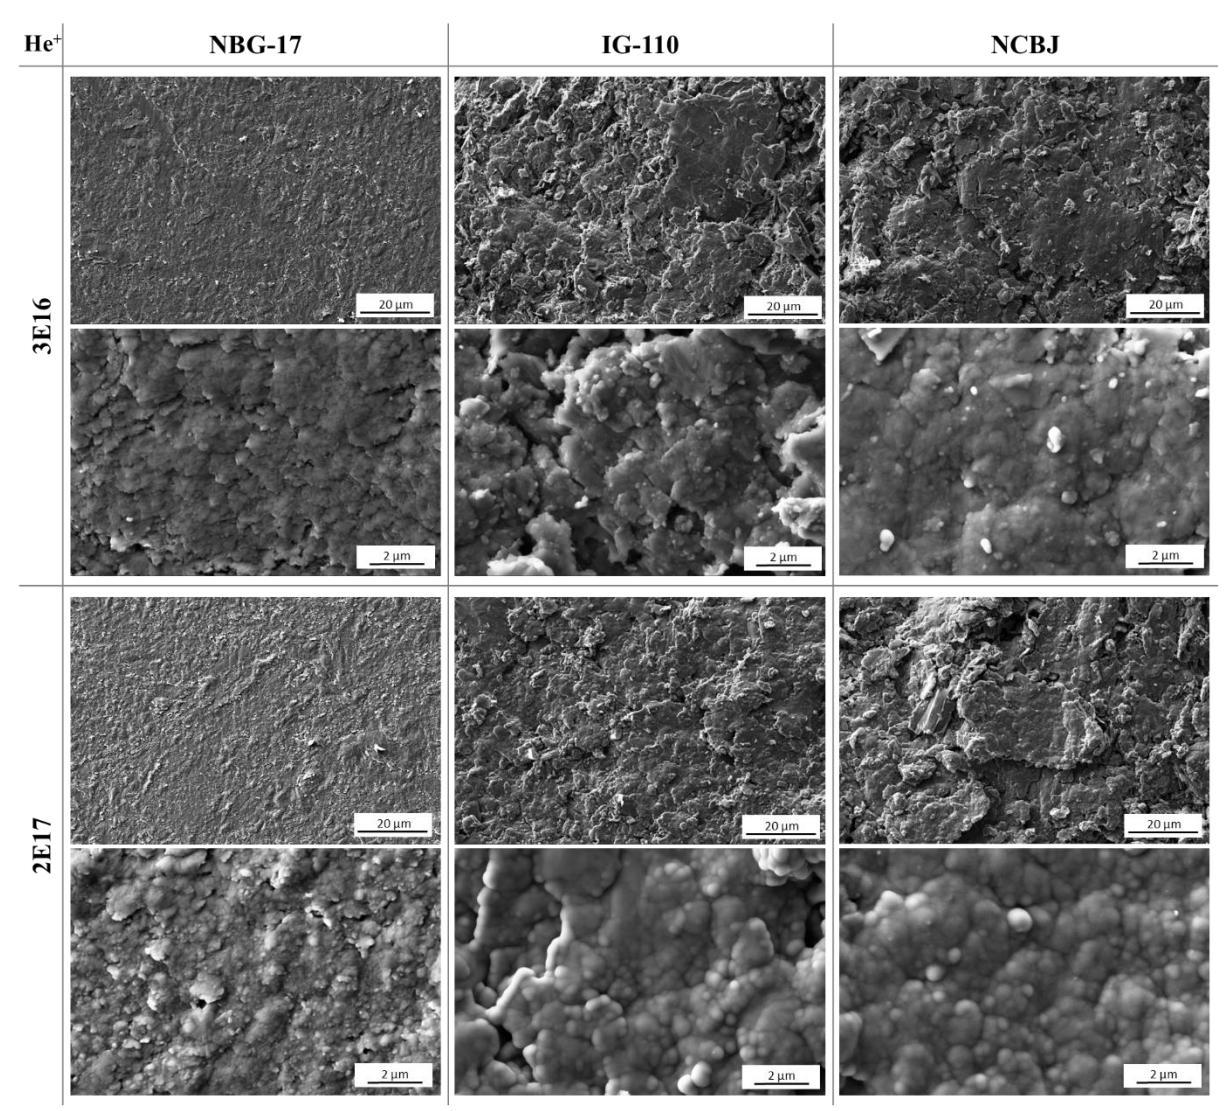
Figure 10 illustrates key features of morphology changes of nuclear graphites irradiated with various irradiation conditions. He⁺ irradiation at 3E16 ion/cm² does not induce significant alterations in the microstructure of NBG-17 graphite compared to the

pristine sample. In IG-110, small pores become visible, while both, small pores and changes in edges appearance towards a more rounded form for NCBJ graphite. At the highest fluence of 2E17 ion/cm², NBG-17 maintains the most stable microstructure, with smaller round-shaped objects comparing to other graphite samples, bearing some similarities to the pre-implantation morphology. In contrast, IG-110 and NCBJ samples exhibit microstructures entirely covered with round-shaped objects of similar size and morphology.

Figure 10. SEM images of nuclear graphites under irradiation by He⁺ ions with fluence of 3E16 ion/cm² and 2E17 ion/cm² corresponding to the crucial morphology changes.
