TIPP 2011 - Technology and Instrumentation for Particle Physics 2011

Long-term Running Experience with the Silicon Micro-strip Tracker at the DØ detector

The Silicon Micro-strip Tracker (SMT) at the DØ experiment in the Fermilab Tevatron collider has been operating since 2001. In 2006, an additional layer, referred to as 'Layer 0', was installed to improve impact parameter resolution and compensate for detector degradation due to radiation damage to the original innermost SMT layer. The SMT detector provides valuable tracking and vertexing information for the experiment. This contribution will highlight aspects of the long term operation of the SMT, including the impact of the silicon readout test-stand. Due to the full integration of the test-stand into the DØ trigger framework, this test-stand provides an advantageous tool for training of new experts and studying subtle effects in the SMT while minimizing impact on the global data acquisition.

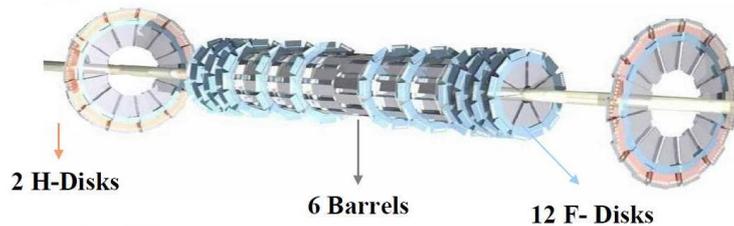
Fig. 1. The upgraded SMT detector consists of 6 Barrels, 12 'F-disks' and 2 'H-disks'. Barrels are interspersed with 'F-disk'. Additional 'F-disks' and 'H-disks' are placed at both ends of the detector.

'H-disk' was removed from each end of the detector in 2006 to accommodate the Layer 0 readout channels. There are two different types of readout chips used for the SMT: SVX-IIe [4] for the original SMT and SVX4 readout chips [5] for Layer 0. The SVX-IIe readout chips are mounted on so-called HDIs (High Density Interconnects), made from Kapton flex circuits laminated to Beryllium substrates. The silicon sensors are glued to them and are referred to as 'module' [1]. There are 432 such modules for the barrel, 288 for the 'F-disks' and 96 for the 'H-disks', for a total of 5712 SVX-IIe chips installed. For L0 the HDIs are ceramic hybrids made of Beryllium oxide. Including Layer 0 there are a total of 730k readout channels providing the largest data flow of all $D\emptyset$ sub-detectors.

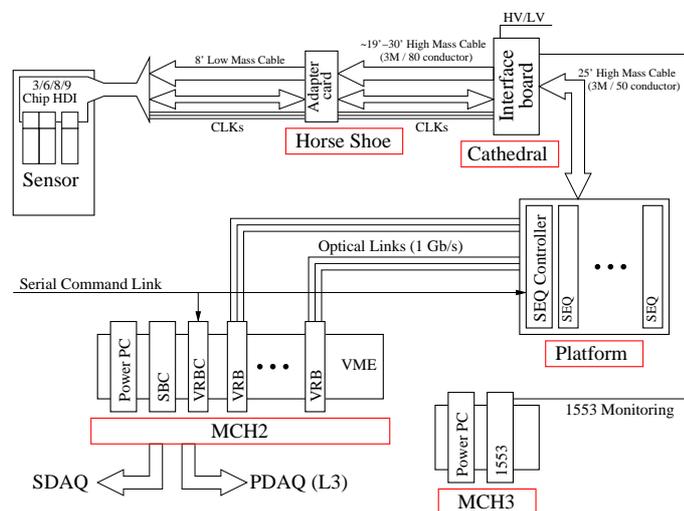
Fig. 2. The hardware and readout chain of the original SMT from the sensor-HDI level to the movable counting house level (MCH) via horse shoe, cathedral and platform level.

A failure in the hardware and readout chain needs to be understood and then traced down to its physical location with the monitoring information at hand. In order to do that it is very important to have monitoring capabilities for low and high level information. This includes the monitoring of voltages and current draws of the power supplies (PS) of the detector. For example a failure of a power supply at the 'Platform' area typically causes lower efficiency for approximately a couple of hours until the failure is addressed. On average

trigger rates. The buffer handling is organized by a VME read-out board controller (VRBC) [6] which controls the VME read-out boards (VRB) [6], which in turn are gathering the data from the sequencer level as sketched in Figure 2. The VRBC firmware was extended with monitoring capabilities for buffer management. The two plots in Figure 7b) show the available buffers (blue), buffers waiting for L2 (green)

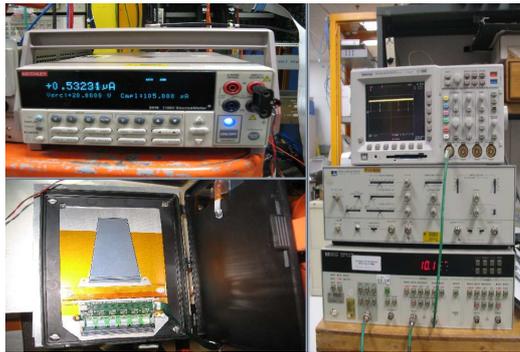
Fig. 3. The picture shows part of the SMT test-stand setup: sensor and a light emitting diode (lower left), PS (upper left), optional signal delay generator with respect to the Tevatron clock (right).

3 shows parts of the test-stand setup for signal-to-noise studies with HV supply (top left), sensor with a light emitting diode (bottom left) and optional signal delay generator with respect to the Tevatron clock (right). In general spare boards are tested at the test-stand before they are installed. This is also true during the longer shutdowns where problematic boards are replaced. During these shutdowns every effort is made to improve the system stability and efficiency. For a complex system like the SMT it is difficult to cite a single quantity characterizing global performance. A good measure is the fraction of enabled HDIs as a function of time as shown in Figure 4. Prior to the 2009 shutdown there was a gradual decrease of this fraction due to hardware issues during continued operation. There are many different types of failures and the most common ones are individual chip failures as well as bad cable connections at various levels as given in Table 1 (larger steps in the fraction of enabled HDIs are explained later in the text). In order to

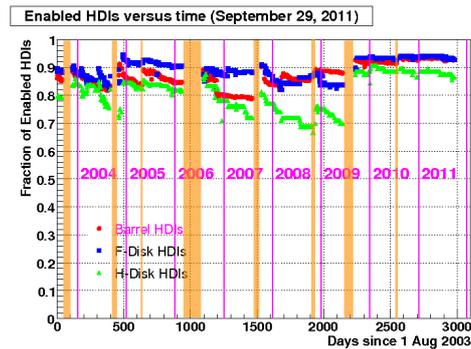
Fig. 4. The graph shows the fraction of enabled HDIs for Barrel, 'F-disk' and 'H-disk' sensors versus time. The shaded yellow bands reflect the shutdown periods of the DØ experiment. For a more detailed explanation of the steps in the fraction of enabled HDIs see text.

trace such a failure to its underlying cause every failure is characterized and a record of previously tried interventions is maintained. The shutdown periods are highlighted with shaded bands in Figure 4. They

allowed for the time-consuming task to investigate and fix these individual failures. The efforts resulted in higher fractions of enabled HDIs after a shutdown. Another example of a sort of failure are broken wire-bonds which interrupted the distribution of the digital power lines to the readout chips. As the readout chips on an individual HDI are daisy-chained, a single chip failure caused the 'loss' of all subsequent chips of a module consisting of up-to 9 chips. The most prominent occasion occurred in late 2006 but it is likely that this sort of failure also contributed to the losses of enabled HDIs prior to that incident. The test-stand facilitated the development of a solution to this problem by using an alternative path to distribute the digital power using a special hardware board (new adapter card). Thus the initial failing chip was bypassed and the readout of the remaining chips on the module could be fully restored as implemented during the shutdown in 2007, which increased the fraction of enabled HDIs by about 10%. Furthermore the test-stand facilitated the development of an improved sequencer firmware version as well as a modified version of the adapter card in order to fix a noise problem. Both have been installed during the shutdown in 2008 and increased the fraction of enabled HDIs. An intensive and thorough investigation for all known sorts of failures took place during the shutdown in 2009 and resulted in the largest fraction of enabled HDIs. The tireless efforts during the past shutdowns allowed re-enabling of HDIs and led to an all-time high number of enabled HDIs. The test-stand was also used for detailed firmware studies in order to improve signal-to-noise (S/N) for the sensors controlled and readout by the SVX-IIe type of chips. The pedestal distribution for the 'old' firmware and the 'new' (improved) firmware is shown in Figure 5a) and b). By moving certain activities

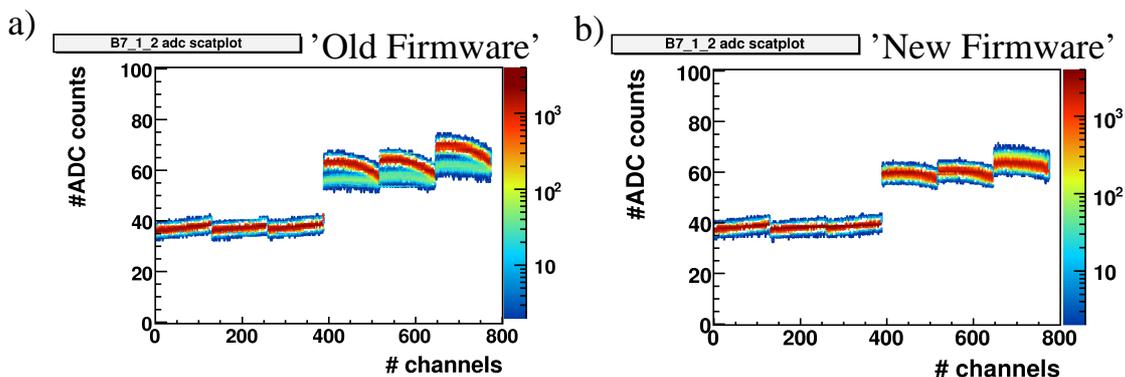
Fig. 5. Pedestal distribution for 6 chips with 128 channels per chip. First three chips are p-side and last three chips are n-side. The pedestal distribution for the 'Old Firmware' is shown on the left, whereas the one for the 'New Firmware' is shown on the right.

on control lines to a different point in time a significant reduction of the noise level was achieved. The biggest impact in terms of reducing the noise was achieved by moving control signals for 'PreAmp'-reset and 'RampReference'-select further away from the start of digitization. For n-side type of sensors the noise was reduced by approximately 20% whereas for the p-side type sensors noise level was stable. The noise source is not coupling in the same way to all channels as it can be seen in Figure 5a). Our interpretation is that the control signal pulse generates noise on the chip. The previously persistent second band structure is now completely removed as it can be seen by comparing Figure 5a) and b). This firmware is now used for the entire SMT.

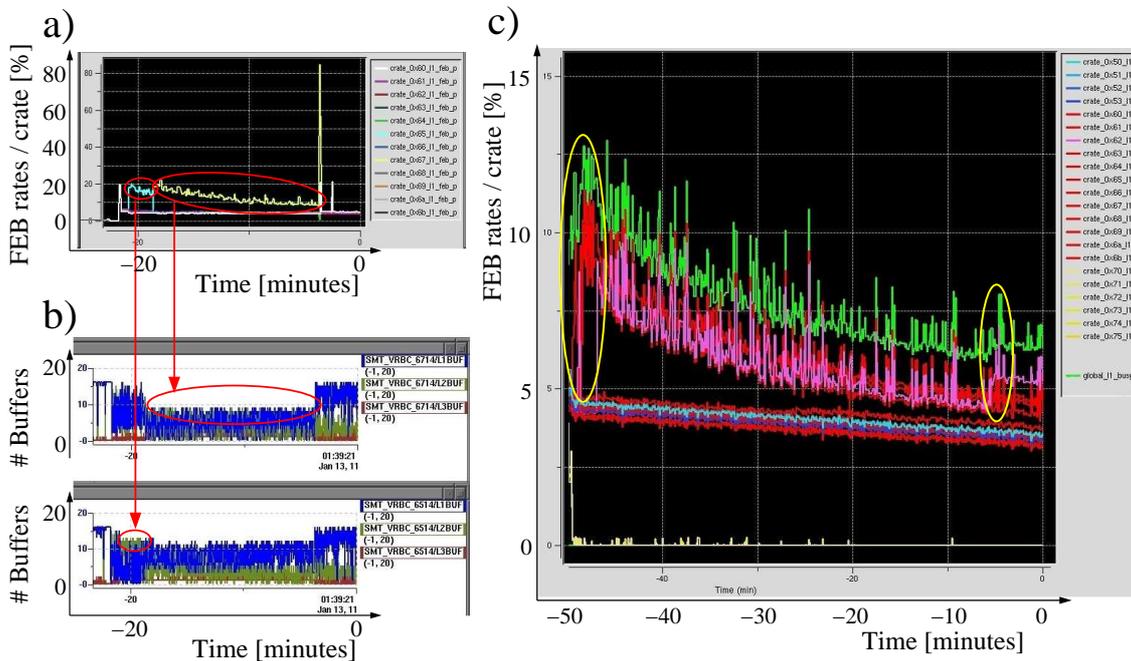
Fig. 7. a) shows FEB rates [%] of all SMT crates (different colors) as a function of time without the improved buffer handling firmware. The two plots in b) show the available buffers (blue), buffers waiting for L2 (green) or L3 decisions (red) as a function of time. As an example the buffer distribution is shown for the two SMT crates which exhibit an increased FEB rate (top plot, crate 0x65 & 0x67) as highlighted by the red ellipses and arrows. c) shows the FEB rates [%] of various detector subsystem crates grouped by colors (SMT crates are colored in red). In addition the global DØ L1 busy rate (green) consisting of all L1 subsystems is shown. More details in the text.

Individual SMT crates showed a very peculiar FEB pattern: one would expect that the SMT crate leading in FEB is given by highest data processing load as it takes more time to process more data. Instead the FEB leading SMT crate seems to appear randomly as shown in Figure 7a). It shows FEB rates [%] of all SMT crates (different colors) as a function of time with the two crates showing the peculiar FEB pattern highlighted by the red circles. This happened on an apparently random basis but more frequently at higher

or L3 decisions (red) as a function of time. The buffer distribution is shown for the two SMT crates which exhibit the increased FEB rate (SMT crates 0x65 and 0x67) as highlighted by the red ellipses and arrows. A good correlation between the number of available buffers and the FEB was seen. In general there are less available buffers at higher trigger rates. The red circles connected by arrows in Figure 7a)-b) highlight the peculiar FEB pattern shown by two different SMT crates. This effect was due to the sudden reduction of available buffers (blue) causing increased dead-times for the affected SMT crates. Figure 7c) shows the FEB rates [%] of various detector subsystem crates (SMT crates are colored in red). In addition the global DØ L1 busy rate consisting of all L1 subsystems is plotted (green). The yellow ellipses highlight an increase of the global L1 busy rate caused by raised FEB rates of particular SMT crates. This illustrates how the sudden reduction of available buffers in SMT crates affected the global L1 busy rate. At higher trigger rates (around -50 minutes) the effect is not large. There is an increase of the global L1 busy rate by approximately 2%

at the same time as the jump in FEB for a SMT crate: from 10% to approximately 12%. At lower trigger rates (around -5 minutes) the effect is smaller and the global L1 busy rate increases only by about 0.4%. The latter can be understood as the reduced number of buffers has largest impact at high data taking rates.

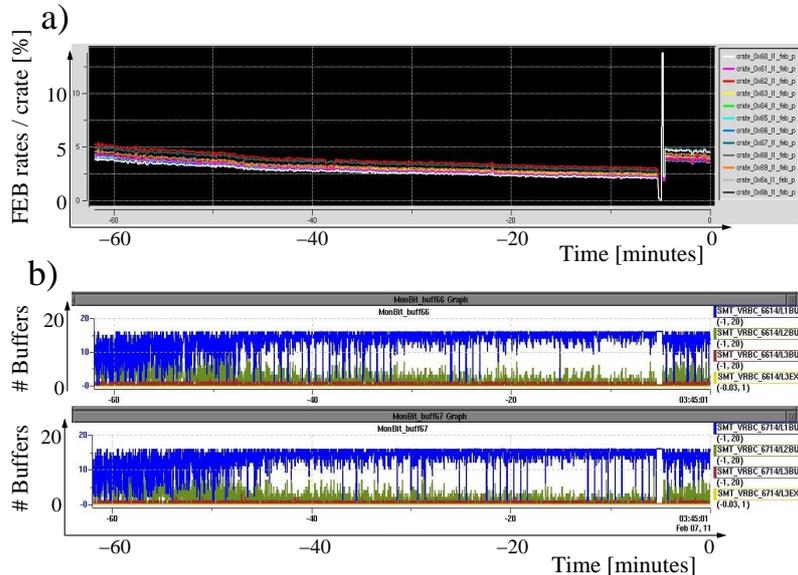
Fig. 8. a) shows the FEB rates [%] of all SMT crates (different colors) as a function of time with the improved buffer handling firmware. The two plots in b) show again available buffers (blue), buffers waiting for L2 (green) or L3 decisions (red) as an example for two different SMT crates. More details in the text.

The SMT test-stand allowed tests at high rates of new versions of the VRBC firmware handling buffer management. A more robust VRBC firmware version was developed and it did not show this problem anymore. Monitoring data for this modified VRBC firmware version are shown in Figure 8a)-b). a) shows the FEB rates [%] of all SMT crates (different colors) as a function of time with the improved buffer handling firmware. There are no SMT crates showing a significantly higher FEB rate. The increased FEB rates visible at the end of the distribution was due to a change in prescale settings, which increased the event rates. Figure 8b) shows the available buffers (blue), buffers waiting for L2 (green) or L3 decisions (red) as a function of time for two different SMT crates. There are no sudden drops in the number of available buffers anymore.

Figure 8b) shows the available buffers (blue), buffers waiting for L2 (green) or L3 decisions (red) as a function of time for two different SMT crates. There are no sudden drops in the number of available buffers anymore.
