# Long-Term Testing and Properties of Acrylic for the Daya Bay Antineutrino Detectors

**ABSTRACT:** The Daya Bay reactor antineutrino experiment has recently measured the neutrino mixing parameter  $\sin^2 2\theta_{13}$  by observing electron antineutrino disappearance over kilometer-scale baselines using six antineutrino detectors at near and far distances from reactor cores at the Daya Bay nuclear power complex. Liquid scintillator contained in transparent target vessels is used to detect electron antineutrinos via the inverse beta-decay reaction. The Daya Bay experiment will operate for about five years yielding a precision measurement of  $\sin^2 2\theta_{13}$ . We report on long-term studies of poly(methyl methacrylate) known as acrylic, which is the primary material used in the fabrication of the target vessels for the experiment's antineutrino detectors. In these studies, acrylic samples are subjected to gaseous and liquid environmental conditions similar to those experienced during construction, transport, and operation of the Daya Bay acrylic target vessels and detectors. Mechanical and optical stability of the acrylic as well as its interaction with detector liquids is r

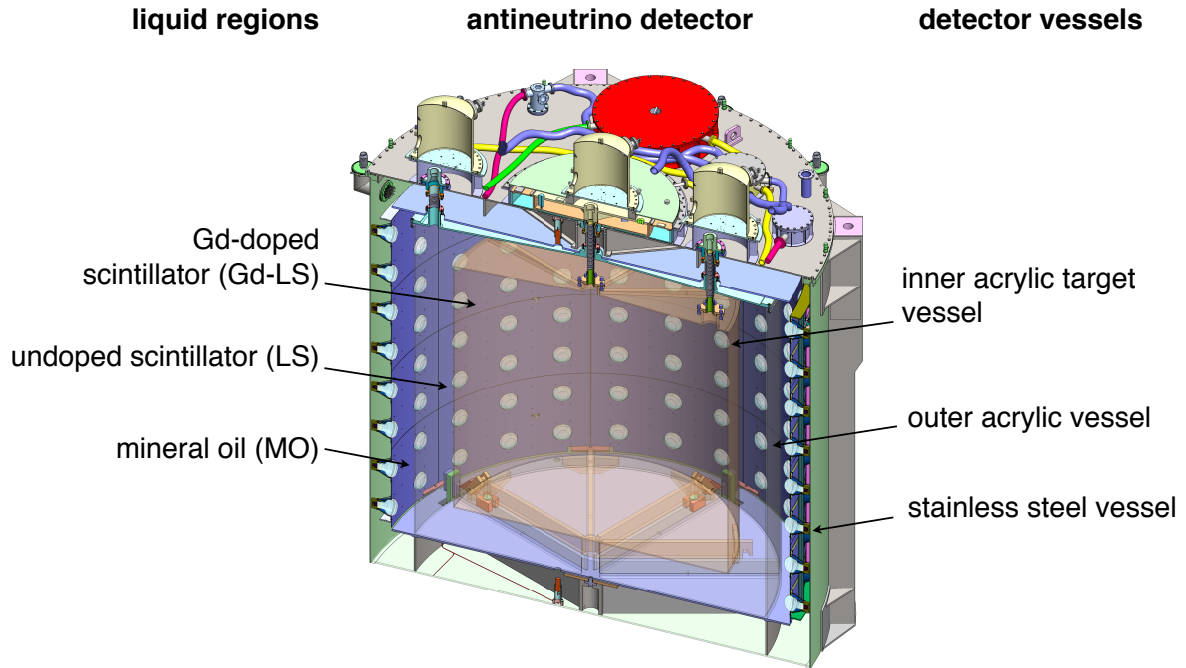
**Figure 1.** Cutaway view of an antineutrino detector, with the inner acrylic vessel containing the Gd-LS, the outer acrylic vessel containing the undoped LS, and the stainless steel vessel containing the mineral oil region and PMTs.

The Daya Bay antineutrino detectors, shown in Figure 1, consist of a nested arrangement of upright cylinders forming 3 concentric zones. The detectors have an outer diameter and height of 5 meters. The detector target consists of 20 tons of gadolinium-doped liquid scintillator (Gd-LS) and is contained in a 3-m diameter inner acrylic vessel (IAV). This inner vessel is surrounded by a 4-m diameter outer acrylic vessel (OAV) holding 21 tons of undoped liquid scintillator acting as a gamma catcher for events with high-energy gammas leaking out of the inner target. The design and construction of the Daya Bay acrylic vessels (AVs) is described in detail in [3]. The liquid scintillator is based on the organic solvent linear alkyl benzene (LAB), and is described in more detail in [4]. The region beyond the OAV is filled with a mineral oil buffer, instrumented with 192 photomultiplier tubes (PMTs) and bounded by a stainless steel vessel (SSV). The PMTs detect scintillation light from the inner regions, using the total detected light to determine the energy of particle interactions in the detector.

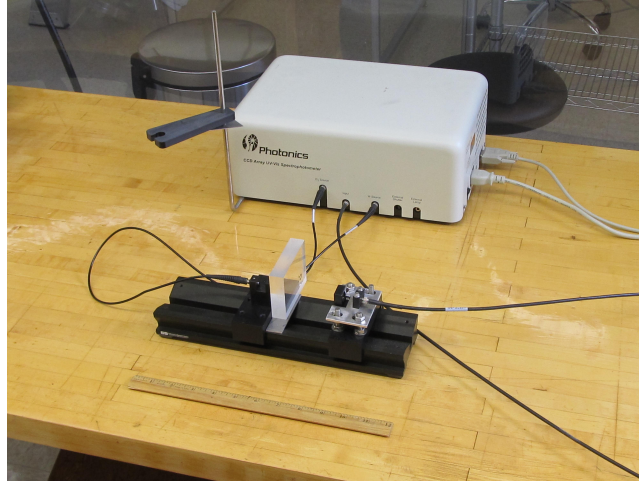
**Figure 2.** A photograph of the transmittance measurement setup. UV and visible light generated by tungsten and deuterium lamps in the spectrometer housing (back) are fed through a fiber-optic cable to the black sample holder (front). After exiting the fiber and traveling through the sample, the light beam impinges upon another fiber-optic cable on the opposite side of the sample. Collimating lenses reduce the dispersion of the light beam. This output light is fed into a CCD array in the spectrometer housing to analyze the wavelengths present after sample traversal.

The optical stability of various samples was tested using an SI Photonics 400 Series UV-Vis spectrometer [9], which measured the percent transmittance of various light wavelengths through each sample. The transmittance measurement setup is shown in Figure 2. Transmittance was measured

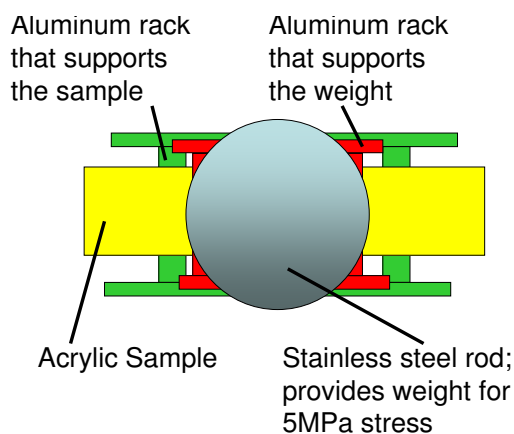
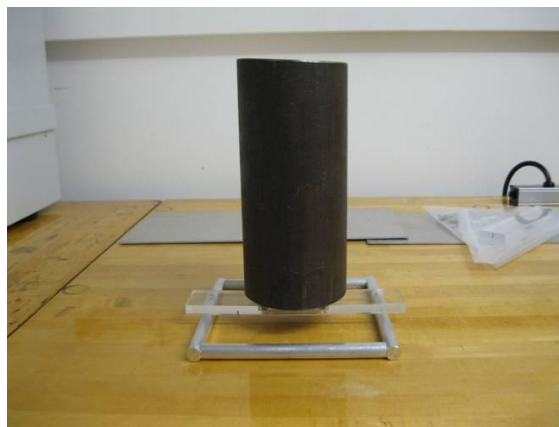
(a) Top-down schematic view of the stress-testing setup.

(b) Photograph of the stress-testing setup.

**Figure 3.** Stress test setup following ASTM D6272. (a) Schematic top view. The acrylic sample (yellow) rests between two Aluminum frames shown in green and red. A cylindrical weight is applied to the top of the red frame which exerts a bending force and resulting stress on the acrylic sample. The bending geometry is defined by the size and spacing of the aluminum frames. (b) Photograph of the test setup.

The mechanical stability of the acrylic samples was measured by stressing the samples according to the ASTM D6272 standard [10]. The set-up of this stressing procedure, shown in Figure 3, depends on a standardized geometry to achieve a desired level of stress in the acrylic sample. Acrylic samples rest between a large bottom frame and a smaller top frame. A steel weight is then placed on the top frame, providing the desired level of stress. The total stress experienced by the acrylic is given by

$$S = PL/bd^2, \quad (2.1)$$

where  $S$  is the stress applied to the sample in MPa,  $P$  is the value of the weight in N,  $L$  is the distance between the two rods of the rack the acrylic samples rests on in mm,  $b$  is the width of the acrylic sample in mm, and  $d$  is the depth of the acrylic sample in mm. For our experiment,  $P = 113.6$  N,  $L = 152.4$  mm,  $b = 38.1$  mm, and  $d = 9.5$  mm, which produces 5.0 MPa of stress in the acrylic sample. This stress value corresponds to the 10-year maximum stress limit guideline followed by Reynolds for all commercial operations and tested in [3]. If exposing stressed samples to a given environment alters appreciably the acrylic's mechanical characteristics, the samples may exhibit signs of cracking or crazing over time.

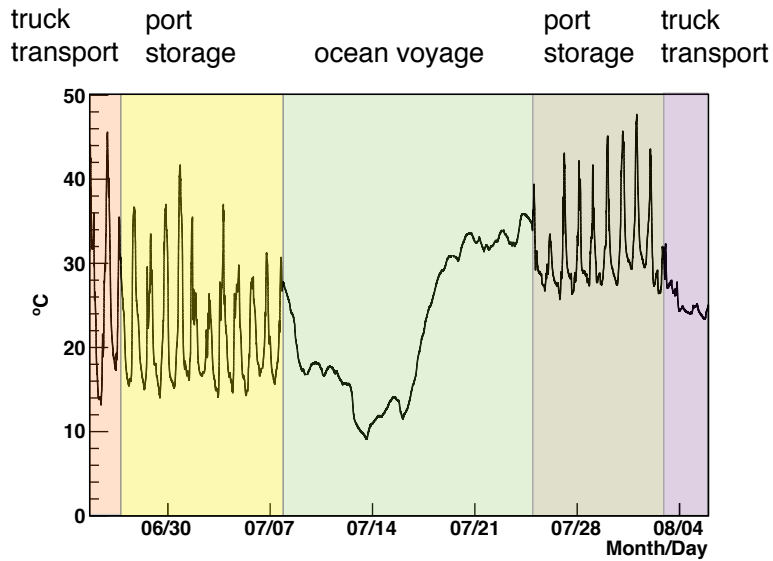
**Figure 4.** Typical temperature measurements experienced during transport of the acrylic vessels from the US to China in 2010. The colored regions represent five periods: transport by truck in the US (red), during storage at port in Long Beach, CA (yellow), during sea transport (green), at port in Yantian, China (gray), and en route to Daya Bay and in the Surface Assembly Building (purple). In our laboratory tests we simulated the temperature cycles experienced during the period from about 7/18 to 8/04. Figure adapted from [3].

from 10 to 46 °C with typical temperatures in the range of 14 to 35 °C. Figure 4 illustrates the temperature variations during the shipment of the outer acrylic vessels for the first two Daya Bay detectors. In order to simulate these temperature changes experienced by the AVs, two acrylic samples were placed in a programmable convection oven. The temperature of the oven was cycled to mimic the measured temperature during transportation. While undergoing these temperature changes the samples were also stressed using the testing setup described in Section 2.3. After finishing the cycling regimen, the samples were inspected for micro-cracks and tested for changes in transmittance. These results were compared to a sample that was stressed in the absence of temperature-cycling to observe any difference in properties.

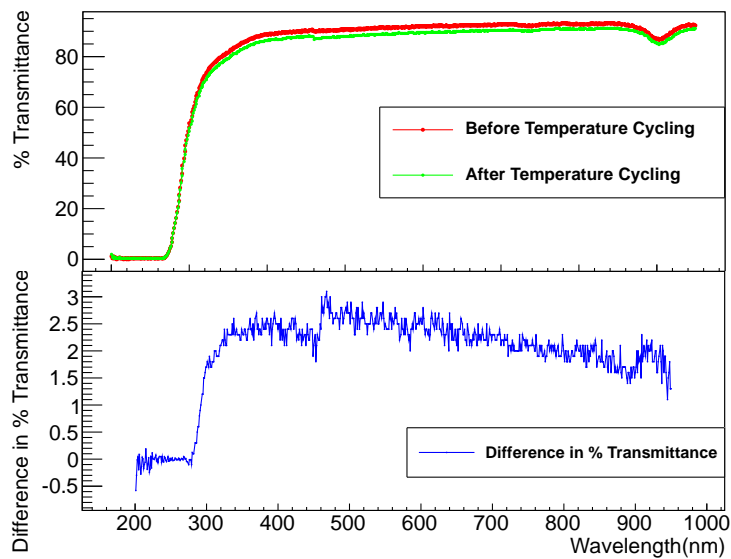
**Figure 5.** Comparison of acrylic sample transmittance before and after temperature cycling. Overall differences between initial and final spectra are smaller than the systematic uncertainty of the spectrometer, indicating no significant change in optical properties from temperature cycling. The measured step in transmittance at 460 nm arises from the switchover between the tungsten and deuterium lamps in the spectrometer.

We found that temperature cycling did not cause any detectable cracking or crazing of the samples, indicating no significant change in acrylic mechanical properties. As shown in Figure 5, the transmission spectrum before and after cycling was unchanged within the spectrometer measurement uncertainty. These results show that the AV transport procedure from the US to China introduces no significant changes in acrylic properties.

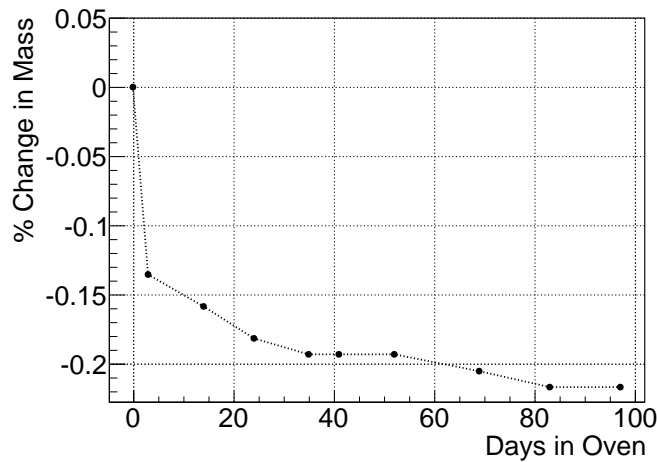
**Figure 6.** Percent change in mass of an acrylic sample consistently baked at 60°C. The initial large drop in mass is likely caused by water evaporation, while the slow subsequent decrease in mass might be the result of degradation of the acrylic chemical structure by extreme dryness or elevated temperatures. The initial total water content of the sample appears to be 0.1–0.2% by mass.

The first test simulated a dry environment by placing acrylic samples in a programmable convection oven operating at 60°C, well below acrylic annealing temperatures. While this does not replicate the environment experienced by the stored AVs, the oven-drying results in complete dry-out of the acrylic, and thus provides an extreme bounding case on possible changes in acrylic properties from exposure to dry environments. Acrylic samples were stressed and baked for a four-week period, and were periodically removed to test their mass, dimensions, and transmittance. The change in sample mass as a function of time can be seen in Figure 6.

This data shows a quick initial exponential loss in mass, likely from evaporation of water in the acrylic, followed by a longer-timescale loss, possibly from slow degradation and evaporation of the acrylic chemical structure from either extreme dryness or elevated temperature. From this test, one can determine that the equilibrium water content of acrylic in average room air humidity is 0.1–0.2% by mass.

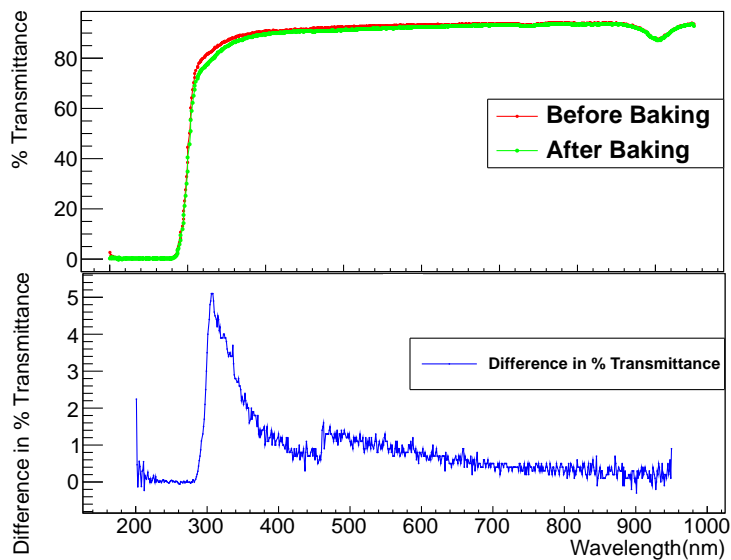
**Figure 7.** Transmittance of an acrylic sample before and after four weeks of consistent baking at 60°C. A small change in transmittance is visible below 400 nm, below the range of light production and transmittance for the Daya Bay liquids. The measured step in transmittance at 460 nm comes from the switchover between the tungsten and deuterium lamps in the spectrometer.

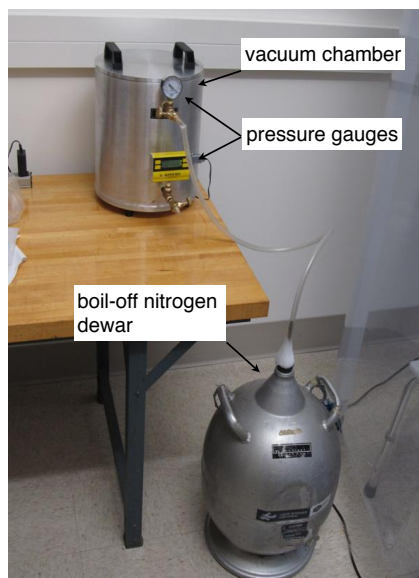
**Figure 8.** Liquid nitrogen boil-off environment test setup. A vacuum chamber connected to the boil-off from a liquid nitrogen dewar is used to simulate the long-term effects nitrogen cover gas on the acrylic vessels.

The second dry-environment test attempted to more closely simulate the nitrogen storage environment by placing acrylic samples in a nitrogen-flushed Abbess vacuum chamber [12], as shown in Figure 8. The nitrogen environment was achieved by connecting a liquid nitrogen dewar to the input of the vacuum chamber and allowing the boil-off to flow through the chamber. As with the stored AVs, in this environment moisture could constantly evaporate from the sample and be carried away in the continuously flushed nitrogen gas. These samples were also stressed according to ASTM D6272 and visually checked through a clear acrylic portal on the top of the chamber for crazing or cracking. Samples were removed from the chamber periodically to check the mass and dimensions of the samples. When the sample was replaced in the chamber after measurement, the dry nitrogen environment was quickly restored by conducting a thorough flush with bottled nitrogen gas.

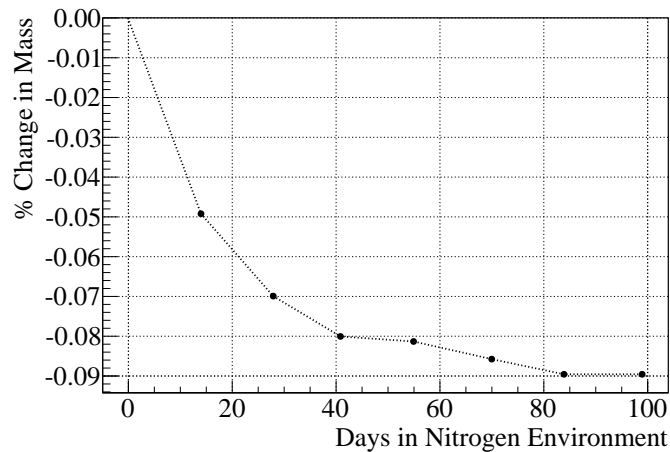
**Figure 9.** The percent change in mass of an acrylic sample in a nitrogen boil-off environment. Error bars are smaller than the plotted points.

It was found that the nitrogen environment did not cause any cracking or crazing in the sample, indicating no significant change in acrylic mechanical properties. In addition, no change in optical properties larger than the spectrometer systematic error were observed. As shown in Figure 9, the sample decreased in mass by  $0.0897 \pm 0.0002\%$  over the course of 100 days. This result indicates a total equilibrium water weight of acrylic in average room air humidity of around 0.1%, in reasonable agreement with that seen in the oven-dried sample.

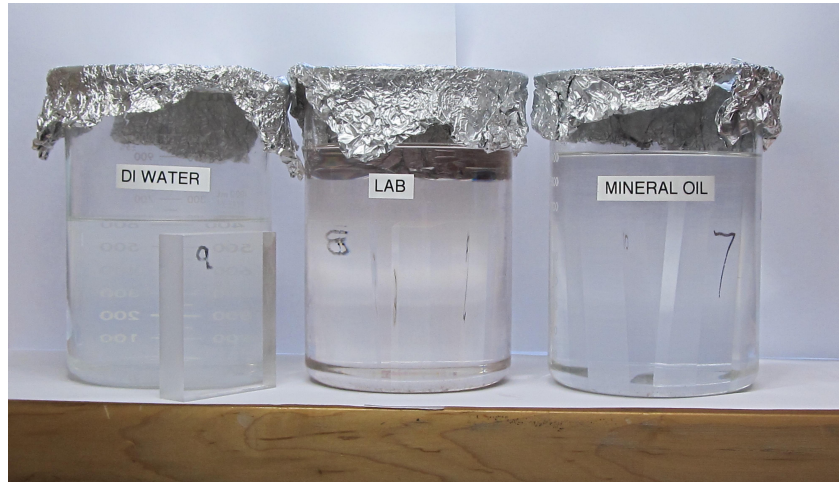
**Figure 10.** Liquid immersion and soak test setup of acrylic samples in the detector liquids LAB and mineral oil, as well as in deionized water.

A first test was conducted by placing three acrylic samples exposed to a typical laboratory environment of roughly 50% humidity and room temperature into each of the detector liquids LAB and mineral oil, as shown in Figure 10. Control samples were soaked in deionized (DI) water because acrylic is known to absorb roughly 2% of its mass in DI water at full saturation, according to R&D tests done for the SNO experiment [13].

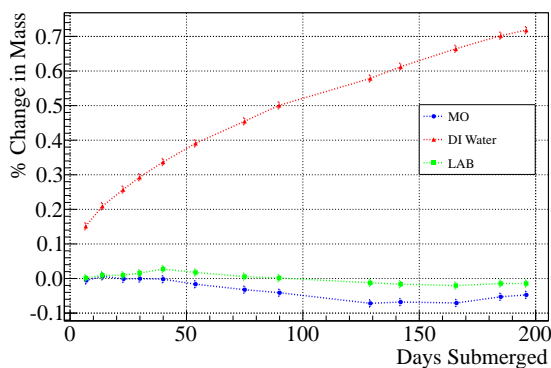
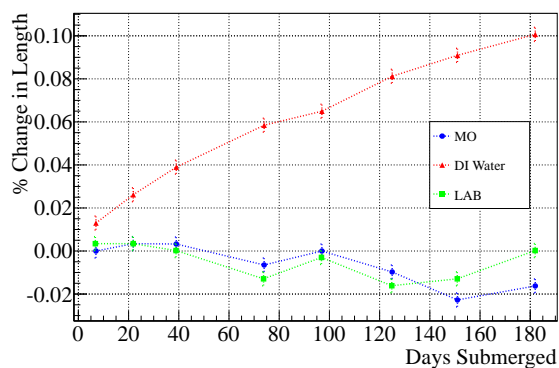
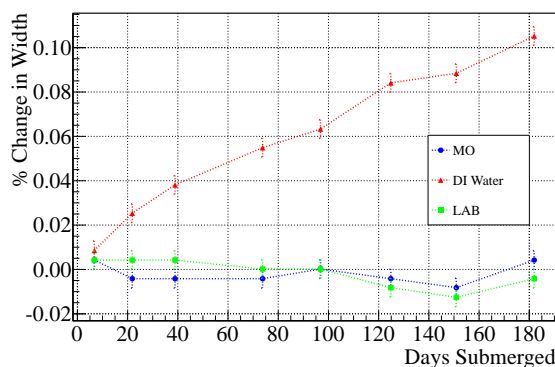
(a) Change in mass of submerged samples.

(b) Change in length of submerged samples.

(c) Change in width of submerged samples.

**Figure 11.** The percent change in the mass (top left), length (top right), and width (bottom) of room-air moisture level acrylic samples submerged in DI water, LAB, and mineral oil. Water-submerged samples show a clear increase in mass and lengths, while samples submerged in the Daya Bay detector liquids MO and LAB do not.

Individually for every liquid, each of the three submerged room-air moisture level acrylic samples showed similar changes in properties. The change in mass, length, and width over time is

shown in Figure 11. The final results are summarized in Table 1 for liquid exposures of nearly 200 days.

These measurements clearly show significant absorption of DI water into the room-air moisture acrylic, with a final water-saturated mass of 1.6% of total mass and an exponential time constant of roughly 400 days, in good agreement with [13]. More importantly, these tests show little change in acrylic sample mass after long-term exposure to Daya Bay detector liquids, whether from absorption of those liquids by the acrylic, or from desorption of water from the acrylic into the detector liquids. This result supports the conclusion that ADs not stored for prolonged periods in a dry environment should experience negligible changes in target mass from AV-liquid interactions. To be more precise, the change in target mass from nearly one year of exposure to detector liquids will be less than 0.016% of the IAV’s mass, which, at an IAV mass of roughly 1 ton, corresponds to 0.16 kg, or 0.0008% of the 20-ton target mass. This is clearly a negligible change in total target mass for these ADs from this source.

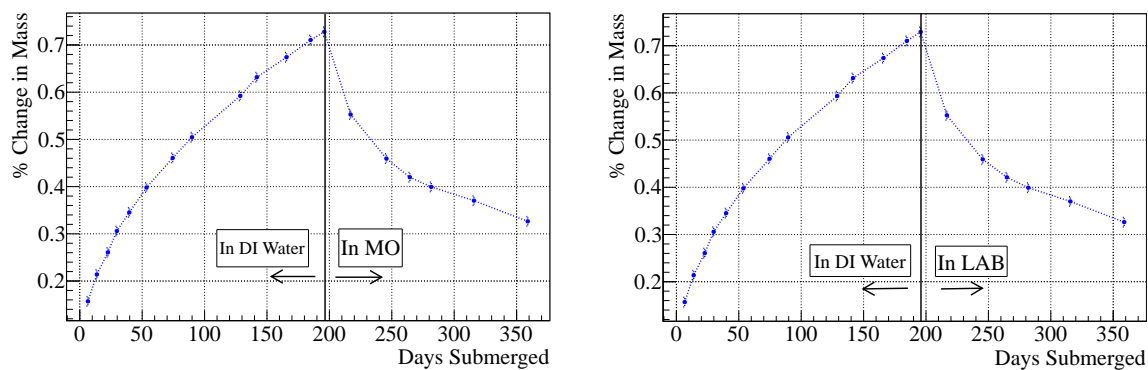
(a) Change in mass of water-saturated samples submerged in MO.

(b) Change in mass of water-saturated samples submerged in LAB.

**Figure 12.** Change in mass of room-air moisture level samples exposed first to a DI water environment and then to a MO or LAB environment. The point of switch-over is shown by the vertical line. Samples clearly absorbed DI water and then desorbed this water over time in the detector liquids.

These initially water-saturated samples showed a decrease in their mass and in their dimensions with time after being submerged in MO and LAB, as shown in Figure 12. This trend indicates that the DI water that had saturated these pieces was seeping out when they were placed into MO or LAB.

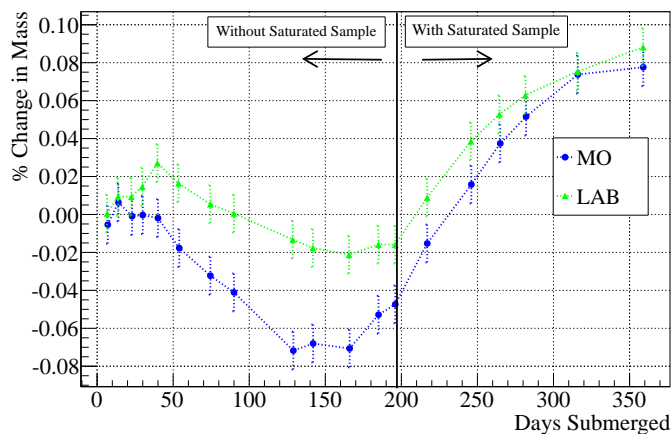
**Figure 13.** The change in mass of room-air moisture level samples submerged in MO and LAB. The first 200 days are replicated from Figure 11a; after 200 days, water-soaked samples were transferred to the LAB and MO. After this change, the original MO- and LAB-submerged acrylic samples show a slight increase in mass. This increase could indicate transition of water from the water-soaked samples to the other samples, or could be a product of systematic environmental changes in the laboratory, such as a slow shift in room temperature or humidity.

hypothesis could be supported by the increase in mass of the air-moisture level samples that share the MO and LAB baths with the water-saturated samples during days 200–360, as shown in Figure 13: the desorbed, dissolved water could subsequently be absorbed by these other comparatively low-moisture samples, raising these samples' measured masses. However, this increase in mass is quite small,  $< 0.1\%$ , and might instead have been caused by systematic changes in environment or in sample preparation over time.

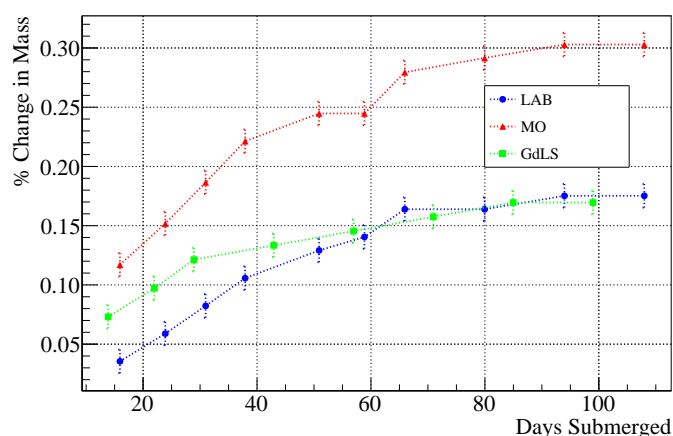
**Figure 14.** Percent change in the mass of acrylic samples dried via oven-baking before being submerged in the three different Daya Bay detector liquids.

To test the interaction of dry acrylic with detector liquids, the samples that had been baked and dried for a four-week period as described in Section 3.2.1 were placed in MO and LAB, as well as in Gd-LS obtained from the collaboration. The change in mass with time is given in Figure 14. The sample in LAB increased its mass by  $0.1752 \pm 0.008\%$  over 110 days while the sample in mineral oil increased its mass by  $0.3026 \pm 0.008\%$  over the same period of time. The sample in Gd-LS increased its mass by  $0.1689 \pm 0.008\%$ . The relatively short time constant of this mass change indicates that any change in mass beyond 110 days of soaking will be minimal. Despite this change in mass, the samples showed no change in transmittance over the duration of the test within the systematic uncertainty of the spectrometer.
