Radiation Testing of Electronics for the CMS Endcap Muon System

Abstract

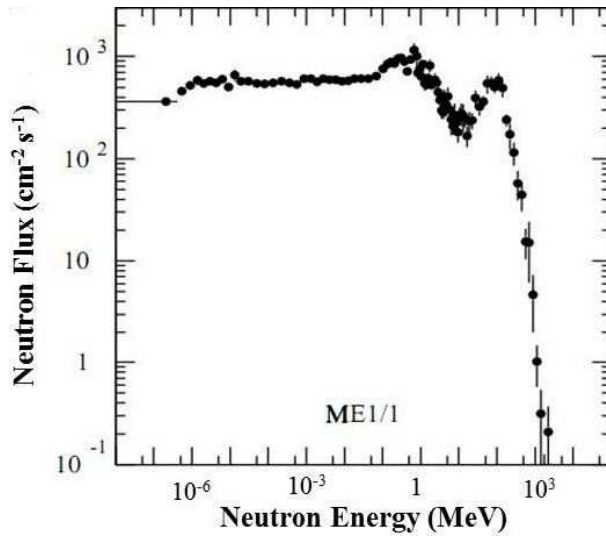
Figure 1: Energy spectrum of neutron exposure for the innermost chambers of the CSC system, based on simulations from the first phase of LHC operation [7].

ME1/1 CSCs are the innermost chambers within CMS and are exposed to the highest rate of radiation damage, largely from neutrons. Figure 1 shows the simulated energy spectrum of neutrons crossing the ME1/1 region; figure 2 shows how the neutron fluence in the endcap region is expected to vary with distance from the beam line. In the area of highest neutron flux, the total fluence for neutrons with energy $E > 100$ keV is about 6×10^{11} cm^{-2} [7], and the TID is 1780 rad over ten years of normal LHC operation. However, for HL-LHC these rates are expected to be five times higher, as summarized in table 1. These data form the baseline for determining the radiation tolerance of the CSC electronics.

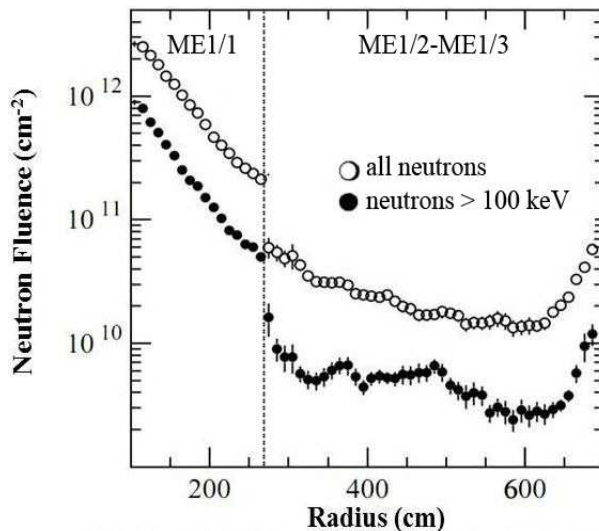
Figure 2: Expected neutron fluence in the Station 1 region of the CMS endcap for the first phase of LHC operation, shown as a function of the distance from the beam line [7].

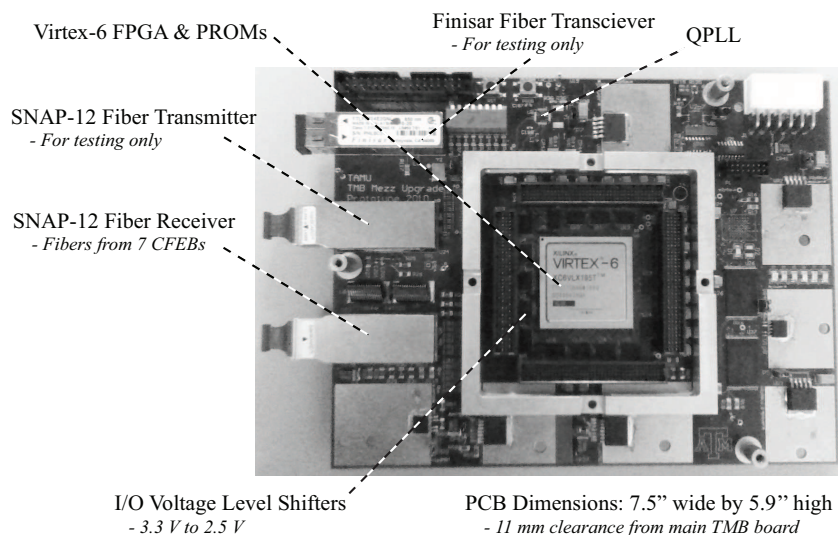
Figure 3: Top-side view of a TMB mezzanine test board, as used in SEU tests for digital components.

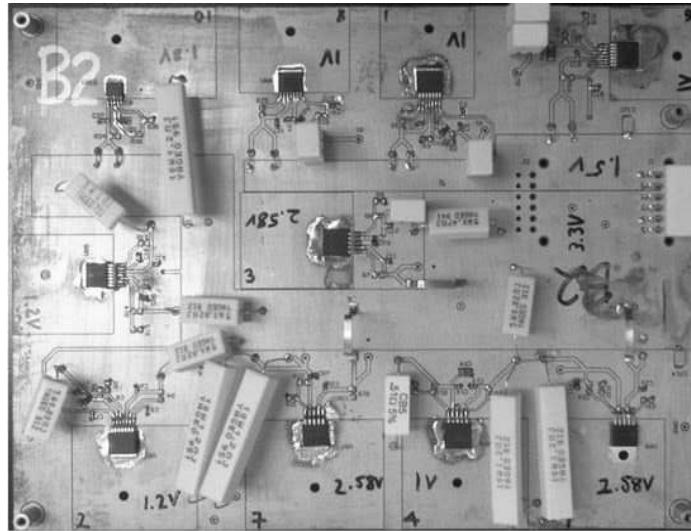
Figure 4: One of the voltage regulator test boards that was exposed to 1 MeV neutrons in the TAMU NSC reactor.

Eleven different voltage regulator models from five different manufacturers were mounted on custom-designed voltage regulator test boards (fig. 4). The boards were placed in the large-sample irradiation chamber, and they were not powered during exposure. The voltage, current and temperature

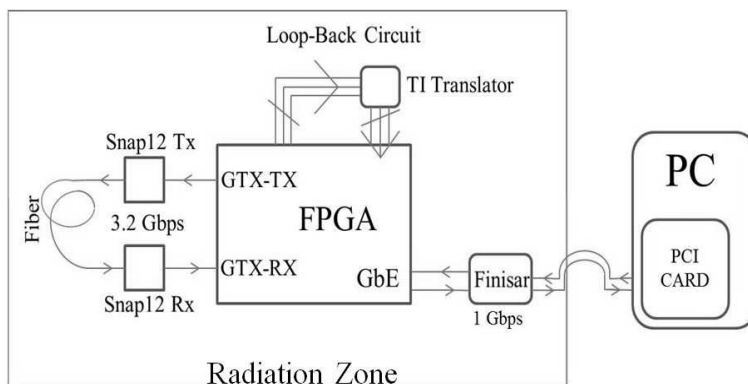
Figure 5: Diagram of the test circuits used on the TMB mezzanine test boards, indicating the five digital devices tested in the TAMU cyclotron.

This section provides a description for each type of component tested and explains the procedures used to carry out the tests in each case; an overview of the test configuration used for the digital components is shown in figure 5. For the non-digital parts, each was tested with dedicated load resistors tuned to emulate the realistic conditions for normal CMS operation. Results are presented for SEU susceptibility and radiation survivability, based on measurements such as SEU counts, voltage levels, total fluence and the dose during each exposure.

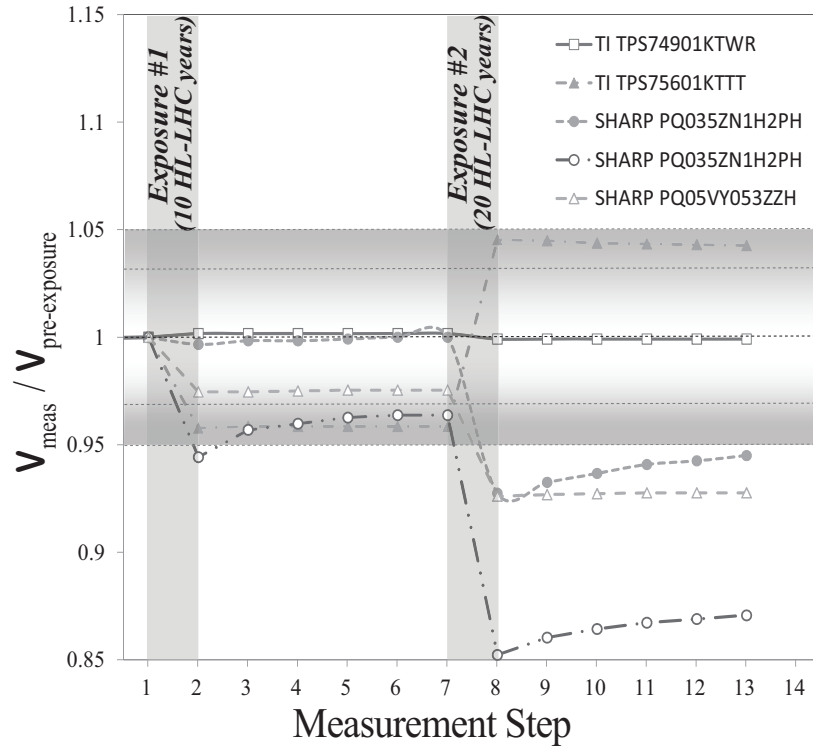
Figure 6: Examples of voltage regulator output stability after each radiation exposure, showing the change in voltage output for regulators that survived the full exposure level. After each exposure the output voltages were measured under power at 30 minute intervals. Voltage regulator deviations greater than 5% are not acceptable for CSC electronics.

In figure 6, a representative sample of results from five different regulators is shown. The vertical axis represents the ratio of the measured voltage (after exposure) to the pre-exposure voltage; the horizontal axis shows the measurements taken in 30-minute time intervals after each radiation exposure. Observing a constant result with value ≈ 1 over time indicates that the regulator is a stable, reliable choice for our design. As seen from the figure, several regulators break down after exposure and fail to regulate; some of the samples perform well after the first 10 krad exposure, and then fail after the final 20 krad exposure. Some chips show a small degree of recovery over time, but they remain outside of the acceptable performance range of $\pm 5\%$ voltage variation.

Three of the six Max8557ETE regulators showed 0 V output after the second exposure, while the other three show approximately 3% decrease in voltage. This is the only observed case of complete failure for a regulator due to radiation. Several other regulators showed more than 5% change in voltage, and regardless of the mechanism, these are all unacceptable for use in CSC electronics.
