## **Comparison of JET main chamber erosion with dust collected in the divertor**

### **Abstract**

A complete global balance for carbon in JET requires knowledge of the net erosion in the main chamber, net deposition in the divertor and the amount of dust and flakes collecting in the divertor region. This paper describes a number of measurements on aspects of this global picture. Profiler measurements and cross section microscopy on tiles that were removed in the 2009 JET intervention are used to evaluate the net erosion in the main chamber and net deposition in the divertor. In addition the mass of dust and flakes collected from the JET divertor during the same intervention is also reported and included as part of the balance. Spectroscopic measurements of carbon erosion from the main chamber are presented and compared with the erosion measurements for the main chamber.

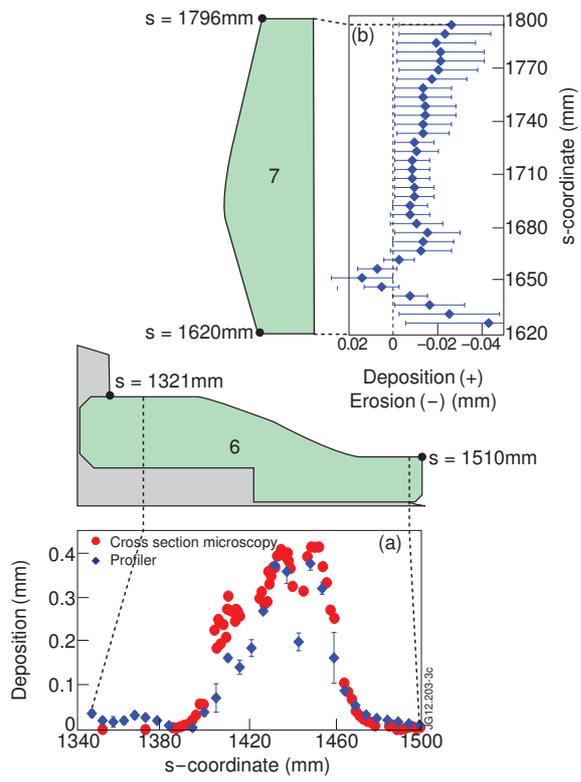
Figure 3 Profiler results for (a) Tile 6 (b) Tile 7.

Results for the total erosion, total deposition and net erosion/net deposition taking into account the number of tiles of each type found within the divertor are also shown in Table 1. Profiler results for Tiles 4, 6, 7 and the Load Bearing Tile (LBT) have been evaluated. Data for Tile 7 was for a tile installed in the vessel from 2005 - 2009 and has been scaled according to plasma time for the 2007 - 2009 operating period as for other tiles. Tiles 1, 3 and 8 have yet to be evaluated, however this will not significantly change the result as the deposition on the sloping surface of tiles 4 and 6 dominate the total amount of deposit of carbon in the divertor. For example Figure 3(a) shows deposit on Tile 6 is an order of magnitude thicker than the erosion observed on Tile 7, Figure 3(b). This is also supported by results presented in [12]. Based on the results available the net deposition onto tiles in the divertor is 533 g.

Figure 3 Profiler results for (a) Tile 6 (b) Tile 7.
