Testbeam and Laboratory Characterization of CMS 3D Pixel Sensors

^a *Physics Department, Purdue University, 525 Northwestern Avenue, West Lafayette, IN 47907-2036, USA*

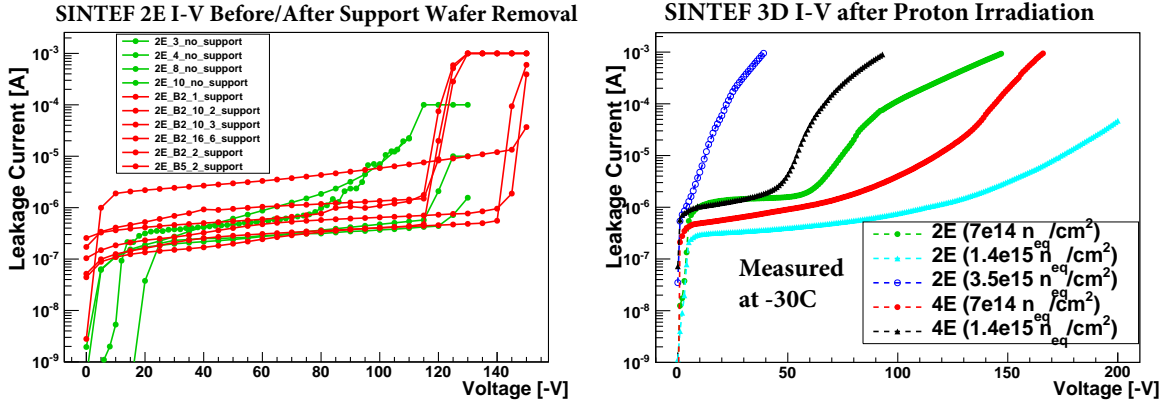
Figure 5. I-V measurements of SINTEF 2E sensors before and after support wafer removal (left), Leakage current of SINTEF 3D sensors after 7×10^{14} - 3.5×10^{15} n_{eq}/cm^2 proton irradiation (right).

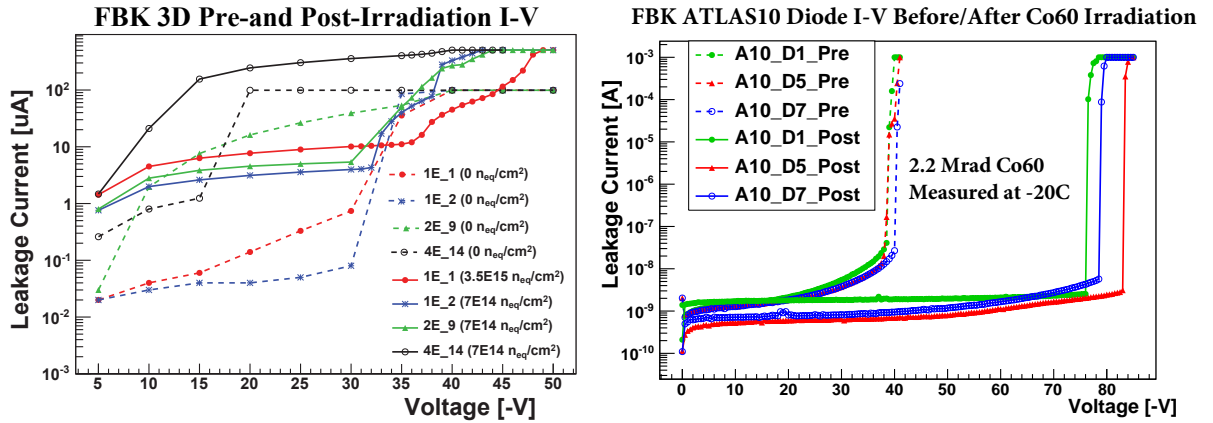
Figure 6. I-V measurements of FBK 3D ATLAS08 sensors (left) before/after $7 \times 10^{14} - 3.5 \times 10^{15} \text{ n}_{\text{eq}}/\text{cm}^2$ proton irradiation, and FBK ATLAS10 1E diodes (right) before/after 2.2 Mrad Co^{60} gamma irradiation.
