Simulation of corrosion and mechanical degradation of additively manufactured Mg scaffolds in simulated body fluid

Journal of the Mechanical Behavior of Biomedical Materials, accepted for publication.
October 2021

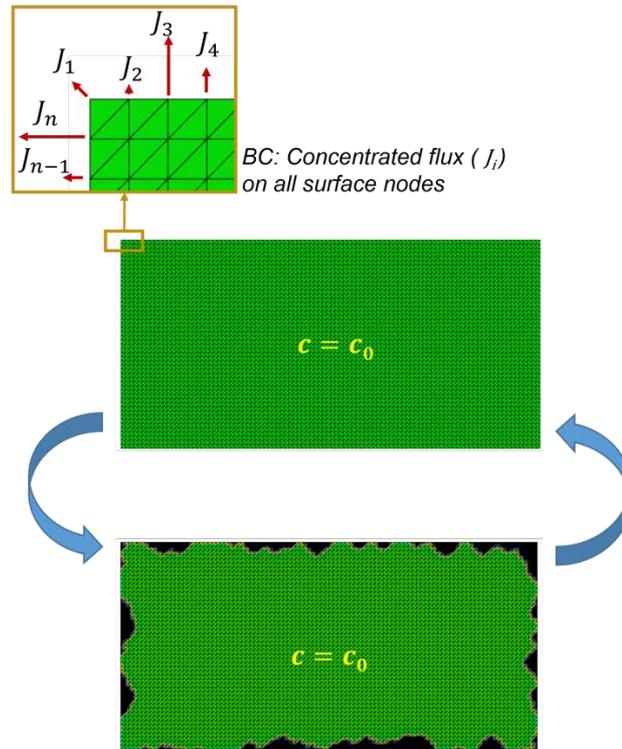
Figure 1. Schematic of the simulation of the corrosion process (including pitting) through the finite element simulation of the diffusion of Mg. The initial concentration of Mg in the solid is c_0 and a random flux of Mg is applied to boundaries following a Weibull probability density function in each time step. The equilibrium concentration of Mg in the solid is determined from the finite element solution of eq. (1) and the process is repeated until the desired time is reached.

where c is the concentration of Mg, t the time, D the isotropic diffusion coefficient of Mg in the alloy (10^{-8} mm²/s) and ∇ the gradient function. The scaffold is discretized with 4-node linear tetrahedra (DC3D4) with an average length of 0.1 mm and it is assumed that corrosion begins at each node on the surface of the scaffold. To this end, a boundary condition of concentrated outward point flux is applied to each node i on the scaffold surface (Fig. 1)-where the flux at node i is given by

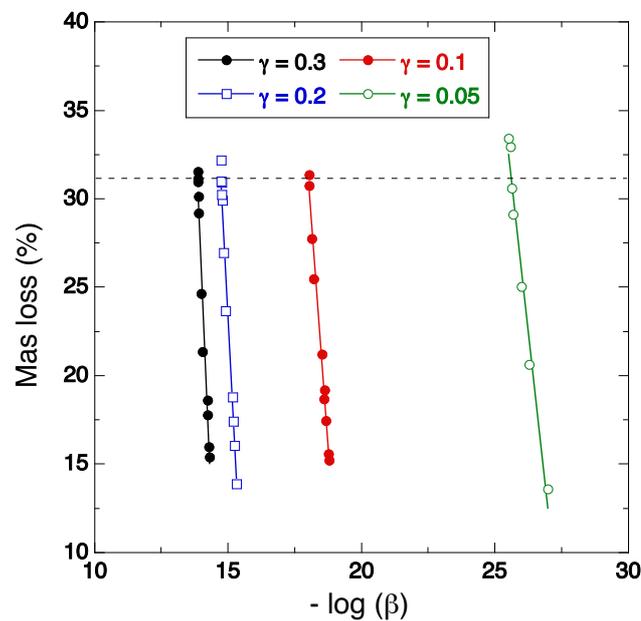
Figure 2. Simulation results of the mass loss of the scaffold (expressed as % of the initial mass) after 168 hours of immersion in SBF as a function of the parameters β and γ of the diffusion model. β is expressed as $\text{mol s}^{-1} \text{mm}^{-2}$. The horizontal dashed lines indicated the mass loss measured by XCT.

Diffusion simulations were carried out in the scaffold with a nominal strut diameter of 500 μm . An initial set of simulations was carried out to assess the relationship between the model parameters β and γ and the mass loss Δm of the scaffold after 168 hours of immersion in SBF and the results are plotted in Fig. 2. As indicated above, the mass loss is determined from elements in which the concentration of Mg is below 40% of the initial concentration. Obviously, Δm increases with β for a given value of γ as β dictates the average flux of Mg for a given concentration gradient. Nevertheless, the influence of β in the corrosion rate is modulated by γ , as it is shown in Fig. 2: the higher γ , the higher variation in the overall mass loss in the scaffold with β .

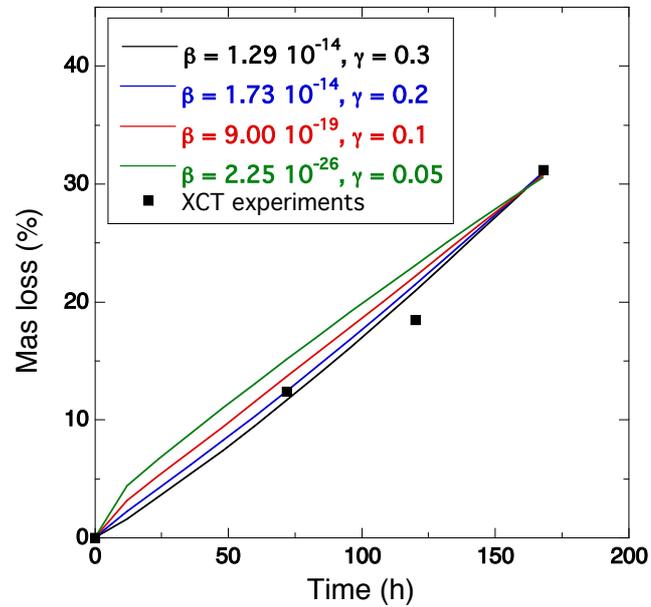
Figure 3. Mass loss (expressed as % of the initial mass of the scaffold) vs. time (h) for the scaffold with struts of 500 μm nominal diameter immersed in SBF. Solid squares stand for the experimental results obtained by XCT [12]. The lines represent the predictions of the diffusion model for different pairs of β and γ . β is expressed as $\text{mol s}^{-1} \text{mm}^{-2}$.

Four pairs of β and γ were chosen to simulate the corrosion of the scaffold under the assumption that the total mass loss predicted by the corrosion model was equal to the one measured by XCT after 168 hours (Fig. 3). The four pairs of parameters were able to predict with reasonable accuracy the evolution of the mass loss with time for the scaffold but they led to diverse corrosion patterns as a result of the differences in the Weibull parameter γ that controls that degree of pitting. The progress of corrosion with time in the scaffold is depicted in Fig. 4 for the simulations with $\beta = 1.29 \times 10^{-14} \text{ mol s}^{-1} \text{mm}^{-2}$ and $\gamma = 0.3$. In this figure, the elements in which the concentration of Mg was below $0.4c_0$ have been deleted to show the

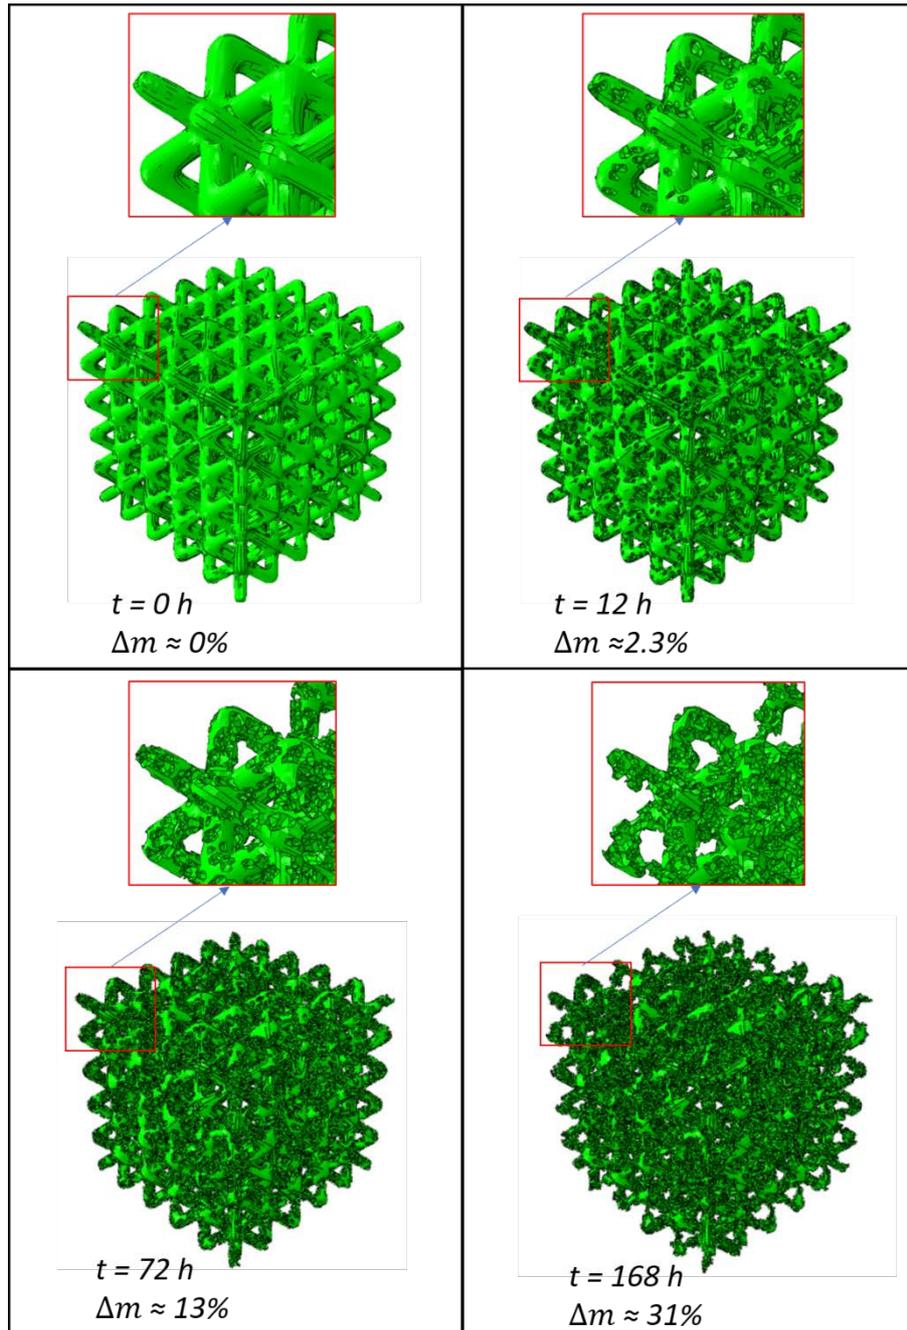
Figure 4. Simulations of corrosion in the scaffold with 500 μm nominal strut diameter as a function of the immersion time in SBF. The elements in which the concentration of Mg was below $0.4c_0$ have been deleted. The immersion time t (in hours) and the mass loss Δm (%) are indicated below each plot. $\beta = 1.29 \times 10^{-14} \text{ mol s}^{-1} \text{ mm}^{-2}$ and $\gamma = 0.3$.

progress of corrosion. They show that corrosion is not uniform but begins by pitting corrosion on localized points of the scaffold surface. After 168 hours, corrosion has spread over the whole scaffold and some struts have been fully corroded, compromising the structural stability of the scaffold.

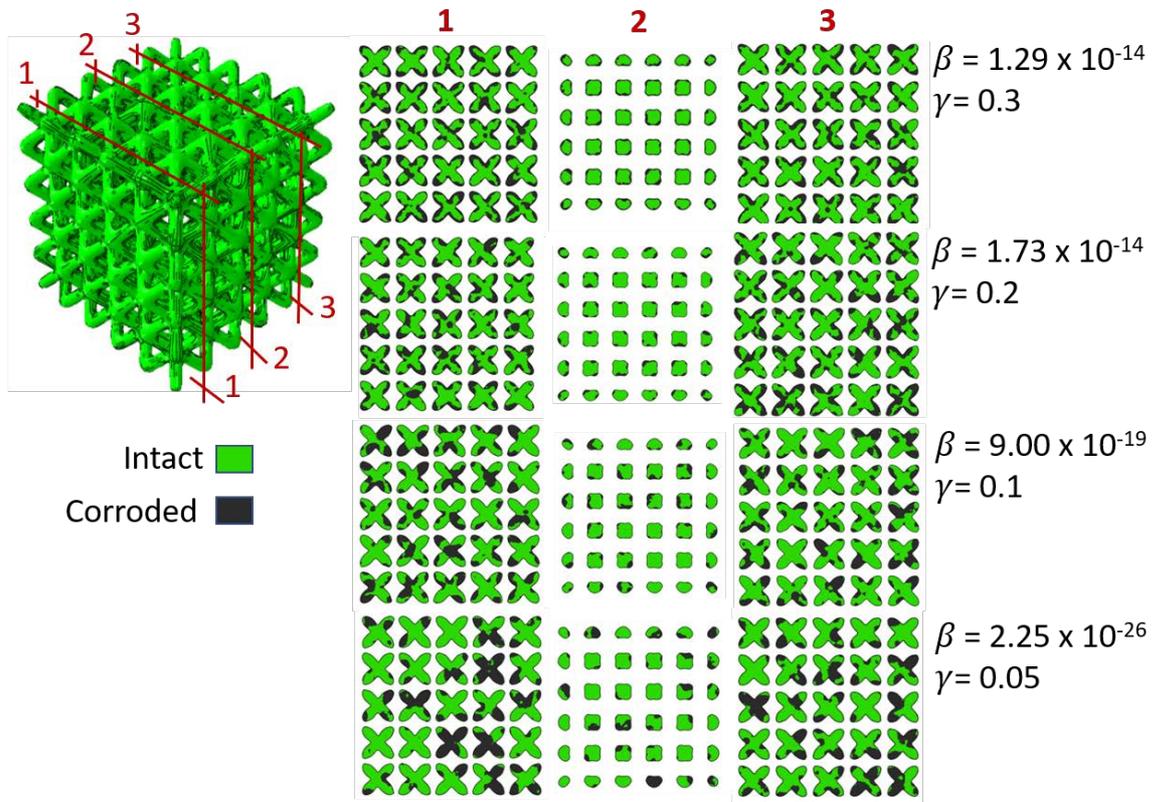
Figure 5. Simulated cross-sections of the scaffold with 500 μm nominal strut diameter after 168 hours of immersion in SBF for different values of β (expressed as $\text{mol s}^{-1} \text{mm}^{-2}$) and γ . The elements in which the concentration of Mg was below $0.4c_0$ have been deleted. The total mass loss was 31% in all cases.

The influence of the Weibull parameter on the corrosion process in three different section of the scaffold (1, 2 and 3) is shown in Fig. 5. The black regions correspond to fully corroded parts of the scaffold in which $c \geq 0.4c_0$ while the remaining zones are green. The mass loss was 31% in all cases but localization of corrosion was controlled by γ . Corrosion was fairly

uniform when $\gamma = 0.3$ whereas large differences in the corrosion rate among different zones of the scaffold can be seen when $\gamma = 0.05$.

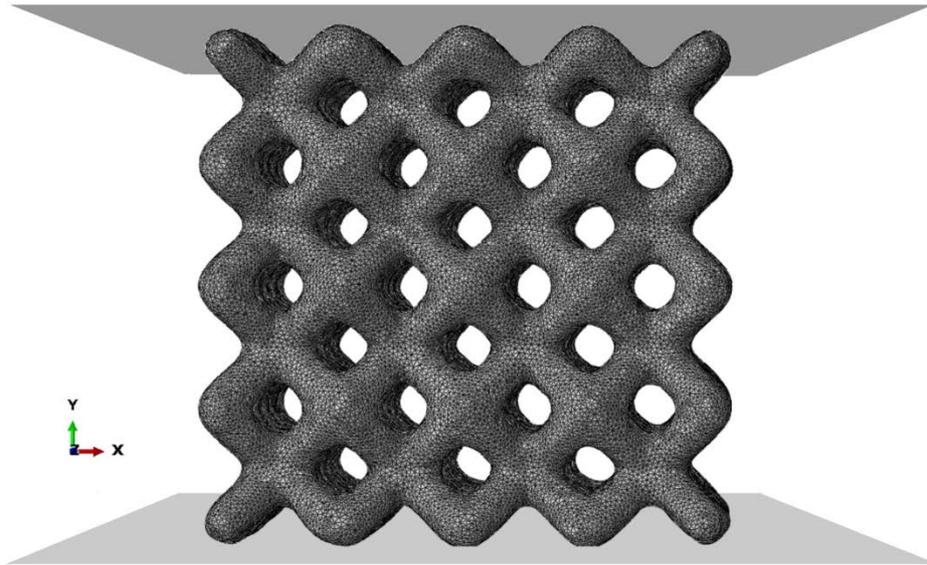
Figure 6. Schematic of the compression of the scaffold between two rigid plates.

The mechanical behavior in compression of the scaffolds with struts of 500 μm and 750 μm in diameter as well as of the corroded scaffolds with struts of 500 μm in diameter was simulated using Abaqus/Explicit [27] (Fig. 6). The scaffolds were compressed between two rigid plates using the General Contact Algorithm in to avoid that the elements of the model overlap with the boundaries of cubic scaffold as a result of buckling. The velocity of the upper surface was -0.033 mm/s, which corresponds to a nominal strain rate of $0.0033 s^{-1}$. The friction coefficient between the plates and the Mg struts was 0.6. It was assessed that the explicit analysis was carried out under quasi-static conditions: the kinetic energy was always less than 2% of the internal energy and the reaction forces extracted from reference nodes on the loading plates were symmetric throughout the analysis.

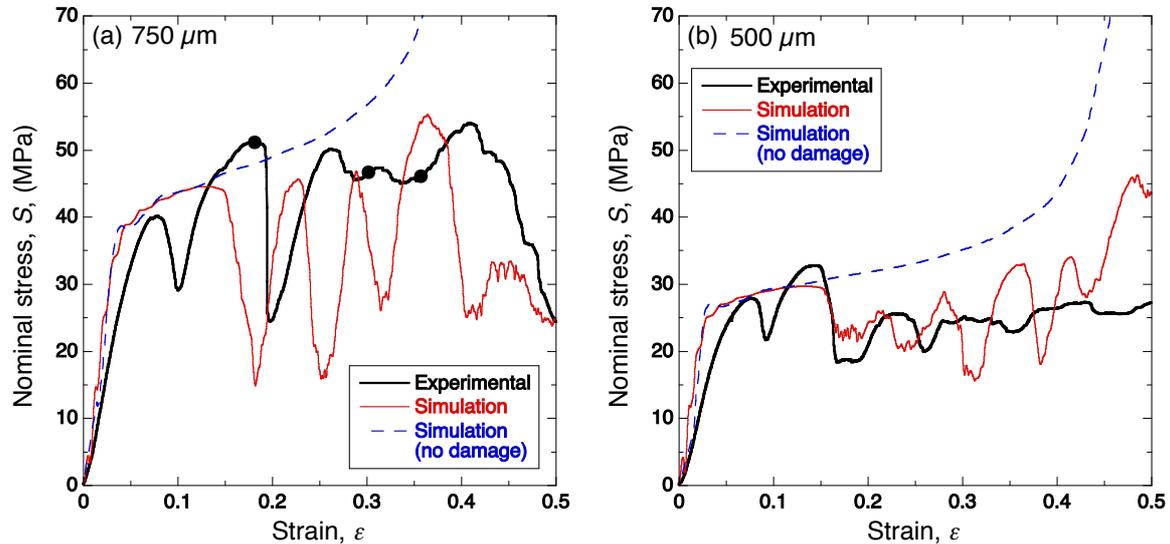
Figure 7. Nominal stress (S) vs. strain (ϵ) curves of the as-printed scaffolds deformed in compression. (a) Scaffold with strut diameter of $750 \mu\text{m}$. (b) Scaffold with strut diameter of $500 \mu\text{m}$.

The video of experimental test in the scaffold with strut diameter of $750 \mu\text{m}$ can be found in the supplementary material (video S4.mp4) and optical images of the scaffold extracted from the video are plotted in Fig. 8 for different values of the applied strain. They show that the first stress drop at an applied strain of 10% was associated with damage in the first row of cells by cracks parallel to the loading axis. The cracks were nucleated at the joints of four struts of the bcc lattice. Tensile stress perpendicular to the loading axis developed at the joints as a result of compressive loading, leading to vertical cracks while the struts were mainly loaded in bending. Afterwards, the stress increased, reaching a maximum of $\approx 50 \text{ MPa}$, and it was followed by another stress drop by the fracture of struts at the bottom row of cells when the applied strain reached 20%. Thus, the serrated shape of the $S - \epsilon$ curve is due to progressive collapse of horizontal layers beginning by those closer to the top and bottom rigid plates.

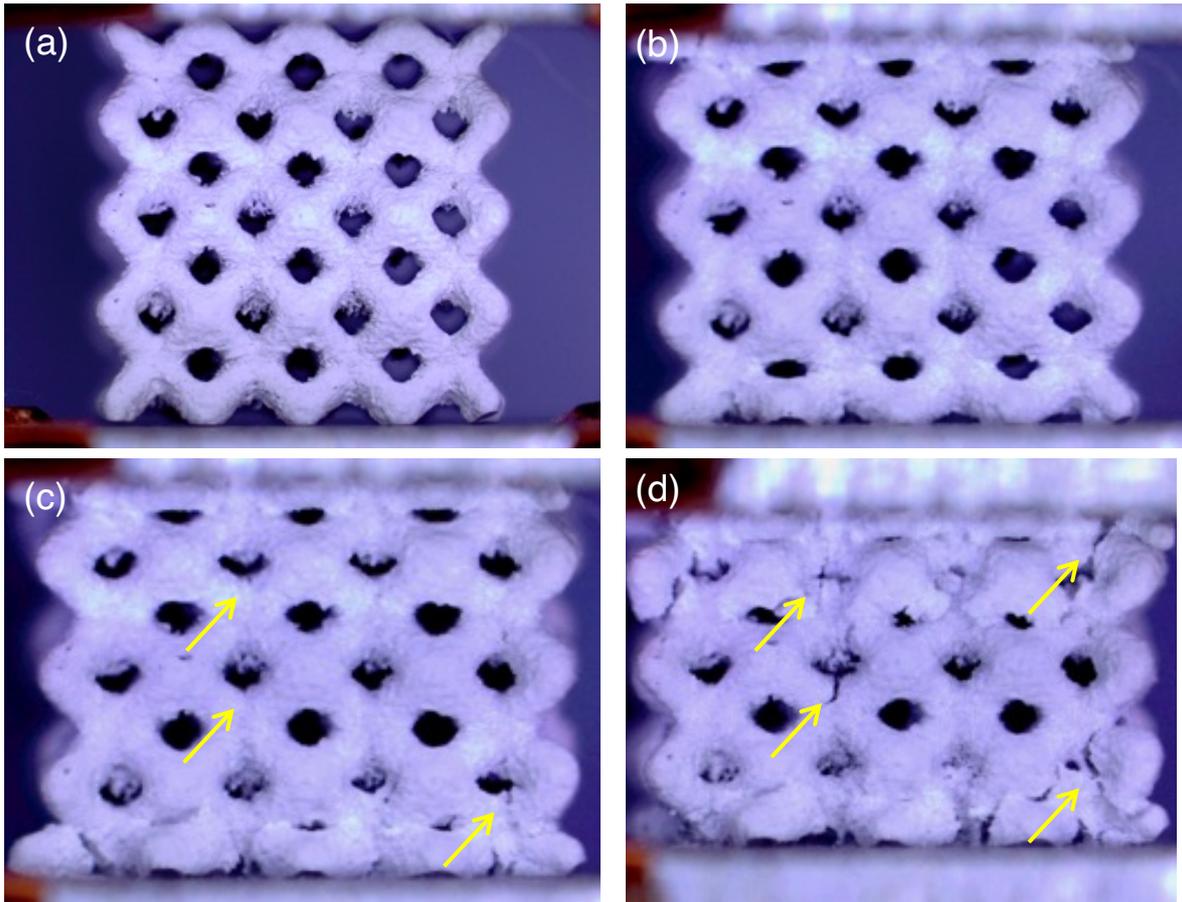
Figure 8. Optical micrographs of the scaffold with nominal strut diameter of 750 μm deformed up to different strains marked by black circles in Fig. 6a. (a) 0%. (b) 18%. (c). 30%. (d) 36%. Cracks at the joints parallel to the loading direction are indicated by the yellow arrows.

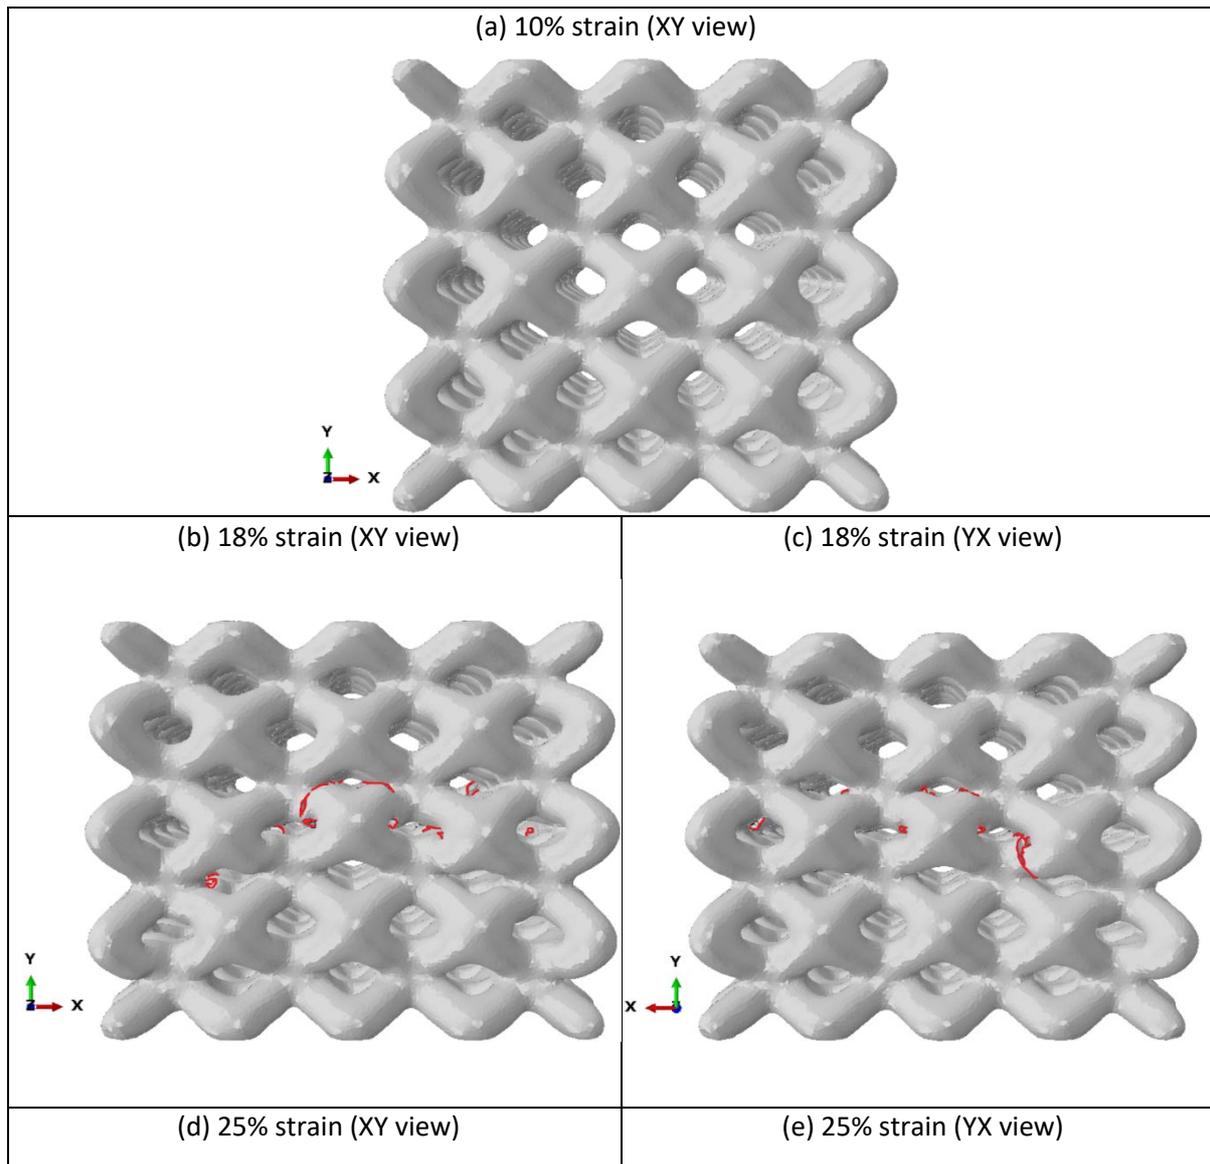
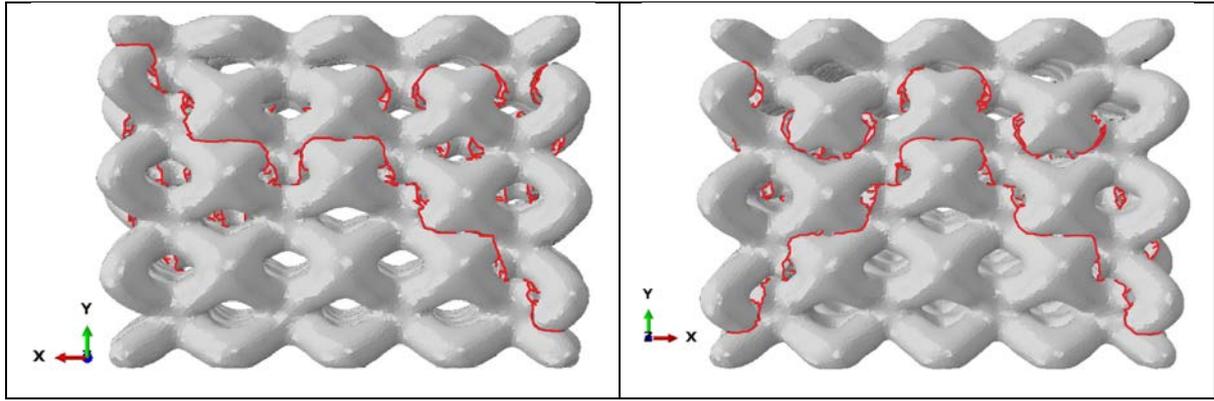
Figure 9. Lateral views of the simulation of the scaffold with nominal strut diameter of $750\ \mu\text{m}$ up to different strains. (a) 10% (close to the minimum stress after the first load drop). (b) and (c) 18% (close to the minimum corresponding to the second load drop). (d) and (e) 25% (close to the minimum corresponding to the second load drop). The cracks in the scaffold have been highlighted in red.

The deformation mechanisms in the simulations are equivalent and the simulated $S - \epsilon$ curve also shows periodic serrations that are associated with the progressive failure of horizontal rows of cells in the scaffold, as shown in the snapshots of the simulations in Fig. 9. The deformation of the scaffold is uniform up to 10% strain (Fig. 9a) but damage is localized afterwards in the central row of the scaffold, as shown by the cracks (marked in red) that appear in the lateral views of the deformed scaffold (Figs. 9b and c). It should be noticed that the stress state in the simulated scaffold is not perfectly uniaxial because of the friction between the loading plates and the scaffold. Thus, compressive stresses perpendicular to the loading axis are present in the simulations. They are higher close to the loading plates and are gradually relieved with the distance to the surface and this is the reason why damage always begin in the central section in the simulations of perfect scaffolds. In addition, the lateral constraint induced by the friction with the loading surfaces leads to small differences in the stresses across any section of the scaffold. The local stresses in the centre of the scaffold are slightly higher than at the boundary and damage is triggered at the centre.

Further deformation after the first row of cells has collapsed leads to the failure of a second row of cells (the one on top of the first collapsed row) at an applied strain of 25% (Figs. 9d and e), which is associated with the second stress drop in Fig. 6a. Vertical cracks in the simulations and in the experiments appear at the joints among struts because the kinematics of compressive deformation of the bcc lattice leads to the development of horizontal tensile stresses at these points.

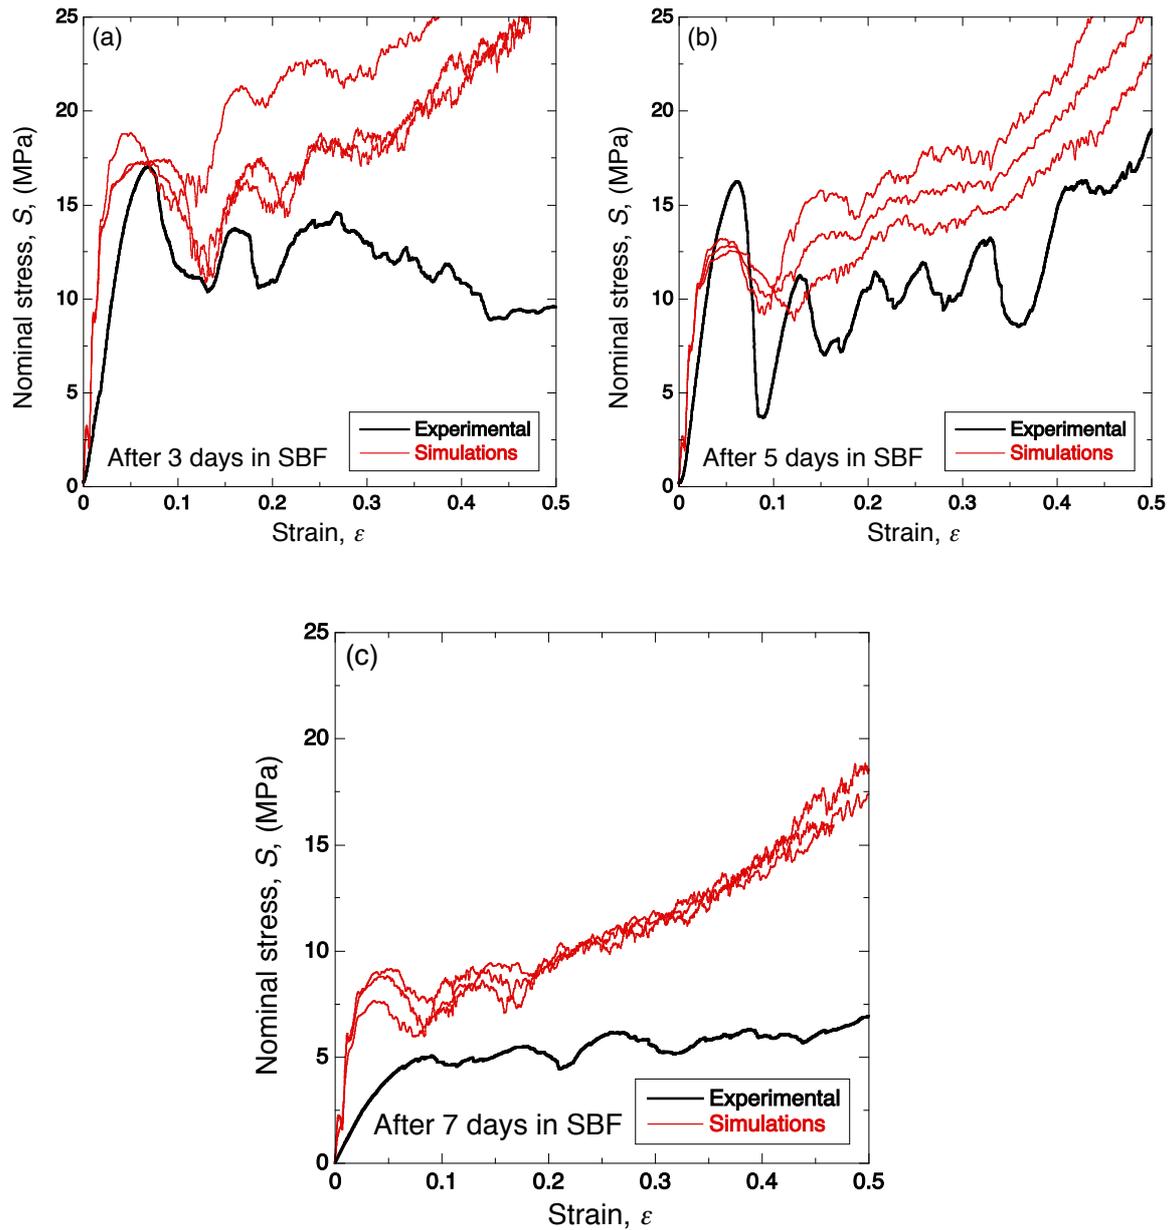
Figure 10. Experimental and simulated nominal stress (S) vs. strain (ϵ) curves of the corroded scaffolds with strut diameter of 500 μm deformed in compression. (a) After 3 days of corrosion in SBF. (b) *Idem* 5 days. (c) *Idem* 7 days.

The $S - \varepsilon$ curves obtained from the simulations of the scaffolds with struts of $500\ \mu\text{m}$ after 3, 5 and 7 days of immersion in SBF are plotted in Figs. 10a, 10b and 10c, respectively, together with the experimental ones [12]. The experimental curves show a marked reduction in the strength of the scaffolds with respect to the as-printed one (Fig. 7b), particularly after 7 days of immersion in SBF. Moreover, the serrations in the curves also tend to disappear with the immersion time because localized corrosion destroys the symmetry of the scaffold and the layer-by-layer failure mechanism is no longer dominant.

Three different simulations were carried out for each corroded scaffold because the corrosion rate at each node of the scaffold surface is assigned randomly at the beginning of the simulation. The corresponding $S - \epsilon$ curves obtained from the numerical simulations are also plotted in Fig. 10 and compared with the experimental ones. Because the reduced number of available scaffolds, mechanical tests were only carried out in one scaffold after 3, 5 and 7 days of immersion in SBF and, therefore, there is no information about the experimental scatter associated with the large variability in the corrosion pattern for same nominal experimental conditions. This limitation may be partially responsible for the differences between experiments and simulations. Overall, the simulations capture the degradation of the mechanical properties of the scaffolds due to corrosion, particularly after 3 and 5 days of immersion in SBF. The experimental elastic modulus in both cases is slightly lower than the one obtained in the simulations for the reasons indicate above but the predictions of the initial yield strength were in good agreement with the experimental values. The simulations predicted very accurately the reduction in the peak stress of the scaffold after 3 days of immersion in SBF but the experimental curve showed a progressive reduction in the load carried by the scaffold afterwards (including several oscillations due to progressive compaction). The simulation showed, however, progressive hardening after the yield strength. The lack of hardening in the experimental curve of the scaffold after 3 days of immersion in SBF could be due to the fall off of struts due to corrosion, which delays the compaction process. On the contrary, the simulations underestimated slightly the experimental peak stress of the scaffold after 5 days in SBF but captured the progressive hardening and the oscillations in the $S - \epsilon$ curve after the yield strength

The quantitative agreement between experiments and simulations is worse in the case of the scaffolds immersed in SBF during 7 days and the yield strength predicted from the simulations overestimated the experimental one by a factor close to 2. Nevertheless, this large difference may be associated with the fact that there was only one experiment in this condition and the experimental scatter is known to increase with the degradation time. Moreover, the simulations capture the disappearance of the serrations in the $S - \epsilon$ curves in the scaffolds after 7 days of immersion.

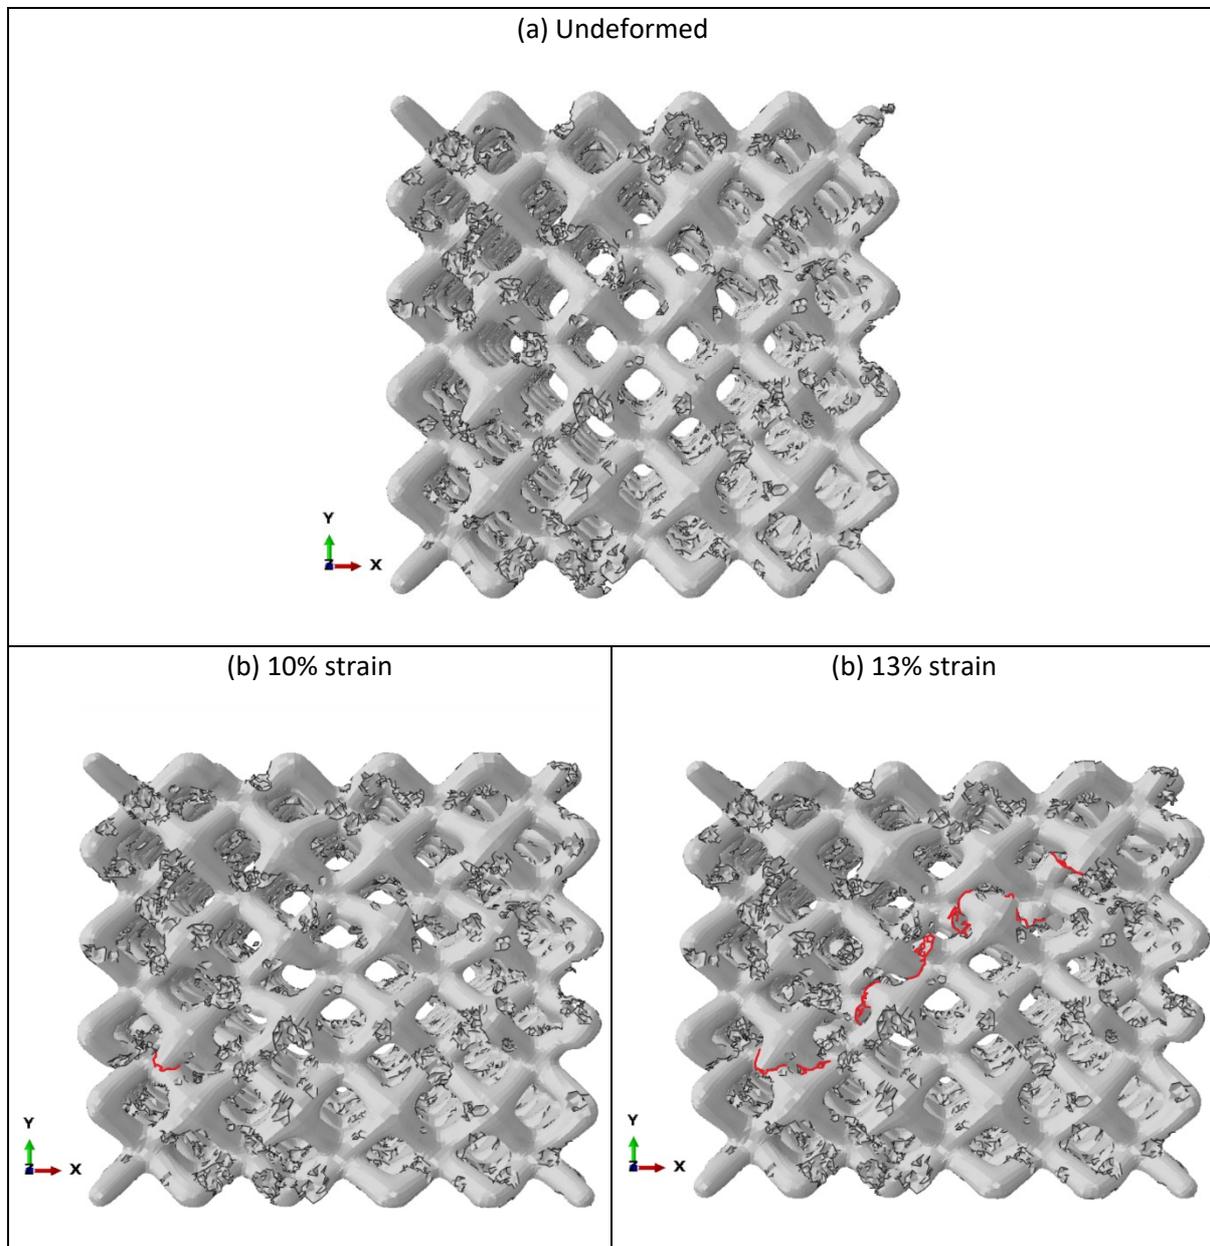
Figure 11. Lateral views of the simulation of the scaffold with nominal strut diameter of 500 μm after 3 days of immersion in SBF up to different strains. (a) Undeformed scaffold with partially degraded struts. (b) Onset of cracking at 10% strain. (c) Formation of a shear band at 45° shear band at 13% strain. The cracks in the scaffold have been highlighted in red.

The deformation and fracture mechanisms of the corroded scaffolds according to the simulations are plotted in Figs. 11 and 12 after 3 and 7 days of immersion in SBF, respectively. The lateral view of the simulated scaffold after 3 days of immersion in SBF is shown in Fig. 10a, where surface damage due to corrosion is easily appreciated. Deformation was homogeneous up to an applied strain of 10%, where the first crack (marked in red in Fig. 11b) appeared at a joint with a large corrosion pit. Further deformation led to the propagation of

damage to form a shear band that was oriented at approximately 45° from the loading axis (Fig. 11c). Thus, failure did not happen by a progressive layer-by-layer collapse and the $S - \varepsilon$ curves did not present the large oscillations in stress found in the as-printed scaffolds. After the formation of the shear band, the stress carried by the scaffold in the simulations increased with strain due to the friction and -at longer strains- to the densification of the scaffold. This phenomenon was not observed in the experimental scaffold tested after three days of immersion in SBF (although it was found in the scaffold tested after 5 days of immersion in SBF, Fig. 10b). This difference between experiments and simulations can be attributed to that the experimental scaffold can fall apart after cracking began and, thus, densification was never observed in the $S - \varepsilon$ curve in Fig. 9a.

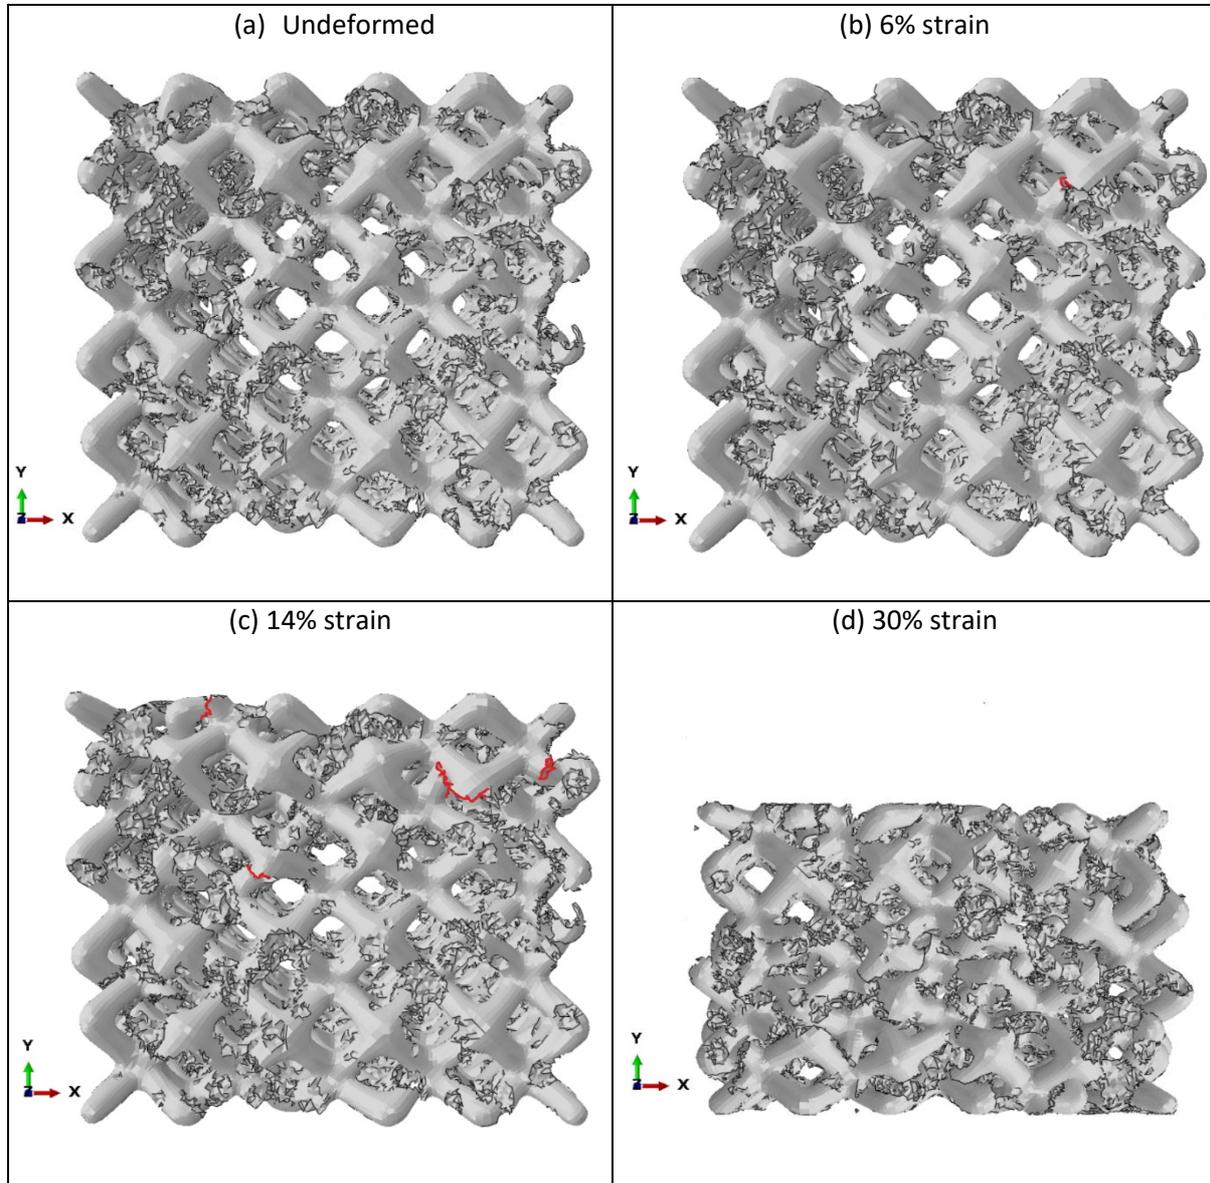
Figure 12. Lateral views of the simulation of the scaffold with nominal strut diameter of 500 μm after 3 days of immersion in SBF up to different strains. (a) Undeformed scaffold with partially degraded struts. (b) Onset of cracking at 6% strain (marked by a yellow arrow). (c) Progressive cracking at 14% strain. (d) Progressive collapse of cells at 30 % strain leading to the beginning of densification. The cracks in the scaffold have been highlighted in red in (b) and (c) but not in (d) because they are everywhere at this point.

The fracture mechanisms in the simulated scaffold after 7 days of immersion in SBF are plotted in Fig. 12. Large corrosion pits are observed in the scaffold surface (Fig. 12a) and the onset of

failure occurs at very low strains (6%) by the apparition of a crack near a large corrosion pit close to a joint (Fig. 12b). Further deformation led to the progressive development of cracks in different regions of the scaffolds with very little increment of the load until densification of the fully cracked scaffold started when the applied strain was around 30 %. Thus, failure by the formation of a shear band did not occur in the grossly degraded scaffold and it was replaced by the progressive collapse associated with the formation of many cracks throughout the scaffold.
