Crystallographic effects on transgranular chloride-induced stress corrosion crack propagation of arc welded austenitic stainless steel

Haozheng J. Qu^{1*}, Fei Tao², Nianju Gu², Timothy Montoya³, Jason M. Taylor³, Rebecca F. Schaller³, Eric Schindelholz⁴, Janelle P. Wharry¹

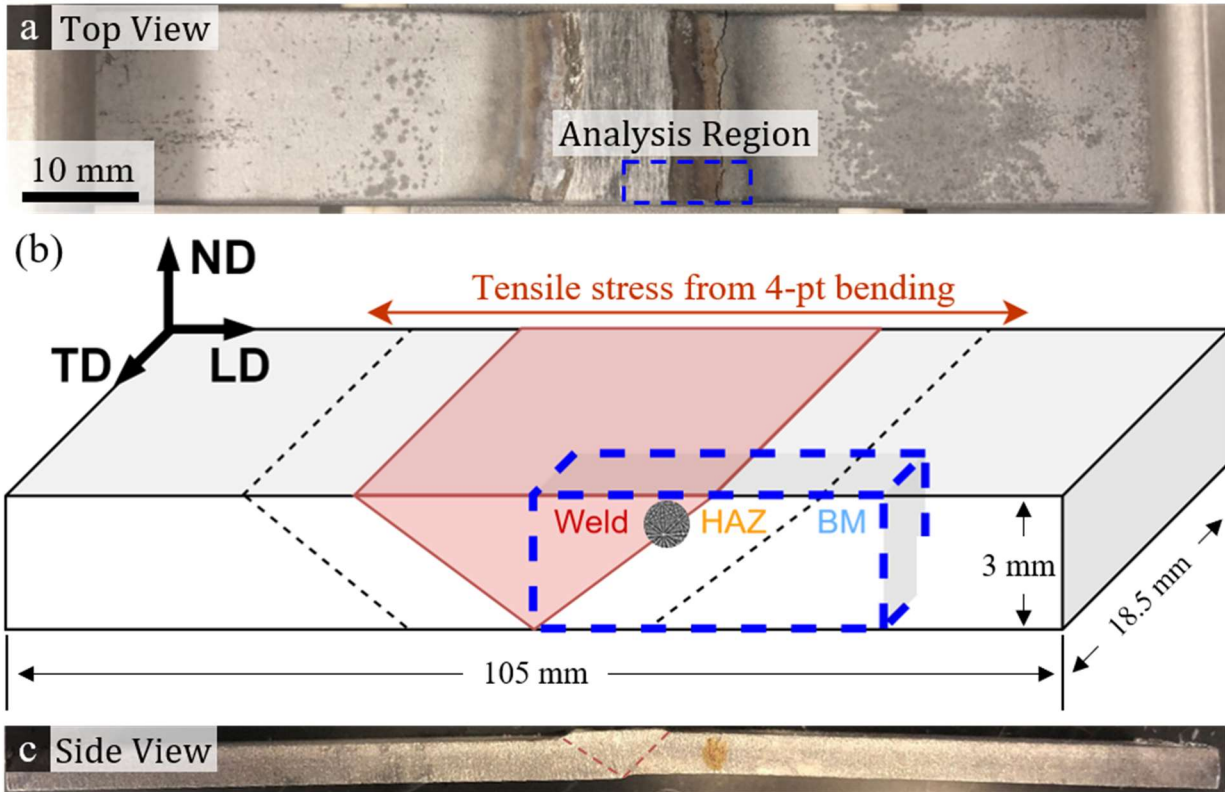
Figure 1. Welded coupon after stress corrosion crack testing in boiling magnesium chloride solution.

(a)(c) Top view and side view; (b) schematic illustration of the welded sample dimension, three different zones produced by GTA welding, and final EBSD analysis regions, marked by Kikuchi pattern. (Images are adapted from ref. ⁴³)

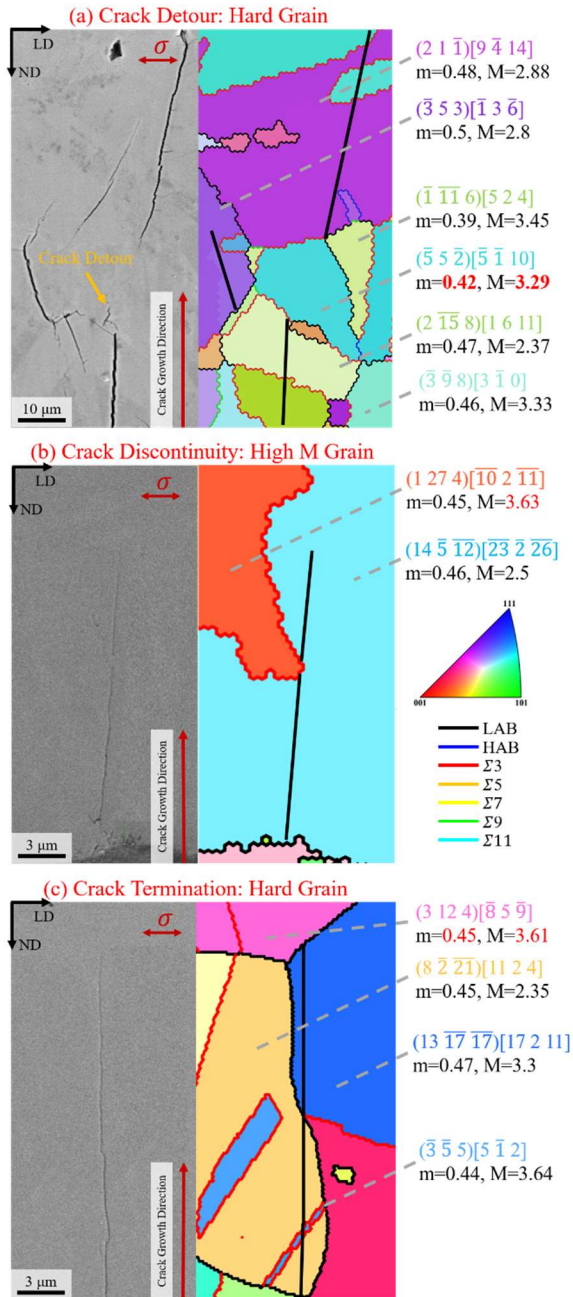
Figure 4. SEM morphology and EBSD maps of representative crack paths for different cracking behaviors.

(a) crack detour; (b) crack discontinuity; (c) crack termination at GB. All Schmid and Taylor factors are identified in all grains along the crack paths. (Images are adapted from ref. ⁷⁶)

The TGSCC crack propagation described in Section 3.1 exhibits some notable crack features, which will be highlighted here. Specifically, discontinuities and crack detours are observed in the HAZ on the scanned cross-section surface. In addition, crack terminations occur predominantly when crack tips arrive at grain boundaries (GBs). EBSD maps showing the Schmid factor and Taylor factor of all grains along crack paths containing representative crack detours, discontinuity, and terminations, are presented in Figure 4.

Crack Detour: Crack detouring describes a set of apparent discontinuities in the crack path around a hard grain – instead of propagating into the incident grain per the original crack path, the crack takes an alternative route around the grain, then resumes the original crack propagation direction on the opposite side of the grain. Crack detours are observed in 2 out of the 37 cracks examined by EBSD. Figure 4a is a representative example of a crack detour shown in SEM with its corresponding SEM-EBSD map. The cyan ($\bar{5} 5 \bar{2}$) grain is the expected incident grain along the crack propagation path from the green ($2 \bar{1} \bar{5} 8$) grain. However, as marked by the black crack path, the crack avoids the cyan ($\bar{5} 5 \bar{2}$) grain. Instead, it takes an alternative route through the purple ($\bar{3} 5 3$) grain before returning to the original crack path in the magenta ($2 1 \bar{1}$) grain. The cyan ($\bar{5} 5 \bar{2}$) grain around which the crack detours has a lower Schmid factor ($m=0.42$) and higher

Crack Discontinuity: Only one crack discontinuity is observed among all 37 closely examined cracks, and it is shown in Figure 4b. This crack is relatively short ($\sim 16 \mu\text{m}$) and has a straight and brittle cleavage appearance. The uncracked “discontinuity” is located at the intersection between the corner of the orange $(1\ 2\ 4)$ grain and the major cyan $(14\ \bar{5}\ \bar{1}\bar{2})$ grain. This discontinuity occurs in the early-stage crack propagation in which the crack path is interrupted at a GB then immediately reappears on the same path on the other side of that grain. It is possible that this discontinuity is a jump of the crack across a grain, because no alternative crack direction is observed in the examined plane, nor is crack branching observed. Such a jump may be akin to the crack bridging phenomenon identified in IGSCC of austenitic stainless steels^{44,45}, which occurs when cracks deviate three-dimensionally around grains and along susceptible sensitized grain boundaries, leaving connected GB ligaments bridging behind the IGSCC crack tip^{44,46}. However, the EBSD maps only show 2D views of the polished cross-section of the specimen, while SCC is 3D in nature⁴⁷. Thus, this crack discontinuity could simply be a form of a crack detour out of the 2D examination plane⁴⁸, with the crack possibly being continuously connected in 3D.

Crack Termination at Grain Boundaries: Cracks tend to terminate exactly at GBs, rather than in the middle of a grain. Of the 37 grains selected for EBSD, 8 cracks are clearly identified to terminate at a GB (although due to the EBSD resolution limit, the exact endpoints of other crack tips are unidentifiable). These crack terminations at GBs mainly occur when the crack is

propagating from a soft to harder grain. The large fraction of crack termini at GBs suggests that CISCC transmission across a GB is controlled by a competition between mechanical, chemical, and crystallographic factors. A representative crack tip terminating at a GB is shown in Figure 4c. It can be observed that after passing through the blue $(13 \overline{17} \overline{17})$ grain ($m=0.47$, $M=0.33$), the crack tip stops at a low-angle grain boundary before the harder pink $(3 \ 12 \ 4)$ grain ($m=0.45$, $M=3.61$).

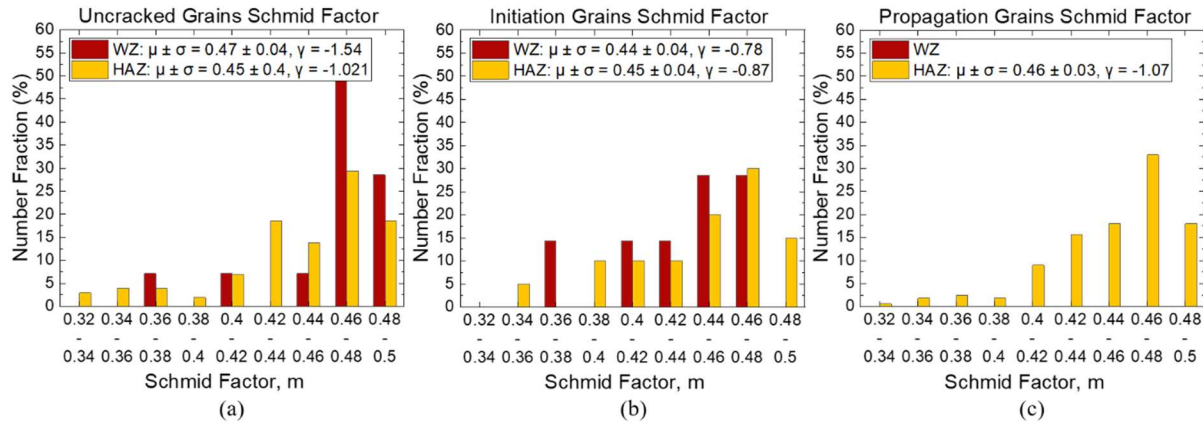
Figure 5. Schmid factor distributions.

(a) uncracked surface grains; (b) surface initiation grains; (c) propagation grains along crack path.

Based on the EBSD maps of the 37 closely examined cracks, the Schmid factor and Taylor factor distributions of 338 grains are presented in Figure 5 and Figure 6, respectively. These distributions are given for (a) all uncracked grains on the specimen surface, (b) grains in which crack initiation occurred, and (c) all propagation grains along the 37 crack paths. Comparing distributions (a) and (b) informs preferential crack initiation orientations while comparing distributions (a) and (c) informs preferential crack propagation orientations.

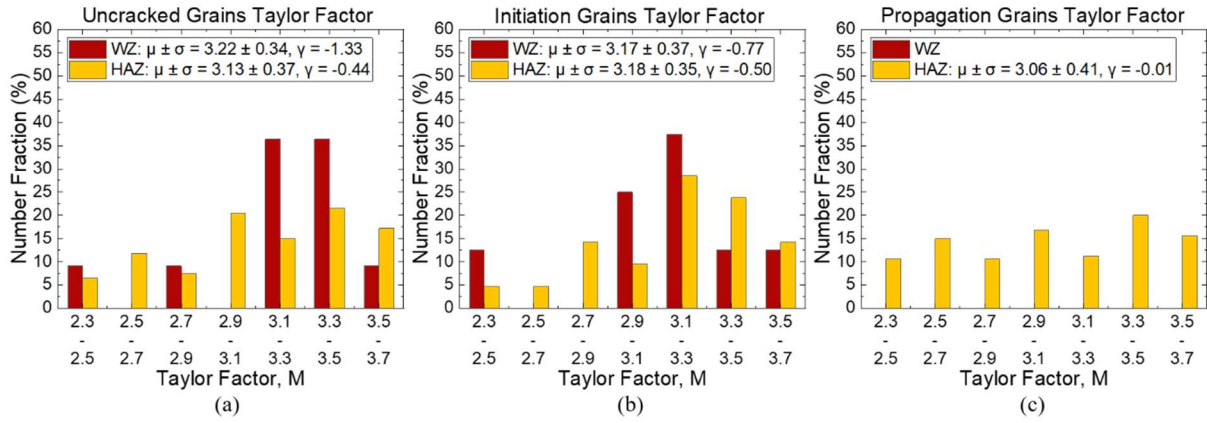
Figure 6. Taylor factor distributions.

(a) uncracked surface grains; (b) surface initiation grains; (c) propagation grains along crack path.

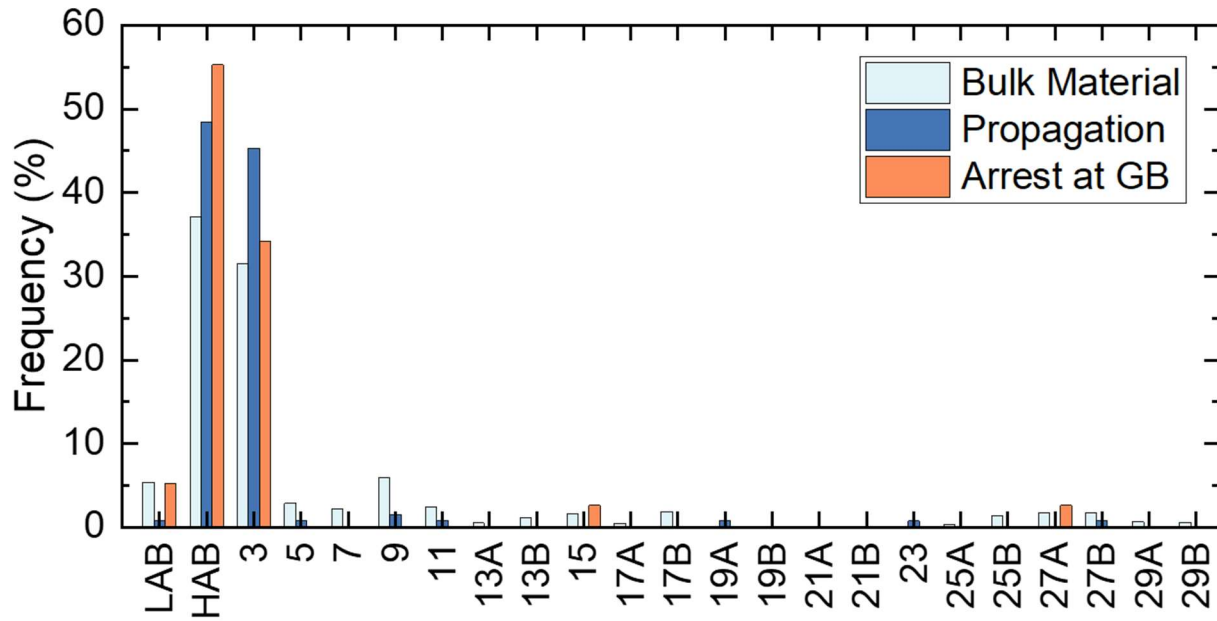
Figure 7. The GB type and CSL boundaries distribution of the bulk material, propagation and arrest scenarios along the 37 crack paths.

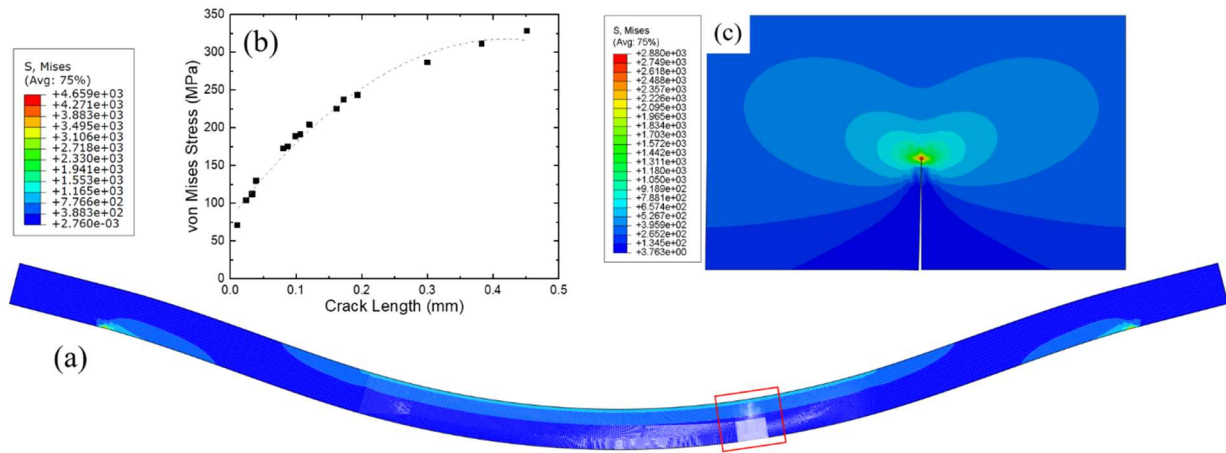
Figure 8. FEA results.

(a) Deformed 4-point bent specimen; (b) von Mises stress at different crack lengths for all cracked grain pairs; (c) high magnification view of the stress distribution near the crack tip.

Initial FEA simulation results are summarized in Figure 8. Figure 8b reports the maximum von Mises stress near a crack tip of varying length, showing that stress concentration follows a typical parabolic shape of linear elastic fracture mechanics (LEFM) analysis⁵⁴. This correlation aligns with the von Mises equivalent stress calculation around a micro-crack under uniaxial tension⁵⁵:

longer cracks experience a greater tendency to propagate. Figure 8c depicts the FEA stress distribution near a crack tip.

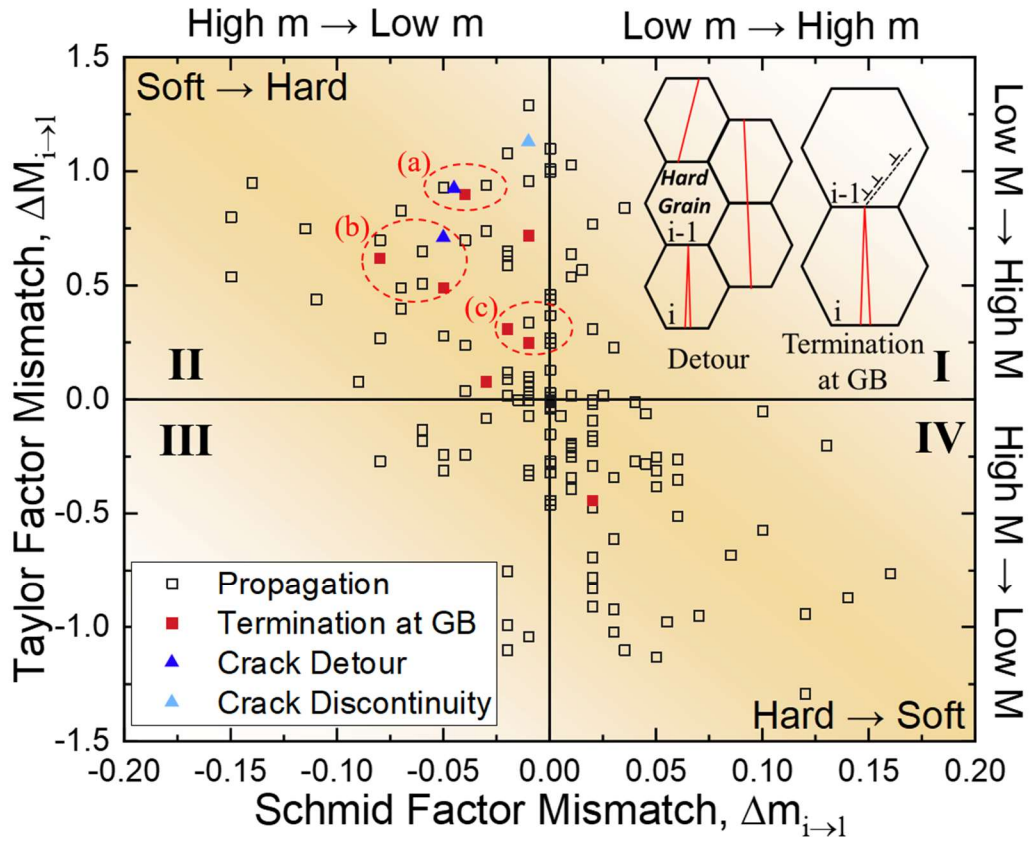
Figure 9. Schmid-Taylor factor mismatch map for transgranular SCC propagation paths.

Each data point represents a grain pair (i.e., GB-crack interaction) along the crack path; data are gathered from all 37 EBSD-analyzed cracks. Subgroups of data points encircled (a)(b)(c) are further analyzed in

TGCISCC propagation grain pairs concentrate in the second and fourth quadrants, indicating a “hard ↔ soft” grain pair preference. That is, TGCISCC propagation is most likely to occur between grains with opposite Schmid factor and Taylor factor mismatches. Cracks located in the second quadrant propagate from a high m , low M grain (soft) to a low m , high M grain (hard). By contrast, cracks in the fourth quadrant propagate from a low m , high M grain (hard) to a high m , low M grain (soft). Notable behaviors such as crack detouring, discontinuity, and termination at GBs are concentrated in the second quadrant (soft → hard), i.e., when a crack propagating in a softer grain meets a harder grain (lower m and higher M). Specifically, it should be noted that the crack detour in Figure 4a occurs in the neighboring soft ($\bar{3} 5 3$) grain, while the other surrounding grains are hard grains with lower m and higher M . Since SCC usually branches and kinks in 3D ⁴⁷, the “soft → hard” crack detour observations indicate that the crack is likely to be drawn towards and detours in the soft neighboring grain in 3D, rather than propagate directly through it. Crack discontinuity occurs between two grains with a large (> 1.0) Taylor factor difference, but the Schmid factor of the grains is similar.

There remain outliers in the mismatch map (Figure 9), which indicates that local strain and stress incompatibility, as represented by the Schmid factor and Taylor factor, may not be sufficient to comprehensively describe and predict TGCISCC behaviors. Thus, other factors, such as temperature^{42,65,66}, chloride concentration^{67,68}, and pH^{5,66,69}, should also be considered when evaluating TGCISCC phenomena. Examination of additional cracks would also improve the statistical significance of trends identified herein.

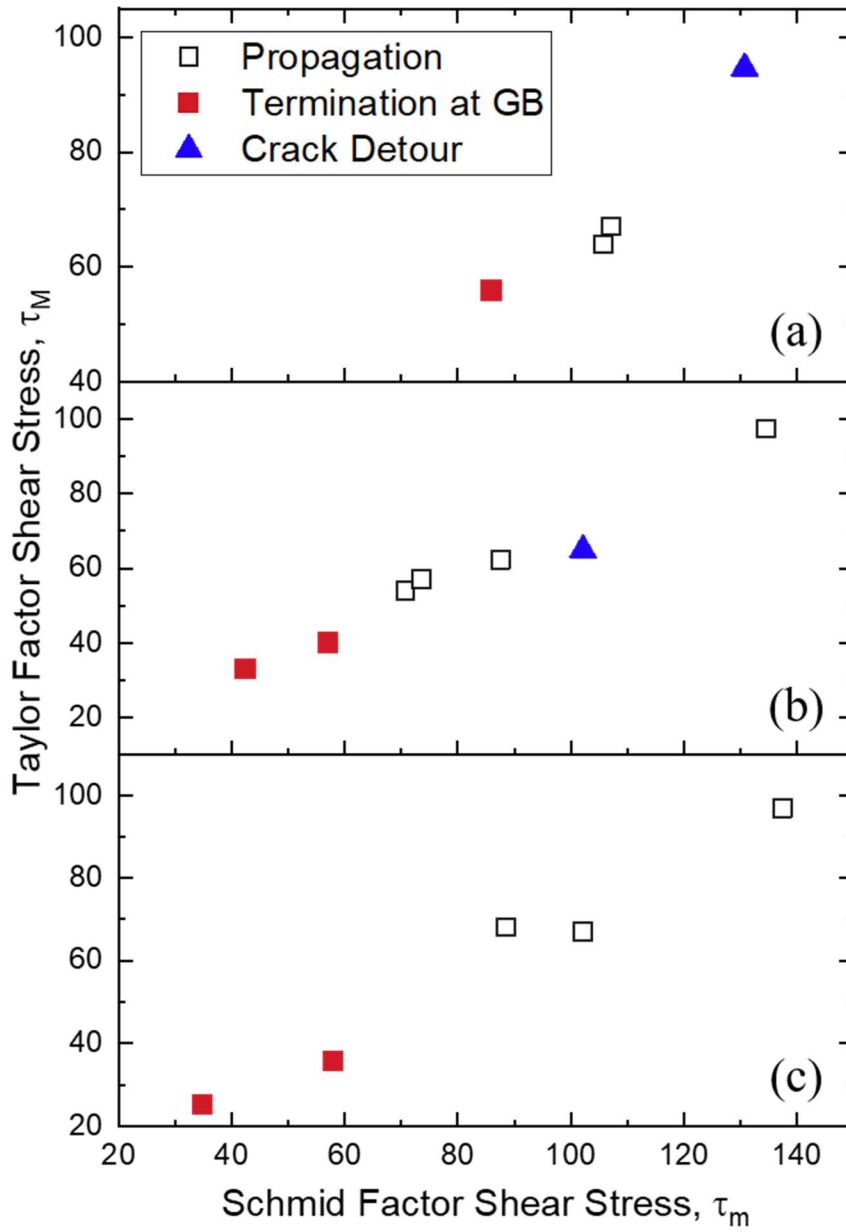
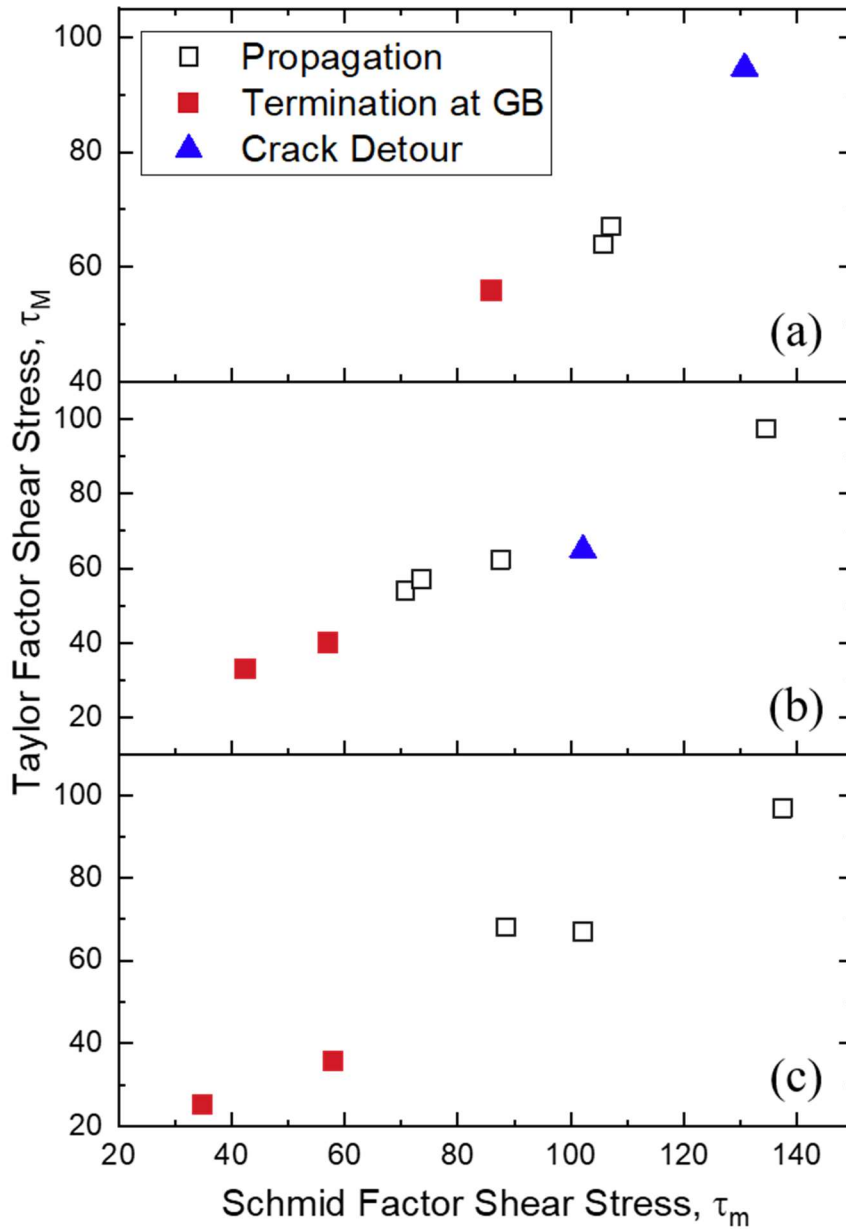
Figure 10. Schmid factor shear stress and Taylor factor shear stress of the grain pairs within subgroups (a - c) as identified on mismatch map (Figure 9).

The FEA resultant von Mises stress at the crack tip is converted to shear stress using both the Schmid factor and Taylor factor, according to Equations 1 and 2. These shear stresses are plotted in Figure 10 for all three subgroups of data, and the instances of crack propagation, termination, and detouring are distinguished symbolically. These plots show that cracks terminate at the GB when shear stress is lowest, while crack propagation and detouring occur at higher shear stress. This demonstrates that crack propagation through a GB requires a threshold level of shear stress (although this threshold between crack termination and propagation differs for each subgroup based on the Schmid and Taylor mismatches). When the shear stress is below this threshold, cracks

The FEA results of similar m and M subgroups in Figure 10 suggest a possible threshold level of shear stress required for the crack to propagate through a GB (although this threshold differs for each m-M subgroup based on the mismatch values). Similar stress thresholds are also reported in past literature^{19,63,64}, but no agreement on the specific value has been achieved yet.
