Bioabsorbable WE43 Mg alloy wires modified by continuous plasma electrolytic oxidation for implant applications. Part II: degradation and biological performance

Biomaterials Advances, accepted for publication.

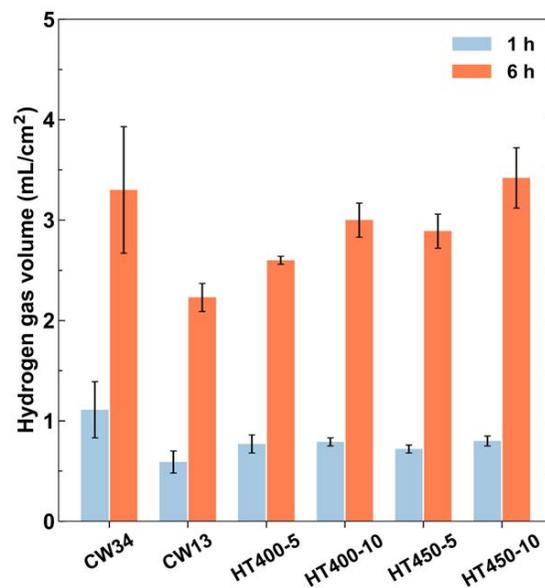
Fig. 1. Degradation rate of Mg wires with different processing conditions measured by the hydrogen evolution after 1 and 6 h immersion in c-SBF.

The early degradation of the Mg wires in c-SBF at 37°C was assessed from the release of hydrogen gas and the corresponding results for wires subjected to different processing conditions are plotted in Fig. 1. The highest corrosion rate after 1 h of immersion was found for the CW34 wire while the lowest corrosion rate was observed for CW13 wire. Annealing of the CW13 wires led to a slightly increase in the corrosion rate after 1 h but the differences

between annealing treatments were negligible. After 6 hours of immersion, the lowest corrosion rate was still found for the CW13 wire. Increasing the amount of cold drawing (CW34) or the annealing temperature or time seemed to enhance the corrosion rate. The effect of annealing on the corrosion rate can be related to the nucleation of precipitates at the grain boundaries, as shown in the transmission electron microscopy observations in [22] while effect of cold work can be linked to the increase in dislocations. It should be noted that the mass loss of the Mg wires after 6 hours of immersion was in the range 20-30% and the differences in the corrosion rates of the Mg wires subjected to various processing conditions were still found to be very limited. Hence, our results clearly indicate that microstructural changes are not enough to tailor the reactivity of Mg alloys and that strategies based on surface modification are necessary.

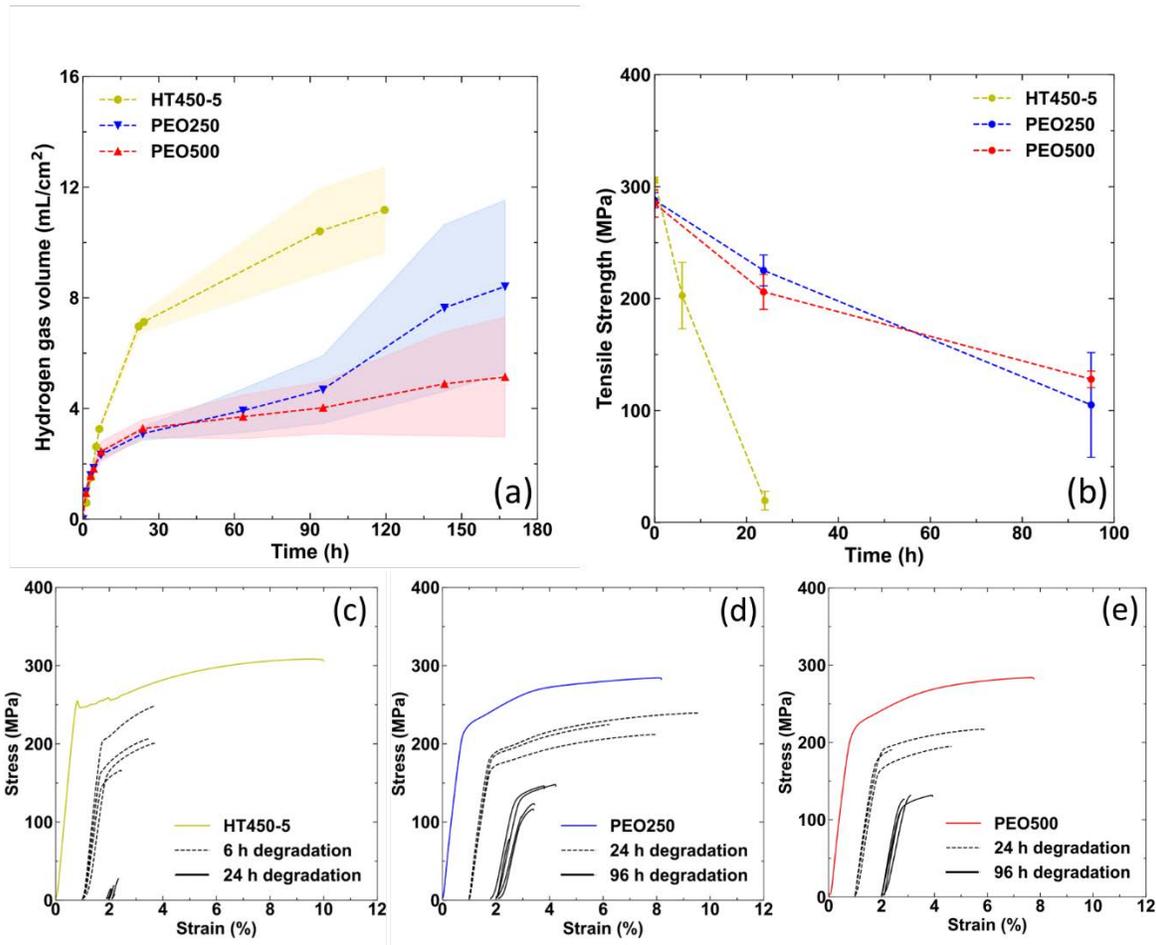
Fig. 2. (a) Hydrogen gas evolution as a function of immersion time in c-SBF at 37°C for Mg wires before (HT450-5) and after (PEO250 and PEO500) surface treatment by PEO. (b) *Idem*

for the tensile strength. The lower row shows changes in the tensile stress-strain curves of (c) HT450-5, (d) PEO250 and (e) PEO500 wires as a function of degradation time. Shaded regions in (a) indicate the standard deviation.

As expected, the continuous oxide layer created by PEO did have a strong effect on the *in vitro* degradation of the Mg wires. The hydrogen volume generated by HT450-5, PEO250 and PEO500 wires as a function of the immersion time in c-SBF at 37°C is plotted in Fig. 2a. The initial corrosion rate (as measured by the hydrogen evolution) was similar for wires without and with oxide layer during the first ≈ 5 h. However, the hydrogen evolution evolved linearly with time in the unprotected wires up to ≈ 20 h while it was significantly reduced for PEO surface-modified wires after 6 - 7 h.

Likewise, the mechanical properties, i.e. tensile strength, of the degraded wires was measured as a function of the immersion time in c-SBF, see Fig. 2b. While the strength of the HT450-5 wires decreased to almost 0 after 24 h of immersion in c-SBF at 37°C, the strength of the wires protected by PEO was > 200 MPa after 24 h and > 100 MPa after 96 h. It should be noted that the decrease in mechanical strength of PEO250 and PEO500 wires was very

similar up to 96 h, which is in agreement with the results of the corrosion tests. The tensile stress-strain curves in Figs. 2c, 2d and 2e show that the failure strain of all wires decreased with degradation time. This phenomenon was much more marked in the HT450-5 wires which presented severe pitting corrosion. Thus, these wires failed at very low strains at the section with the smallest cross-section in the wire in which deformation was localized. Surface modification of the Mg wires by PEO provided higher strain-to-failure in all cases. Tensile tests could not be carried out on wires immersed for longer times than depicted in the figure since they lost mechanical integrity and were too fragile to test reliably.

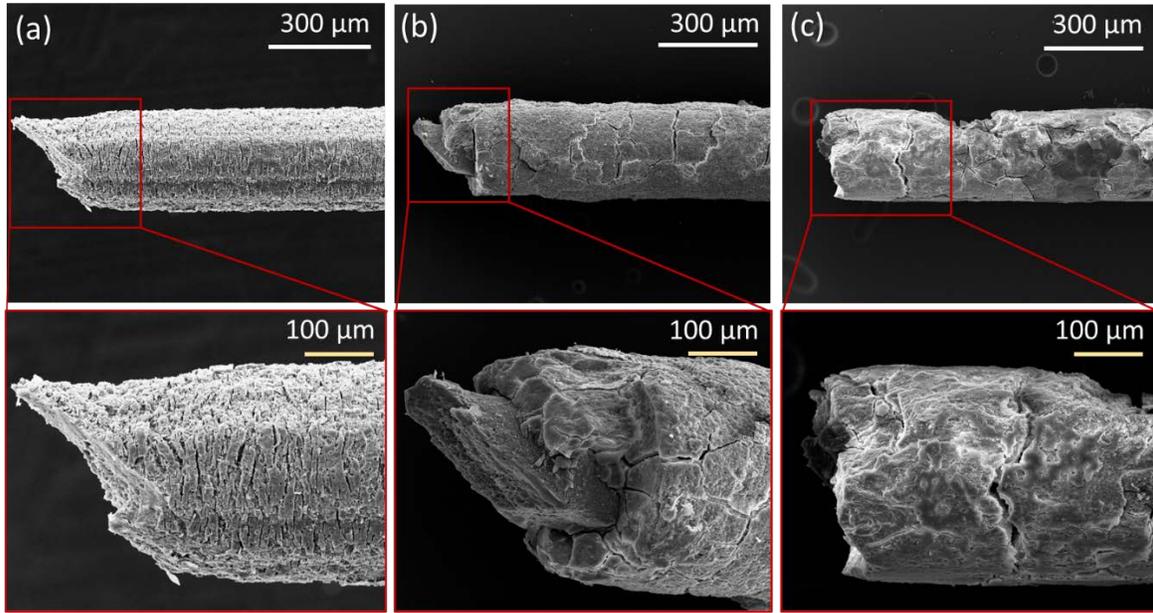
Fig. 3. SEM images of Mg wires before and after degradation. (a) Fracture region of the PEO500 wire deformed under tension before immersion in c-SBF. (b) *Idem* after 96 h in c-SBF. (c) Fracture region of a HT450-5 wire after 24 h immersion in c-SBF.

The fracture region of the PEO500 wire tested in tension before immersion in c-SBF is depicted in Fig. 3a. The fracture surface is oriented at 45° from the tensile loading axis, indicating that the final fracture process took place by shear, a typical mechanism in Mg alloys. The image at higher magnification shows many cracks, perpendicular to the loading axis, in the oxide layer. They indicate that the oxide layer was well adhered to the Mg wire and failed in tension because of the load transfer during the plastic deformation of the wire. The fracture region of the PEO500 wire deformed after 96 h of immersion in c-SBF is depicted in Fig. 3b. It shows a core region of Mg, which also failed by shear, surrounded by a thick circumferential oxide layer, which is homogeneously distributed and did not detach from the Mg core. On the contrary, the fractures of Mg wires that were not modified by PEO showed to be fully brittle after 24 h degradation (Fig. 3c) and the strain to failure was negligible.

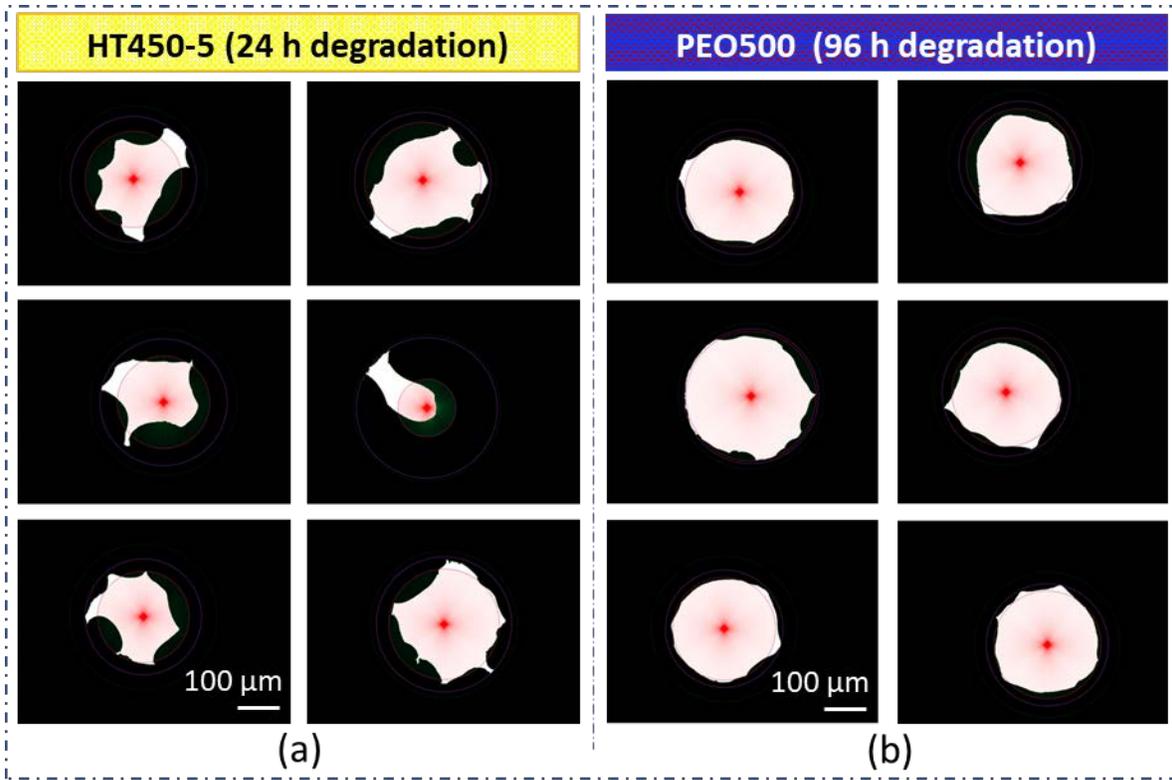
Fig. 4. (a) Representative cross-sections of HT450-5 wire after 96 h immersion in c-SBF. (b) Idem of PEO500 wire after 96 h immersion in c-SBF. Red points mark the original center of cross section before degradation. The scale bar of 100 μm is for all cross-sections in this figure.

The presence of the oxide layer created by PEO did not only reduce the average corrosion rate of the wires but also reduced the intensity of pitting corrosion. This is shown in Figs. 4a and 4b, in which random cross-sections of the Mg wires (including only the Mg section of the wire) are depicted for the HT450-5 wire after 24 h of immersion in c-SBF and for the PEO500 wire after 96 h of immersion in c-SBF, respectively. For the wire without any surface protection by PEO, corrosion was easy to localize in random cross-sections of the wire and the mechanical strength of the wires was quickly reduced to a negligible value within 24 h of immersion. On the contrary, the PEO oxide layer showed to hinder the development of severe pitting corrosion and the Mg cross-section of these wires remained almost circular and intact even after 96 h of immersion in c-SBF.

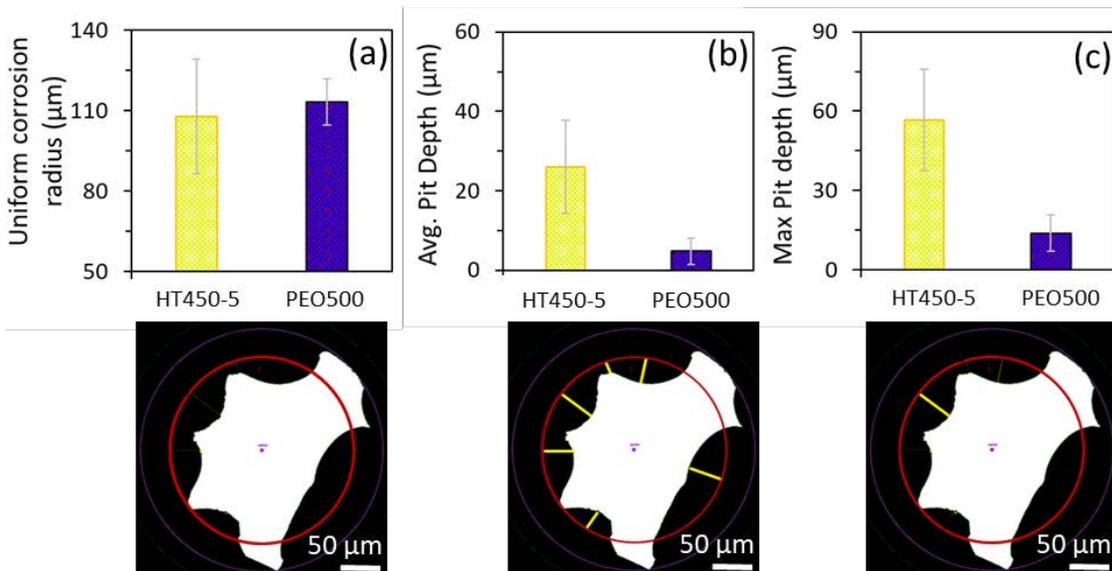
Fig. 5. Metrics representing the intensity of pitting corrosion in HT450-5 and PEO500 wires and representative cross sections of degraded HT450-5 Mg wire: (a) Uniform

corrosion radius (marked by red circle). (b) Average pit depth (each yellow line marks the deepest point of each pit). (c) Maximum pitting depth (marked by yellow line).

The differences in corrosion profile were quantified by evaluating the severity of pitting corrosion by image processing using PitScan [24]. To this end, cross-sectional images of degraded wires were analyzed following the procedure detailed in the supplementary information. The metrics that characterize the intensity of pitting corrosion are summarized in Fig. 5. They are the uniform corrosion radius in Fig. 5a (the radius of the circular section that has the same area as the corroded cross-section), the average pit depth in Fig. 5b (average distance from the degraded cross-section to the uniform corrosion circle), and the maximum pit depth in Fig. 5c (maximum distance from the corroded cross-section to the uniform corrosion circle). Fig. 5a confirms the hydrogen evolution results reported in Fig. 2a and the uniform corrosion radius of PEO500 ($113 \pm 8.5 \mu\text{m}$) was still larger after 96 h than that of the non-surface treated HT450-5 ($108 \pm 21 \mu\text{m}$) after only 24 h. Moreover, the high standard deviation of the uniform corrosion radius of HT450-5 shows the greater variation of mass loss at different cross sections with respect to PEO500. The differences in the intensity of pitting corrosion between both wires also become evident in the average pit depth and in the maximum pit depth as plotted in Figs. 5b and 5c. The reported localization of damage was responsible for the obvious drop in strength and ductility of the HT450-5 wires when immersed in c-SBF.

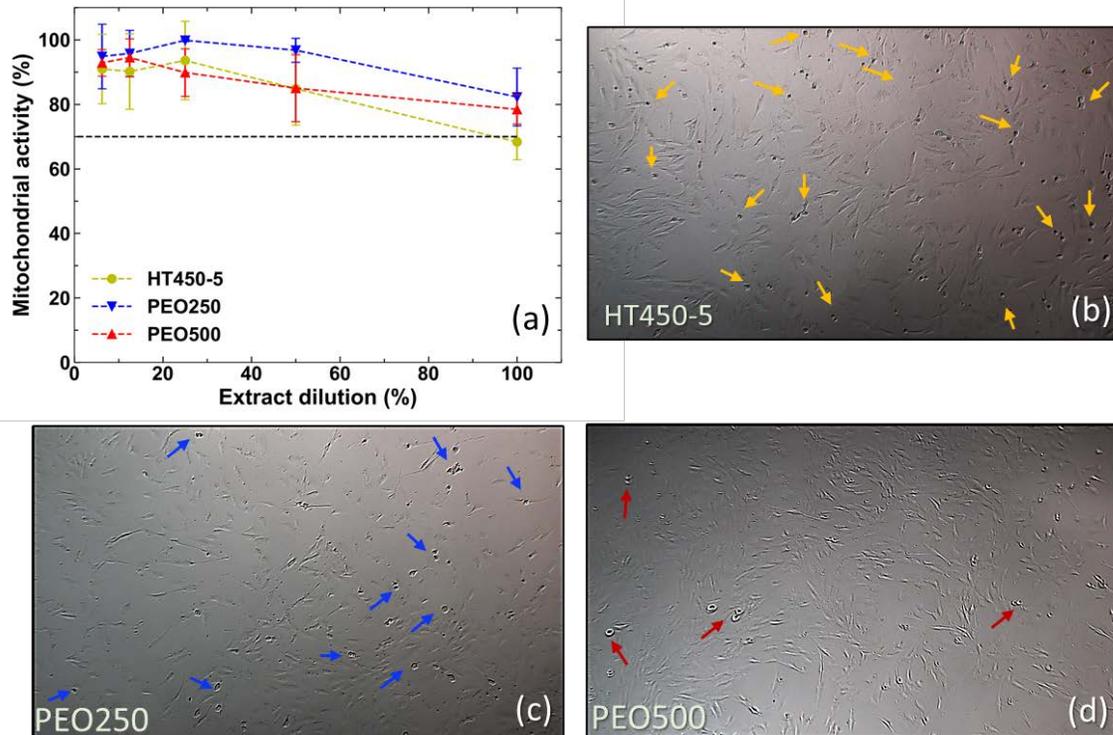
Fig. 6. (a) Mitochondrial activity of the MC3T3-E1 pre-osteoblasts after 24 h of incubation in extracts obtained from Mg wires immersed in culture medium. (b), (c) and (d) Optical micrographs of living (elongated) and dead (circular, marked with arrows) cells in the 100 % extracts of HT450-5, PEO250 and PEO500 Mg wires after 24 hours. Magnification was 10x. Arrows point to dead cells which show a dark round shape.

The mitochondrial activity of the MC3T3-E1 preosteoblasts after 24 h of incubation in extracts obtained from different Mg wires (HT450-5, PEO250, PEO500) immersed in the culture medium is depicted in Fig. 6a over different dilutions. Pure extracts equal 100% of value while 50%, 25%, 12.5% and 6.25% indicate the concentration of the pure extract in culture medium. HT450-5 Mg wire showed slight toxic behavior in 100% extract with a cell viability of 68.4 ± 5.5 %, while both PEO-modified Mg wires did not show any cytotoxic potential. These results are supported by the optical microscopy images of 100% extracts in Fig. 6b, 6c and 6d which show alive (elongated) and dead (circular, marked with an arrow) cells in the 100% extracts of HT450-5, PEO250 and PEO500 wires, respectively, after 24 h of incubation. While the results in Fig. 6a may be biased by the presence of corrosion products that can change the absorbance of the solutions, the fraction of dead cells in the 100% extracts followed the order HT450-5 > PEO250 > PEO500 and shows the slightly elevated cytotoxic activity of the HT450-5 wires due to more pronounced degradation and associated effects, such as pH increase and higher hydrogen gas evolution. Also, MC3T3-E1 cell viability is known to drop when the concentration of Mg ions in the culture medium increases [26], which is in agreement with these observations. However, no sample showed any toxicity already after the first dilution.

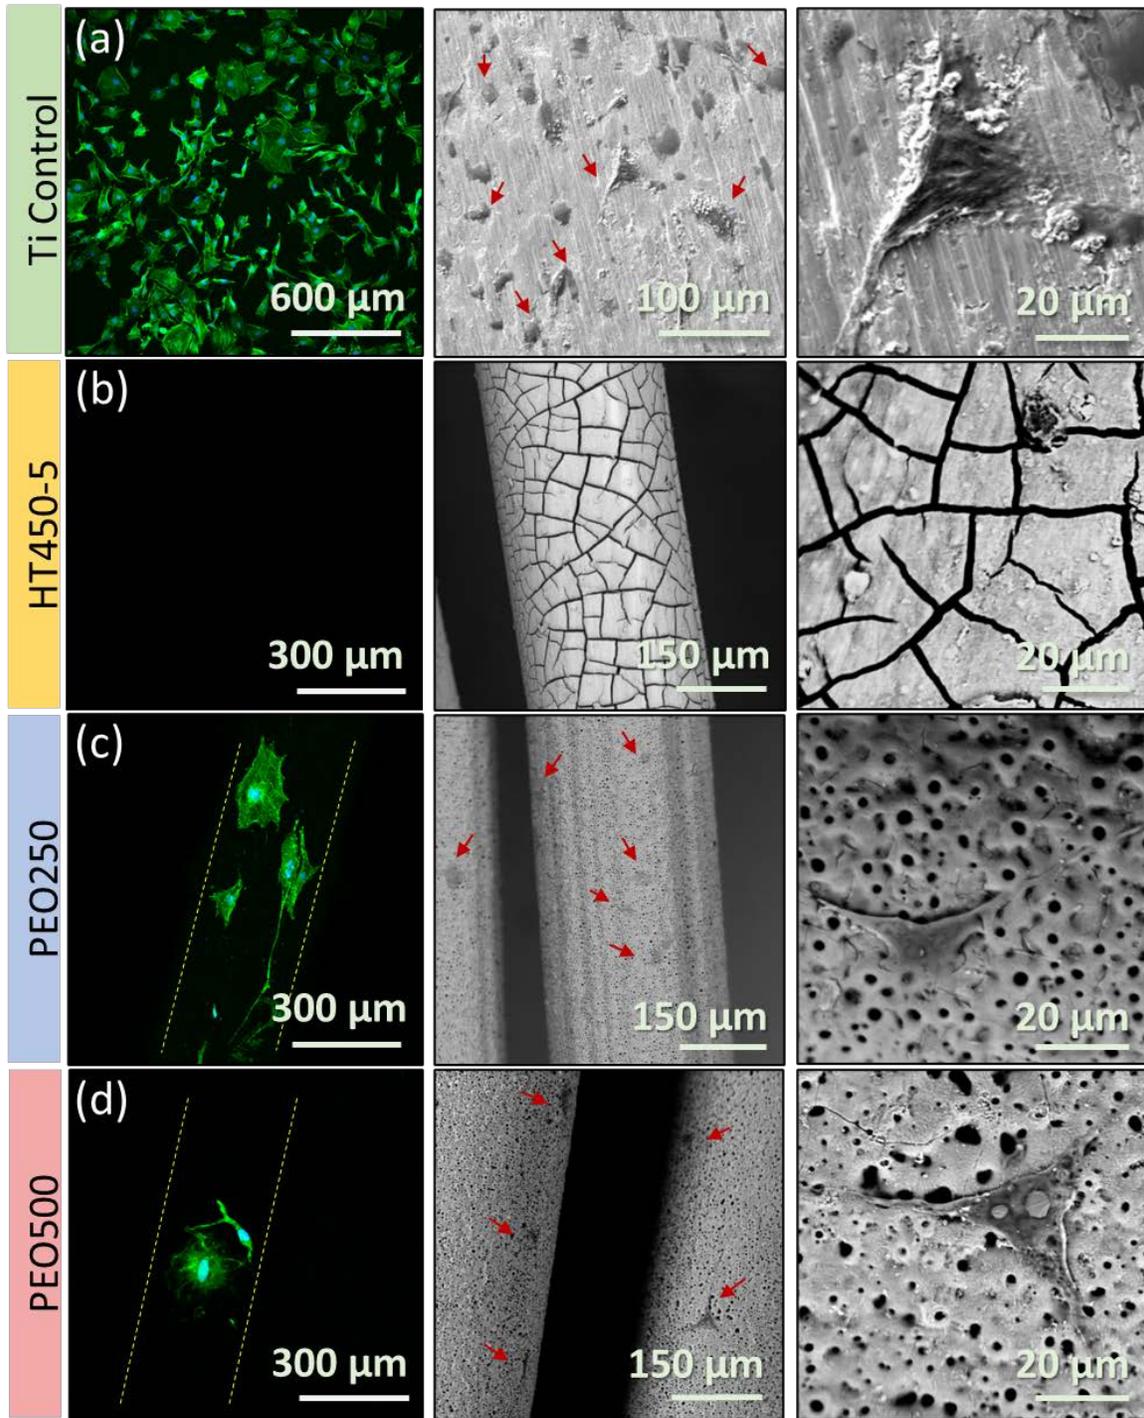
Fig. 7. Confocal microscopy and back-scattered SEM images of the surface interaction between MC3T3 pre-osteoblasts and the tested Mg wires for 24 h. (a) Ti control sample. (b) HT450-5. (c) PEO250. (d) PEO500. Yellow dashed lines indicate the wire edges. Red arrows indicate the presence of cells on the wire surface.

The direct interaction between the cells and the Mg wires was assessed by means of observations under a confocal microscope and SEM (Fig.). After 24 h, the MC3T3-E1 cells covered the surface of the Ti control samples by cell-cell and cell-material interactions, as shown by both confocal and SEM images in Fig. 7a. On the contrary, cells could not attach on the surface of the HT450-5 Mg wire (Fig. 7b) which can be linked with the dynamic environment on the metallic surface of the wires in which fast corrosion leads to hydrogen gas release and/or to a local alkaline environment. The surface of the HT450-5 Mg wire appeared fully cracked in the SEM because of the dehydration and shrinkage of the corrosion

layer by dehydration already in air or under the vacuum of the SEM. On the contrary, many living cells were able to attach on the surface of the PEO250 and PEO500 Mg wires. The connection between cells and the PEO surface was shown in both cases by bridging filopodia structure which generally is evidence of a good cell adhesion to surface [18][27][28]. Qualitatively both PEO250 and PEO500 Mg wires had same favorable cell attachment behavior. This behavior indicates that the presence of the oxide layer was necessary to enable a proper adhesion of cells to the wire surface by providing a porous surface with stable environment in terms of gas release and surface alkalinity.

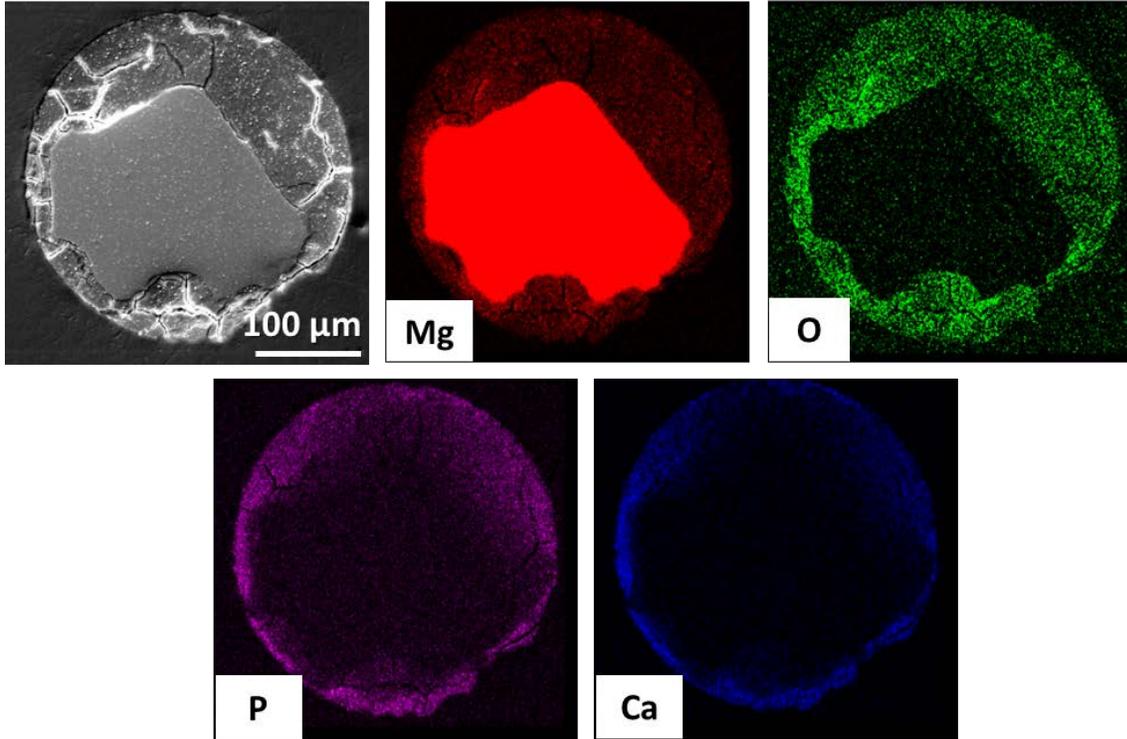
Fig. 8. Analysis of the cross-section of HT450-5 wire under SEM/EDS after 24 h of immersion in c-SBF at 37°C. The first image is obtained with secondary electrons and the other images stand for the elemental composition maps representing Mg, O, P and Ca were obtained by EDX.

Even though the corrosion layer becomes thicker during the corrosion progress, it is not compact enough to stop the corrosion by diffusion of the c-SBF solution. The amount of P and Ca decreases from the outer edge of the corrosion layer to the inner core of the Mg (Fig. 8) suggesting the formation of Ca-P phosphates and carbonates following the reactions indicated above (Eqs. 3, 4, 5 and 6), in agreement with a recent report [33]. The reduction in Ca and P concentration with depth is likely due to the slow transport of Ca^{2+} ions through degradation layer, thus promoting its precipitation near the outer edge. The exact composition of Calcium Phosphates depends on the Ca/P ratio [34].

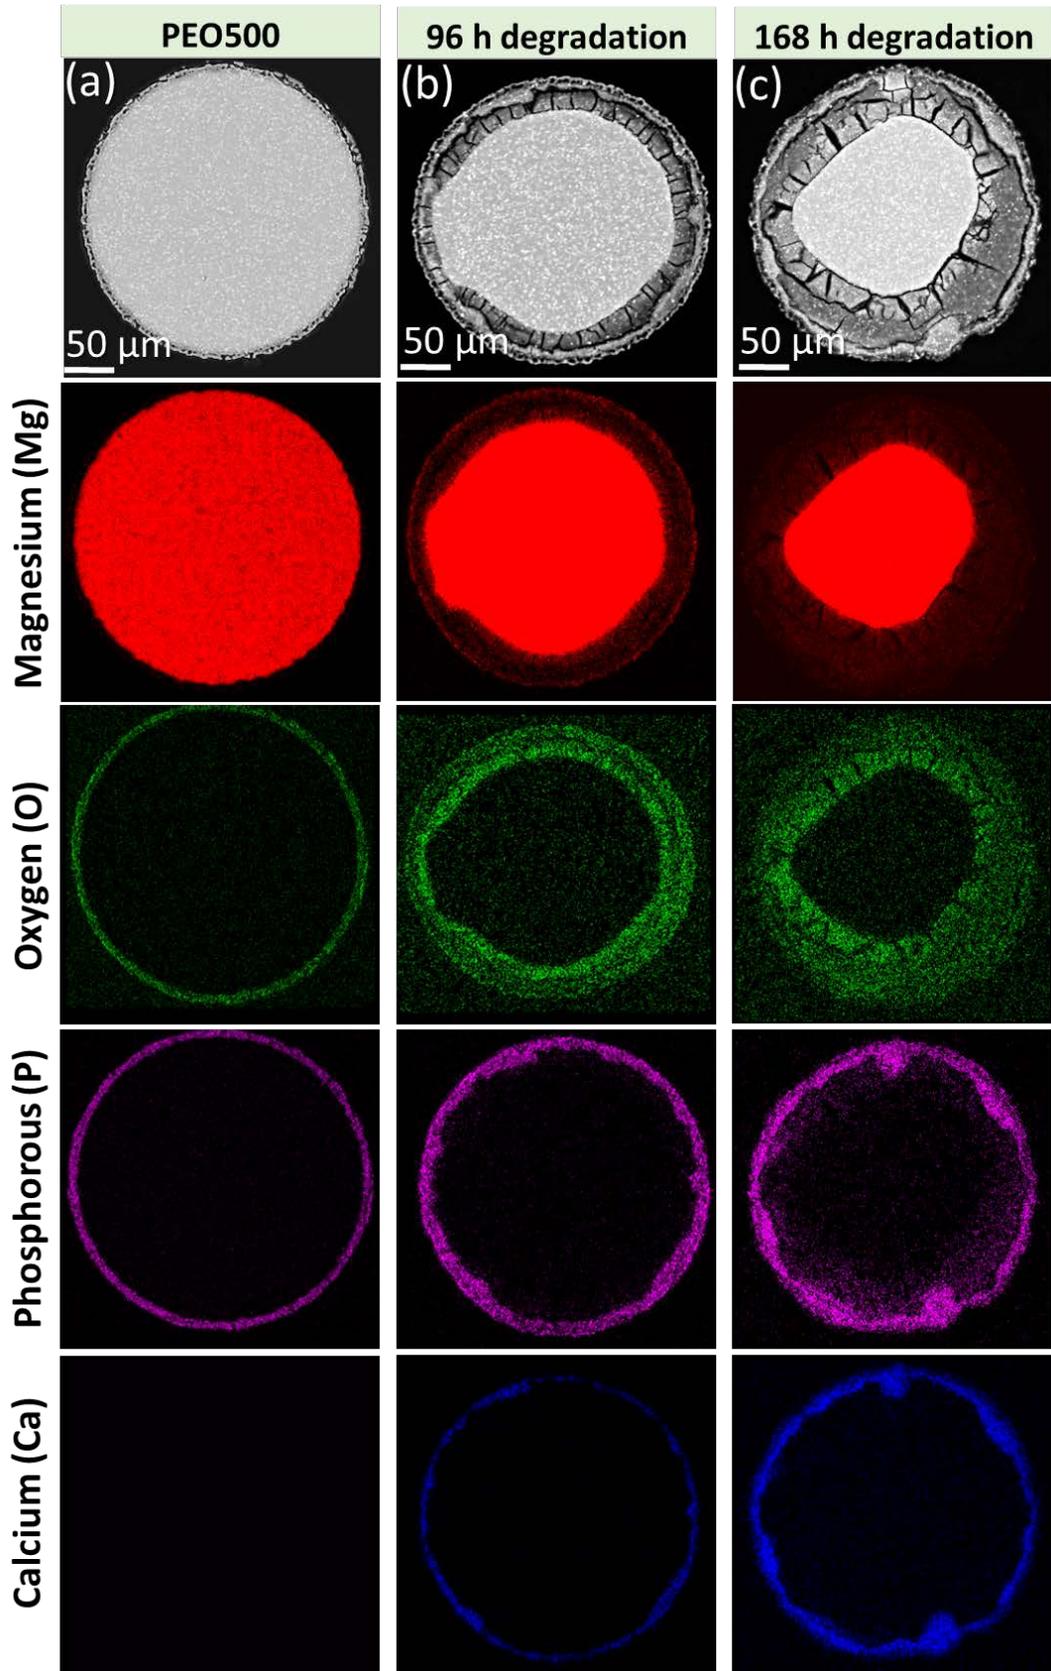
Fig. 9. Analysis of the cross-section of the PEO wire (a) before and after (b) 96 h and (c) 168 h of degradation in c-SBF at 37°C. The first column shows the back-scattered electron image and the other columns represent the compositional distribution of Mg, O, P and Ca obtained by EDX.

The corrosion mechanisms in the presence of an oxide layer created by PEO seem very different, as shown in the cross-sections of the PE500 wire before (Fig. 9a), after 96 h (Fig. 9b) and after 168 h (Fig. 9c) of degradation in c-SBF at 37°C. The chemical composition of the continuous oxide layer before degradation includes Mg, O and P and, thus, consists mainly of MgO and Mg₃(PO₄) [22]. Independent of the closed barrier layer covering the immediate interface to the metal substrate, the PEO oxide layer has an outwards open porous surface. Hence, aqueous molecules from the c-SBF solution might be able to reach the surface of the Mg wire after breaking the barrier layer by corrosive attack, leading to the same corrosion mechanisms described above for HT450-5 Mg wires. Thus, similar values

for the initial corrosion rates of both HT450-5 and PEO500 wires might be justified. However, after a certain time in the corrosive environment, the degradation rate of the PEO surface-modified wire is significantly reduced which might be associated with the appearance of an external protective and dense corrosion layer containing O, Ca and P (Fig. 9b). This dense layer is located beneath the PEO but on top of the typical porous oxide layer resulting from the progressive oxidation of Mg to form $\text{Mg}(\text{OH})_2$, which is found between the external Ca-P dense layer and the Mg core of the wire. Even not fully inhibiting diffusion processes, the presence of this dense Ca-P layers seems to slow down migration of Cl^- and other corrosive ions which in turn decreases the elimination of the $\text{Mg}(\text{OH})_2$ layer (Eq. 2). As a result, the corrosion rate of the Mg wire is reduced, and pitting corrosion is suppressed. This protective process seems to continue over degradation time and the dense and continuous Ca-P layer is still seen on top the Mg oxide layer even after 168 h of immersion in c-SBF (Fig. 9c) while the remaining Mg core is still present in the center with unaltered oval with no prominent pits.

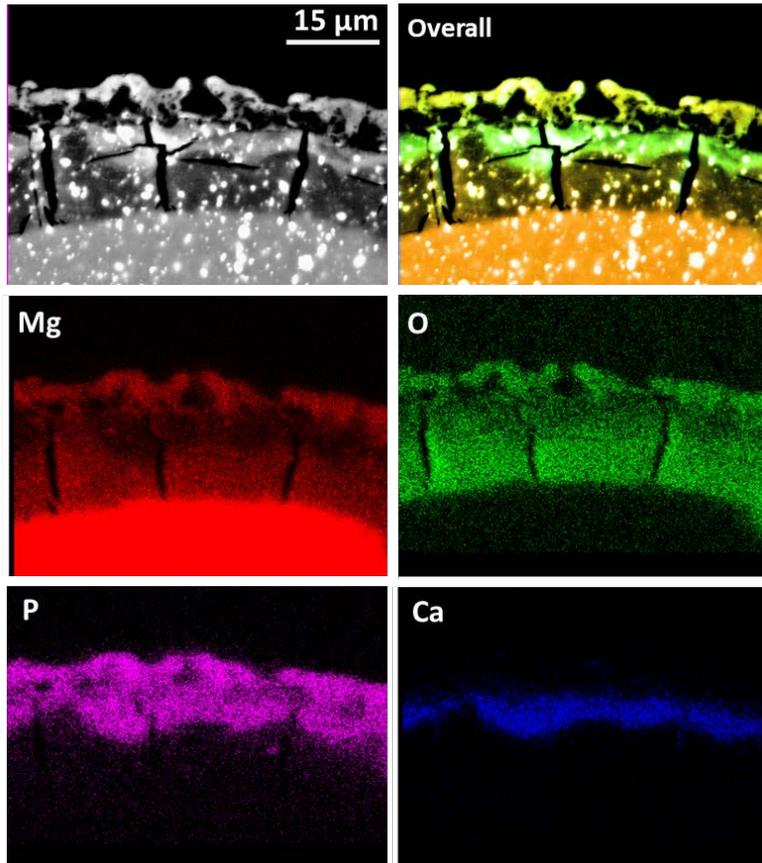
Fig. 10. Higher magnification analysis of the surface of the PEO500 wire after 96 h in SBF. The first image on the top left shows the back-scattered electron image and the other present the compositional distribution of Mg, O, P and Ca obtained by EDX.

As a result, we attribute the reduced corrosion rate and the uniform degradation on PEO surface-modified WE43 Mg wires to the presence of this Ca-P rich layer deposited during initial stages of the corrosion process. Even though a Ca-P layer growing over time was also observed for the HT450-5 wires, this natural corrosion layer was not as compact and continuous as for the PEO variants. Since there is no evidence in literature about the formation of a dense and continuous Ca-P layer during corrosion of PEO surface modified Mg, the following explanation for its appearance is hypothesized. During the first stages of corrosion, the initial oxide layer created by PEO on top of the Mg wire is cracked because of the expansion associated with corrosion. This oxide layer contains $\text{Mg}_3(\text{PO}_4)_2$ and might

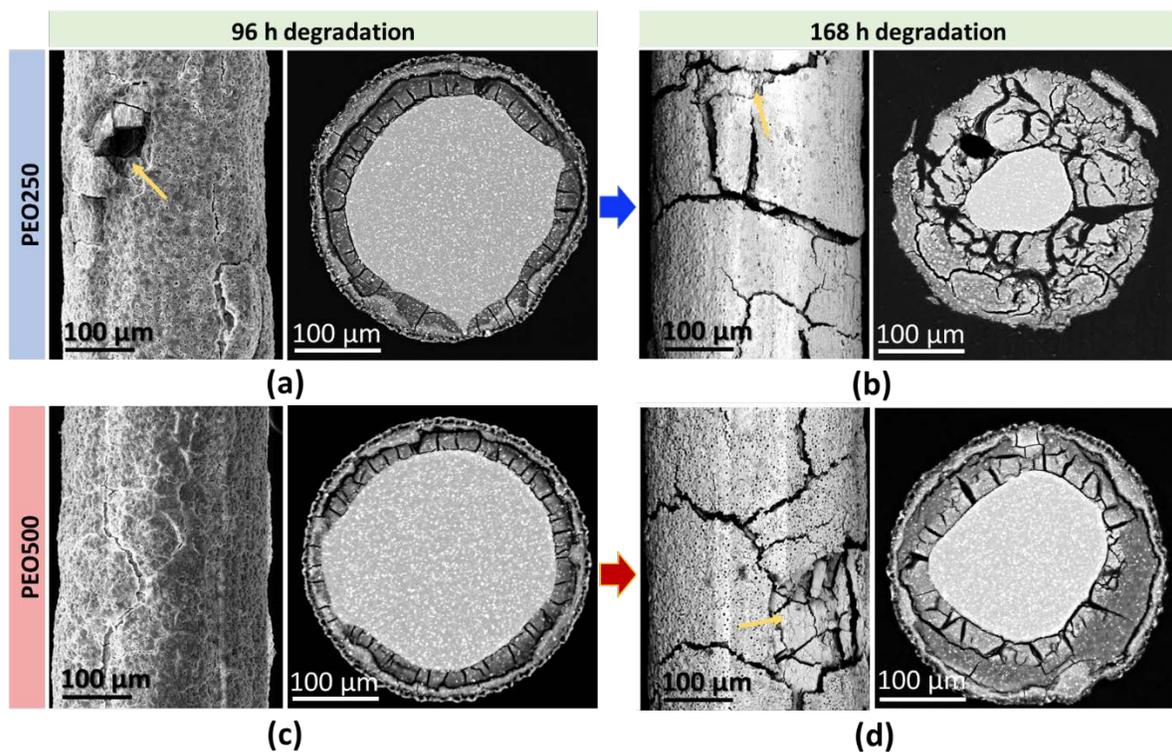
Fig. 11. Back-scattered electron images of the cross section and lateral surfaces of PEO250 (a-b) and PEO500 (c-d) Mg wires after 96 h and 168 h of degradation in c-SBF at 37°C, respectively. Yellow arrows indicate detachment of the PEO oxide layer.

After degradation for 96 h and 196 h in c-SBF, cracks were found in particular on the lateral surfaces of the PEO250 (Figs. 11a and 11b) and PEO500 wires (Figs. 11c and 11d). These cracks seemed to be formed because of the internal stress induced by the expansion of corrosion products [35] and to facilitate the influx of the media to the Mg core, leading to the partial detachment of the external corrosion layer. However, the degree of surface

degradation seemed to rely on the nature of the initial PEO oxide layer since it was much more pronounced in the PEO250 wire, in which the external corrosion layer completely detached after 168 h in the c-SBF (Fig. 11b). On the contrary, the external oxide layer was mostly intact (Fig. 11d) for the PEO500 wire although cracks were also found on the surface of this variant. These results confirm the importance of optimizing electrical parameter of the PEO process to slow the degradation of the wires and to promote the formation of the Ca-P dense layer upon degradation of Mg core. Moreover, they also explain why the corrosion rate of both PEO surface-modified wires was similar up to 96 h after which the corrosion rate of the PEO250 wire apparently increased due the detachment and degradation of the PEO oxide layer.

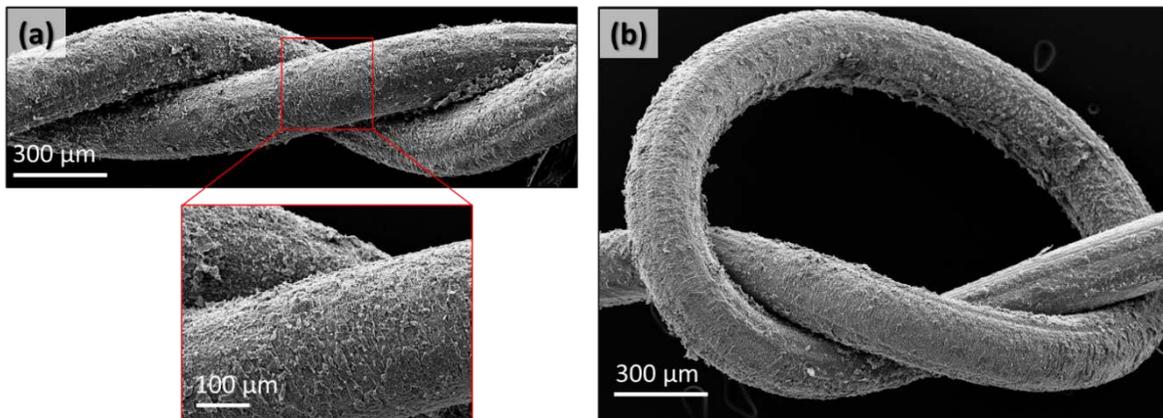
Fig. 12. SEM images of (a) twisted and (b) knotted PEO500 Mg wires, showing a fine network of cracks on the PEO oxide layer upon deformation.

It should be finally noted that the continuous oxide layer promoted by continuous PEO in our work presented good adhesion on the Mg wire but showed some typical brittleness which might lead to fine cracks in the presence of sufficient strains. For instance, multiple parallel cracks appear on the surface when the wires are twisted or knotted, even though no detachment or delamination can be seen even at elevated strains (Fig. 12). To minimize this phenomenon of strain-induced cracking, we propose to reduce the oxide layer thickness (in order of 1~2 microns) which is possible by finely controlling the electrical parameters of the electrochemical PEO process. Another possibility might be to carry out PEO while subjecting the wires to tensile stress, so that the PEO oxide layer will be under compression once the wire is relaxed. These strategies are part of our future work.
