Inconsistencies between the forces from code live load models and real traffic on truss bridges

The forces acting on bridge structural elements caused by live loads are computed by live load models defined in design codes. In most cases, such live load models are defined by studies performed on girder bridges, where extreme values of shear forces and bending moment are intended to be predicted. This paper shows that when code live load models are applied to truss bridges, the estimated forces in some structural elements may not be representative of those caused by actual traffic. Three WIM (weigh-in-motion) databases, which are recorded on roads in Mexico, are used as real traffic data. The results suggest that current code live load models are not entirely adequate to estimate forces in structural elements of truss bridges.

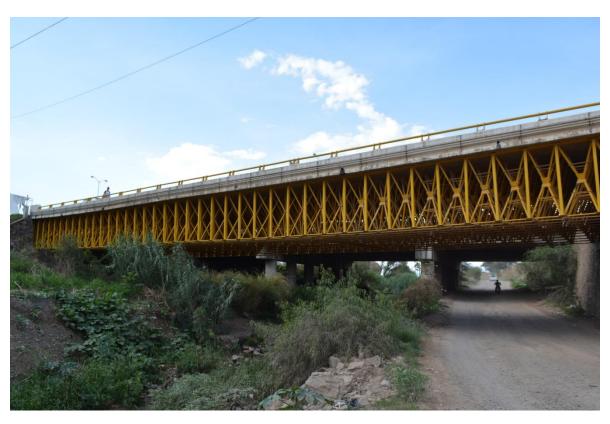
Figure 1 Tridilosa Bridge

Tridilosa became very popular. Tridilosa bridges are mainly composed of two parts: (1) a three-dimensional steel truss, and (2) a reinforced concrete slab over the truss. Figure 1 shows an example of Tridilosa bridge. To date, many Tridilosa bridges have exhibited severe fatigue problems and, in most cases, they have been replaced by prestressed concrete girder bridges. Nevertheless, a few Tridilosa bridges remain in operation, such as the one shown in Figure 1. Unlike Tridilosa bridges which tend to exhibit fatigue problems, girder bridges perform much better for practically the same conditions. This aspect is considered relevant by the authors. Consequently, one of the possible causes of this phenomenon is investigated in this study.

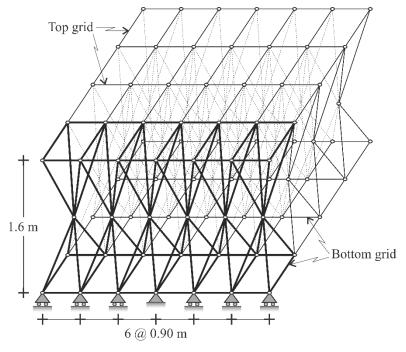
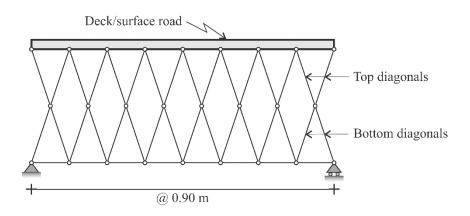
Figure 3 Geometry of Tridilosa-type bridges

Additionally, two Tridilosa-type bridges with 9 m and 18 m long spans, like the ones schematically showed in Figure 3, are used to inspect the inconsistencies of employing code live load models to obtain element forces in these bridges. This is also aimed at exploring whether induced forces on structural elements caused by code live load models, in comparison to those by actual traffic, are one of the main reasons why these bridges are more susceptible to fatigue issues.

a) Isometric transversal view

b) Longitudinal view

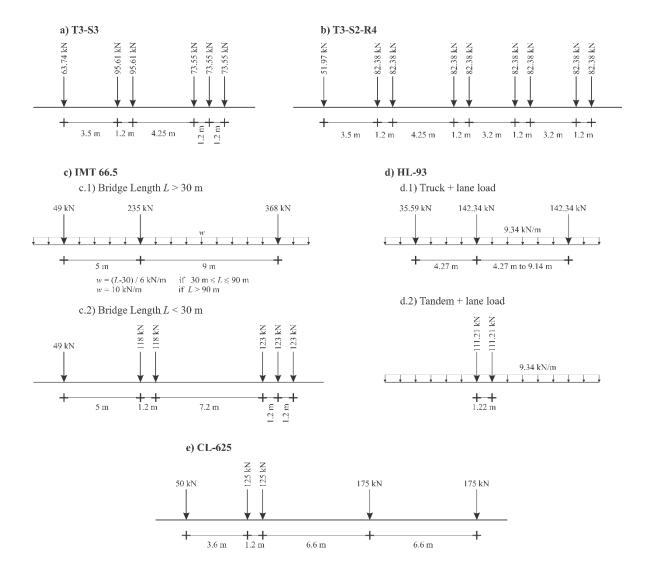
Figure 4 Code live load models

Several live load models defined in different bridge design codes are used to predict the element forces in the studied truss bridges. T3-S3 (Figure 4a) and T3-S2-R4 (Figure 4b) are considered (IMT/SCT 1999) since these live load models were widely used to design Tridilosa-type bridges; they correspond to actual truck configurations in Mexico. Also, the T3-S2-R4 model was used to design "*El Infiernillo*" bridge. The IMT 66.5 (Figure 4c) defined in IMT/SCT 2004 is also considered, which was developed based on traffic surveys carried out in the 1990s in Mexico. Also, the HL-93 (Figure 4d) and CL-925 (Figure 4e) models defined by the American (AASHTO 2017) and Canadian (CAN/CSA 2014) standards, respectively, are used.

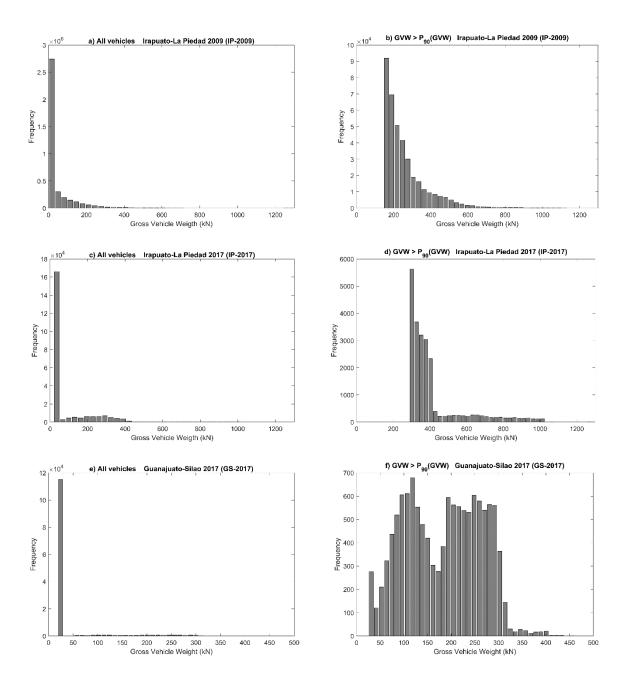
Figure 5 GVW distribution for used WIM databases

The second database was recorded in the same highway for one week (January $24^{th} - 30^{th}$, 2017) encompassing 226,488 vehicles recorded by temporal WIM stations. Figure 5c shows the histograms distribution for all vehicles according to their GVW. As in the previous case, Figure 5d shows the vehicle distribution with GVW > P_{90} (GVW). These WIM data will be defined hereinafter as IP–2017.

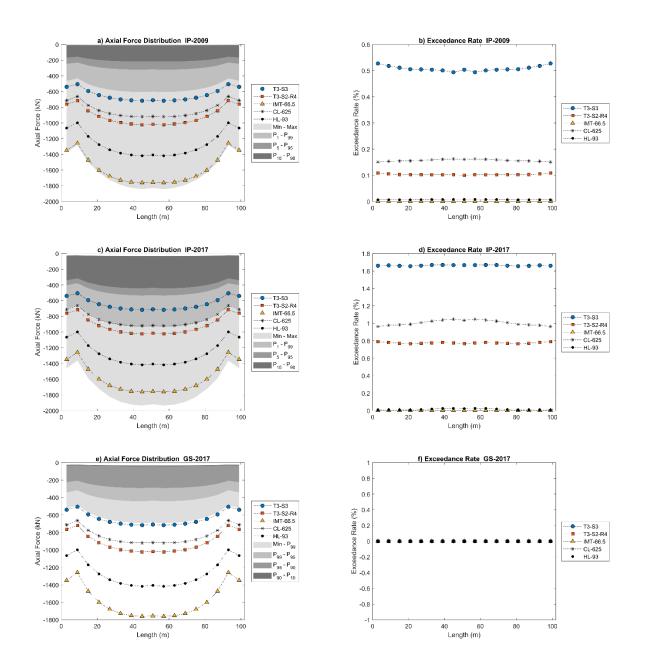
Figure 6 Results for top chord of "El Infiernillo" bridge

A good live load model should adequately estimate force magnitudes in all bridge elements during its service life. As the magnitudes and frequencies of actual live loads evolve on time, it is not surprising that estimated force magnitudes from code live load models are exceeded by actual vehicles; however, the number of times which estimated forces from a code live load model are exceeded by traffic should remain approximately constant in all bridge elements, which is shown in Figure 6 for the top chord of "El Infiernillo" bridge.

The left side of Figure 6 shows the forces acting on top chord elements along the bridge for IP-2009 (Figure 6a), IP-2017 (Figure 6c) and GS-2017 (Figure 6e). The convention that compression and tension forces are negative and positive, respectively, is adopted. A scale of gray colors is used to represent the force distribution acting on each member along the bridge for the used databases; lighter gray (15% gray) is used to represent the range in which the minimum and maximum values of acting forces on elements along the bridge are presented. Lower and upper limits of gray at 25% are used to represent the 1% and 99% of the largest forces, (*i.e.*, P₁ and P₉₉ respectively; this convention is adopted for other percentages). In the same way, lower and upper limits of gray at 40% represent the P₅ and P₉₅ force value distribution. P₁₀ and P₉₀ force value

distribution are represented by lower and upper limits of darkest gray (65% gray). Forces distributions are on the negative side because top chord elements are subjected to compression forces only. Since limits for lower value forces can be very close, the way of presenting the results for each database allows a better visualization of the largest force values acting on elements. Figures 6a, 6c and 6e make clear the fact that only a very small fraction of the heaviest trucks causes the largest forces in the chord; although this could be expected, the figures allow to inspect this issue at a glimpse. The force values caused by each code live load model considered are plotted with markers. All presented results are unfactored. The study is neither intended to discuss the adequacy of each model to capture the actual forces from the databases, nor to be calibrated to represent truss forces for given return periods (extrapolation or analysis of extremes is out of the scope of this study). The use of code live load models is rather envisaged to inspect whether the models approximately capture the shape of the real element forces; if this is possible, a calibration task to reach desired extrapolated values will be feasible. In fact, it can be observed in Figures 6a, 6c and 6e that all the models adequately follow the trend of the maximum compressions (for the top chord). We will come back to this aspect for other truss elements later.

The right side of Figure 6 illustrates the number of times (in percentage) that vehicle induced forces from the database exceed the value for each live load model, *i.e.*, the exceedance rates for structural elements along the bridge are shown; Figure 6b for IP-2009, Figure 6d for IP-2017 and Figure 6f for GS-2017. As can be noted, exceedance rates are practically uniform for top chord elements for all code live load models, which can be associated with a uniform probability of failure for those bars. Thus, if exceedance rates would be too large to reach a selected reliability level, a recalibration of live load factors for design force combinations is expected to lead to uniform reliabilities, for all truss elements along the top chord of the bridge (for all code models considered). As can be seen in Figures 6b, 6d and 6f, the exceedance rate values are directly related to the GVW in each database, leading to null exceedance rates for GS-2017, since in this database there are only light vehicles, which do not generate greater forces than code live load models. It becomes evident that different live load models (and/or live load factors) should be prescribed for highways with different traffic characteristics. Similar results for the bottom chord of "El Infiernillo" bridge are observed for all databases considered, except that tensions instead of compressions are obtained, and they are not shown for brevity.

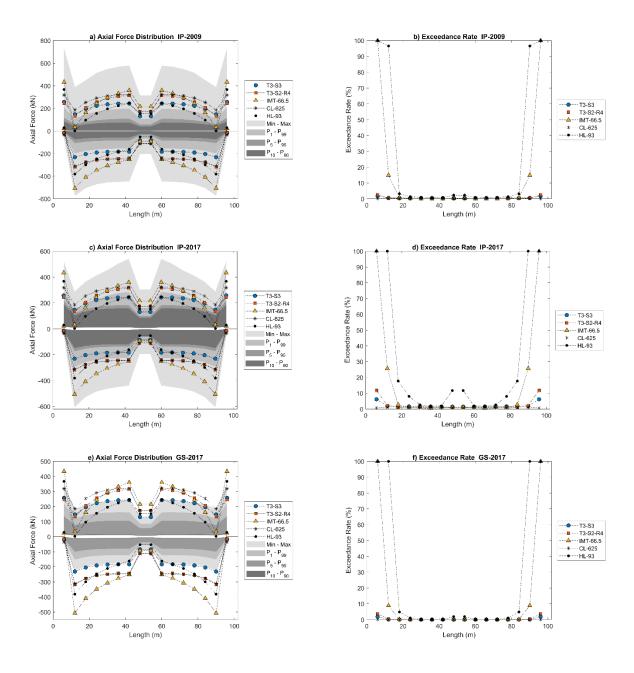
Figure 7 Results for vertical elements of "El Infiernillo" bridge

So far, no relevant inconsistencies in the ability of truck models to capture (at least in relation to the trends shape) the realistic truss element forces are observed. However, Figure 7 illustrates results for vertical truss elements in "El infiernillo" bridge and, unlike top chord elements, which are subjected to compression forces only, vertical elements are subjected to load reversals, so two force distributions are shown on the left-hand side of Figure 7 (for the three WIM datasets, analogously to Figure 6), positive for tension forces, negative for compression. For these vertical truss elements, the exceedance rates are no longer uniform along the bridge; moreover, for IMT-66.5 and HL-93 models, there are elements with 100% of exceedance rates (as shown in the right-hand side of Figure 7). This occurs because those live load models include uniformly distributed loads, leading to some members to be always in tension or compression, being these models unable to adequately represent the load reversals that occurs when running the vehicles in the databases along the bridge. Similar trends as those in Figure 7 are found for the diagonal truss elements and are not shown for brevity. Overall, Figure 7 shows that code live load models do not capture the range variation of forces in vertical elements (or diagonals) as uniformly as in chord elements (differences are not discussed in detail for each model but they can be inspected in the figure). Therefore, a not so uniform reliability level (Garcia-Soto et al., 2015 and 2020) would be expected for different bridge truss elements. It is considered that there is room for improvement of current available code live load models by using optimization techniques with information like the one presented in Figures 6 and 7, and even to propose live load models specifically developed for truss bridges, given the obtained results and the fact that something similar was found for continuous bridges (Garcia-Soto et al., 2020) and the results for the Tridilosa-type bridges discussed in the following.

The fact that structural elements exhibit non-uniform exceedance rates along the bridge (Figures 7 to 9) implies that elements with higher exceedance rates have a greater probability of excessive deformations, fatigue, cracks, etc., *i.e.*, they are expected to have more critical conditions associated with different limit states.

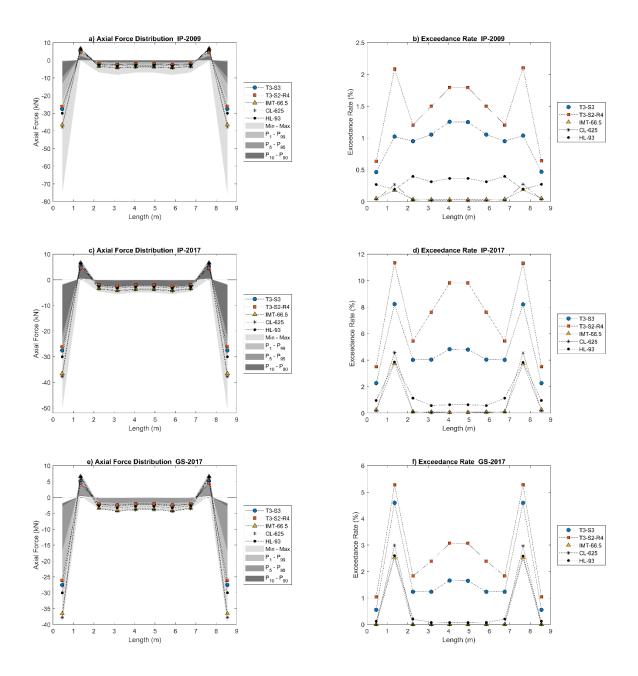
Figure 8 Results for bottom diagonals for 9 m long Tridilosa-type bridge

Figures 8 and 9 show the results for bottom diagonals for Tridilosa-type bridges of 9 m and 18 m span length, respectively. As can be noted, the following elements to those connected at supports (*i.e.*, second and penultimate diagonal members) have the highest exceedance rates for all databases. It should also be noted that highest exceedance rates are not related directly with GVW as in the top chord of "El Infiernillo" bridge. This may occur since vehicles in IP-2017 and GS-2017 databases have higher loads per axle, although the GVW is not necessarily heavier. In addition, these cases correspond to short bridges, where heavier and longer vehicles do not entirely fit on these bridges.
