Fatigue behaviors and atomic-scale mechanisms in nanocrystalline gold thin film

The fatigue properties of 930 nm-thick Au films and 1 μm -thick Au film with a Ti interlayer are systematically investigated. The dominant damage behaviors of 930 nm-thick Au films under dynamic bending cyclic loading changed from extrusions to intergranular cracks with the decrease in strain ranges and the increase in cyclic cycles. The different fatigue behaviors are attributed to the process of edge dislocation annihilation and vacancy formation during cyclic deformation. Depositing 10 nm-thick Ti interlayers between the PI substrates and 1 μm -thick annealed Au films is effective to suppress strain localization and increase the rupture strain and the fatigue properties of thin Au films. This study shed lights on the fatigue mechanism and provide clues to design nanocomposites in the flexible displays in the practical application.

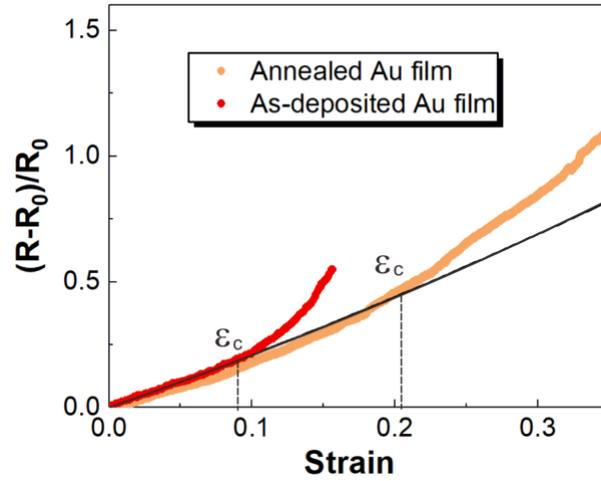
Figure 1. Relative resistance increase vs applied strain in the Au films during tensile tests.

Figure 1 shows the curves of relative resistance change versus tensile strain for a 930 nm thick deposited gold thin film and a 1 μm thick annealed gold thin film. The black line in the figure represents the predicted ideal curve of relative resistance change with tensile strain. The critical fracture strains for the two thicknesses of gold thin films can be obtained. The critical fracture strain for the deposited gold thin film is 9.4%, while for the annealed gold thin film, it is 21%. Figure 2 shows the fatigue life curves as a function of applied cyclic strain range for a 930 nm thick deposited gold thin film and a 1 μm thick annealed gold thin film. From the figure, it can be observed that the fatigue performance of the annealed gold thin film is superior to that of the deposited gold thin film. Particularly in the high-cycle region, the fatigue performance of the annealed gold thin film is significantly better than that of the deposited gold thin film. A significant amount of research indicates that the strength and fatigue performance of metal thin films increase with a reduction in film thickness/grain size^{18,26,28}. In comparison to the 1 μm thick annealed gold thin film, the 930 nm thick deposited gold thin film has smaller film thickness and grain size (the average grain size of the deposited gold thin film is 102 nm, while the grain size of the annealed gold thin film is 120 nm). Theoretically, the fatigue performance of the deposited gold thin film should be superior to that of the annealed gold thin film; however, in practice, the fatigue performance of the two gold thin films is opposite to the theoretical results.

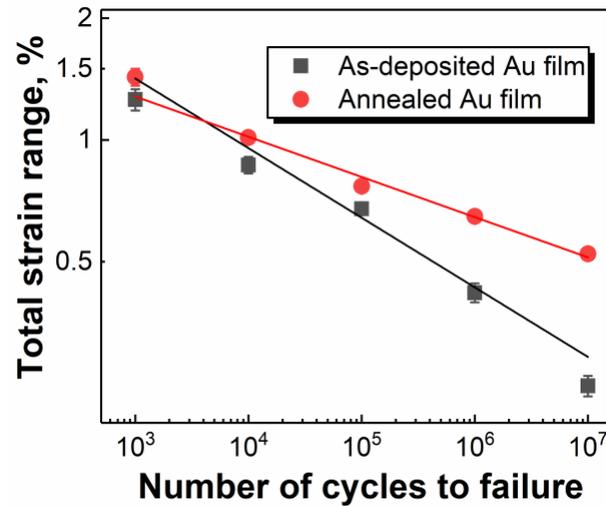
Figure 2. Applied strain range-fatigue life curve of the as-deposited Au films with a thickness of 930 nm and the annealed Au films with a thickness of 1 μm .

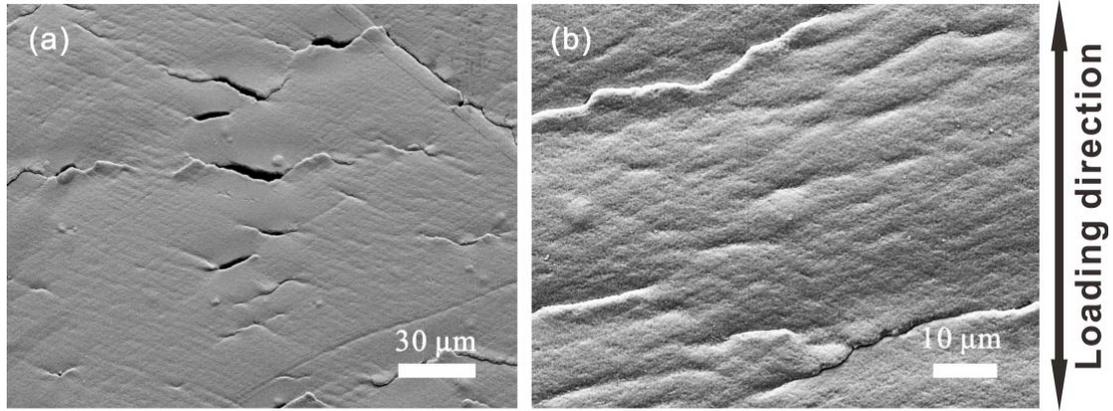
Figure 3. SEM observation of crack morphology in the 1 μm-thick annealed Au films.

Figure 3 shows scanning electron microscope (SEM) observations of the annealed gold thin film after tensile testing. From the figure, it can be observed that the primary failure mode of the gold thin film is the nucleation and extension of microcracks. The surface buckling is attributed to the modulus mismatch between the gold thin film and the polyimide substrate. The substrate contraction induces compressive stress perpendicular to the direction of the cracks in the gold thin film, causing the already cracked gold thin film to delaminate and protrude. The damage morphology of the annealed gold thin film after tensile testing is similar to that reported for copper thin films¹² and silver thin films³⁹ in the literature.

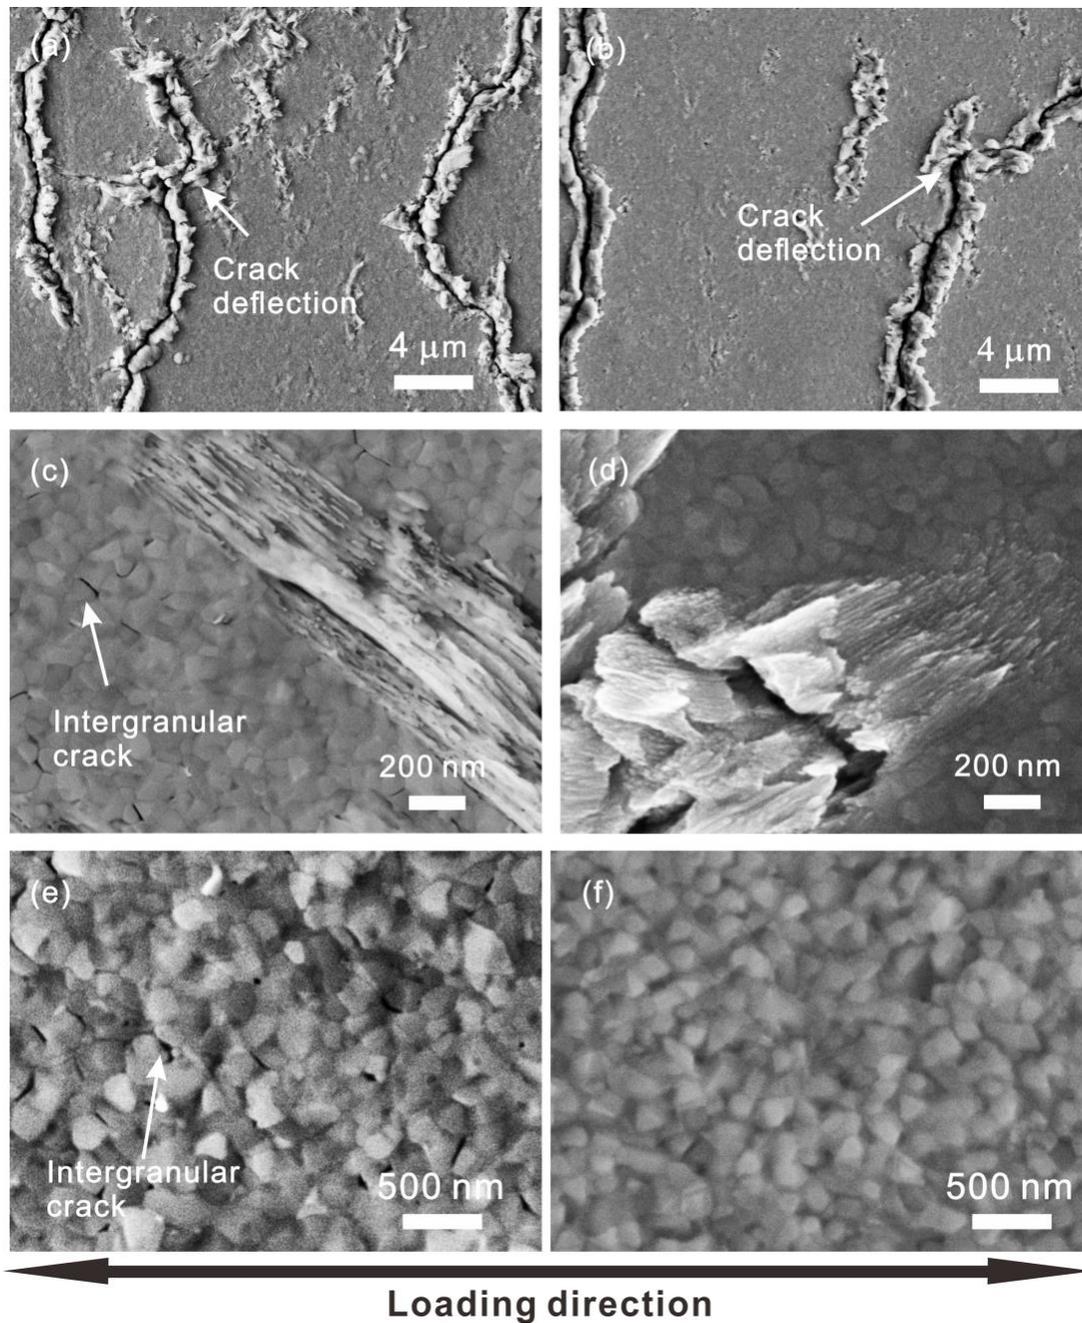
Figure 4. SEM observation of damage morphology in Au films with a thickness of (a) 930 nm at $\Delta\varepsilon=1.41\%$ and $N_f=10^5$, (b) 1 μm at $\Delta\varepsilon = 1.32\%$ and $N_f=10^4$, (c) 930 nm at $\Delta\varepsilon = 0.46\%$ and $N_f=10^8$, (d) 1 μm at $\Delta\varepsilon = 0.61\%$ and $N_f=10^8$, (e) 930 nm at $\Delta\varepsilon = 0.14\%$ and $N_f=10^8$, (d) 1 μm at $\Delta\varepsilon = 0.2\%$ and $N_f=10^8$.

Figure 4 illustrates the surface damage morphology of the 930 nm thick deposited gold thin film and the 1 μm thick annealed gold thin film. In both types of films, fatigue damage resembling the intrusions/extrusions observed in bulk metallic materials can be observed, as shown in Figures 4a and 4b. This fatigue damage behavior is very similar to the fatigue damage behavior reported in copper thin films^{11, 14, 31, 40, 41, 42} and silver thin films³¹ in the literature. Fatigue cracks primarily initiate at the extrusions and propagate during subsequent cyclic loading processes. Additionally, it can be observed from the figures that the fatigue cracks are not typical Type I (opening) cracks. There is a slight deviation in the propagation of fatigue cracks, and the crack propagation path is roughly perpendicular to the loading direction. Differently, in the high-cycle region, the fatigue damage behavior of the deposited gold thin film includes not only fatigue extrusions but also a significant number of transgranular cracks, as shown in Figure 4c. However, under the same failure cycles, the surface of the annealed gold thin film still exhibits fatigue extrusions without observable transgranular cracks, as depicted in Figure 4d. Furthermore, in the high-cycle region at

a low cyclic strain range (0.14%), the surface of the deposited gold thin film after fatigue only shows transgranular cracks, as seen in Figure 4e. However, under the same conditions, the surface of the annealed gold thin film does not exhibit obvious fatigue damage, as shown in Figure 4.

To recap, at high applied cyclic strain ranges, the only fatigue damage behavior observed on the surface of the gold thin film is extrusion damage. As the applied cyclic strain range decreases and the cycle count increases, the fatigue damage behavior gradually transitions from extrusion damage to both extrusion and transgranular crack damage. At low applied cyclic strain ranges and high cycle counts, the surface of the gold thin film after fatigue only exhibits transgranular crack damage. Therefore, it can be inferred that the extrusion damage behavior and transgranular crack damage behavior in the fatigue process of the deposited gold thin film compete. As the applied cyclic strain range decreases and the cycle count increases, the fatigue damage behavior shifts from extrusion damage to transgranular crack damage.

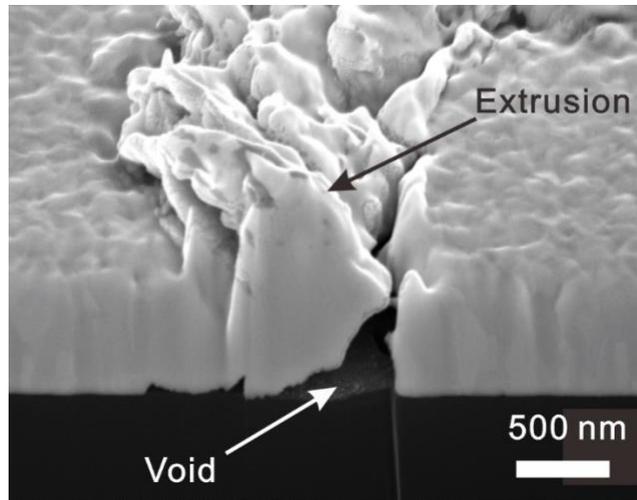
Figure 5. SEM image of the cross-sectioned extrusions in 930-thick as-deposited Au films after fatigue tests.

Figure 5 shows cross-sectional observations of extrusion sites in the deposited gold thin film after fatigue. It is clear from the figure that pores form at the film/substrate interface of the deposited gold thin film after fatigue. The cross-sectional morphology of the deposited gold thin film after fatigue is similar to that reported for copper thin films^{11, 28, 32} and silver thin films³¹ in the literature. Numerous studies have indicated that metal thin film/substrate specimens develop pores at the film/substrate interface after fatigue, and subsequent fatigue cracks initiate and propagate at these pores^{11, 28, 31, 33}. In contrast to the deposited gold thin film, to enhance the adhesion between the film and the substrate, we introduced a 10 nm thick titanium bonding layer between the annealed gold thin film and the substrate. To investigate the influence of the titanium bonding layer on fatigue damage behavior in the annealed gold thin film, helium ion microscopy was used to cut and observe the cross-sectional morphology at extrusion damage sites after fatigue,

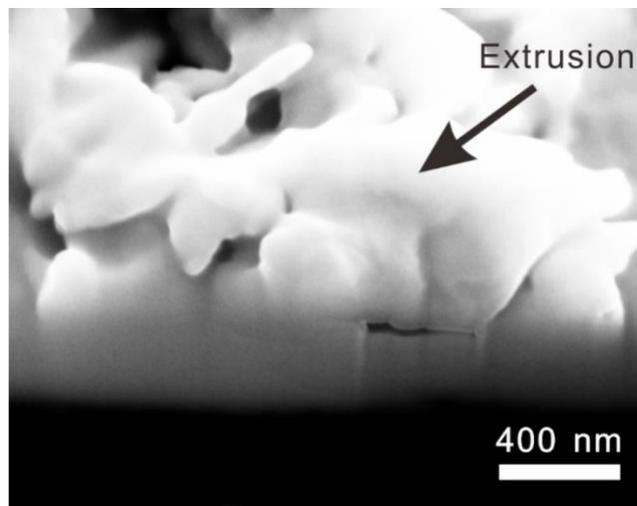
Figure 6. SEM image of the cross-sectioned extrusions in a fatigued 1 μm-thick annealed Au film after 10⁴ cycles.

as shown in Figure 6. It can be seen that there are no apparent pores present at the film/substrate interface. This experimental observation differs from the cross-sectional morphology of the deposited gold thin film.

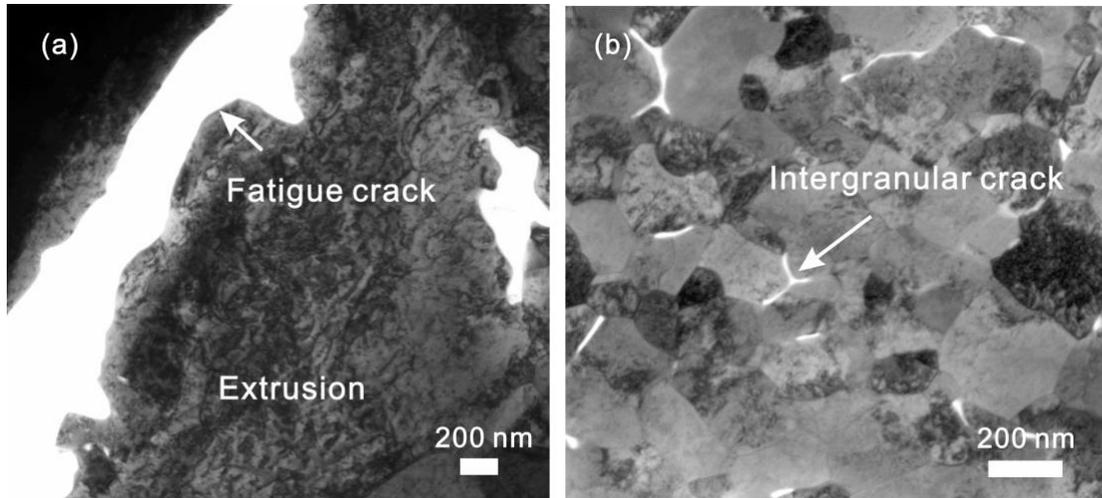
Figure 7. TEM images in the fatigued 930 nm-thick Au films (a) around the fatigue cracks, (b) around the intergranular cracks.

Observations of the deposited gold thin film after fatigue using transmission electron microscopy (TEM) (Figure 7) reveal a significant presence of dislocations within the grain interiors, as shown in Figure 7a. The dislocation configurations are predominantly single dislocations or entangled dislocations, with no evidence of cell-like or wall-like dislocation structures forming inside the grains. No specific dislocation structures were observed near transgranular cracks, as shown in Figure 7b. Further high-resolution transmission observations of the deposited gold thin film after fatigue are presented in Figure 8. Figure 8 depicts high-resolution TEM images of the deposited gold thin film after fatigue. From the figure, it can be seen that numerous dislocation dipoles appear within the grain interiors after fatigue (highlighted by yellow circles in the image)^{43, 44, 45, 46, 47, 48, 49}.

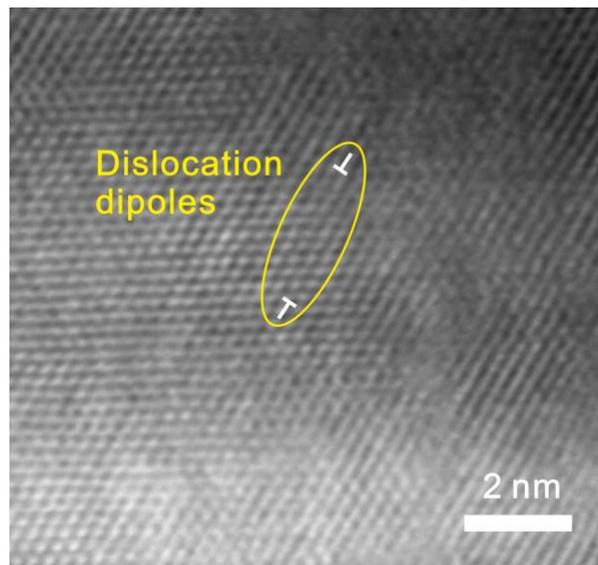
Figure 8. HRTEM images of the fatigued 930 nm-thick Au films.
