Observation of Buried Phosphorus Dopants near Clean Si(100)-(2×1) with Scanning Tunneling Microscopy

Geoffrey W. Brown,* Holger Grube, and Marilyn E. Hawley

Materials Science & Technology Division, Los Alamos National Laboratory, Los Alamos, NM 87545

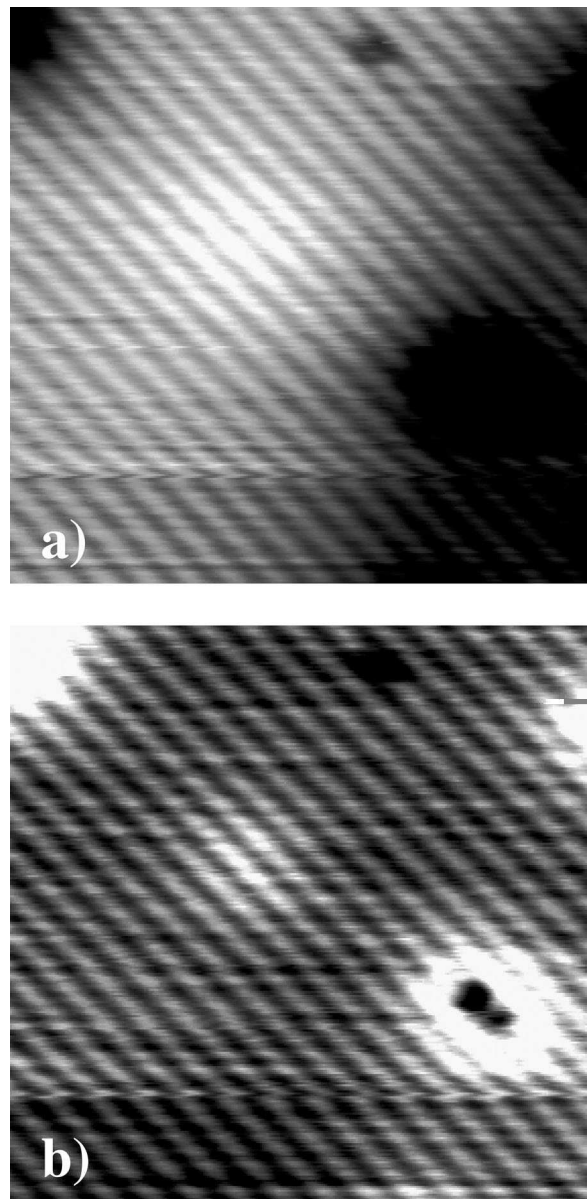
FIG. 1: a) Filled- and b) empty-state images of the same area on a Si(100)-(2×1) surface. The images show a feature in the center which appears as a long range enhancement in both biases but which does not have an associated surface structure. The filled states image was acquired at -0.7 V sample bias and the empty states at +1.0 V. The tunnel current for both was 130 pA and the image area is $100 \text{ \AA} \times 100 \text{ \AA}$.

Figure 1 shows images of the features that we attribute to subsurface dopants. Figures 1a and 1b are simultaneously acquired filled- and empty-state images, respectively, of a feature that appears as a long range enhancement in both biases, but without a corresponding surface defect. For comparison, a positively charged multi-dimer vacancy defect appears in the lower right section of the image. As expected for these PtIr tips, the filled state depression associated with the positively charged surface vacancy is visible. The extent of the dopant signature is similar to that of the charged defects but the amplitude is somewhat weaker in the empty states.

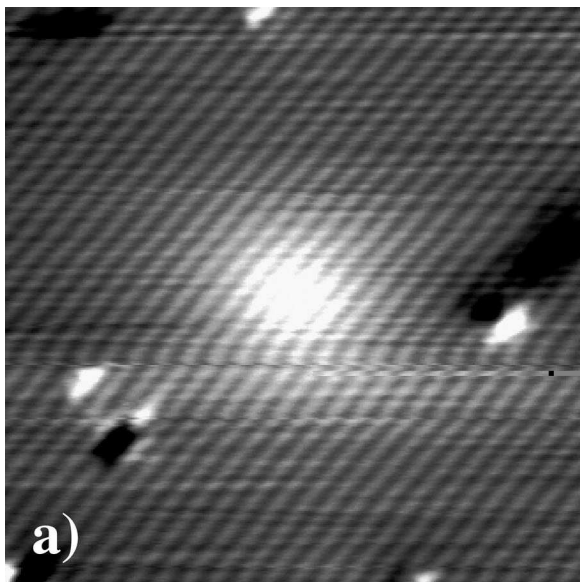
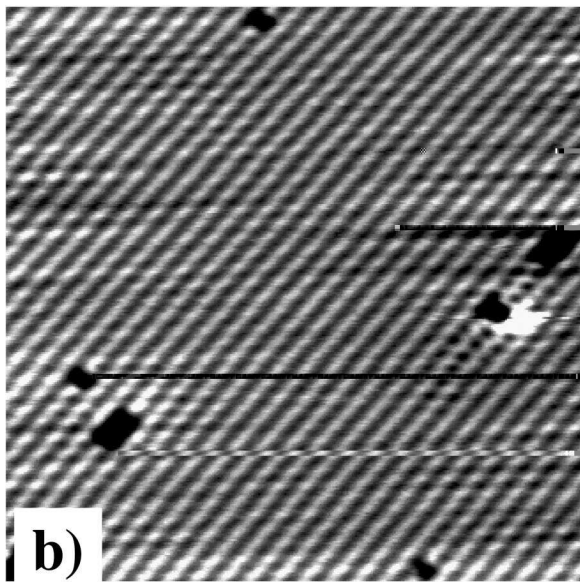
FIG. 2: Filled-states image of a subsurface dopant acquired at a) -0.6 V and b) -1.5 V sample bias. The dopant signature has a strong bias dependence and is not visible at -1.5 V. There is also no topographic surface structure (i.e. vacancy or adsorbate) associated with the feature. Image areas are both $220 \text{ \AA} \times 220 \text{ \AA}$ and the tunnel currents were 110 pA .

Figures 2a and 2b show another one of these features at low (-0.6 V) and high (-1.5 V) sample bias, respectively. The images were taken sequentially in the same area, as seen from the other defects. In Figure 2b we clearly see the absence of a surface defect, indicating that the signature in Figure 2a arises from a subsurface feature. At low bias, the band edges contribute strongly to the tunnel current and the effect of band bending is visible. At high sample bias the band edge states contribute only very weakly to the tunnel current.

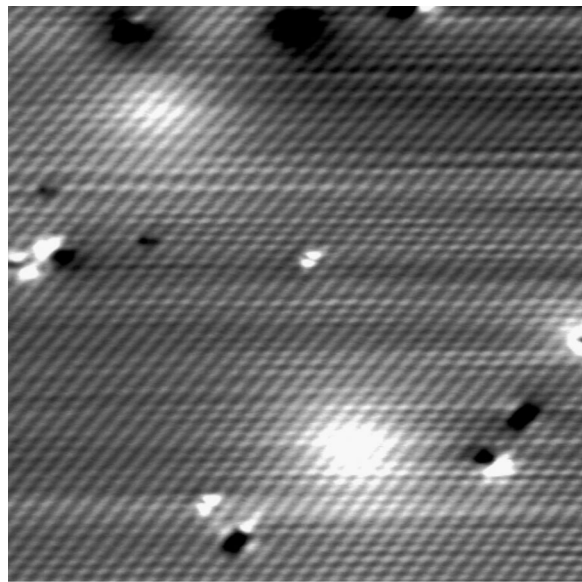
FIG. 3: Filled-state images of a pair of dopants on $\text{Si}(100)-(2 \times 1)$. The upper feature is weaker than the lower feature implying that it is either farther below the surface or has a smaller charge. The tunnel current in both cases was 110 pA , the sample bias was -0.7 V and the image size is $320 \text{ \AA} \times 320 \text{ \AA}$.

Finally, in Figure 3 we see two of the dopant features in a single filled state image. The upper feature has weaker amplitude than the lower one, implying that the upper dopant is either farther below the surface or has a smaller charge.
