Pyramidal structural defects in erbium silicide thin films

A new pyramidal structural defect, 5 to 8 μm wide, has been discovered in thin films of epitaxial ErSi_{2-x} formed by annealing thin Er films on Si(001) substrates at temperatures of 500°C to 800°C. Since these defects form even upon annealing in vacuum of TiN-capped films their formation is not due to oxidation. The pyramidal defects are absent when the ErSi_{2-x} forms on amorphous substrates, which suggests that epitaxial strains play an important role in their formation. We propose that these defects form as a result of the separation of the silicide film from the substrate and its buckling in order to relieve the compressive, biaxial epitaxial stresses. Silicon can then diffuse through the silicide or along the interface to fully or partially fill the void between the buckled ErSi_{2-x} film and the substrate.

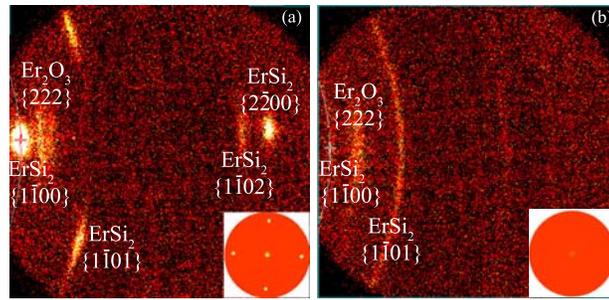
Fig. 1

1. X-ray diffraction GADDS (general area detector diffraction system) scans of an erbium silicide film formed (a) on a Si(001) substrate and (b) on a preamorphized silicon substrate and annealed at 500°C for 60 s. The x-axes are 2θ and the y-axes are χ . The insets are pole figures along the $\text{ErSi}_{2-x} \{1\bar{1}00\}$ direction.

Phases were identified using x-ray diffraction (Bruker D8 GADDS x-ray diffractometer with 2D detector), electron diffraction and secondary ion mass spectroscopy (SIMS). Figure 1(a) shows a typical XRD pattern for an Er film deposited on Si(001) and annealed for 60 s at 500°C (temperatures up to 800°C showed similar results). This figure shows the $\{1\bar{1}00\}$, $\{2\bar{2}00\}$, $\{1\bar{1}01\}$, and $\{1\bar{1}02\}$ peaks of AlB_2 hexagonal erbium disilicide. The observation of dominant $\{1\bar{1}00\}$ and $\{2\bar{2}00\}$ peaks in the 2θ scans suggests that ErSi_{2-x} $\{1\bar{1}00\}$ (prism plane) is oriented parallel to the (001) Si substrate surface, i.e., the c-axis of ErSi_{2-x} lies parallel to the substrate. Furthermore, the observation of the two $\{1\bar{1}01\}$ peaks symmetrically displaced from the central axis (containing the $\{1\bar{1}00\}$ and $\{2\bar{2}00\}$ peaks) implies that this is not simply a fiber texture, but that there is a strong in-plane texture as well. The inset in Fig. 1(a) shows a pole figure of the same film. The 4-fold symmetry (rather than the 2-fold symmetry expected if the ErSi_{2-x} were a single crystal) confirms that there are two distinct ErSi_{2-x} epitaxial orientations relative to the Si substrate. That is, the ErSi_{2-x} film contains both regions where the [0001] (i.e., c-axis) is parallel to Si[110] and regions where it is parallel to Si[1 $\bar{1}$ 0], in agreement with previous reports [5, 10, 11]. All films grown on the crystalline Si substrate and annealed between 500 and 800°C with and without TiN capping exhibited epitaxy.

The pyramidal defects are absent from ErSi_{2-x} films grown on preamorphized (PAI) Si substrates (the amorphous region extended from the surface into the substrate to 45 nm). Figure 1(b) shows that the ErSi_{2-x} film formed on amorphized silicon is a random polycrystal rather than epitaxial as in growth on crystalline Si(001).

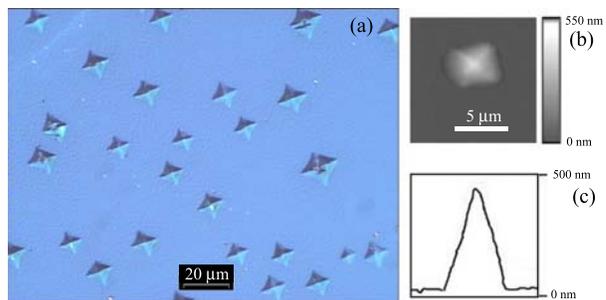
Fig. 2

2. (a) Optical image of pyramid structural defects in an erbium silicide film annealed at 500°C for 60 s. (b) Atomic force micrograph showing the pyramidal shape of one defect. (c) A linear scan through along the pyramidal defect (through the peak) in (b) showing the shape and height profile more clearly.

Figure 2(a) is an optical micrograph of a sample annealed at 500°C for one minute. The image shows that the film contains many pyramidal defects. These defects all have nearly square bases and all of the defects share the same orientation. This micrograph, together with the atomic force microscopy (AFM) images in Figs. 2(b) and 2(c), suggests that these defects are square-based pyramids (apex points away from the Si/ ErSi_{2-x} interface). Similar observations were made on samples annealed at $500 \leq T \leq 800^\circ\text{C}$. The pyramidal

defects are 4–8 μm wide and have a density on the order of 10^5 cm^{-2} . The presence of these defects in all samples, independently of whether the film was capped with TiN or not prior to annealing in vacuum or in N_2 , indicates that the formation of these defects is not associated with oxidation. To our knowledge, the presence of such pyramidal defects has not previously been reported. On the other hand, earlier reports suggest that pits penetrating into the Si substrate form when ErSi_{2-x} films are grown on Si(001) at low temperature [3, 4, 9].

Examination of a large number of the pyramidal defects in the scanning electron microscope shows that many of the defects are cracked (these can also be seen in the optical micrograph in Fig. 2(a)). The cracking, represented in Fig. 4(f), is likely a result of the large tensile stresses formed near the four edges of the pyramid that meet at the apex and the contraction of the ErSi_{2-x} film upon cooling. The coefficient of thermal expansion of erbium silicide is larger than that of silicon hence large differential strains occur on cooling from the annealing temperature to room temperature.

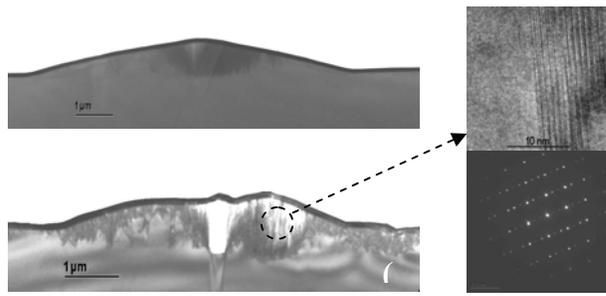
Fig. 3

3. Cross-sectional TEM micrographs of pyramidal structural defects on an erbium silicide film annealed at 500°C for 60 s. Figure (a) shows a buckled region that is completely filled with Si, while (b) shows a void at the center of the defect that extends from film to interface. The insets to (b) show a HRTEM image and the corresponding electron diffraction pattern of the defective Si region between the buckled film and the original interface.

Figure 3 shows cross-sectional transmission electron micrographs (XTEM) of pyramidal defects like those shown in Fig. 2. In Fig. 3(a), the space between the ErSi_{2-x} film and the original Si substrate surface is filled with Si, as confirmed using electron dispersive spectroscopy. In Fig. 3(b), the intervening space is only partially filled with Si; i.e., there is a void below the pyramid apex that extends from the film to the substrate. In both cases, the silicon between the film and original substrate surface is highly defective. Electron diffraction and high resolution TEM of the defective area (see the inset in Fig. 3(b)) show that the defective region of the Si consists of a dense array of parallel stacking faults on $\{111\}$ ($(a/6)\langle 110 \rangle$ translations).

consists of layers of Si and Er perpendicular to the c-axis). When the Si atoms reach the edge of the defect, they can diffuse either on the Si(001) surface or on the free ErSi_{2-x} surface (Fig. 4(c)). As shown in Fig. 4(c), silicon may grow simultaneously from the two surfaces. In the case of Si growing on the Si(001) surface, only one crystal orientation is possible. In contrast, there is considerable evidence that Si formed on free ErSi_{2-x} surfaces may grow with different orientations (see [15]). Eventually, the two re-crystallization fronts meet as shown schematically in Fig. 4(e), resulting in the filled pyramidal defect of Fig. 3(a). Figure 3(b) shows the case where a void remains (i.e., where the two fronts have not yet met) as in Fig. 4(d).

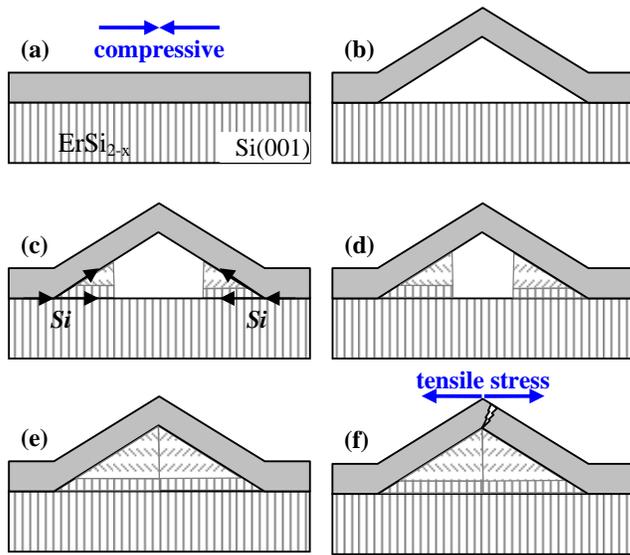
Fig. 4

4. Schematic representation of the formation and evolution of the pyramidal defect, showing (a) the initial, compressively stressed ErSi_{2-x} film on a Si substrate, (b) the buckling of the silicide film and its separation from the substrate, (c) Si atom diffusion along Si(001) free surface and within the ErSi_{2-x} film, (d) a partially filled pyramidal defect as in Fig. 3(b), (e) a completely filled defect as in Fig. 3(a), and (f) the formation of a crack in the ErSi_{2-x} film in the pyramidal defect upon cooling.

The proposed pyramidal defect formation mechanism is illustrated in Fig. 4. The film buckles away from the substrate to relieve the very large epitaxial strain energy (Fig. 4(b)). We note that the pyramidal defect density is too low to significantly relieve the total strain energy stored in the film. Such buckling or blistering must originate at a pre-existing defect or region where the bonding between substrate and film is weak. These may either be processing defects or form as the result of plastic deformation. While it is possible for a compressively stressed film to buckle while remaining attached to the substrate, the observations of voids beneath the pyramidal defect (Fig. 3(b)) and the highly defected Si where the void was filled (insets to Fig. 3(b)), both suggest that the film separates from the substrate upon buckling. Further, if the film remained attached to the substrate upon buckling, the density of the pyramidal defects would be much larger than that observed (to relax much of the strain energy stored in the ErSi_{2-x} film).

After the pyramidal defect forms by buckling, Fig. 4(b), the open region between the film and substrate begins to fill with Si, Figs. 4(c)–(e). This filling occurs in order to lessen the surface energies; filling the void below the buckled ErSi_{2-x} film covers part of both the Si free surface and the ErSi_{2-x} free surface. One indication that this filling occurs is the observation that the Si that fills in, under the buckled ErSi_{2-x} film, has a very different defect structure from that in the original Si substrate. That is, this Si contains a high density of $\{111\}$ stacking faults (see Fig. 3(b)). The Si atoms located at the $\text{ErSi}_{2-x}/\text{Si}$ interface close to the defect diffuse along or near the interface towards the defect. The stoichiometry of ErSi_{2-x} obtained from Rutherford backscattering spectrometry (RBS) indicates that 1 in 6 Si sites is vacant [14] —hence the notation ErSi_{2-x} with $x = 1/3$. Therefore, we expect that the Si diffusivity through the ErSi_{2-x} , perpendicular to the c-axis, is very high (note that ErSi_{2-x}

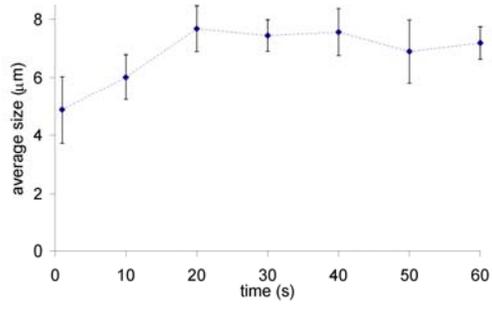
Fig. 5

5. The average size of the defects formed at 600°C as a function of annealing time. The zero of time corresponds to the beginning of the rapid thermal anneal and the first data point is at one second.

The mechanistic model described above suggests that a balance between the elastic energy stored in the unbuckled film and the surface and interface energies determines the size of the pyramidal defects. Therefore, once the ErSi_{2-x} film forms and buckles on rapid thermal annealing, the size of the pyramidal defects should not increase on further annealing. As a check on the validity of the mechanistic model, we measured the pyramidal defect size in several films, formed by annealing for different times. The results are shown in Fig. 5. Except for very short times (corresponding to incomplete silicide formation), the pyramidal defect size is independent of annealing time—in agreement with the predictions of the mechanistic model.
