Studies of aging and HV break down problems during development and operation of MSGC and GEM detectors for the Inner Tracking System of HERA-B [★]

Abstract

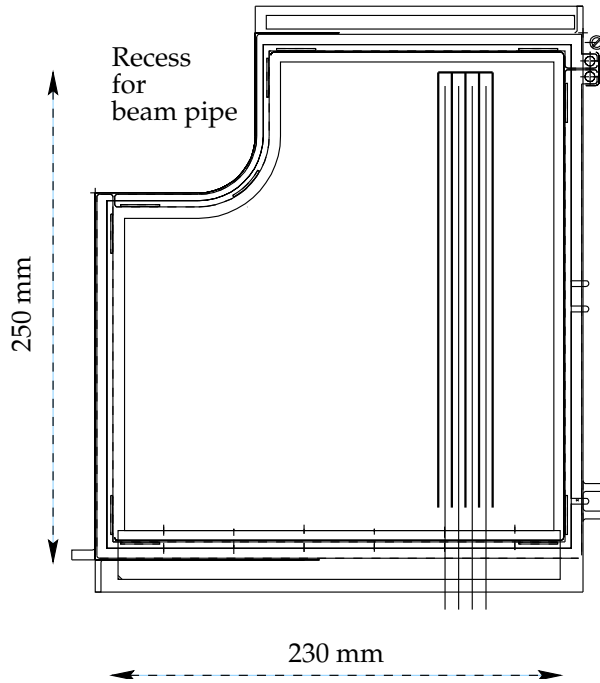
Fig. 1. Sketch of a MSGC chamber indicating size and shape of the wafer.

The interaction rate at the target varied between 3 MHz and 40 MHz. Most of the data were taken at 5 MHz. A typical distribution of the hit density in a detector is shown in Figure 16 for 5 MHz interaction rate. The hit density is about 0.006 per anode and event. The shape of the distribution is determined by the beam recess of the MSGC wafer (see Fig. 1) and the radial decrease of particle density.

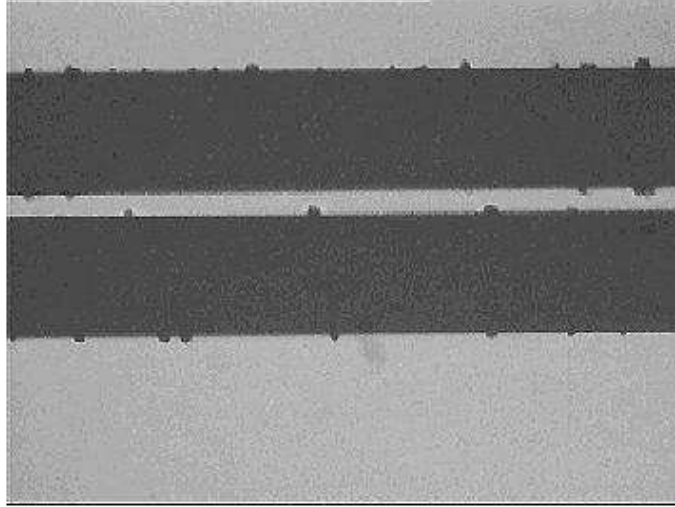
Fig. 2. Photograph of MSGC electrodes after operation of the chamber in a pion beam. Characteristic defects are observed at the electrode borders.

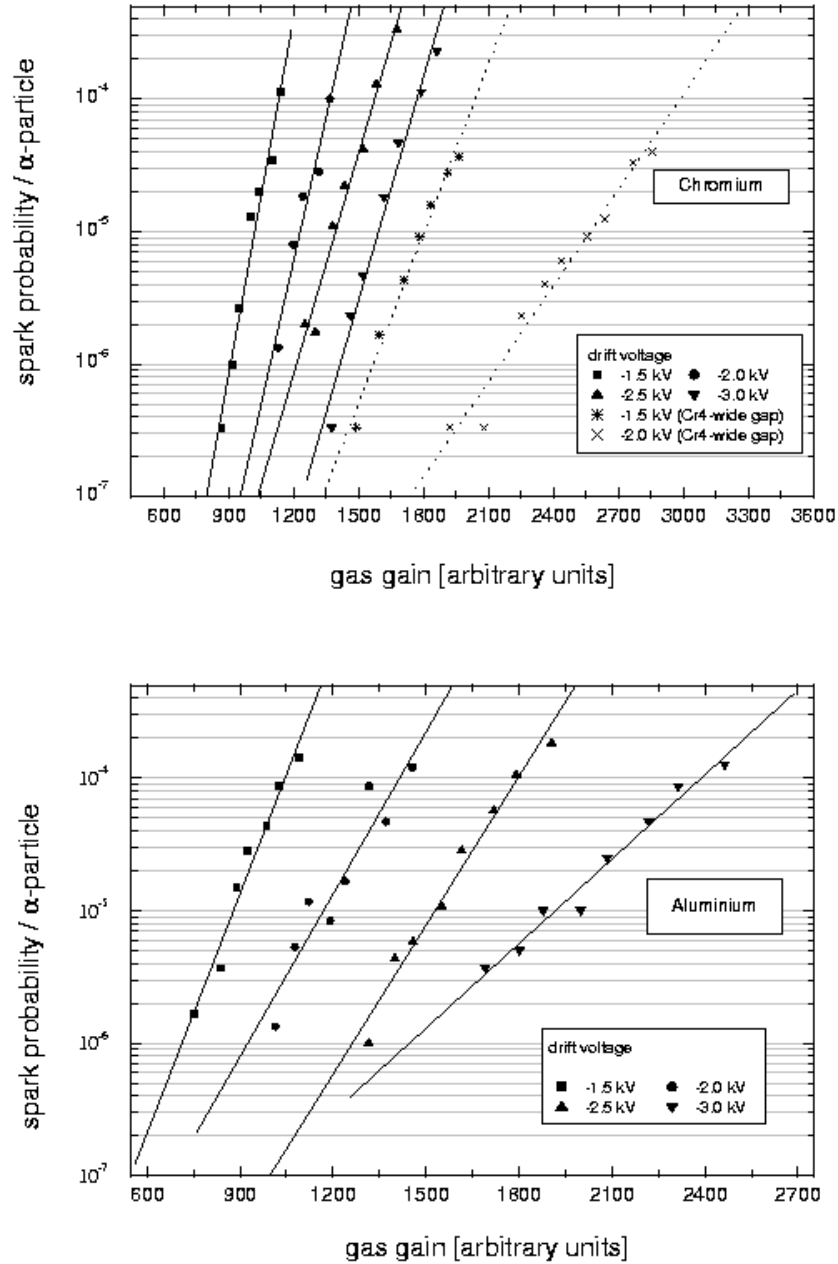
A characteristic result from the second method is presented in Figure 3 which shows the spark rate as a function of the cathode and drift voltages measured with a $0.15 \mu\text{m}$ thick chromium structure and with $1 \mu\text{m}$ thick aluminium electrodes. We observe a strong exponential rise of the spark rate with the cathode voltage which is responsible for the

Fig. 3. Spark probability per α particle as a function of the cathode and drift voltages measured with a $0.15 \mu\text{m}$ chromium and a $1 \mu\text{m}$ aluminium structure.

field near the surface and a much weaker dependence on the drift voltage. At fixed gas gain, high drift fields are favorable.

The effect of the width of the anode cathode gap was studied by increasing it by a factor two to $120 \mu\text{m}$. At fixed gain the spark rate is smaller (see Figure 3), but this positive effect is more than compensated by the more severe damage per spark observed with the wide gap, where the energy stored in the anode-cathode capacitance is much larger.

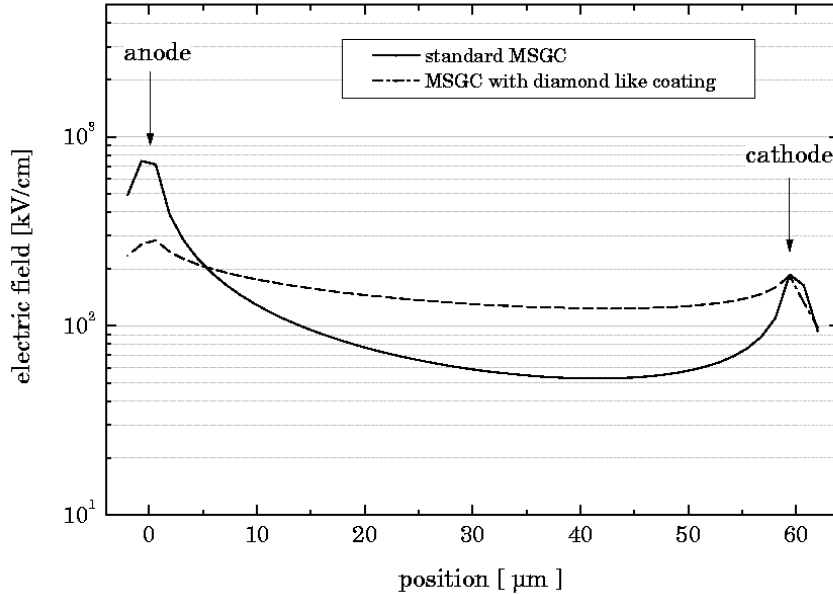
field component parallel to the surface near the surface, whereas bare glass produces a strongly decreasing field near the anode, which suppresses streamer discharges [11,12]. The electric fields between the electrodes computed for a coated and an uncoated substrate are shown in Figure 4. Even though dynamical effects from the space charge created by the avalanche are neglected, the simulation illustrates the qualitative difference between the two configurations.

Fig. 4. Simulation of electric field for coated and uncoated MSGC.

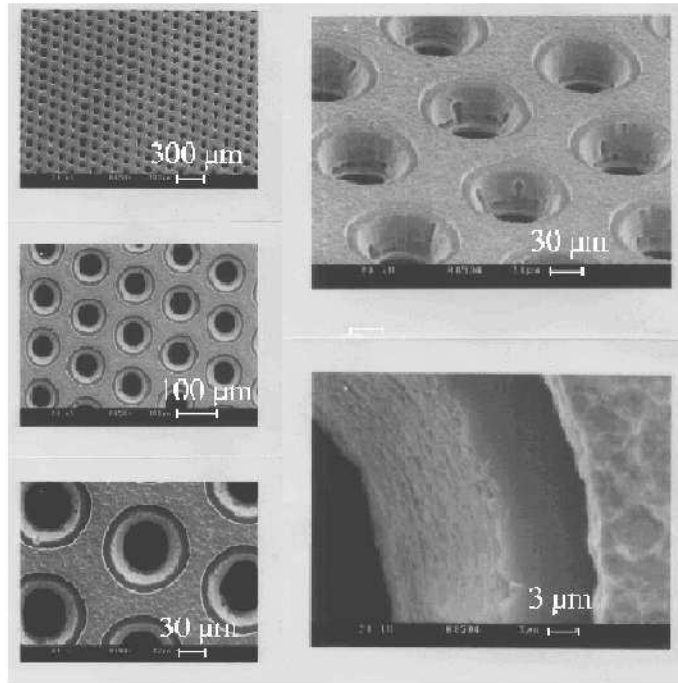
Fig. 5. Photographs of a GEM with different enlargements

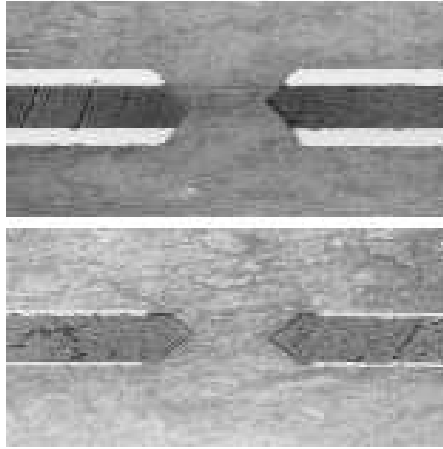
Fig. 6. Cross section of GEM foil before and after final etching step.

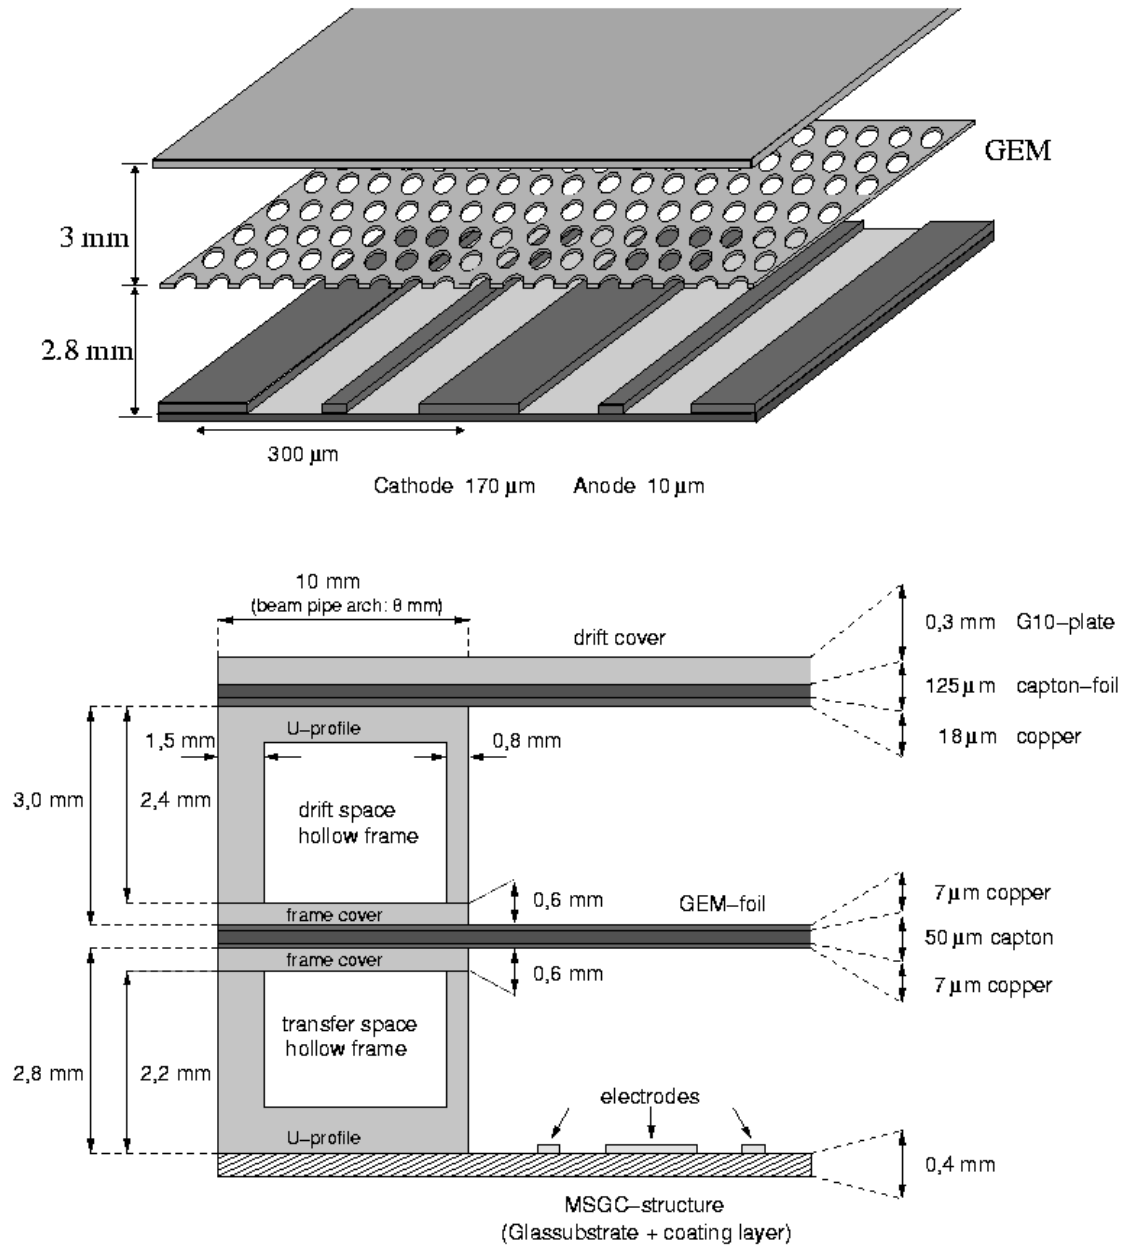
Fig. 7. Schematic view of a MSGC/GEM detector (top) and cross section showing the frame (bottom).

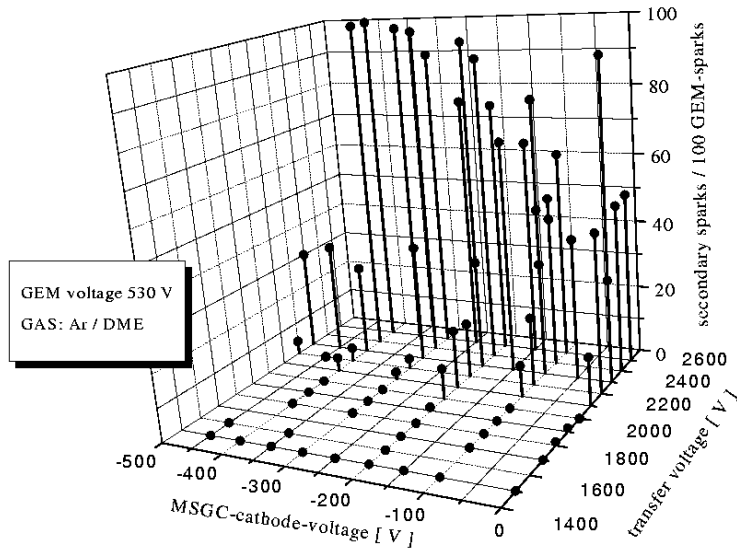
Fig. 8. Spark rate as a function of the cathode voltage and the voltage between GEM and the anodes. A transfer field of 2.5 kV/cm corresponds to

with additional gas amplification there, are likely to produce secondary sparks. Thus the rate of those strongly depends on the strength of the transfer field. This was confirmed by laboratory measurements presented in Figure 8 and it explained also the different behavior of the chambers at the two PSI tests which were performed at slightly different HV settings.

A significant dependence of the secondary spark rate on the cathode voltage has not been observed (see Figure 8).

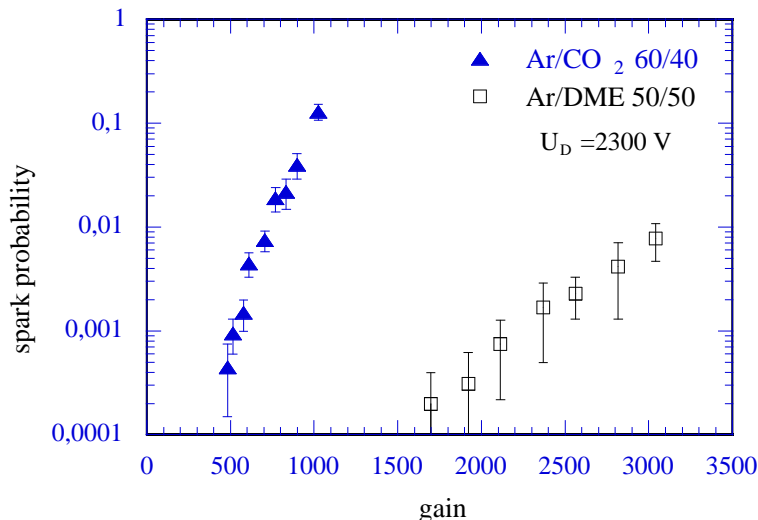
Fig. 9. Discharge rate induced by α -particles in a MSGC versus gas gain (arbitrary units) for two gas mixtures Ar-DME and Ar-CO₂.

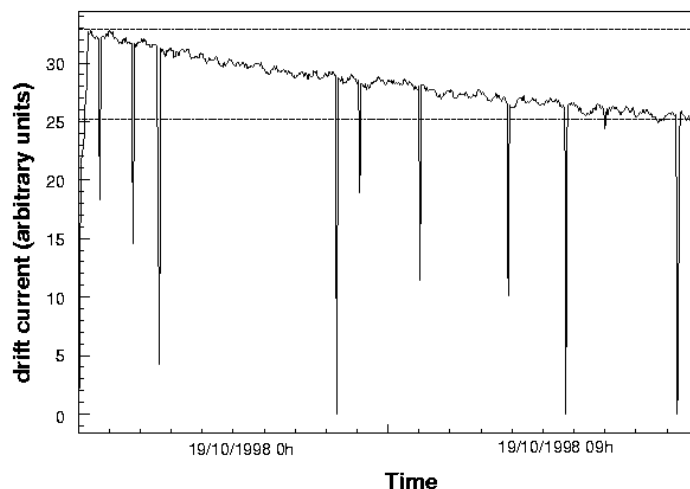
Fig. 10. Drift current (arbitrary units) as measured in the MSGC/GEM detector versus operation time during intense proton irradiation at PSI. The beam current was kept stable during the exposure. The gaps correspond to beam losses.

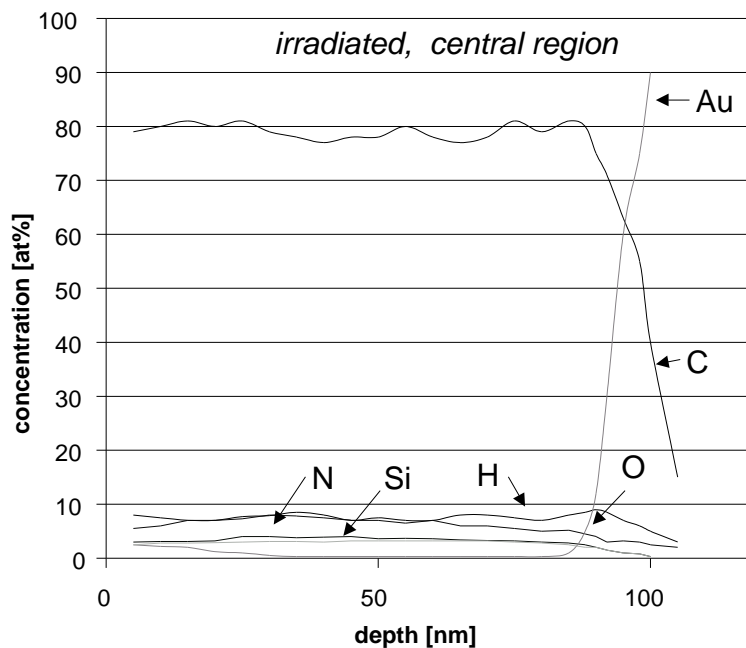
Fig. 11. Concentration of elements as a function of depth for the anode area in the irradiated region. A layer of carbon of 80 nm thickness is covering the gold surface.

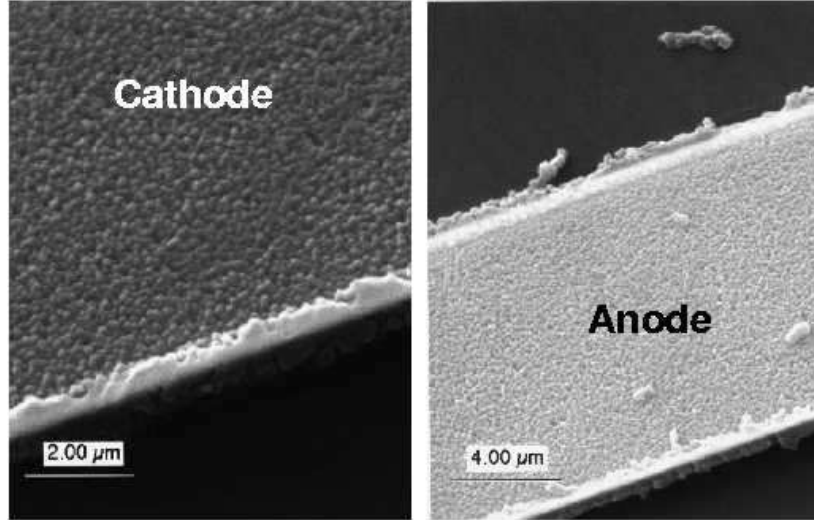
Fig. 12. Photograph (electron microscope) of anodes in the irradiated area of the MSGC after beam test at PSI.

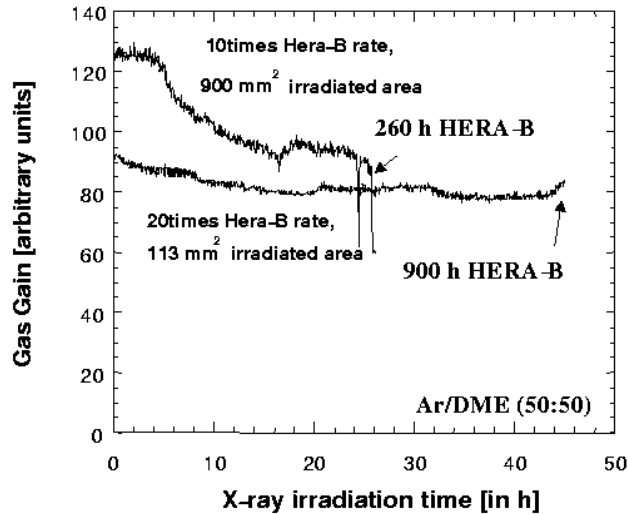
Fig. 13. Gas gain versus irradiation time for a MSGC/GEM detector using Ar-DME 50/50 and two different sizes of the irradiated area. The detector was irradiated with X-rays using a charge deposition rate corresponding to 10 respectively 20 times the maximal rate expected at HERA-B.

We therefore have to draw the conclusion that gas aging effects depend strongly on the size of the irradiated area. All evidence supports the assumption that the origin of these deposits is the DME itself. We have no explanation for this experimental fact but it invalidates all aging tests done before.

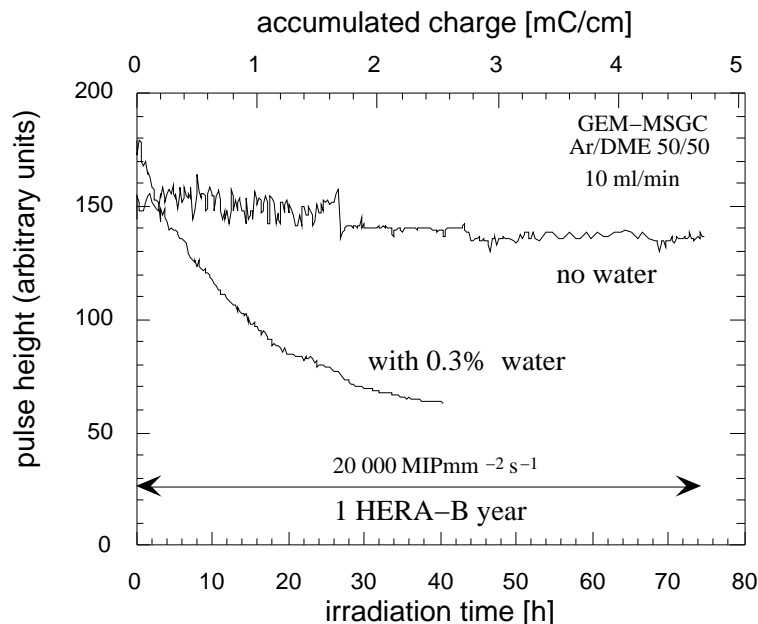
Fig. 14. Development of the pulse height for a gas mixture of Ar-DME with 0.3% of water and without water as function of the irradiation time.

The operation characteristics of a MSGC can be significantly improved by adding small amounts of water, typically 0.3%, to the counting gas. This avoids discharges near insulators e.g. near the detector frames and anode ends and improves the overall protection against sparking, probably by reducing the surface resistivity of plastic materials which tend to absorb water. Addition of water to the counting gas shows however very severe and fast gas aging for both, Ar-DME and Ar-CO₂. This is shown in Figure 14 which compares the pulse height as a function of accumulated charge for Ar-DME with and without an admixture of water. For the gas with water admixture the pulse height drops by a factor three for an accumulated charge of less than 3 mC/cm. Moreover the anodes show deposits in the irradiated area.

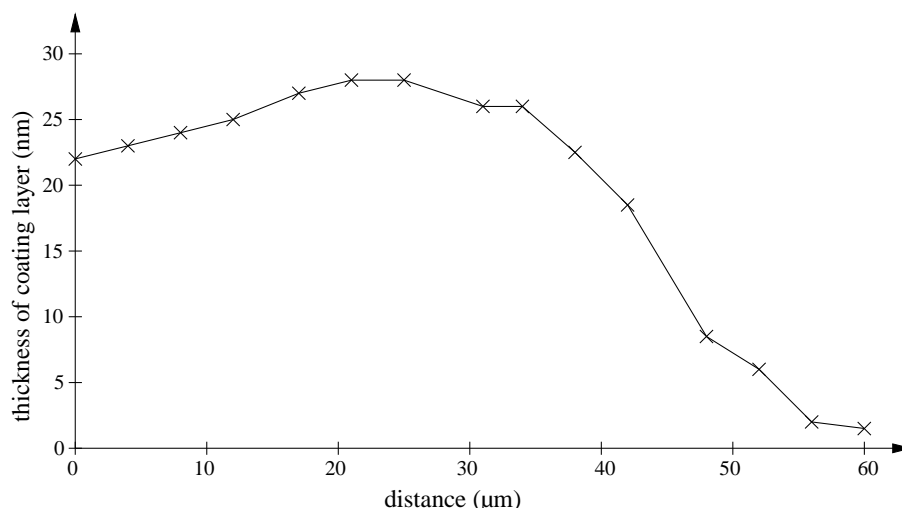
Fig. 15. Thickness of the coating layer across the cathode anode gap after strong irradiation. The anode starts at 60 μm .

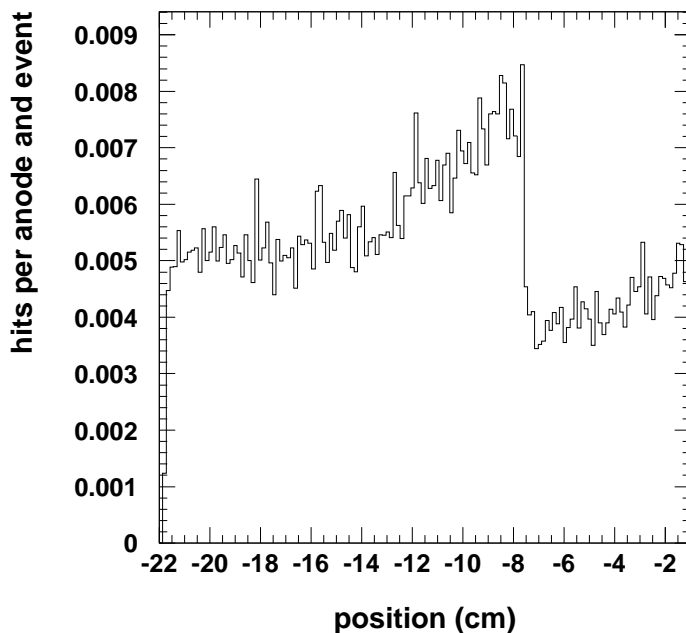
Fig. 16. Hit density as a function of the horizontal distance to the beam axis.

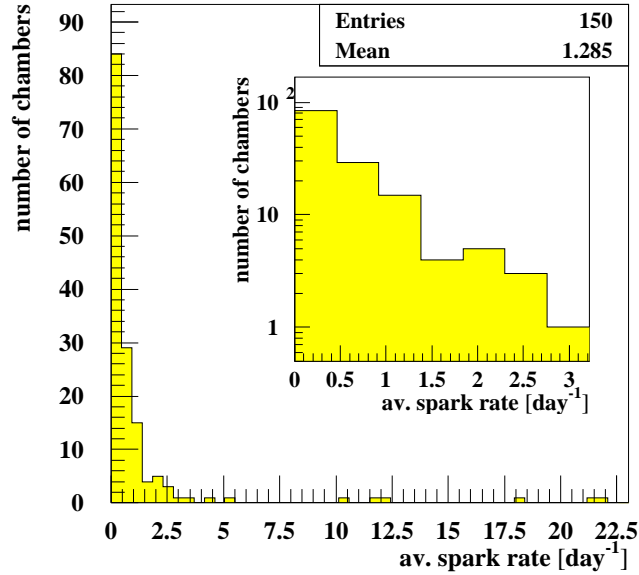
Sparking in GEMs cannot be avoided completely, but under normal conditions the rate is quite low, of the order of a single spark per day (see Figure 17), a rate which is tolerable. Only six chambers showed sparking at rates above ten per day.

Fig. 17. Number of chambers as a function of their average spark rate. Most chamber show rates below two sparks per day at an average target rate of 5 MHz.

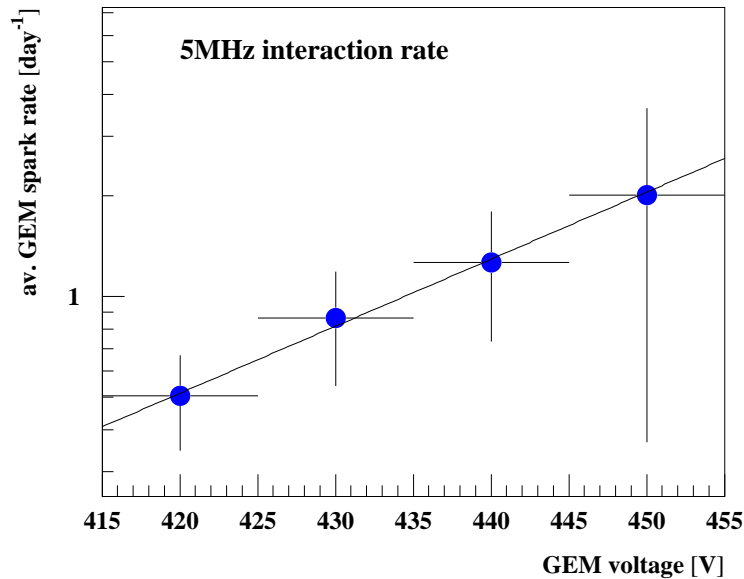
Fig. 18. Spark rate versus GEM voltage averaged over all chambers with rates below six per day. The error bars include systematic uncertainties.

The spark rate increases exponentially with the GEM voltage rising from 1 to 5 sparks/day when the GEM voltage is increased from 400 V to 450 V. This is shown in Figure 18 for chambers behaving normally. Chambers with exceptional high rates are excluded in this Figure to avoid a biased picture. As expected, the sparking rates increased with the beam intensity. Similar results have been reported in Refs. [20,21] where a linear dependence of the sparking probability on the beam intensity and a strong dependence on the beam composition has been observed.

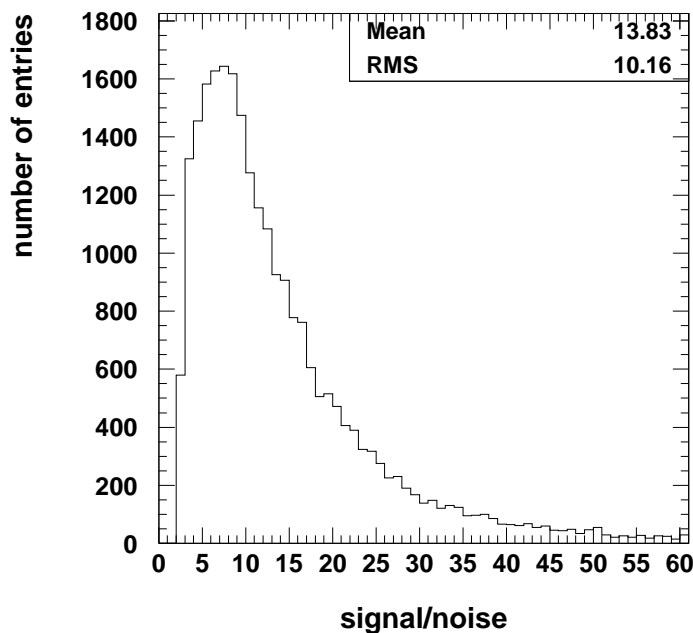
Fig. 19. Signal over noise distribution.

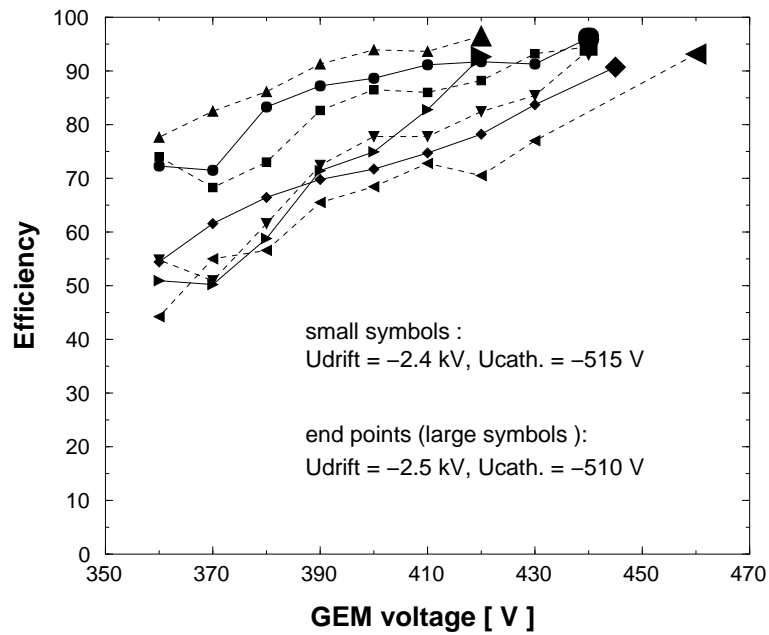
Fig. 20. Efficiency of seven detectors of station MS01 versus GEM voltage for fixed cathode and drift voltages. The large symbols show the efficiencies for the current voltage settings after individual gain adjustments.

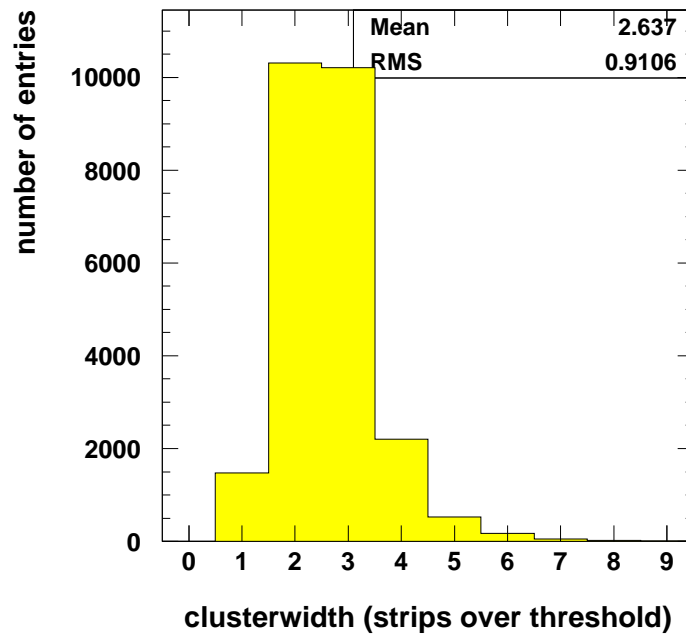
The strip multiplicity distribution shown in Figure 21 corresponds to a mean value of 2.6 for a threshold of 5000 electrons, which is twice the average noise level. This rather high value is compatible with the large transverse diffusion in Ar-CO₂ along the long drift path of the electrons.

Fig. 21. Distribution of cluster width.

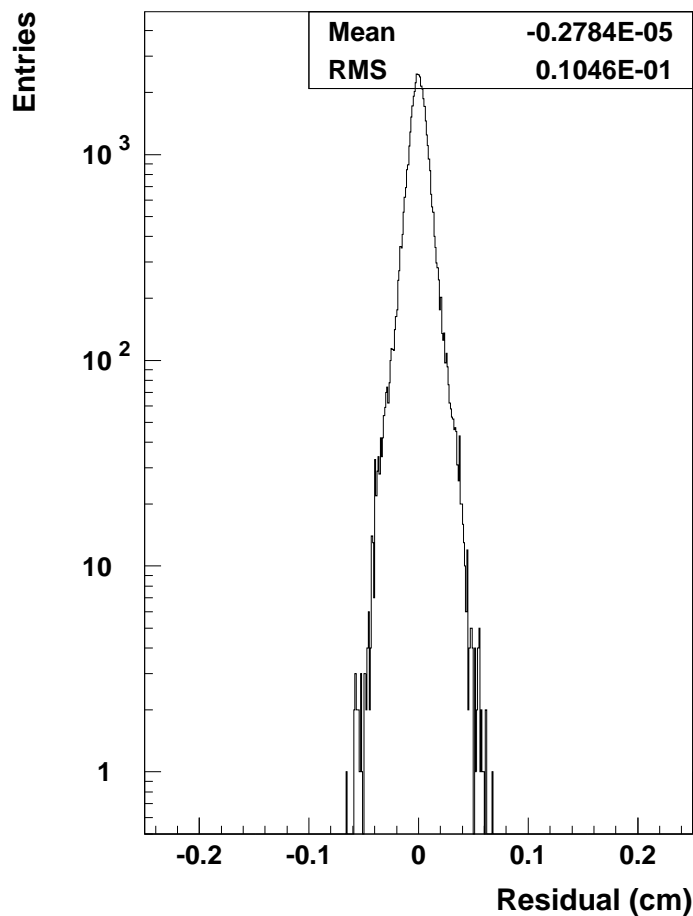
GeV/c is presented in Figure 22. In average 15 chambers contribute to one track. From a comparison of the observed root mean error of $105 \mu\text{m}$ with a Monte Carlo simulation we conclude that the intrinsic spatial resolution of the detectors is better than $110 \mu\text{m}$.

Fig. 22. Distribution of track residuals.
